ESKOM HOLDINGS SOC LTD

ESKOM KOMATI POWER STATION ESIA AND WULA PRELIMINARY CONTAMINATED LAND STUDY

18 AUGUST 2022

PROJECT NO.: 41103965
DATE: AUGUST 2022

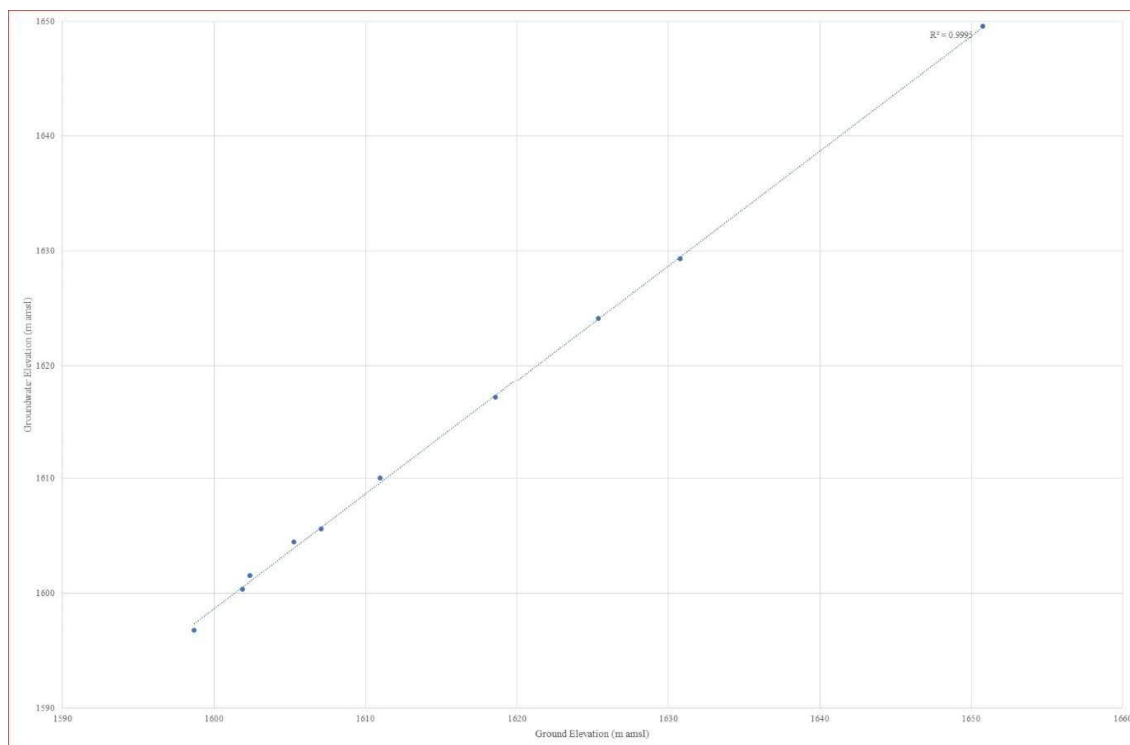
Figure A – Correlation: Topography versus Groundwater Elevation

Comparing topographic and groundwater elevations an R^2 value of 0.99 is calculable (**Figure A**) resulting in a very strong correlation coefficient and consistent with previous works. The interpolated groundwater flow is illustrated on **Appendix A: Figure 6** and confirms an overall flow direction to the north.

Very broadly, an average hydraulic gradient is calculated with reference to groundwater elevations (**Table 5**) at BH08 in the south and BH01 in the north. This represents a difference of ~52.82 m over a lateral distance of approximately 2,866 m, equating to a hydraulic gradient of ~0.018. It should be stressed that hydrogeological conditions are unlikely to be homogenous especially recognising that the shallow aquifer is discontinuous and, therefore, local variability should be expected that may differ markedly from this calculated average.

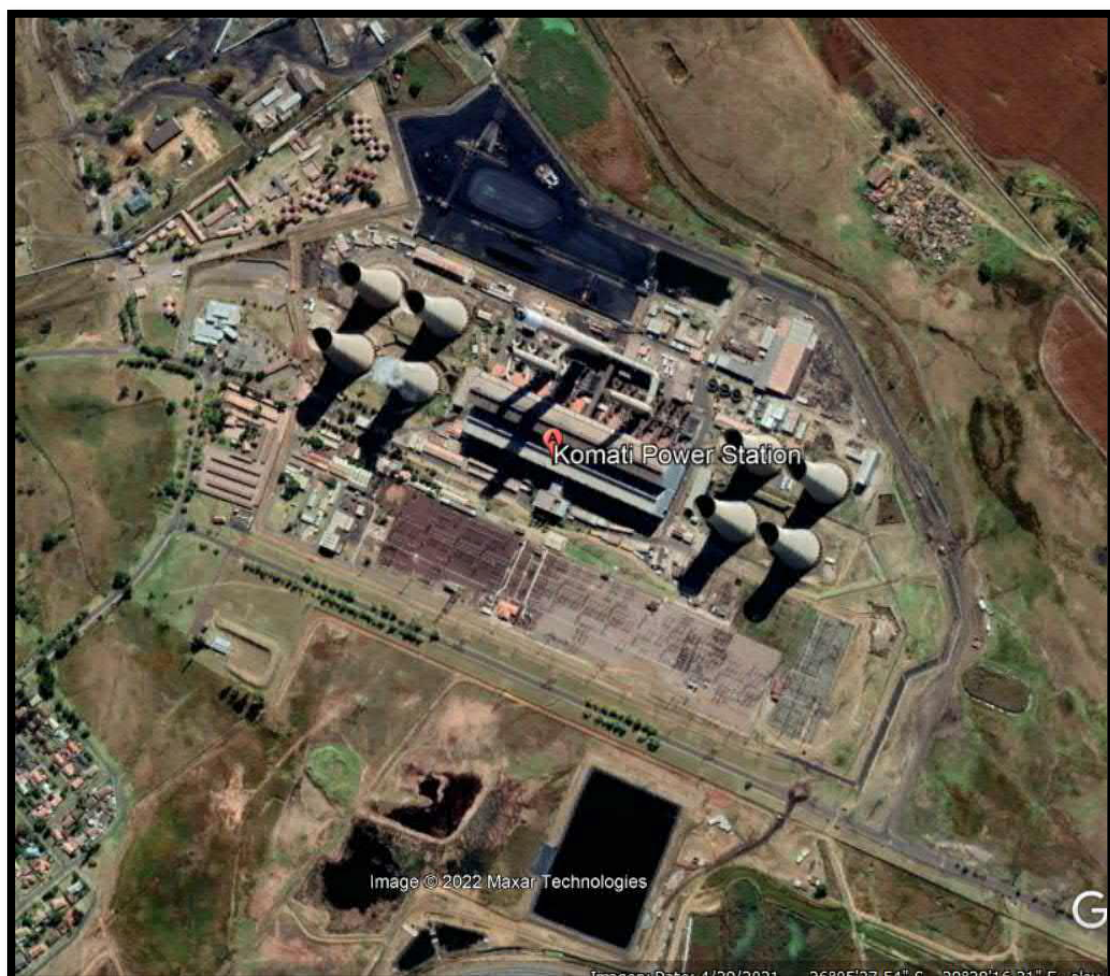
Site work was completed on 08 June 2022. The survey area as per image 1 below.
