Title: **Containment Re-Analysis for Long-Term Operation**

Document Identifier: **331-691**

Eskom has embarked on a project to extend the operating life of the Koeberg Nuclear Power Station (Koeberg). Koeberg requested an IAEA Safety Aspects of Long-Term Operation (SALTO) support mission to ensure a safe and structured approach. As part of this process, the containment buildings were subjected to an ageing management assessment to ensure that the required design margins would be maintained throughout long-term operation (LTO). These reinforced concrete containment buildings are post-tensioned and have a leak-tight steel liner.

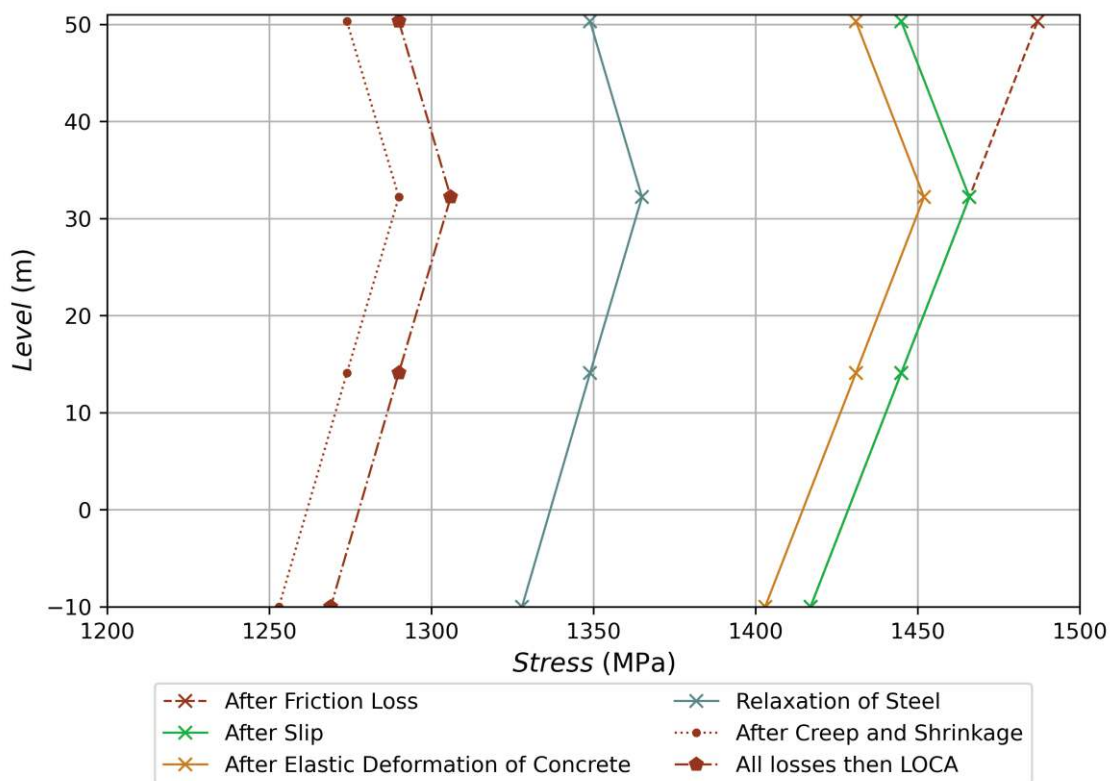
The original summary of the final containment analysis results [27] provided the stresses in the vertical cables[§], considering the various causes of tension losses, including the tension during a LOCA after the estimated loss of tensioning from all causes. These stresses are shown in Figure 9 and the same values are converted to force in Figure 10.

Figure 9: Summary of Design Stress in Vertical Tendons

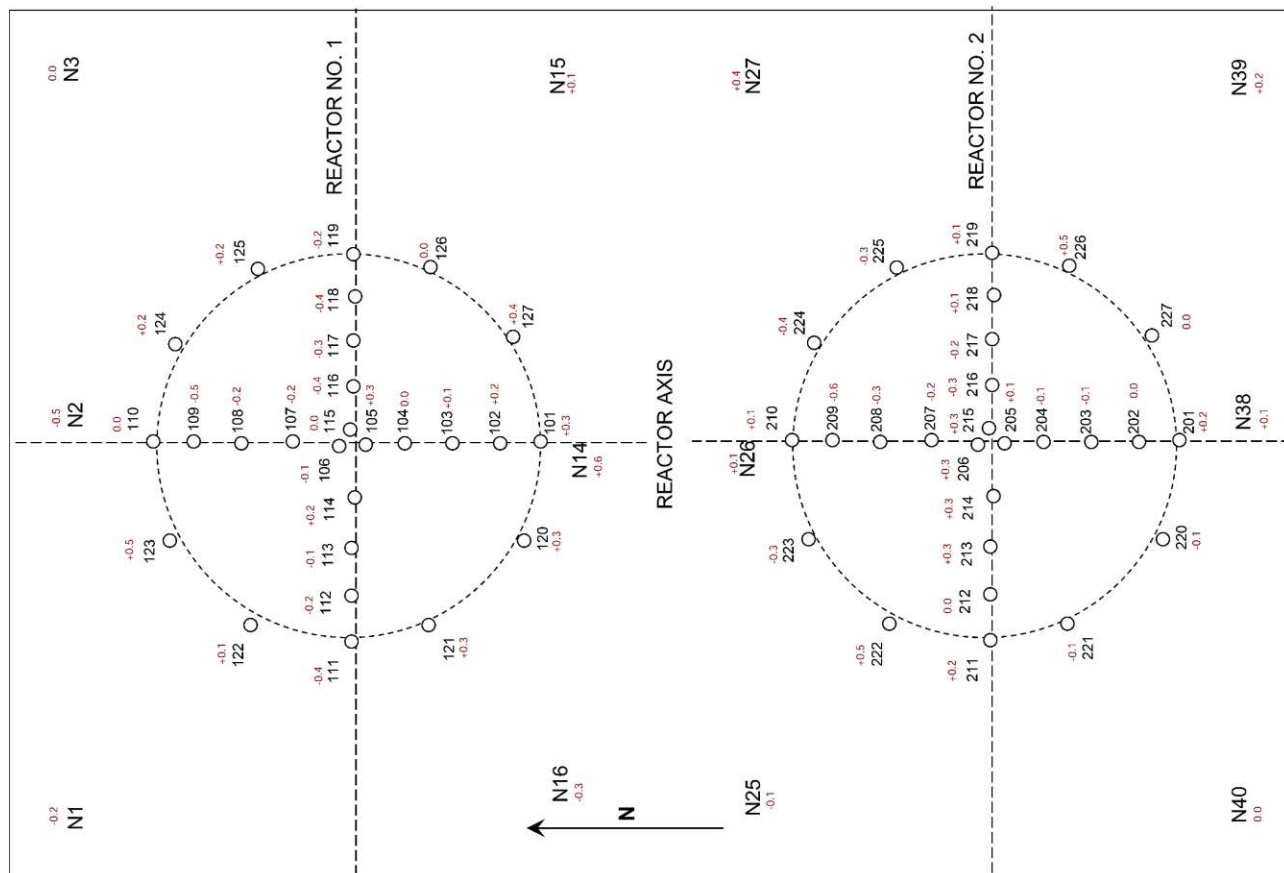
Figure 13: Aseismic Vault – Relative height differences in millimetres, 2016-2021

It is noted that the extreme relative movement between the upper and lower raft (i.e., the residuals) are +0.6mm and -0.5mm. It is concluded in the topographic survey report that the “residuals fall within the precision range of the survey. The settlement was more fully assessed and treated separately under TLAA 304, report L1124-GN-RPT-045.

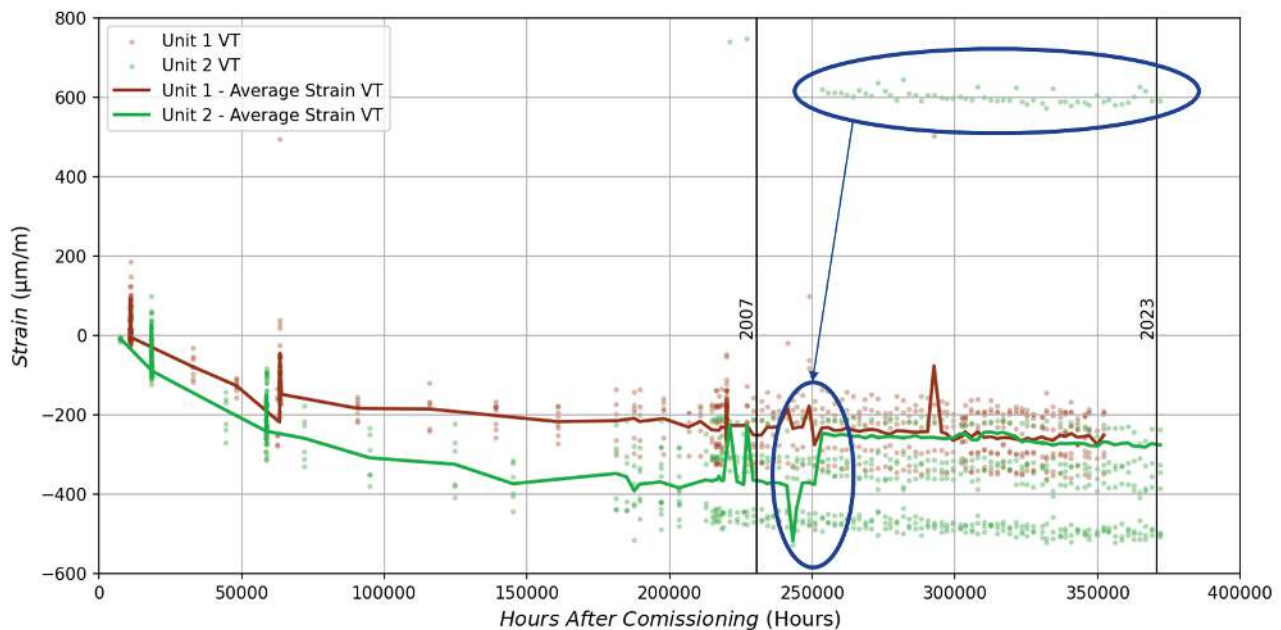
The raw vertical strain data for the +22.89m level gauges are presented below in Figure 22 for both Unit 1 and Unit 2. For Unit 2, a strain gauge can be seen to be an outlier (circled in Figure 22) which skews the data when inspecting the 'jump' in the average of the strain. This strain gauge (Unit 2, No. 10) is located at +22.89m on Grade 110. The strain gauge is however paired with No.12 at the same location which fits the data and is not excluded.

Figure 22: Raw Vertical Strain Data at +22.89m

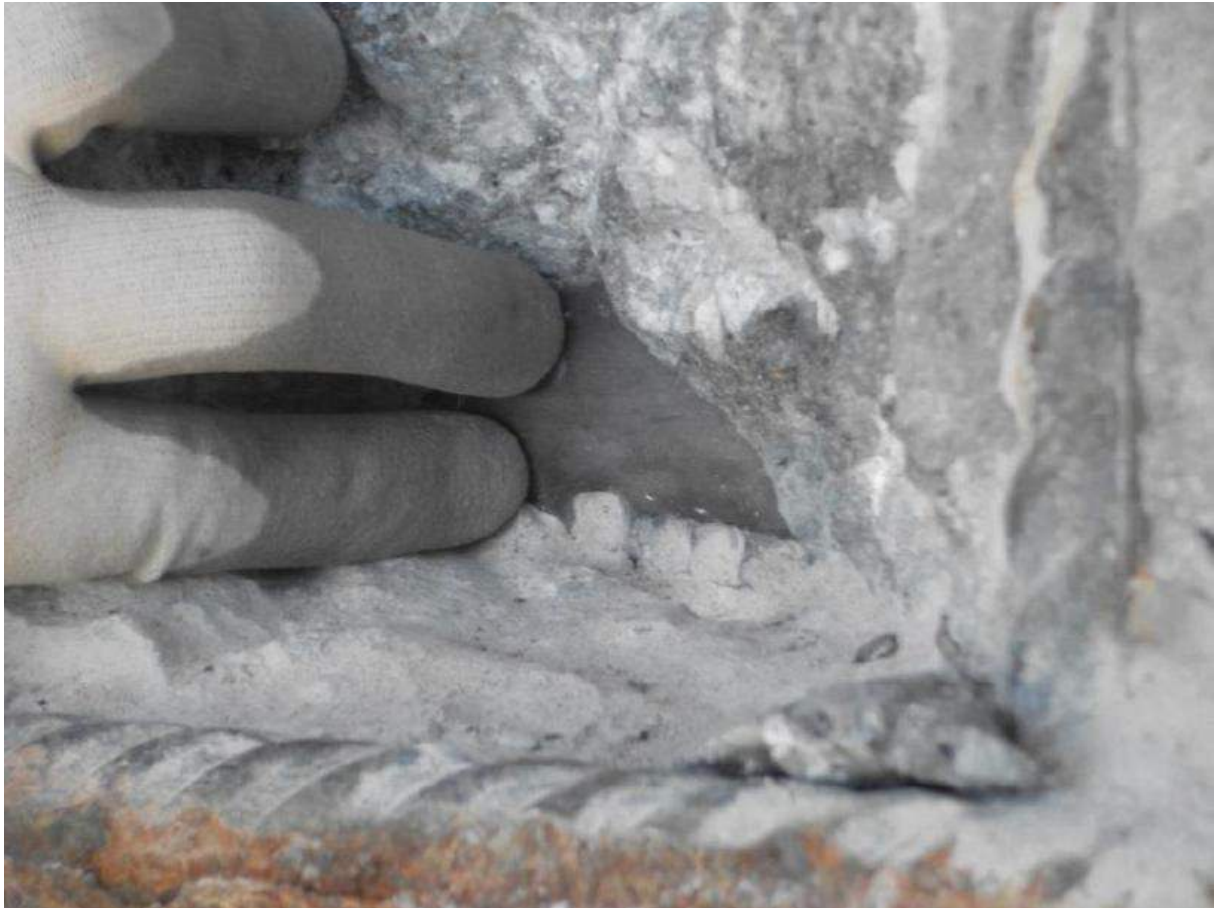
The tendon ducts were mostly in a good condition with no to very limited surface corrosion (which was considered to be the original condition when the duct was cast into the concrete [20]) as shown in Figure 70.

Figure 70: Exposed Tendon Duct

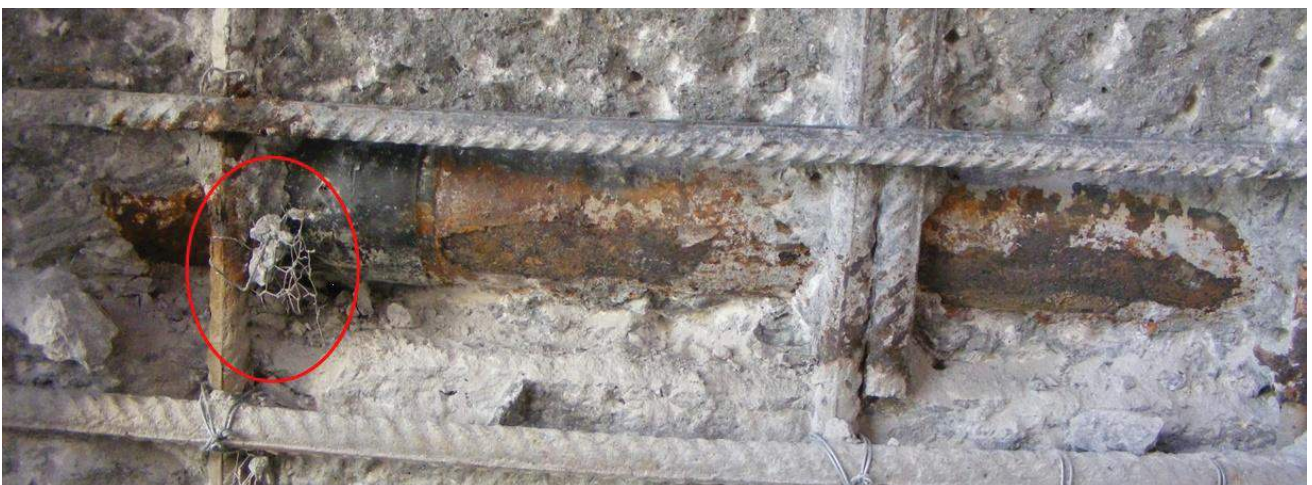
Cases of corrosion were identified and it was concluded during investigation [20] that the corroded part of this tendon duct is located in an area where a horizontal and vertical cold joint in the concrete occurred (note the chicken wire mesh used in the cold joint of Figure 71).

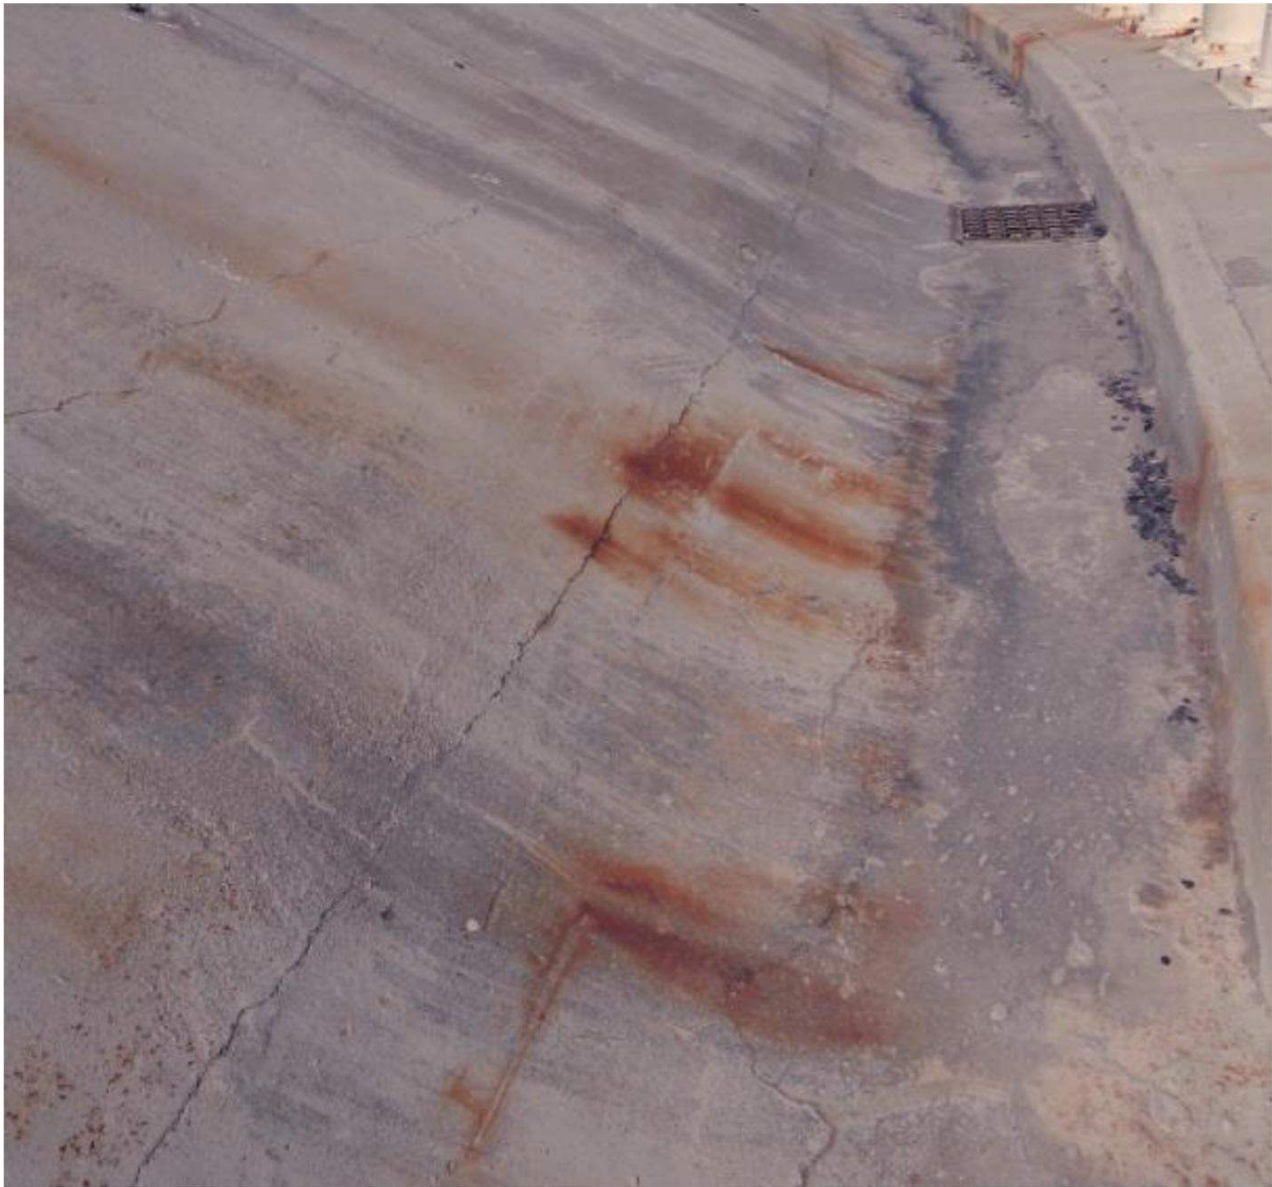
Figure 74: Crack on Domes

During the ISI routine civil inspections, circumferential dome cracking ("the dome crack") on both Unit 1 and 2 was identified (circa 2010 and 2011 respectively). The dome crack is along the entire circumference of the dome ($\pm 110\text{m}$) and is located on $\pm 17.3\text{m}$ radius from the containment centre, as shown in Figure 73, a photo of the crack is also shown in Figure 74.

After the ILRT tests and as part of the patch repair project, the dome cracks were sealed on both dome structures in accordance with the crack repair specification developed for the dome (reference [10]). A photo of the crack post-repair is provided in Figure 76 (June 2018).

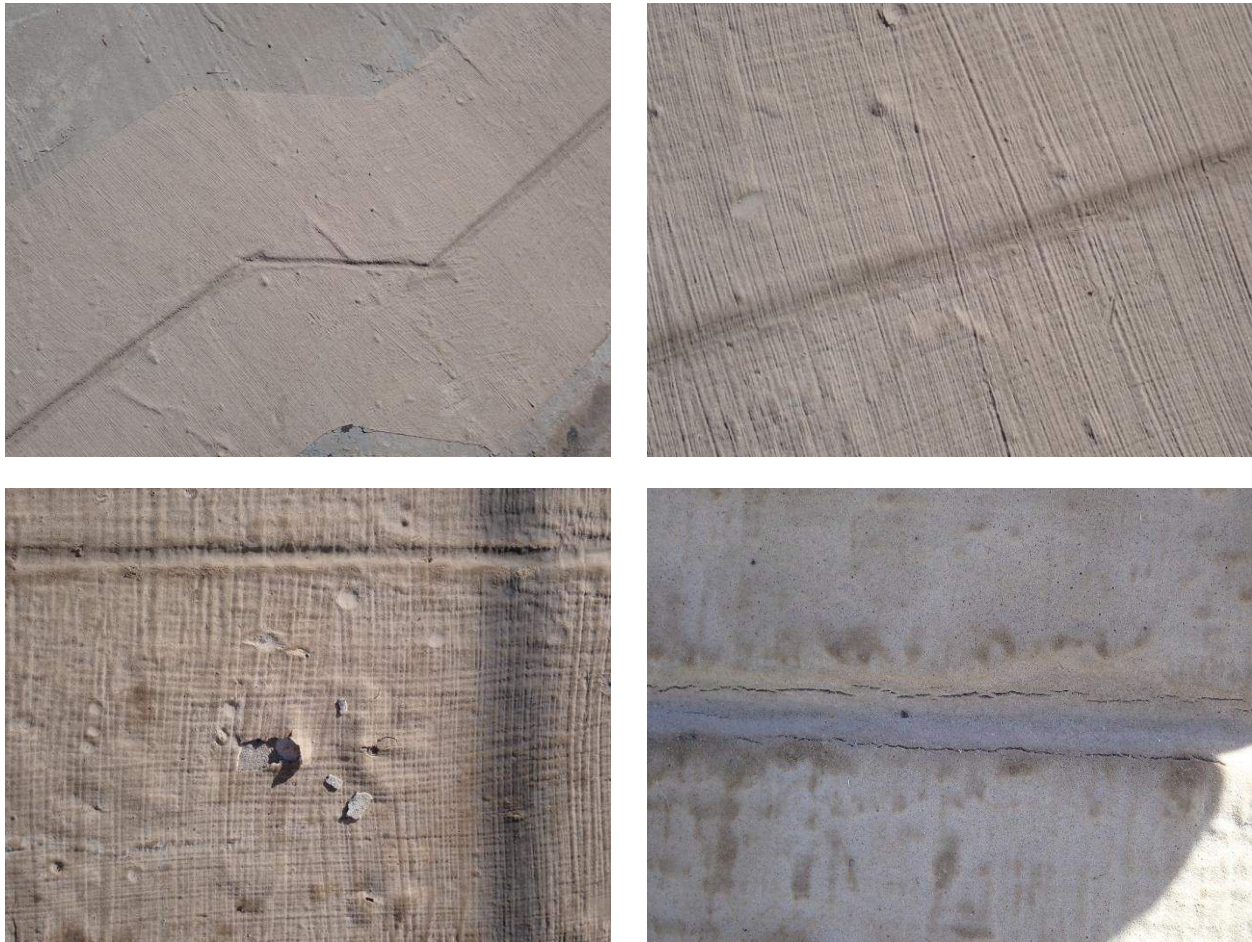
Figure 77: Condition Assessment of Repaired 1 HRX Dome Crack

During Outage 126 on Unit 1, an inspection was performed on the dome of the containment structure (October 2023). The repair of the dome crack has performed well with minor degradation of the coating, as illustrated in Figure 77.
