# **Koeberg – Ankerlig proposed 132kV power line walk down report**

(Conducted at the request of Eskom in fulfilment of the recommendations of a prior EIA process)

Prepared for:  
Savannah Environmental (Pty) Ltd

May 2016

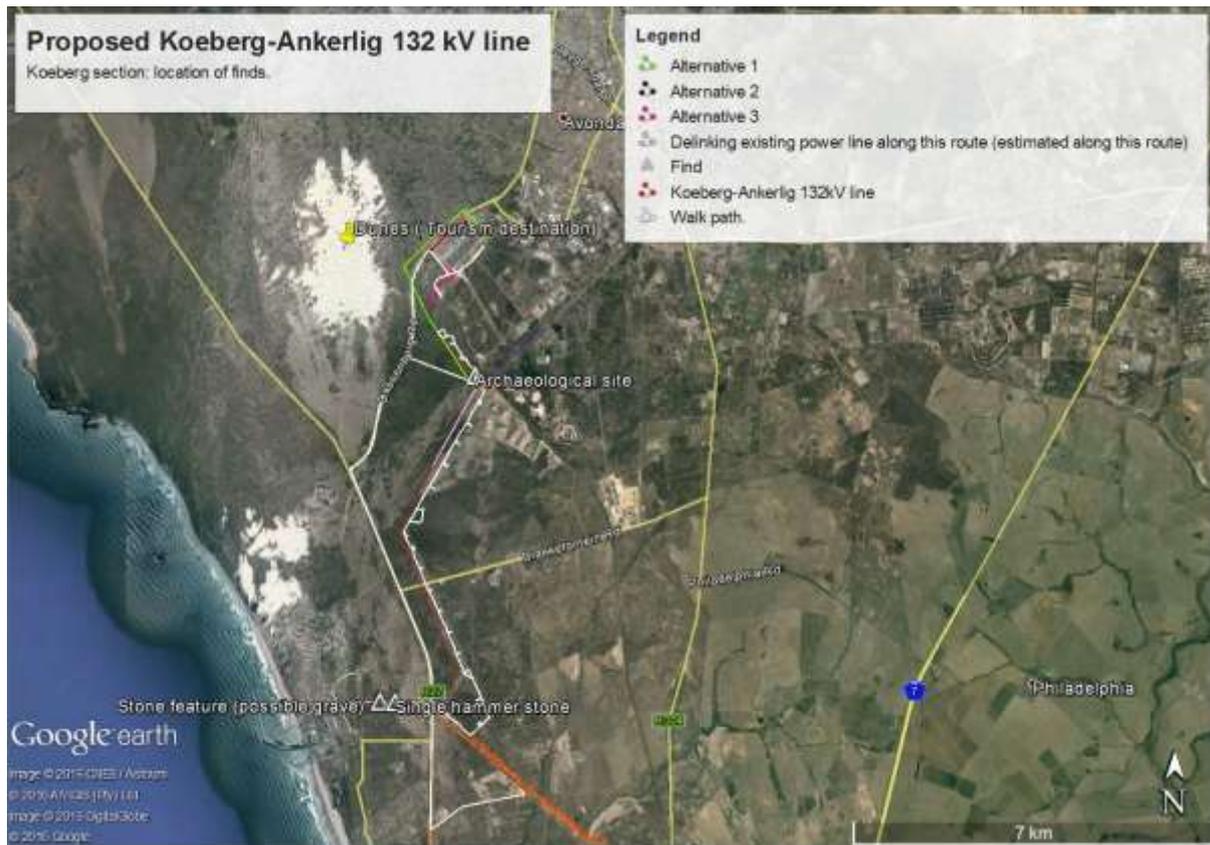
Figure 1 The project area with track log and finds. No material has been found associated with Alternative 2.

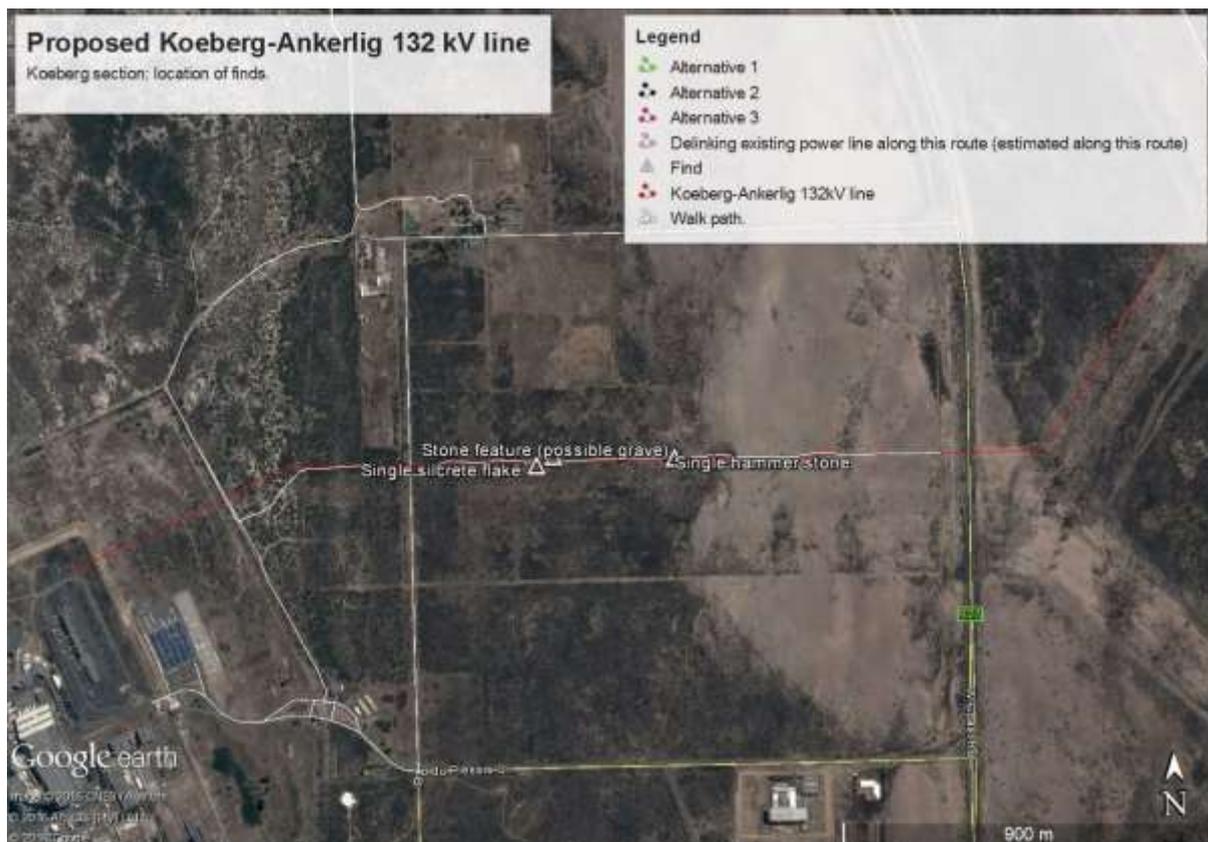
Figure 2 Expanded view of track log and finds within the Koeberg Nature Reserve.

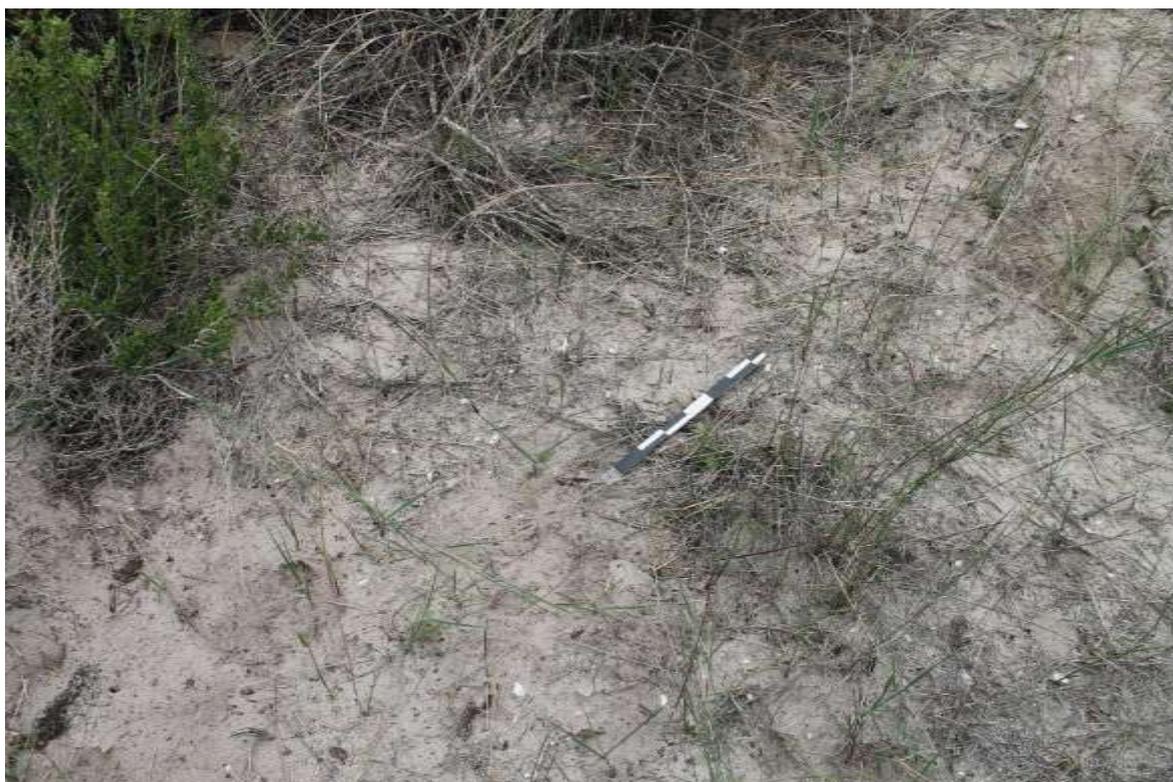
Along the proposed power line, one archaeological site was observed (wpt 010) Indicated in Figure 1. This is a low density shell midden situated on one of the remaining fossil dunes (Figures 1,3). It is unknown so far how deep the deposit goes, but it is relatively wide spread over the top and slope of the dune. This site is situated on the edge of the current existing servitude associated with the existing power lines. No further action is required. A single silcrete flake of Middle Stone Age origin, a single

Figure 3 Location of a shell midden at wpt 010

- With respect to the shell midden (wpt 010) the impact will be minimal as long as the site is avoided. A 20 meter buffer around its location will suffice.
- A further site that needs to be pointed out to the maintenance crew for avoidance is the suspected grave within the Koeberg Nature Reserve. The Eskom conservation office has been informed of the location of the site and has

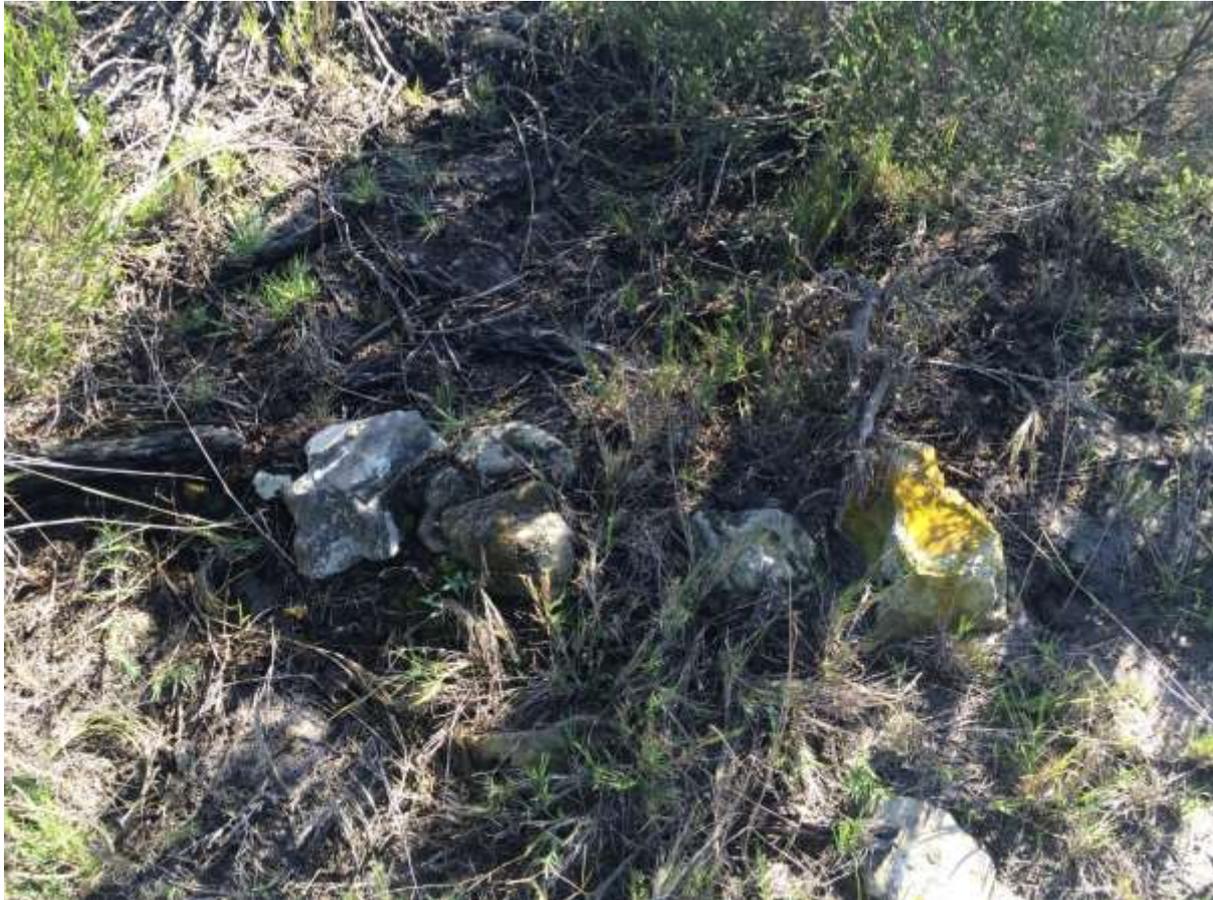
hammer stone is all the archaeological material that was noted within the Koeberg Nature Reserve. This is of very low significance and will not be impacted. There is also a small stone features that is clearly out of natural context (see Figure 2, 4) close to the alignment. The possibility of this being a grave cannot be excluded. The find has been pointed out to the Koeberg conservation officers as the find is easily avoided during maintenance.

*Figure 4 An un-natural alignment of stone which could be a pre-colonial grave.*

confirmed that they would be in a position to make sure it is cordoned off and avoided during maintenance.
