**ENVIRONMENTAL COMPLIANCE AUDIT REPORT
FOR
CONSTRUCTION PHASE FOR DINALEDI - MADIBENG SUBSTATION 132 KV
8km POWERLINE IN MADIBENG MUNICIPALITY**

DEA REF: 14/12/16/3/3/1/1442

December 2017

AUDIT REPORT NO 9

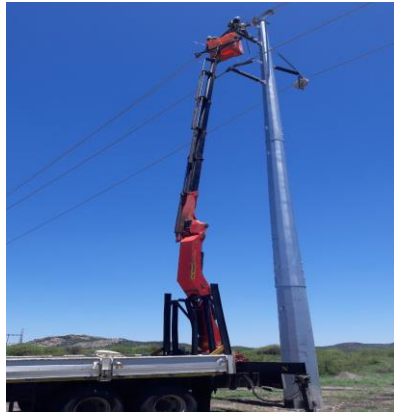
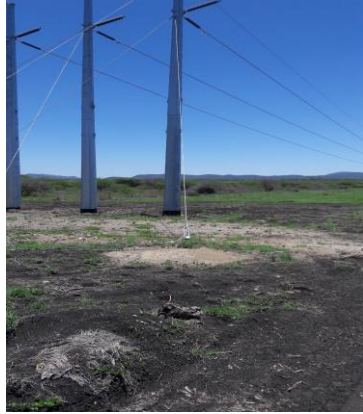
Photo 1 & 2: construction activities -Stringing

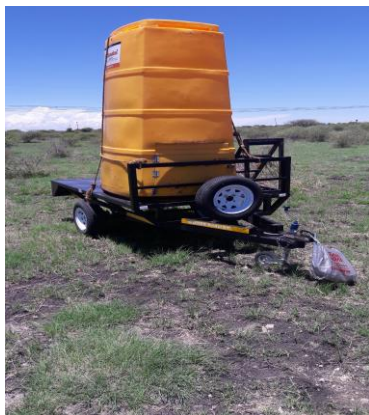
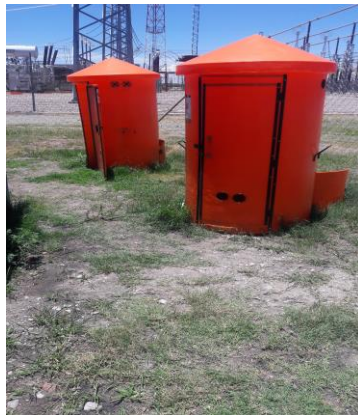
Photo 3 & 4: toilet at site and camp

1.2	Chemical toilet supplied serviced regularly		2	Mobile toilets were serviced but manifest not in place	Toilets need to be serviced at least once a week

1.3	Waste manifest , Waste transportation licence available	Contractor	1	Waste manifest not available in the file	Waste manifest should be provided whenever toilets are serviced
Score			6/9		Improve
%			67%

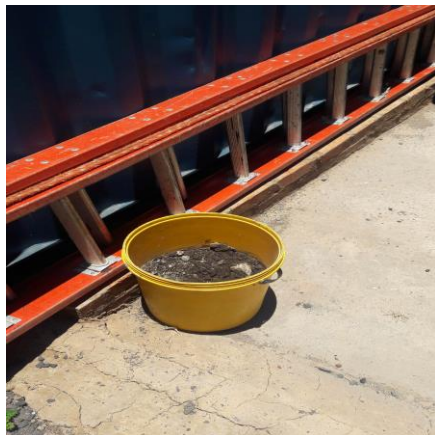
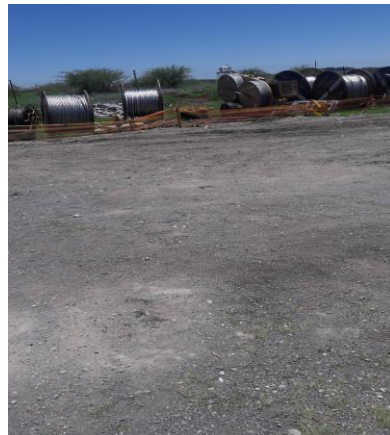
Contaminated soil stored in a bucket and storage area at camp

9.8	Avoid contamination of soil with	Contractor, EO	2	Petrol spillage contained.	Contaminated soil

oil, grease, diesel, petrol, waste or any other foreign matter, which may impact on the capability of the soil as a growth medium.				should be disposed of at hazardous landfill site.

spill kit to be used whenever such incidents happen to clean up the contaminated soil and dispose contaminated soil at a hazardous landfill site			
--	--	--	--	--	--
