**ENVIRONMENTAL COMPLIANCE AUDIT REPORT
FOR
CONSTRUCTION PHASE FOR DINALEDI - MADIBENG SUBSTATION 132 KV
8km POWERLINE IN MADIBENG MUNICIPALITY**

DEA REF: 14/12/16/3/3/1/1442

MAY 2017

AUDIT REPORT NO 2

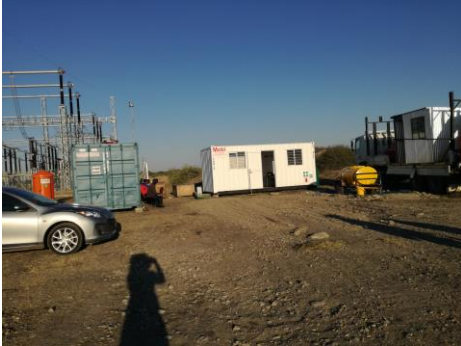
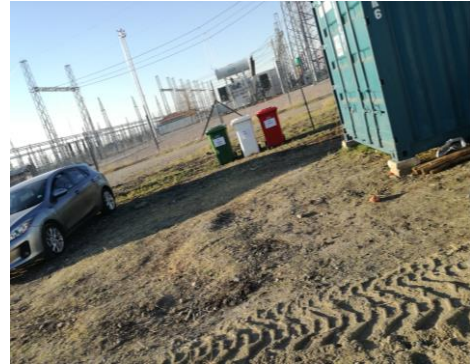
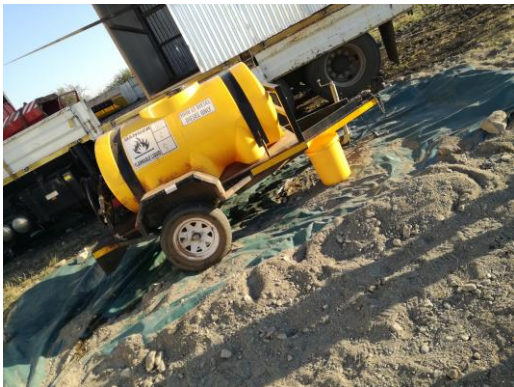
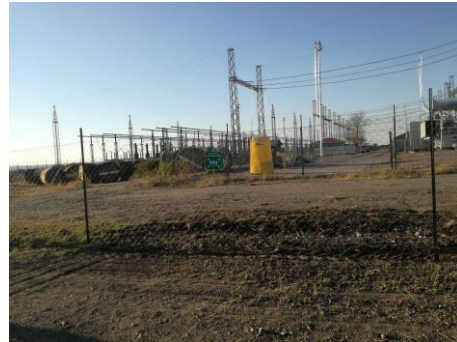
Photo plate of Dinaledi site camp

The toilet at the camp does not have toilet paper and no water is provided for washing hands after using toilet. This practise is totally discouraged for health and safety of workers. It is recommended to put a 20L container with tap to wash hands and put an empty bucket underneath in order contain waste water and to avoid water runoff and creating unfavourable conditions at site offices. Such waste water collected can be recycled and used to supress dust at the site camp and the surrounding area.

Slight improvement on diesel tank will be required, currently the heavy duty is layed on a flat ground, the potential risk is that should leakages or spill occur, it will run freely onto the ground and contaminate the soil. It is advised to dig enough size fit for the diesel, excavate 500m down and fill with soil about 300m before laying the heavy duty this will prevent any possible spill that may occur to contaminate the soil. Should spills occur and penetrate the 300m soil under the plastic, remove the affected soil and fill again. Such contaminated soil removed should be disposed of at hazardous waste licensed site.

Though dry winter now, weeds as well as alien plant should be monitored and taken care of around the site camp. The camp is being managed effectively in terms of the conditions stipulated in the EMPr and EA so far. The general housekeeping at site camp was good no weeds and no littering were noticed during this inspection.
