PHASE 1 HERITAGE IMPACT ASSESSMENT FOR THE CONSTRUCTION AND UPGRADING OF THE PROPOSED ACCESS ROADS TO THE BRAAMHOEK PUMPED STORAGE SCHEME

REFERENCE NUMBER: BRAMHOEK-HER-1

DATE: 9 DECEMBER 2005

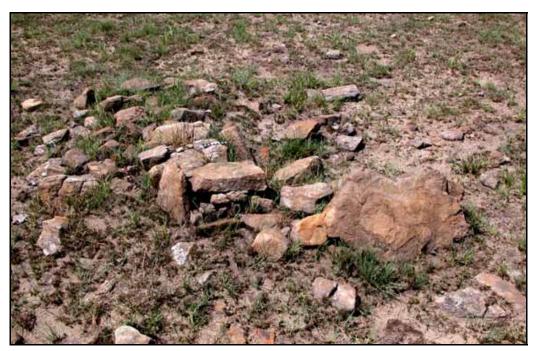
The structure is situated some distance away from the road, and no negative impact is expected.

Plate 1 Stone structure at site **BH1**.

However, should the alignment of the road be changed so that the site will be impacted upon, the following recommendations would be required:

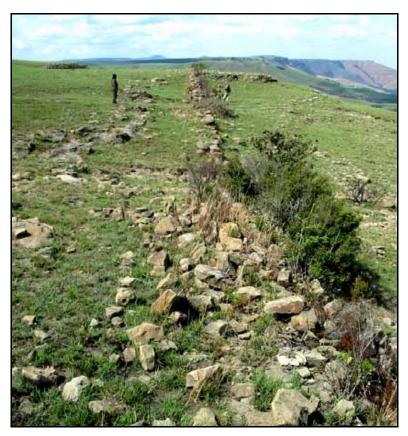
The existing road of the Bramhoek Pass passes over a section of the site.

Plate 2 General view of the possible boundary wall.

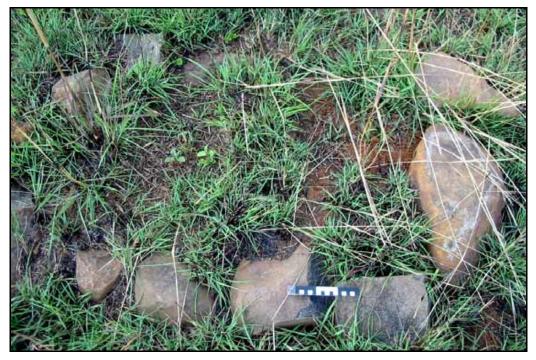
The site is comprised of a number of features located in the same general location. Undecorated potsherds, iron objects and possible ash lenses were also observed in the area. The features include the following:

- A stone-lined structure orientated along the east-west axis. This may be a grave.
- · Terrace walling.
- Rectangular foundations of at least two structures.

Plate 3 Stone-lined structure that may be a grave.

The dwelling foundations are associated with farm labourer housing. These foundations are not significant. However, a worst case scenario, wherein the stone-lined structure is indeed a grave, was used to assess the site significance. As a result the site is given a **High Significance** rating.

Reconnaissance excavation of the stone-lined structure must be undertaken to assess whether it is a grave. This excavation can only take place once a permit from AMAFA has been received. Should suitable evidence for the existence of a grave be found (i.e. coffin fragments, burial pits, skeletal remains etc.), the excavation hole must be backfilled and a full grave relocation process undertaken.

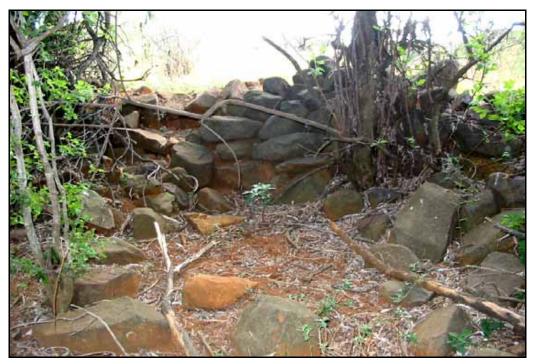
Plate 4 Section of the stone kraal at Site BH4.

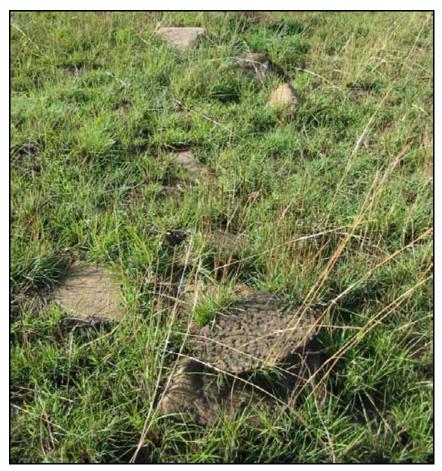
This is the location of a highly disturbed stonewall foundation. A number of undecorated potsherds were observed in the surrounding area. The general area is characterised by sheet erosion.

The possibility exists that this stone foundation formed part of a Late Iron Age/Historic settlement. The walling was most probably robbed to construct the more recent structures from **Site BH3** and **Site BH4**. Due to the disturbed nature of the site, **BH5** is of **Low Significance**.

Plate 5 The disturbed stonewall at **Site BH5** is barely visible.

If Alternative 1 is approved, **Site BH5** will be impacted upon. The following mitigation measures are recommended:

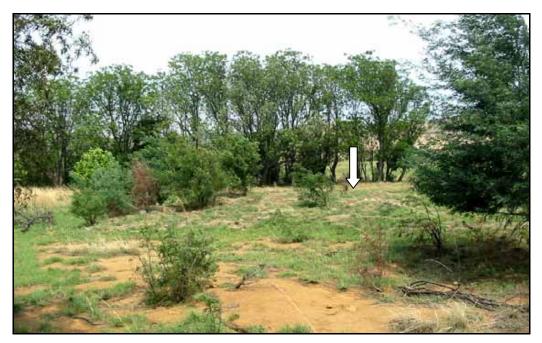
The proposed Bramhoek Pass road is too far away to impact on the farmstead. If the road alignment is changed so that the line of the planned road moves closer to the farmstead, suitable mitigation measures must be undertaken.

Plate 6 General view of the site. The arrow marks the dwelling's position.

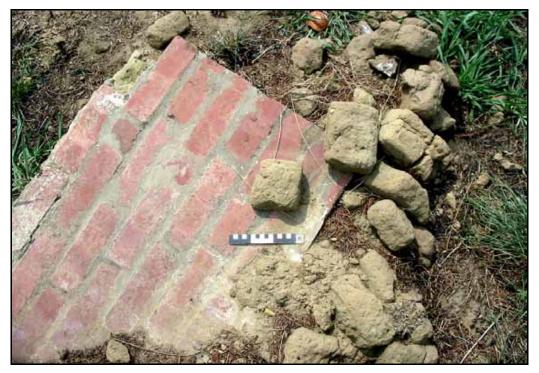
- Rectangular foundation structure that was the dwelling. Mud bricks as well as red
 fired bricks were used in its construction. The preservation of the dwelling is very
 poor with only the footprint still visible.
- Small rectangular stables that consist of a stone and mortar foundation structure
 with a mud brick extension on top. These extensions are called *deige*. The mud
 brick sections of the inner and outer walling were plastered. The structure's
 doorframes and supporting cross-beams are all made of wood, while the roof is
 missing.

Plate 7 Remains of the farm dwelling. Note the mud bricks on the right as well as the more conventional red fired bricks on the left.

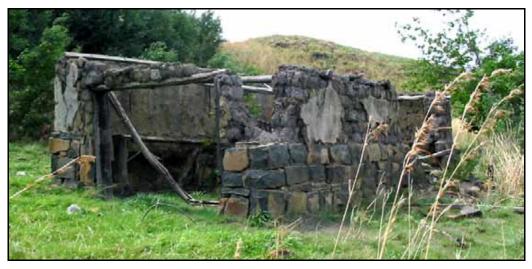
Plate 8 The remains of what used to be the farmstead's stables.

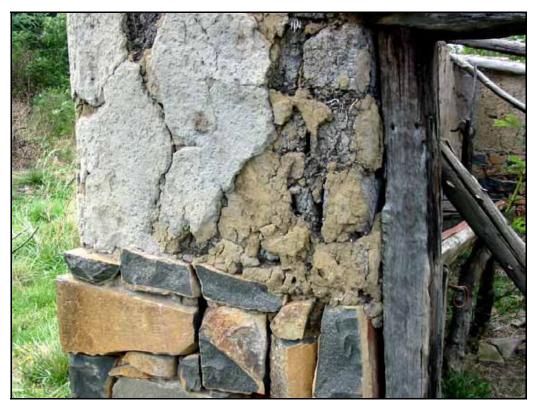
Plate 9 Close-up view of the stone structure with the mud brick extension (*deige*) on top.

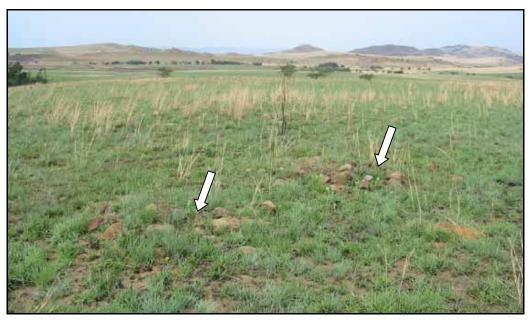
A worst case scenario, wherein the two stone concentrations are considered to be graves, was used to assess the site significance. As a result the site is given a **High Significance** rating.

Plate 10 The possible graves at Site BH7.

Reconnaissance excavations of the two stone structures must be undertaken to
assess whether they are indeed graves. These excavations can only take place
once a permit from AMAFA has been received. Should suitable evidence for the
existence of graves be found (i.e. coffin fragments, burial pits, skeletal remains
etc.), the excavation holes must be filled in and a full grave relocation process
undertaken.

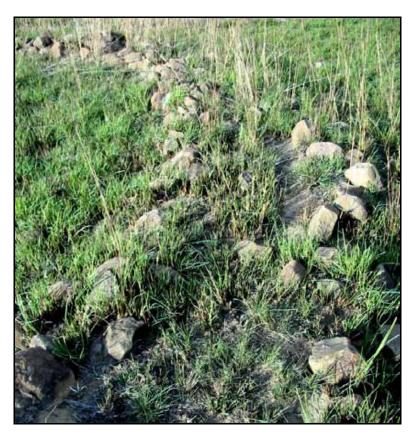
The building technique conforms to typical Late Iron Age stone-wall construction method with double-packed sides and stone rubble infill.

Plate 11 This photograph depicts a section of one of the circular stone enclosures.

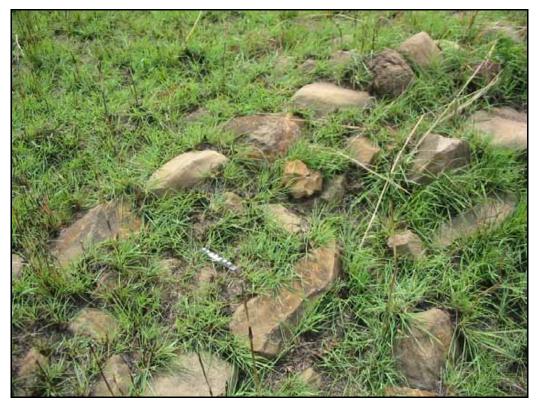
Plate 12 Close-up view of a section of stonewalling from **Site BH8**.

If Alternative 1 is approved, **Site BH8** will be impacted upon. The following mitigation measures are recommended:

- The site must be carefully documented in the form of photographs and scaled layout maps.
- After documentation, a destruction permit must be applied for from AMAFA. The site may only be disturbed or destroyed once a permit has been issued.
- The issuing of the permit must be subjected to the condition that a watching brief
 is agreed upon to monitor the site during the construction phase. If any
 archaeological finds or features are exposed, a re-assessment of the site may be
 required.
- Reconnaissance excavation of the possible grave must be undertaken to assess
 whether it is indeed a grave. This excavation can only take place once a permit
 from AMAFA has been received. Should suitable evidence for the existence of a
 grave be found (i.e. coffin fragments, burial pits, skeletal remains etc.) the
 excavation hole must be backfilled and a full grave relocation process undertaken.

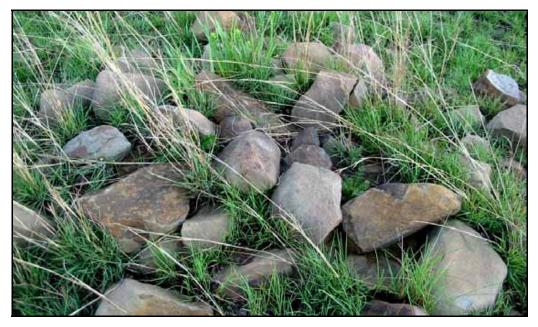
A single stone-packed concentration similar to the features found at **Site BH7** was observed in the vicinity of the circular enclosures. This structure can potentially also be a grave.

Plate 13 Stone concentration at **BH8**.

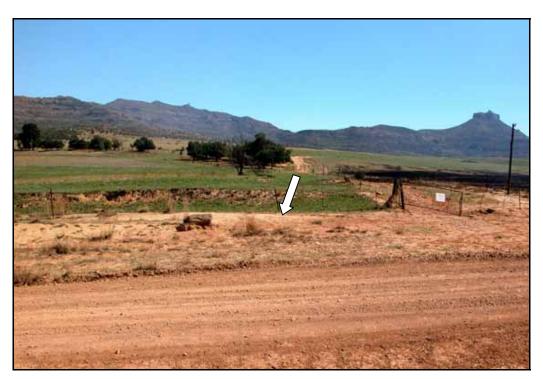
A single Stone Age lithic was exposed in the earthworks on the side of the road. The site is located close to a small stream. No other Stone Age artefacts could be observed in the direct vicinity, and as such the site must be viewed as a findspot.

Plate 14 BH9. The arrow indicates the approximate spot where the lithic was observed.

If Alternative 3 is approved, **Site BH9** will be impacted upon. The following mitigation measures are recommended:

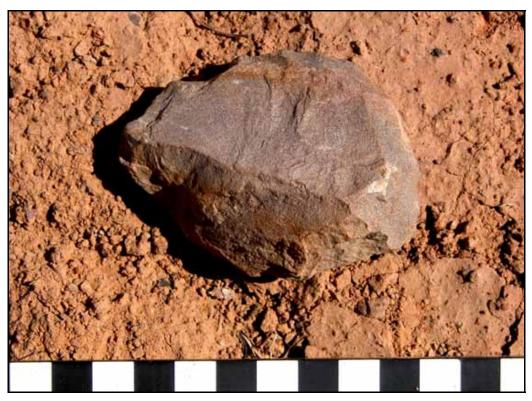
Plate 15 Close-up view of the artefact.

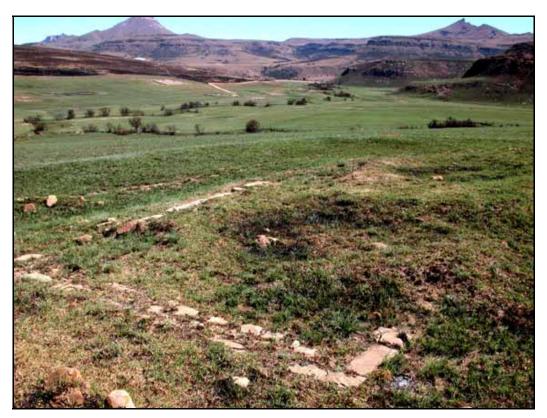
A number of stone foundation structures are located on a west-facing slope overlooking a non-perennial stream. These structures are located directly adjacent to the northern fence of the road.

Site BH10 is of Low to Moderate Significance.

Plate 16 One of the rectangular foundation structures can be seen in the foreground.

• After documentation, a destruction permit must be applied for from AMAFA. The site may only be disturbed or destroyed once a permit has been issued.

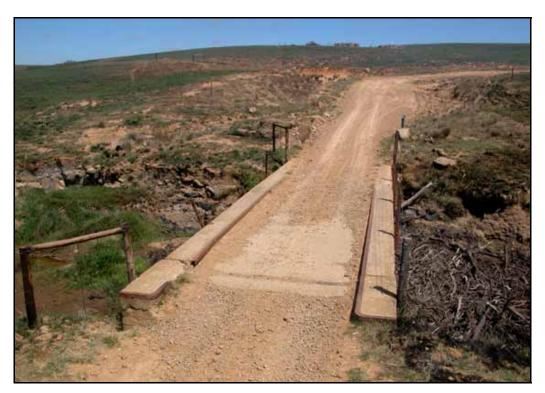
The site consists of a reinforced concrete bridge over the Wilge River. The bridge was located on the road between Collins Pass and Harrismith, on what used to be Chatsworth 388 (the section on which the bridge is located is today known as Wilgerivier 319).

Plate 17 The bridge at present.

If Alternative 3 is approved, **Site BH11** will be impacted upon. As the bridge was completed during 1927, it is older than 60 years. The following mitigation measures are recommended:

- The site must be documented in the form of photographs and scaled layout plans.
 In this regard, the available blueprints will already provide a basis for documentation.
- After documentation, a destruction permit must be applied for from AMAFA. The bridge may only be disturbed or destroyed once a permit has been issued.

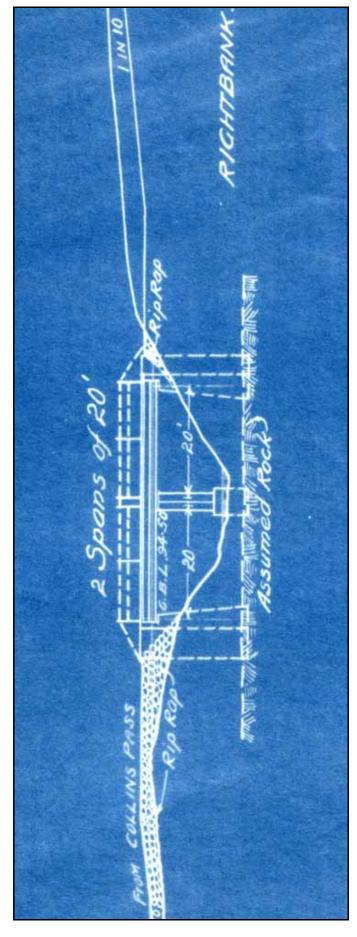
Figure 16 Blueprint for the Chatsworth bridge, dated 28 September 1925.

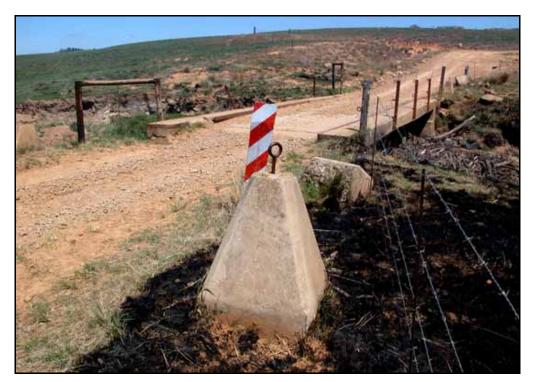
Plate 18 One of the bollards that is found at both ends of the bridge.

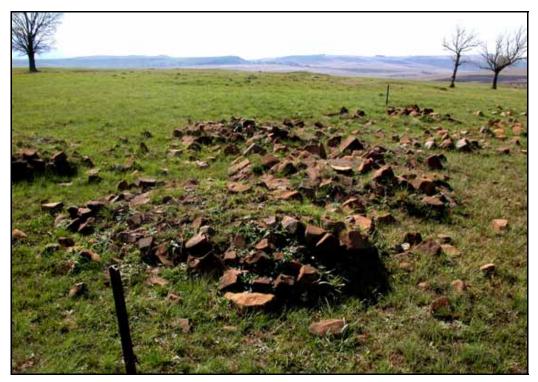
The cemetery is situated approximately 25 meters to the west of the existing fencing along the road. As a result it no impact is expected on the graves.

Plate 19 General view of cemetery.

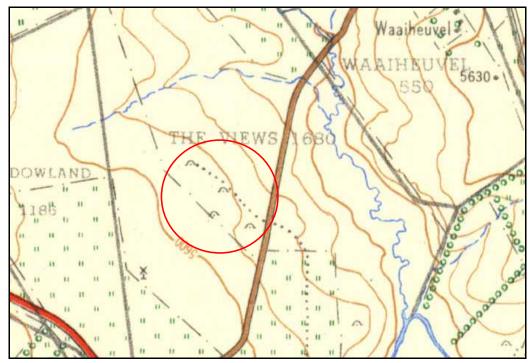
Figure 17 Enlarged section of the 2829AD VAN REENEN Topographical Map, which dates from 1965. Four huts (indicated in red) are shown in the vicinity of the cemetery at **Site BH12.**

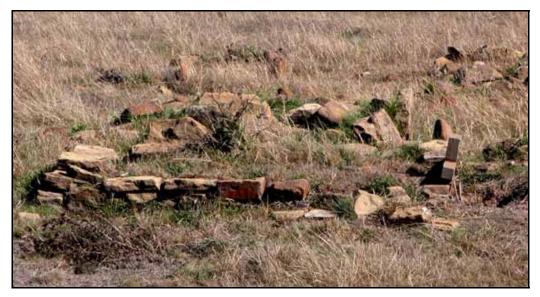
The cemetery is approximately seven meters from the road fence.

Plate 20 A number of graves from **Site BH13** can be seen.

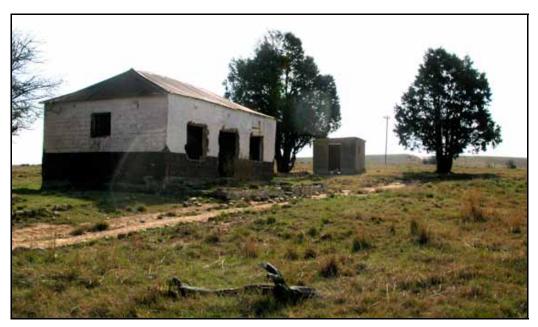
The site consists of a building that may be older than 60 years. The building is constructed of bricks and has a corrugated iron roof. The condition of the structure is poor, with all windows and doors missing.

Plate 21 The building from BH14.

- The site must be documented in the form of photographs and scaled layout plans.
- After documentation, a destruction permit must be applied for from AMAFA. The bridge may only be disturbed or destroyed once a permit has been issued.

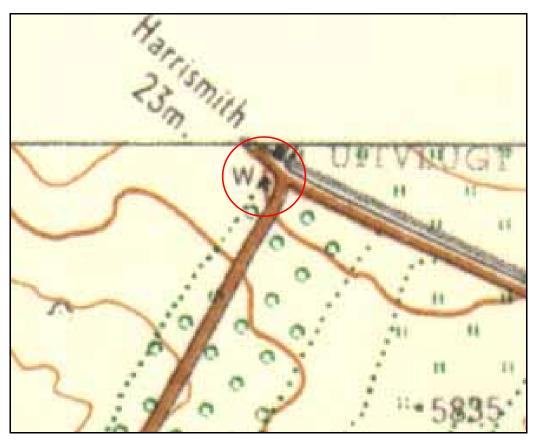
Figure 19 Enlarged section of the 2829AD VAN REENEN Topographical Map, which dates from 1965. **Site BH14** is marked with a red circle.

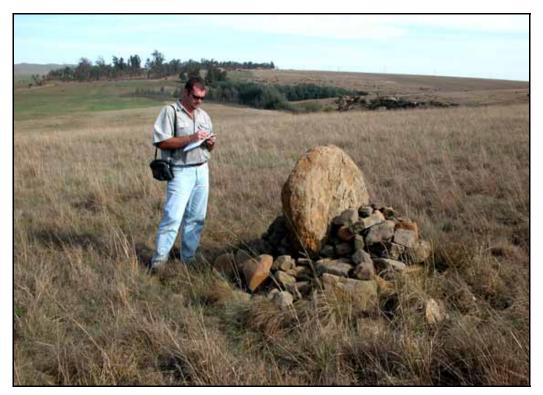
Plate 22 The upright stone with a number of loose stones packed at its base.

Social consultation must take place to evaluate the site in terms of the existence
of a grave in this locality. Should the feature be confirmed as a grave site, a full
grave relocation process must be undertaken in accordance with the relevant
legislation.

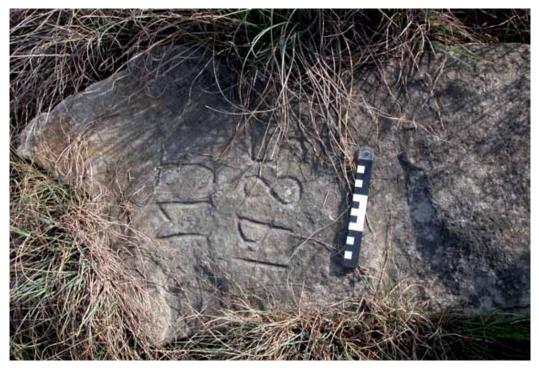
Plate 23 Flat stone bearing an inscription.

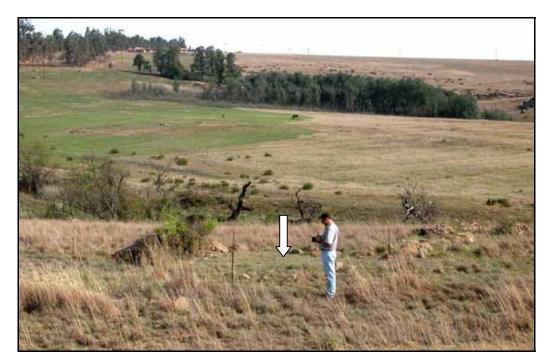
A single rectangular foundation structure was observed here. The structure is situated to the south of the road, and directly adjacent to the fence.

Plate 24 The position of the foundation structure is indicated with an arrow. The person is standing on the road side of the fence.

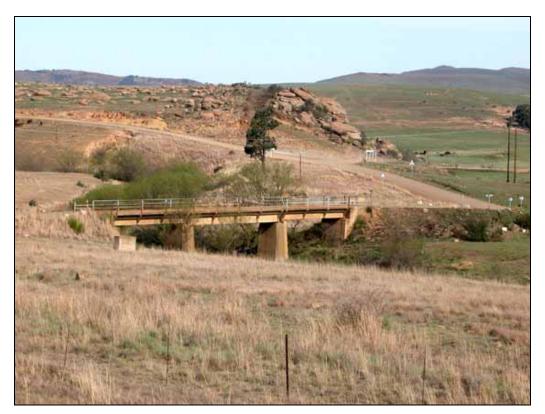
The bridge appears to have been completed during or before 1928.

Plate 25 Present-day view of the bridge at **Site BH18**.

Site BH17 will be impacted upon. As the bridge was completed during or before 1928, it is older than 60 years and protected by legislation. The following mitigation measures are recommended:

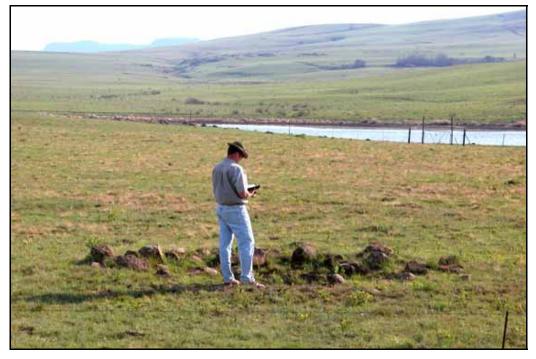
The site consists of a single oval-shaped stone feature. The feature is approximately three meters in diameter, and some 11 meters from the road fence.

Plate 26 Small oval-shaped feature.

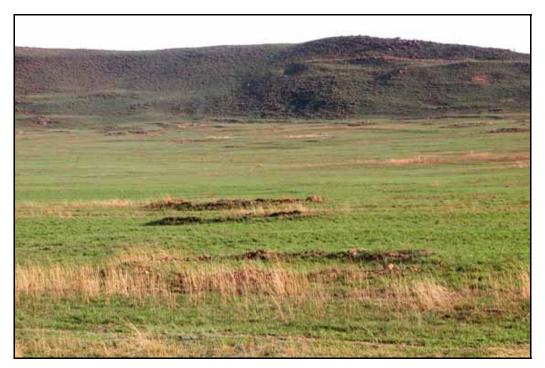
The site consists of numerous circular Late Iron Age stone enclosures located in a valley. The existing gravel road transects the site and these enclosures were observed on both sides of the road.

Plate 27 General view of the site from the north-west.

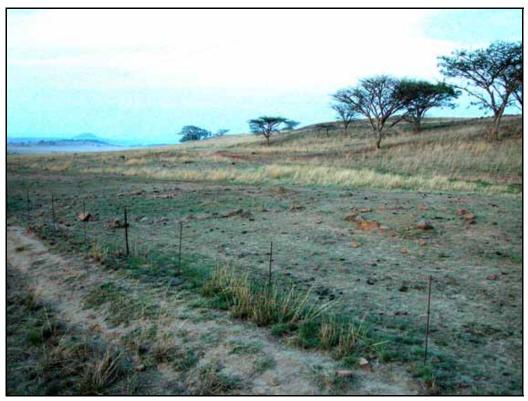
The site is located adjacent to the road fence.

Plate 28 The two stone structures can be seen.

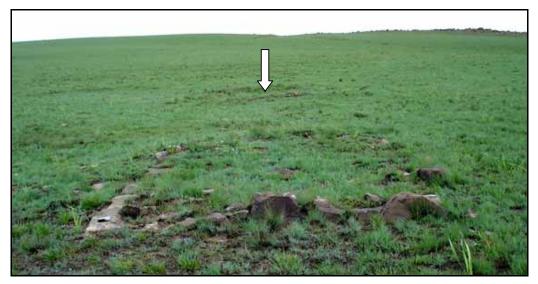
The site consists of two stone foundation structures located at the north-eastern foot of a small rise. The structures appear to be historic-recent worker housing.

At present the age of the structures are unknown. The possibility exists for them to be older than 60 years. No cultural material was observed in the surrounding area.

Plate 30 BH23. The rectangular structure is visible in the foreground, while the arrow indicates the circular structure.

Should the site be impacted upon, the following recommendations are required:

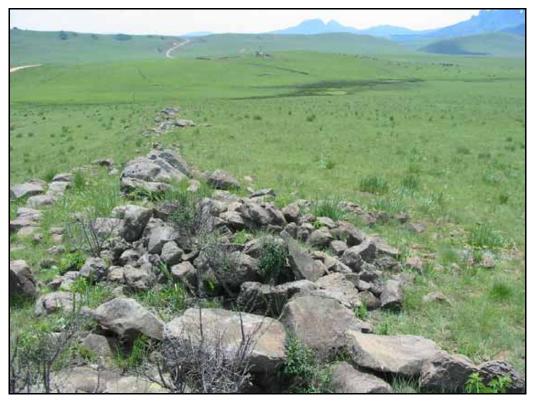
The site consists of a small circular stone structure located on a dolerite dyke. No cultural material was observed in the surrounding area.

Plate 31 The small stone circle is visible adjacent to the dolerite dyke.
