**ENVIRONMENTAL IMPACT ASSESSMENT FOR THE
PROPOSED MATIMBA-WITKOP NO. 2 400 kV
TRANSMISSION LINE, LIMPOPO PROVINCE**

**SPECIALIST STUDY – HERITAGE IMPACT
ASSESSMENT**

APPENDIX H

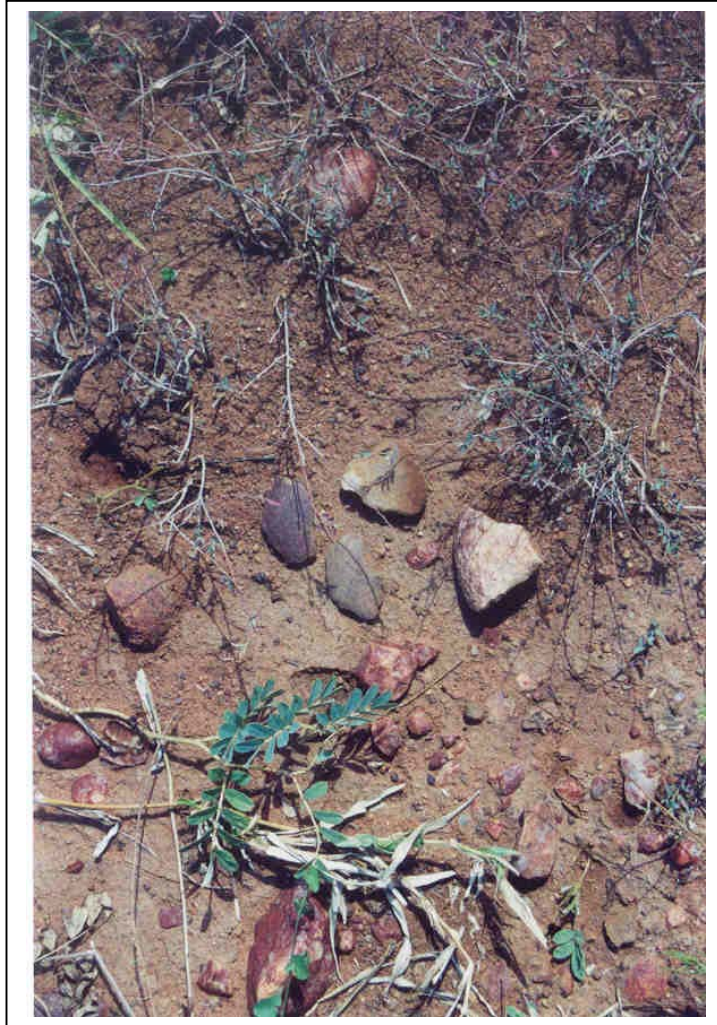
A small scattering of Late Stone Age (LSA) tools was found at this site (Photograph 1). No cores or unmarked flakes were present. A small number of tools were recorded. Therefore, this site is not seen as representing a manufacturing site.

Photograph 1: Site MaWit 001. Small scatterings of Late Stone Age tools

This site does not constitute a manufacturing site and, therefore, has little scientific or cultural value. The concentration of stone tools is common in this area and the impact of a single tower foundation is considered to be minimal.

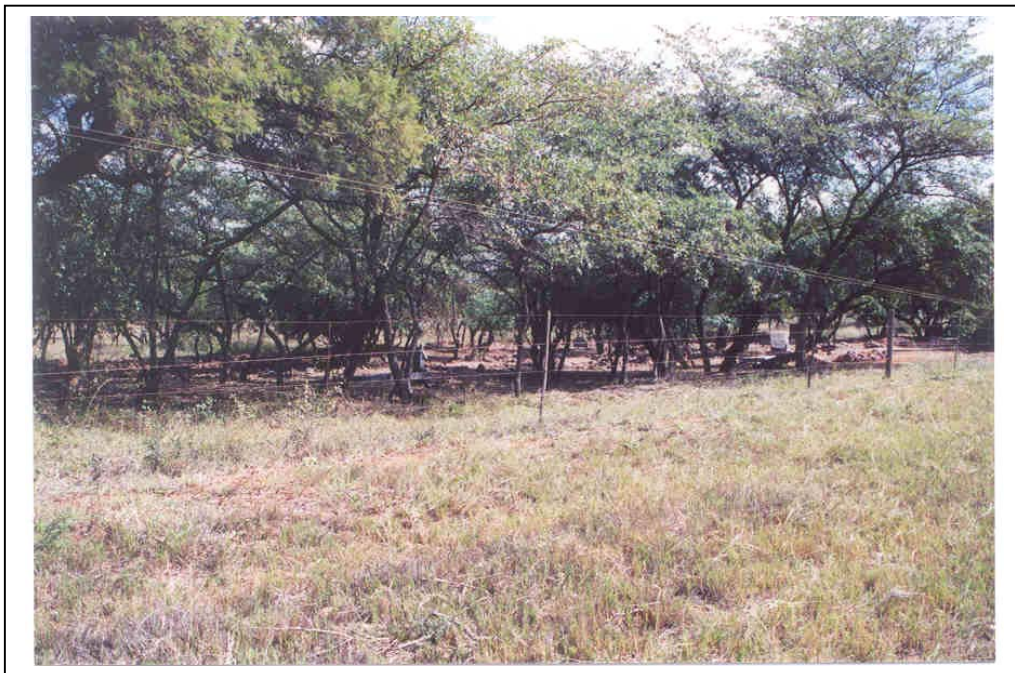
A community graveyard with approximately 50 graves was recorded at the village of Kafferboom next to the dirt road (Photograph 2). The graveyard is still in use.

Photograph 2: Site MaWit 002. Community graveyard

The community graveyard is an important aspect of the social fabric of the community and should preferably not be moved or altered.

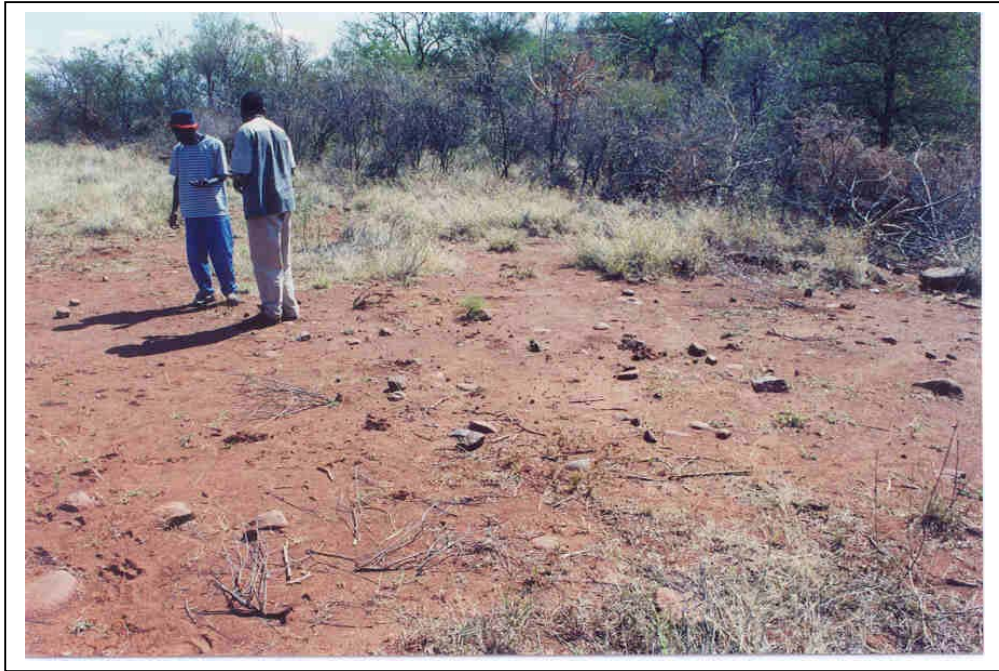
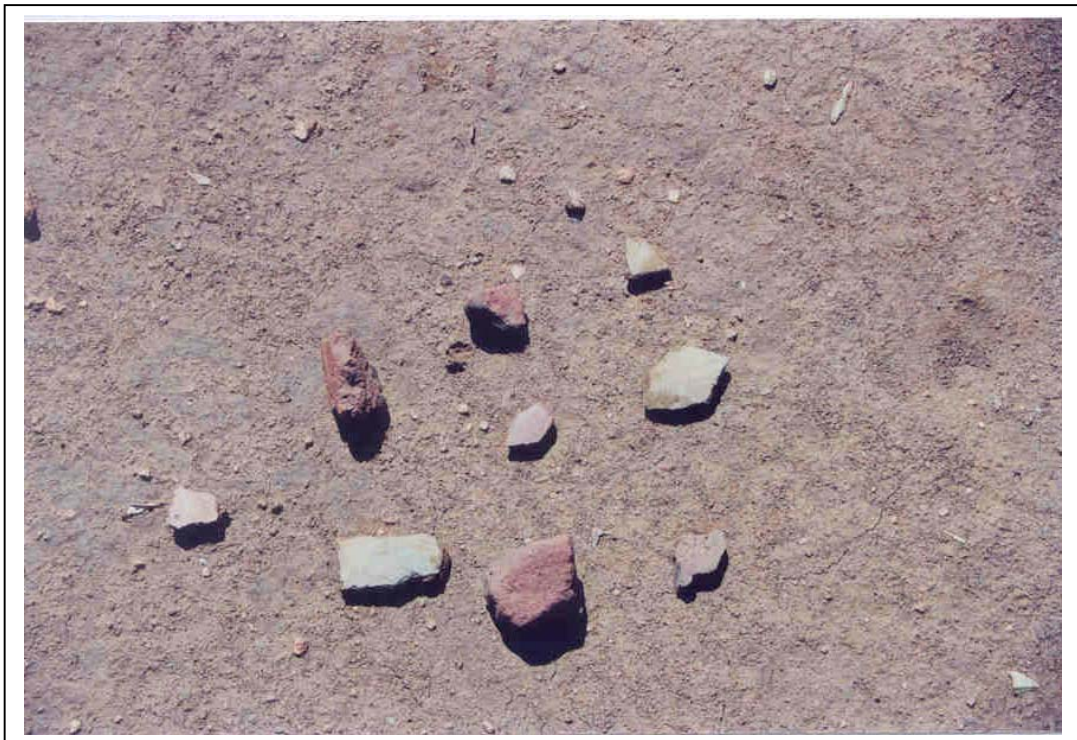
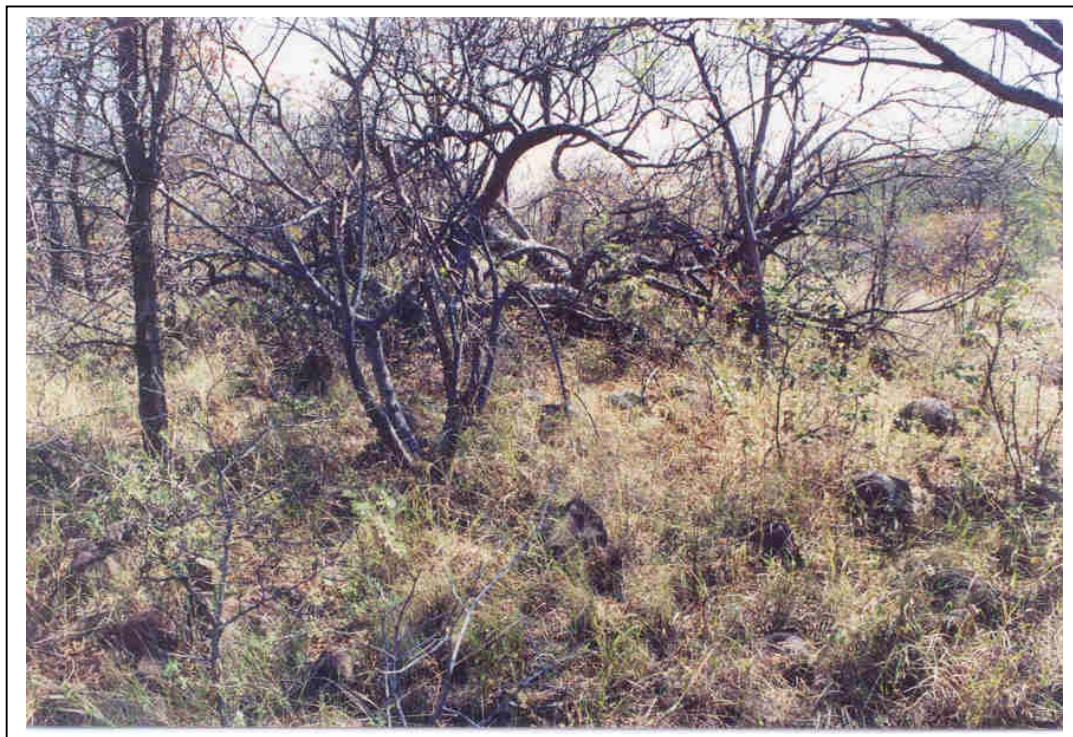
A surface scatter of potsherds, daga fragments and a few stone tools were recorded at this site (Photographs 3, 4 and 5). The scatter was of low density and was found in the neck between two hills. The surrounding areas were very rocky, although this area was without rocks. A fragment of a grinding stone was also recorded. Evidence of hut clay or a daga fragment was recorded all over the site. Possible features, such as dilapidated stone walls, were also recorded. The site extends over an area at the foot of one hill and measured approximately 50 m x 120 m. The site is not very big or rich in feature and artefacts. The *Euphorbias* growing on the side of the hill were most probably brought in by occupants.

Photograph 3: Site MaWit 003. Potsherds, daga fragments and some stone tools

Photograph 4: Site MaWit 003. Potsherds, daga fragments and some stone tools

Photograph 5: Site MaWit 003. Rocky surroundings

This site has significant scientific potential. The survey indicated that Iron Age sites in this area are uncommon, and little is known of such sites due to this situation. It is, therefore, recommended that the site be avoided as far as possible in order to limit damage to the site. If a tower has to be placed on this area, rescue work will have to be performed in order to preserve the information contained at this site.

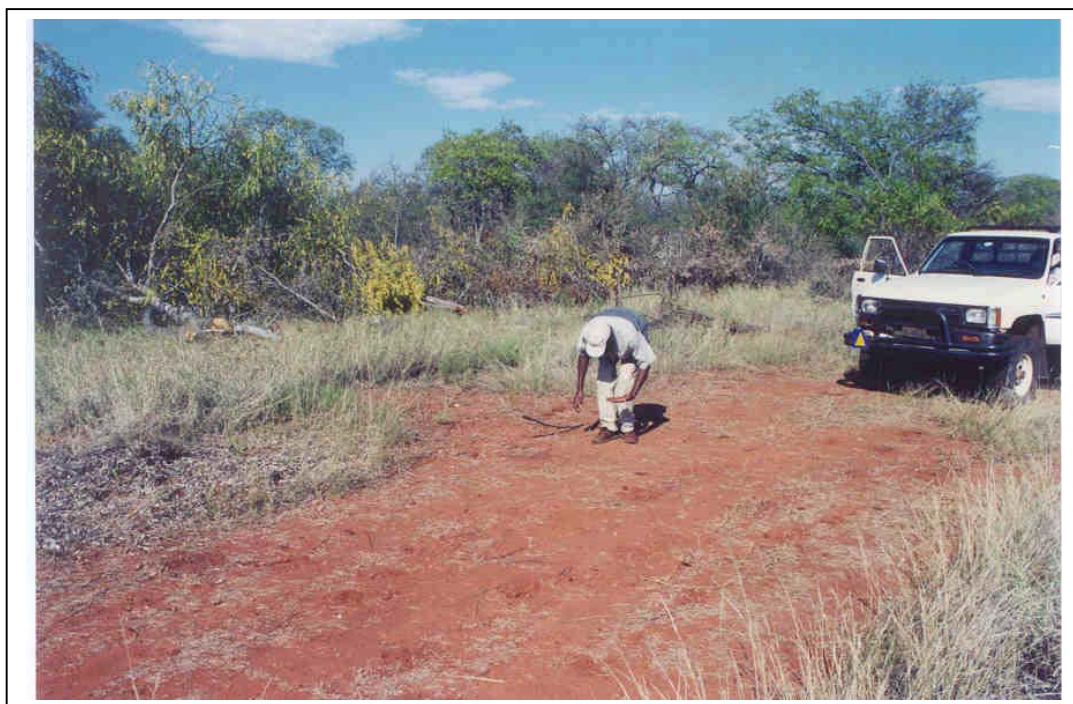
A small concentration of slag and tuyère fragments was found in the road (photo 6). The road was slightly graded open to expose scatter. The concentration measured approximately 20 m x 30 m but was of a very low density.

Photograph 6: Site MaWit 004. Small concentration of slag and tuyère fragments

Indications of an iron production site abound here, and should be further investigated should the line pass here.

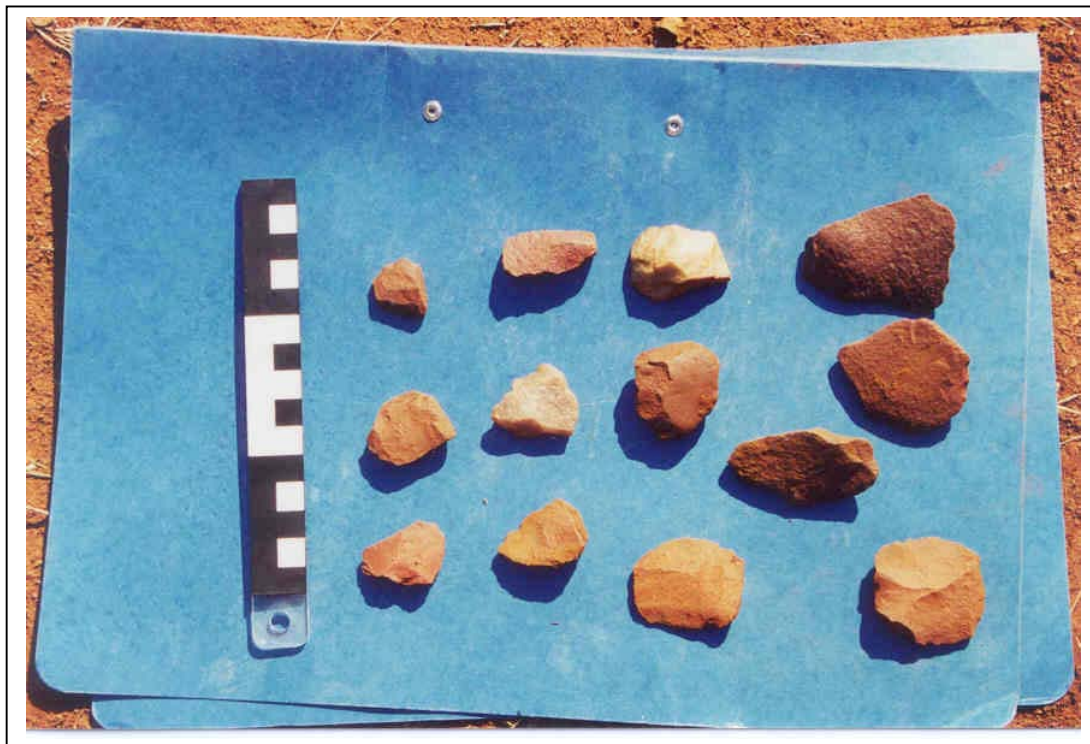
A low density scatter of stone tools was recorded in a sandy area in-between a stretch of exposed rocks. The stone tools consist of cores, flakes, scrapers and blades (Photograph 7). The area measured approximately 100 m x 100 m. Only a surface scatter was recorded with reworked cores. This is not considered as a production site.

Photograph 7: Site MaWit 005. A variety of stone tools

These sites do not constitute manufacturing sites and, therefore, have little scientific or cultural value. The concentration of stone tools is common in this area and the impact of a single tower foundation on such sites is considered to be minimal.

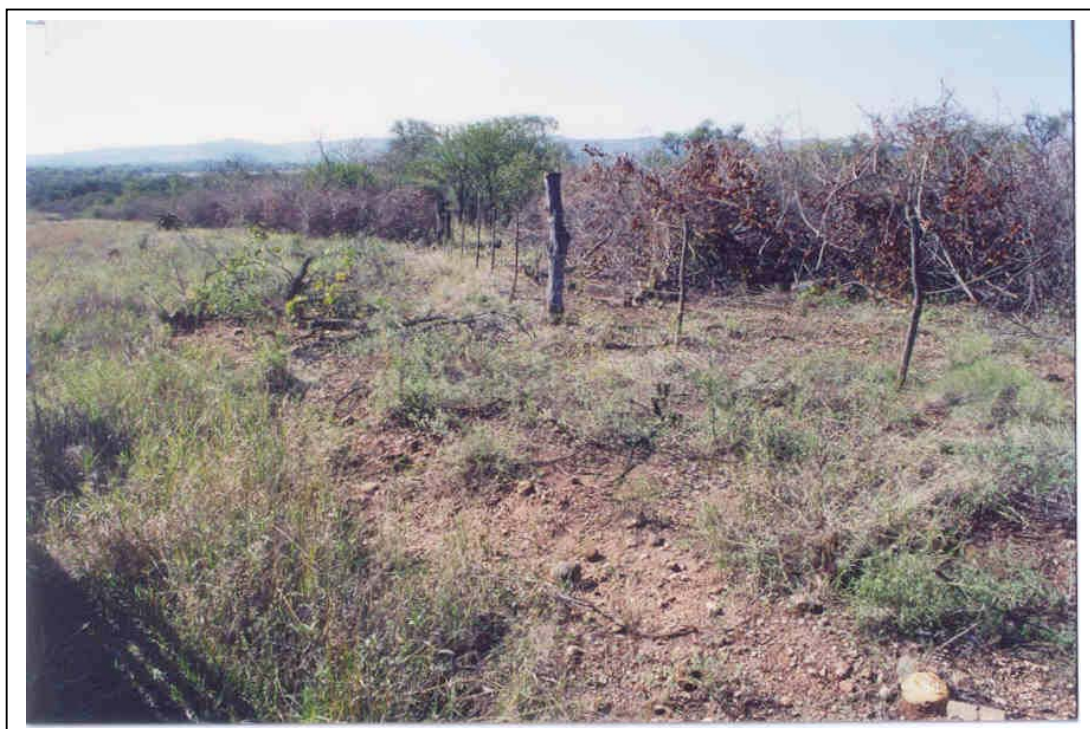
A concentration of Late Stone Age tools and microliths were recorded at this site (Photograph 8). The area was slightly disturbed due to development of infrastructure (fencing, a road and a powerline).

Photograph 8: Site MaWit 006. Late Stone Age tools and microliths

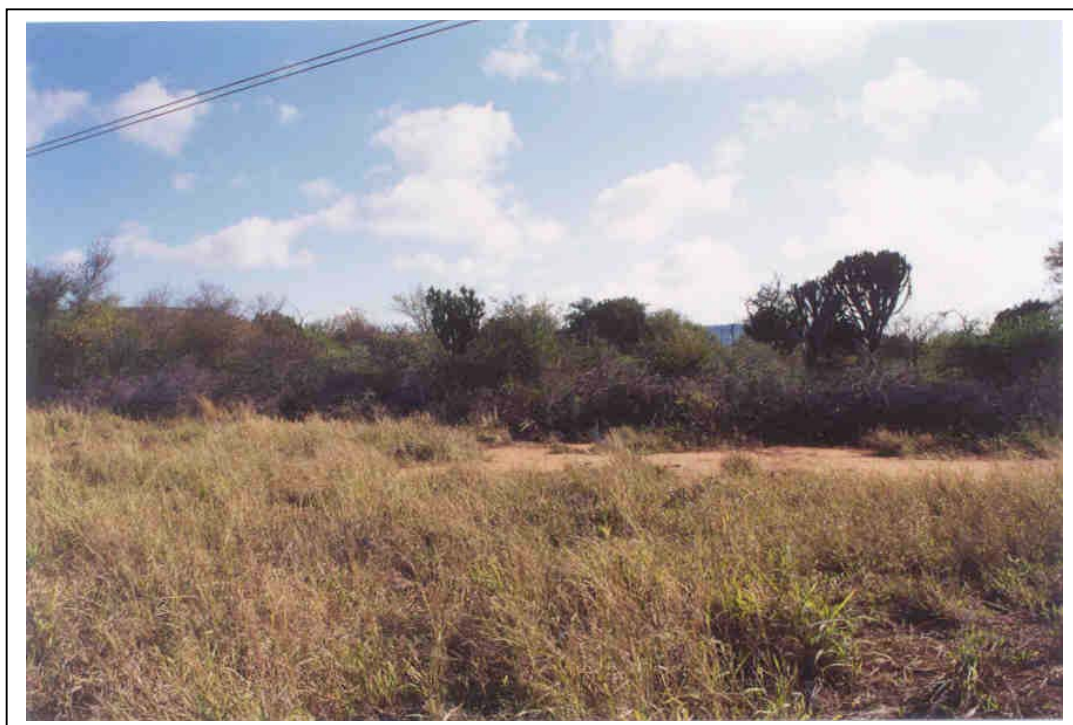
A low density scattering of Late Stone Age tools was recorded on this site (Photograph 9).

Photograph 9: Site MaWit 007. Scattering of Late Stone Age tools

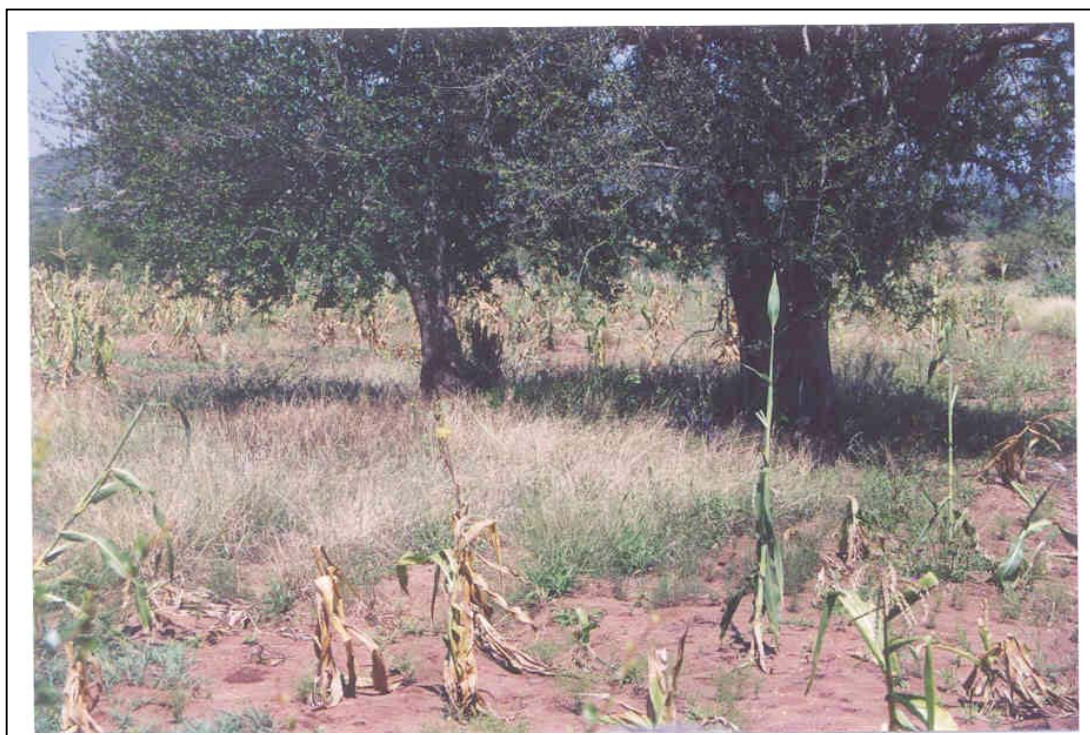
A cluster of eleven graves indicated by a paved stone outline dressing was recorded at this site (Photograph 10). These are located on a ploughed field approximately 80 m from the existing Matimba-Witkop NO 1 400 kV Transmission line.

Photograph 10: Site MaWit 009. Cluster of graves

The community graveyard is an important aspect of the social fabric of the community and should preferably not be moved or altered.

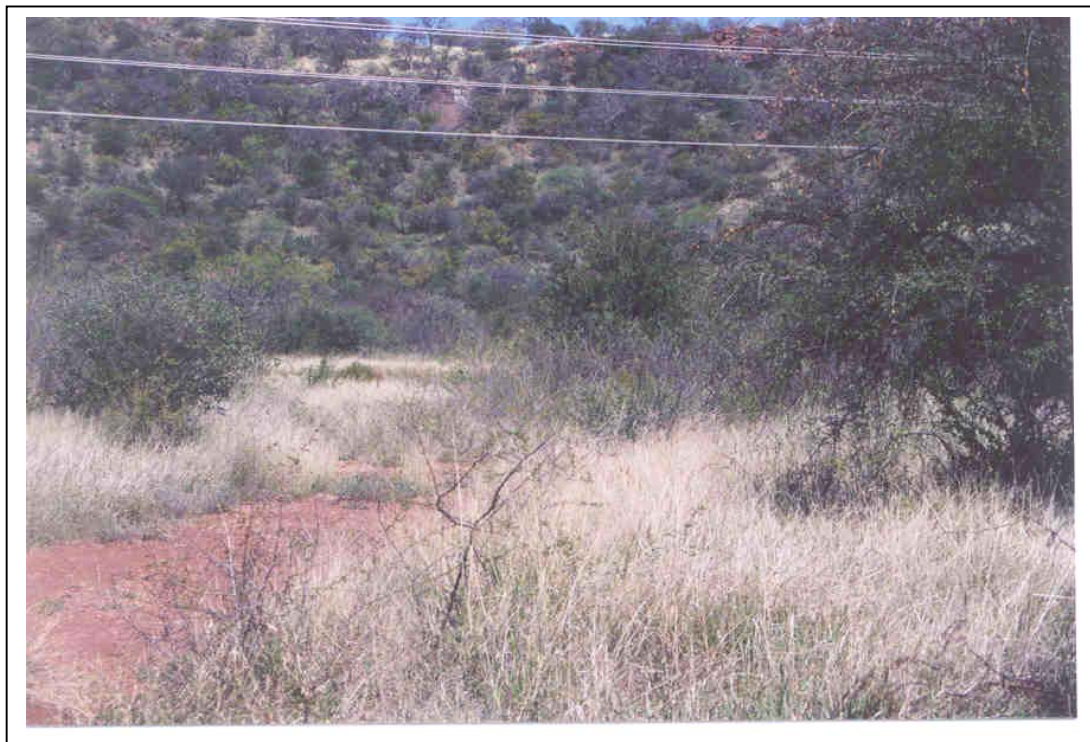
A dilapidated hut foundation and some scattered potsherds indicate the remains of an informal settlement at this site (Photograph 11). The settlement moved during the early 1960s to a formal village in the Vlakfontein region. The site covers a maximum of 10 ha. The site was destroyed and damaged by the construction of the road and existing Transmission line.

Photograph 11: Site MaWit 010. Remains of an informal settlement

The inhabitants of this informal settlement moved to a formal settlement approximately 3 km to the north-east of the site during the 1970s. Interviews with local inhabitants indicated that no graves were located close to the site or within the site itself. The site has little or no scientific or cultural value.

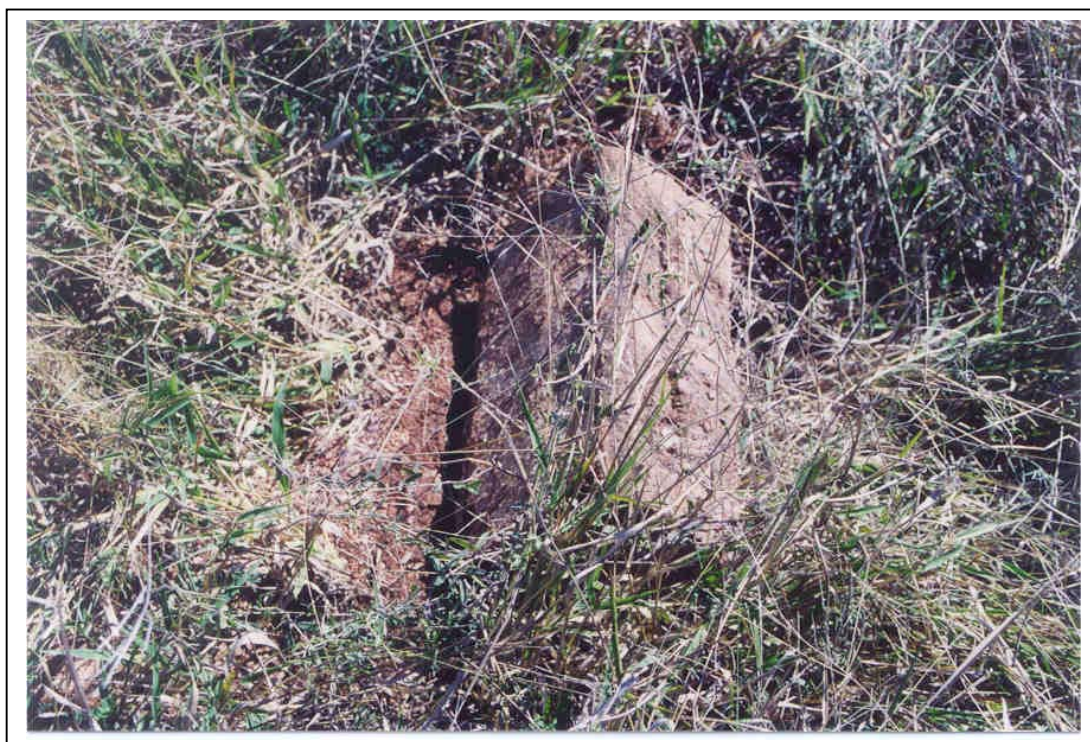
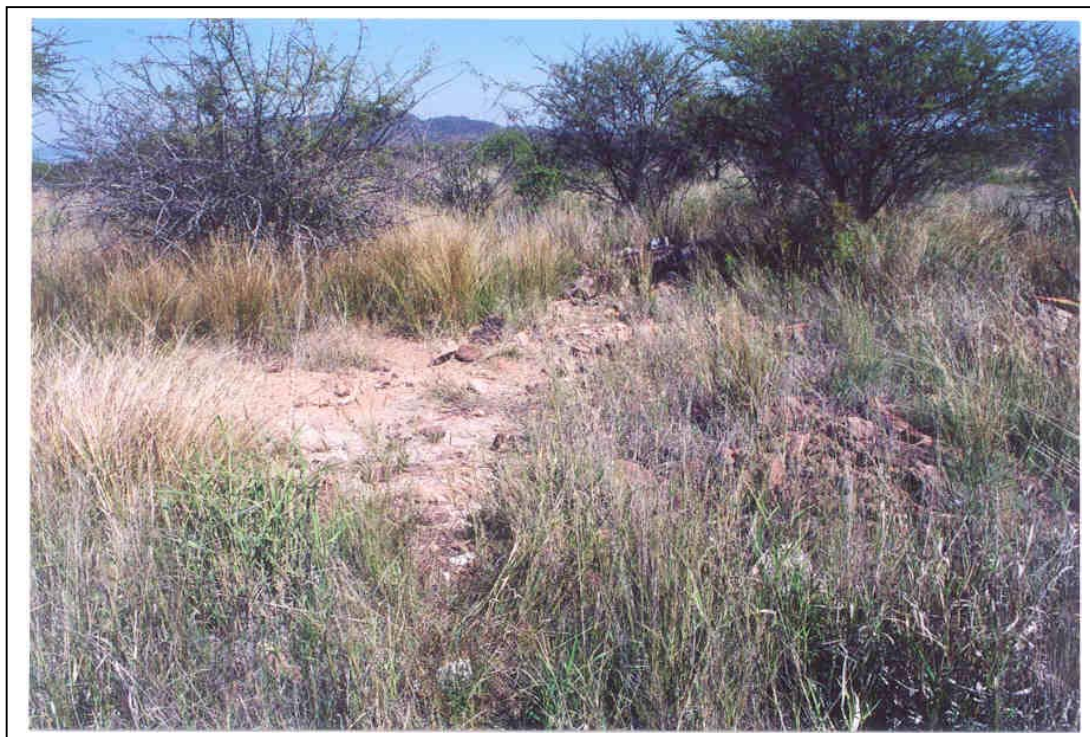
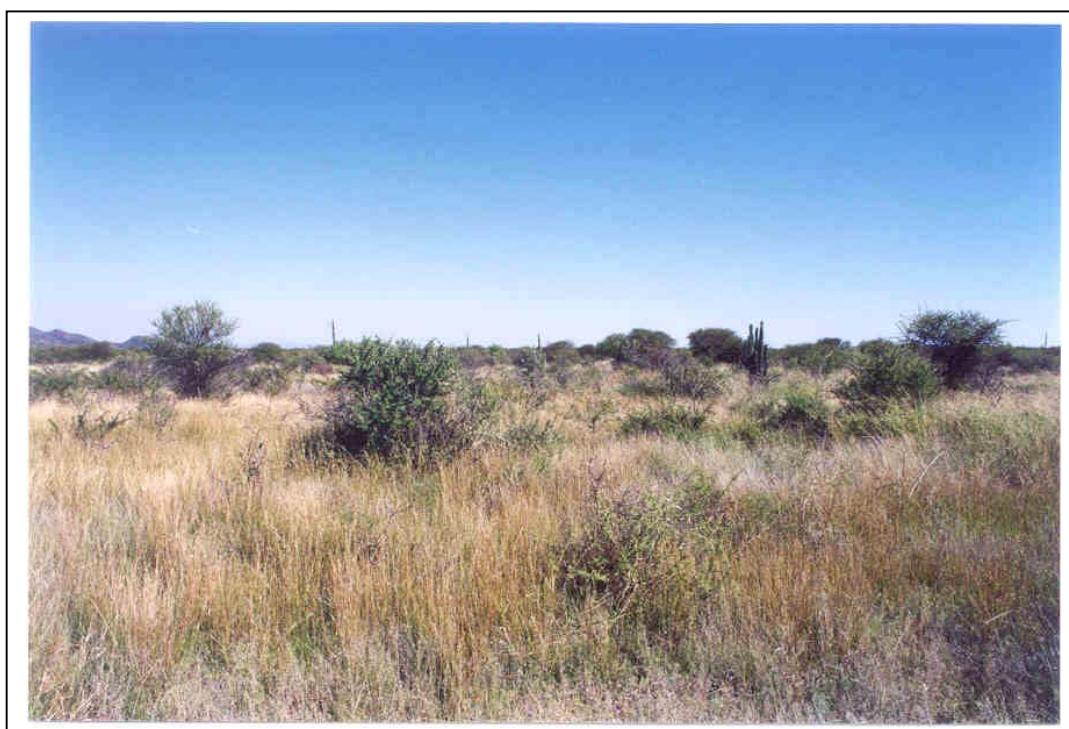
Large amounts of European type structures were recorded in a 3 – 4 ha area at this site (Photographs 12 and 13). Several porcelain and metal remains were recorded. Most of the inhabited area is defined by cacti and large tracts of pioneer plant growths (Photograph 14). The document studies to indicate that these were the ruins of the Dorsland settlement that was abandoned during the 1960s. Although no reference to a graveyard could be found, it is highly likely that graves will be located close to this settlement.

Photograph 12: Site MaWit 011. European type structures and remains

Photograph 13: Site MaWit 011. European type structures and remains

Photograph 14: Site MaWit 011. Cacti and pioneer plant growth

The main concern in this area will be the locality of graves. Should the line pass here, the locality of these will have to be determined.

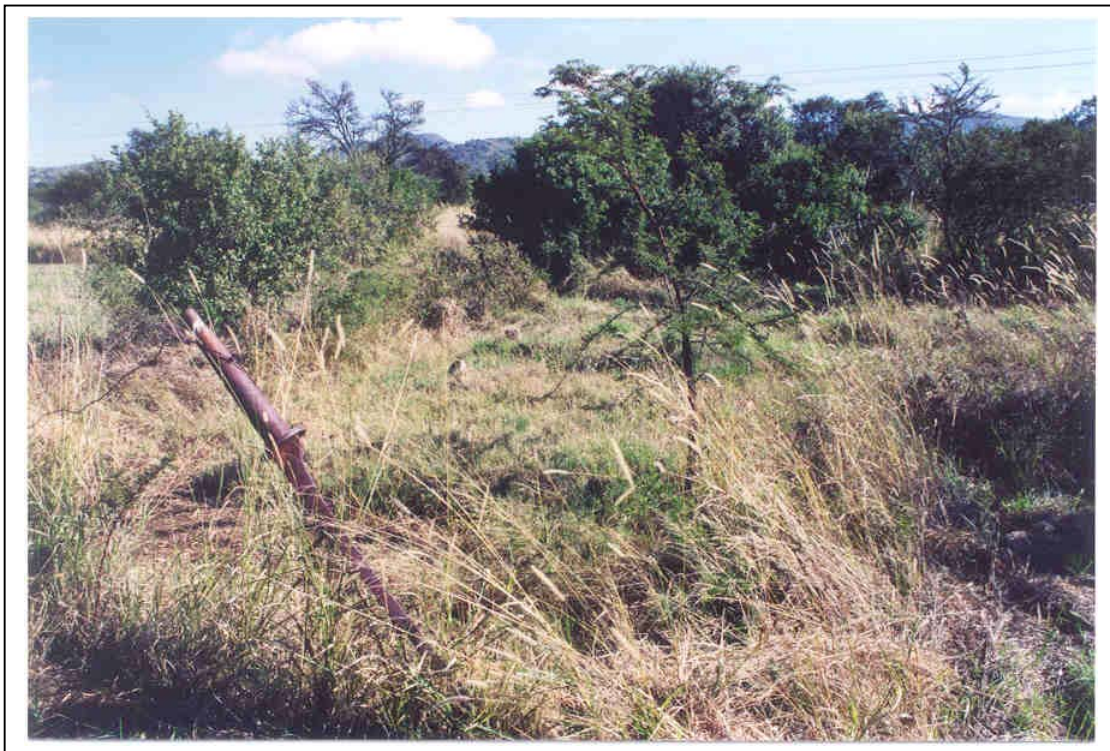
An historic fenced-in graveyard with 3 graves was recorded close to tower 542-543 on the northern side of Witkop Substation (Photograph 16). The graveyard and the layout seems to indicate that the graveyard is of Western or European origin. No names were indicated on the headstones.

Photograph 16: Site MaWit 013. Historic graveyard

The graveyard probably forms part of the farm settlements around this area. The next of kin of these graves could possibly be located. Provided that the graves

are not disturbed and access to them are not inhibited, they should not pose any problems for the proposed line.

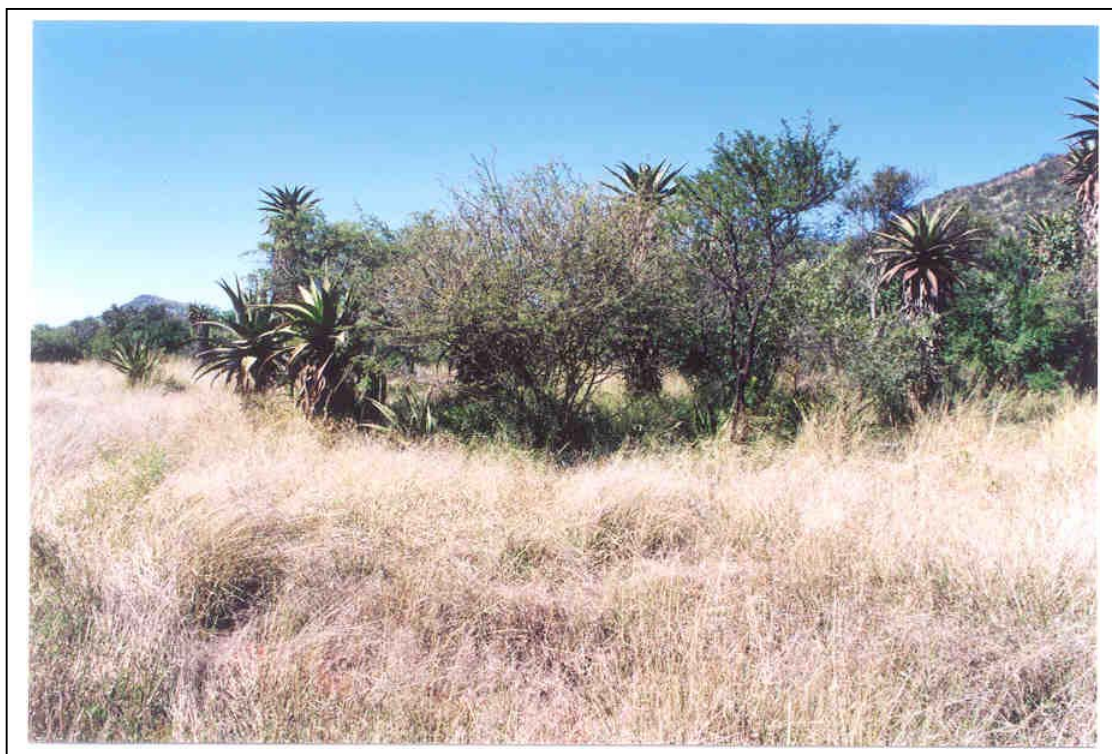
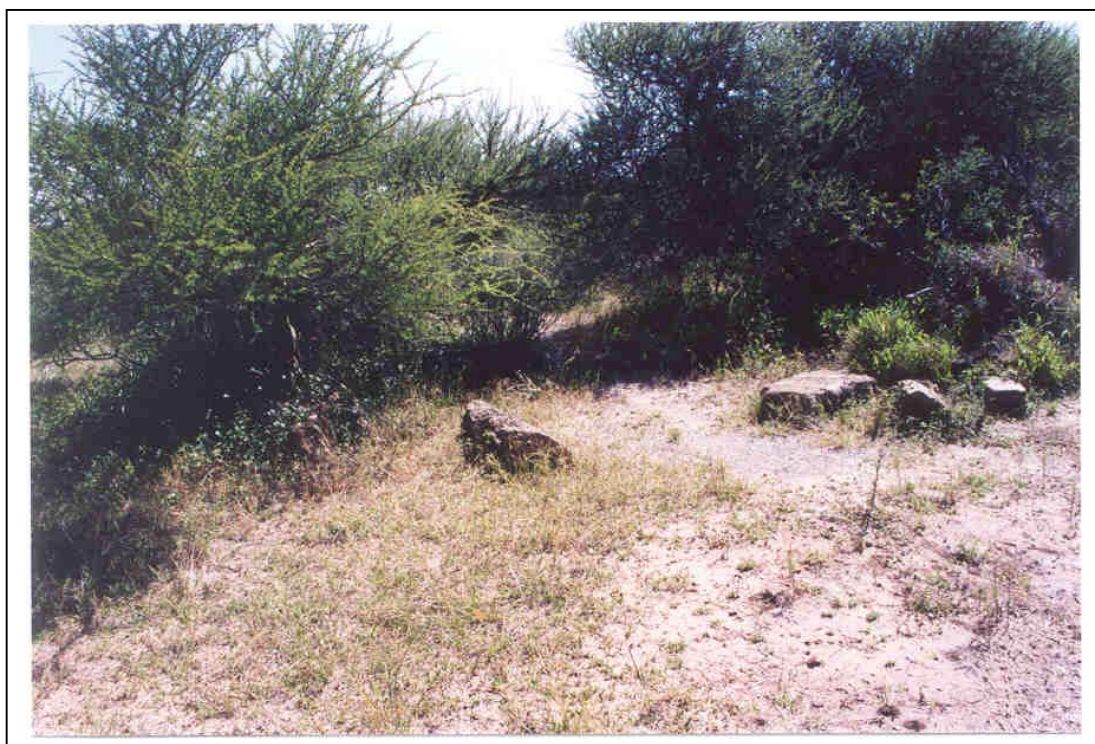
A large area on the northern side of the valley running from Witkop Substation towards the N1 shows indications of habitation. This was most likely a Late Stone Age site and there is a strong possibility of gravesites being located here (Photographs 17 and 18).

Photograph 17: Site MaWit 014. Late Stone Age site

Photograph 18: Site MaWit 014. Late Stone Age site

Very little structural remains were recorded at this site. This lack of hut remains and stone walling would suggest that these might have been Ndebele settlements of the late 1800s. The affected area spans approximately 2 – 3 ha, and has previously been damaged. Although the site has some scientific value, it contains very little material remains and would, therefore, not be a significant research site. However, should the line pass through here, it would be important to identify any graves in the surrounding area.

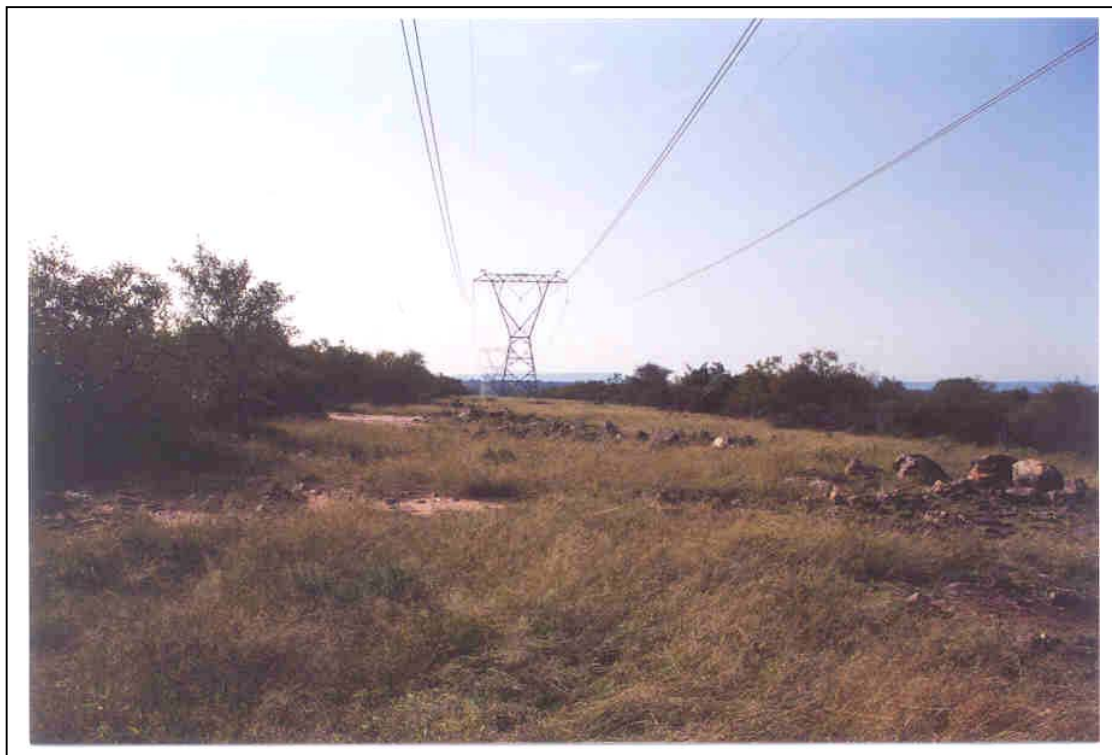
The clearing of the servitude usually involves only the removal of vegetation for fire control beneath the line. This has minimal impact on surface structures and could even assist in preserving sub-surface features by minimising root damage.

Photograph 19: Impact: clearing underneath line

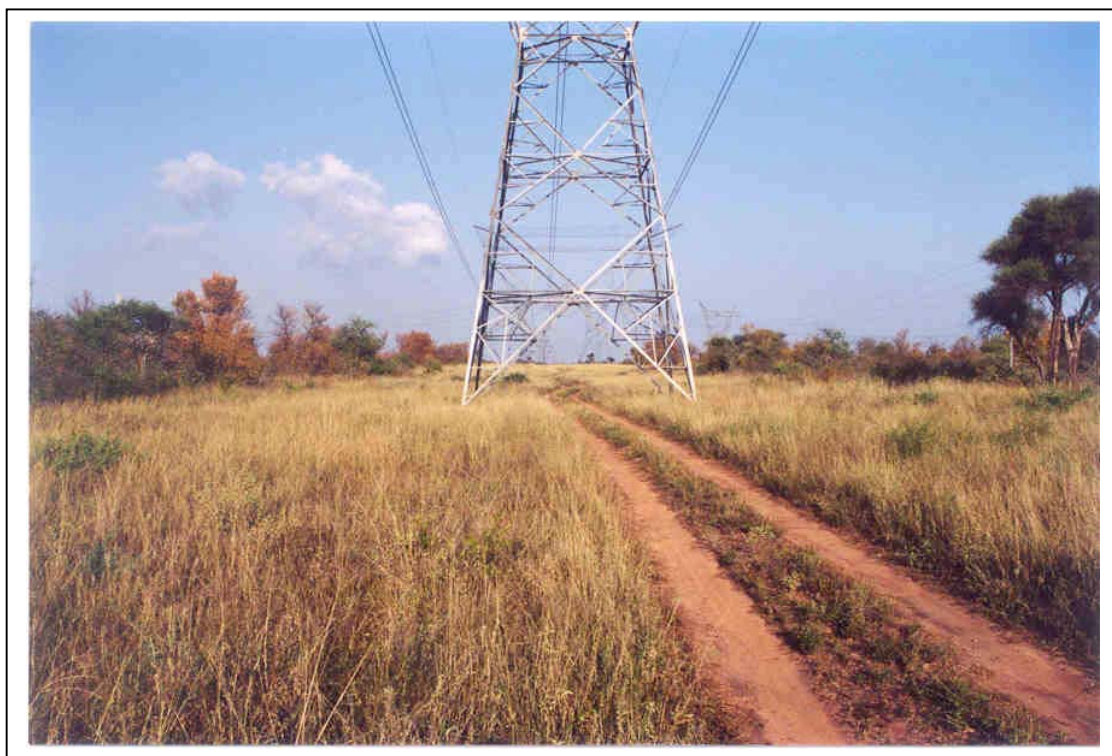
The following recommendations are provided for the identified sites. These recommendations are based on the qualitative parameters outlined under the section on Methodology. Recommendations are based on the impact that the towers will have on the surface. This effect has been determined to be minimal. The towers examined during the study showed that only approximately 4 m² of ground surface is disturbed by the foundations feet of the towers.

Should similar structures be used as in the existing line, the surface effect of these will be minimal and the information lost through these excavations is negligible.

Photograph 20: Impact: placement of tower foundations

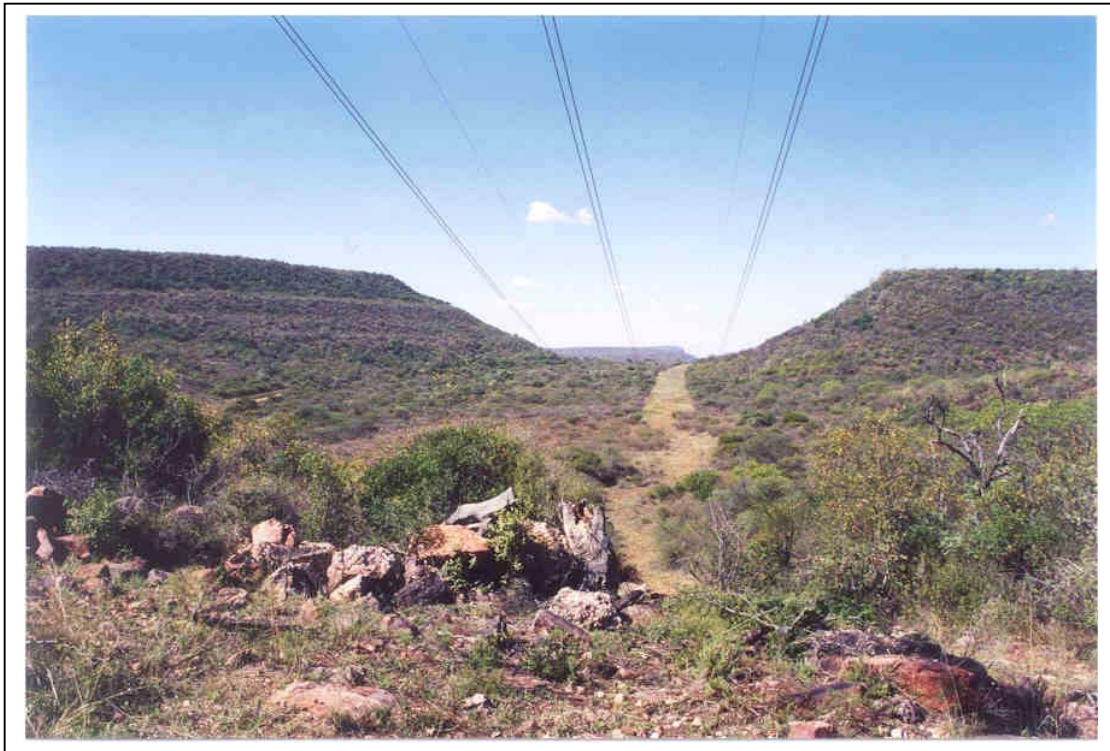
The only further negative effect of the pylons on heritage sites could be the visual impact that a tower would have on such sites. Only sites that have a score of 4 and above would, however, justify the movement of a tower due to the visual impact that it would have on such a site. No such sites were identified on any of the routes.

Photograph 21: Visual impact on sites
