**ENVIRONMENTAL IMPACT ASSESSMENT FOR THE
PROPOSED MATIMBA-WITKOP NO. 2 400 kV TRANSMISSION
LINE, NORTHERN PROVINCE**

SPECIALIST STUDY – HERITAGE IMPACT ASSESSMENT

APPENDIX J

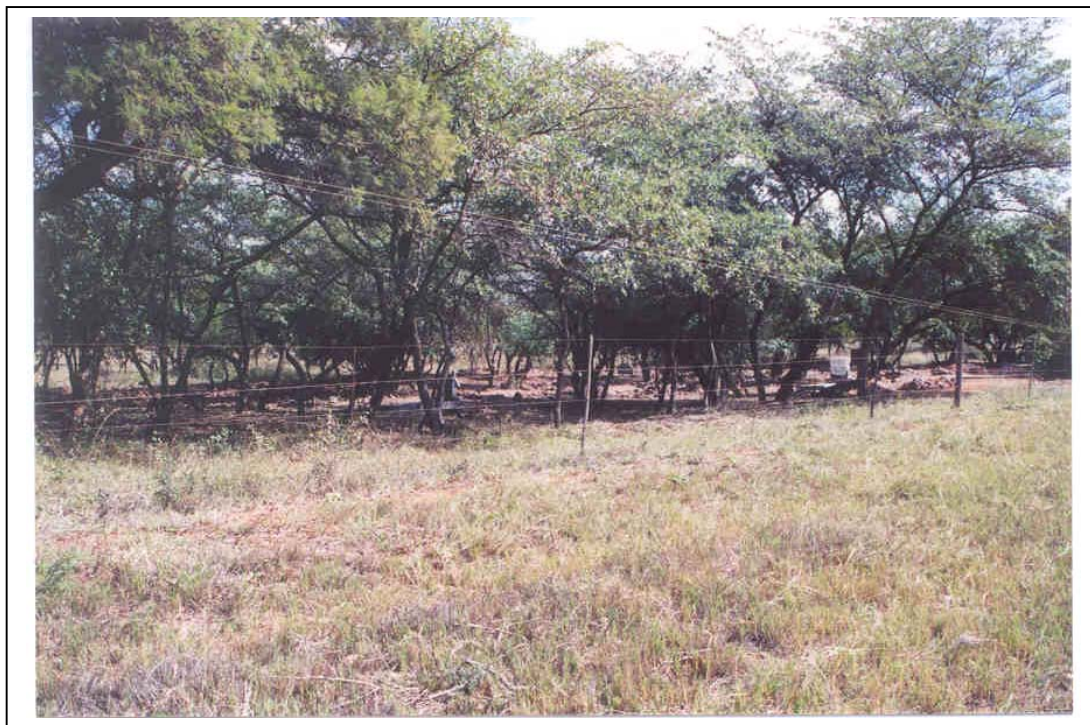
A community graveyard with approximately 50 graves was recorded at the village of Kafferboom next to the dirt road (Photograph 2). The graveyard is still in use.

Photograph 2: Site MaWit 002. Community graveyard

ii. MaWit 002 (Score 3)

The community graveyard is an important aspect of the social fabric of the community and should preferably not be moved or altered.

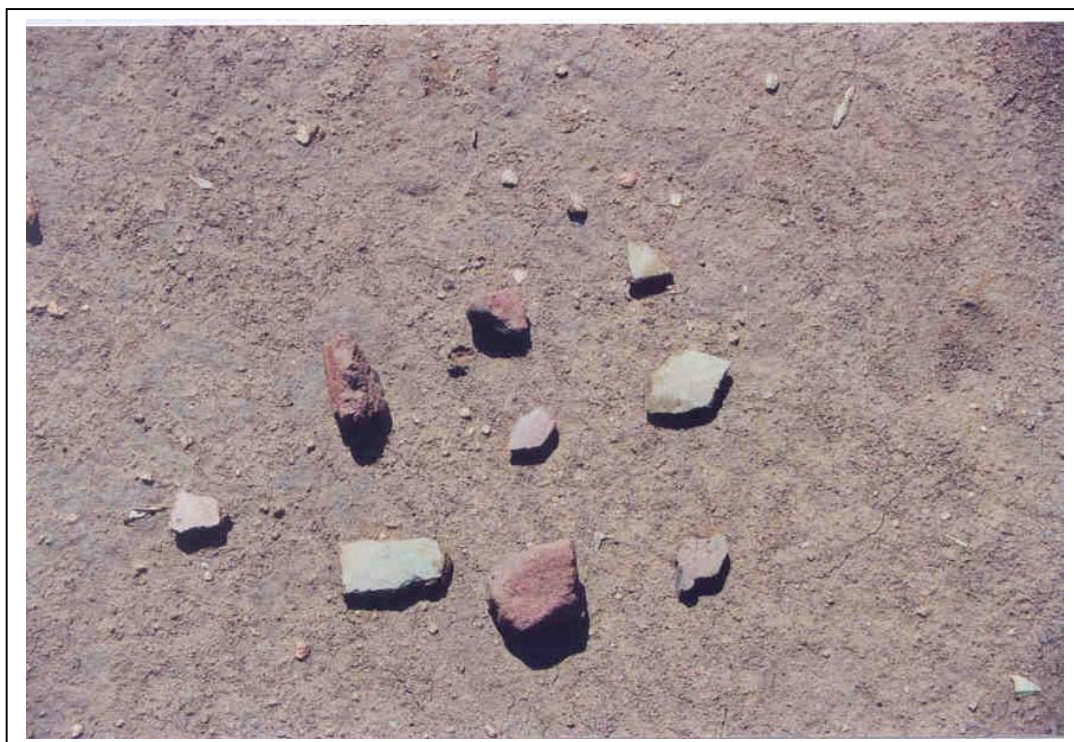
A surface scatter of potsherds, daga fragments and a few stone tools were recorded at this site (Photographs 3, 4 and 5). The scatter was of low density and was found in the neck between two hills. The surrounding areas were very rocky, although this area was without rocks. A fragment of a grinding stone was also recorded. Evidence of hut clay or a daga fragment was recorded all over the site. Possible features, such as dilapidated stone walls, were also recorded. The site extends over an area at the foot of one hill and measured approximately 50 m x 120 m. The site is not very big or rich in feature and artefacts. The *Euphorbias* growing on the side of the hill were most probably brought in by occupants.

Photograph 3: Site MaWit 003. Potsherds, daga fragments and some stone tools

Photograph 4: Site MaWit 003. Potsherds, daga fragments and some stone tools

iii. MaWit 003 (Score 3)

This site has significant scientific potential. The survey indicated that Iron Age sites in this area are uncommon, and little is known of such sites due to this situation. It is, therefore, recommended that the site be avoided as far as possible in order to limit damage to the site. If a tower has to be placed on this area, rescue work will have to be performed in order to preserve the information contained at this site.

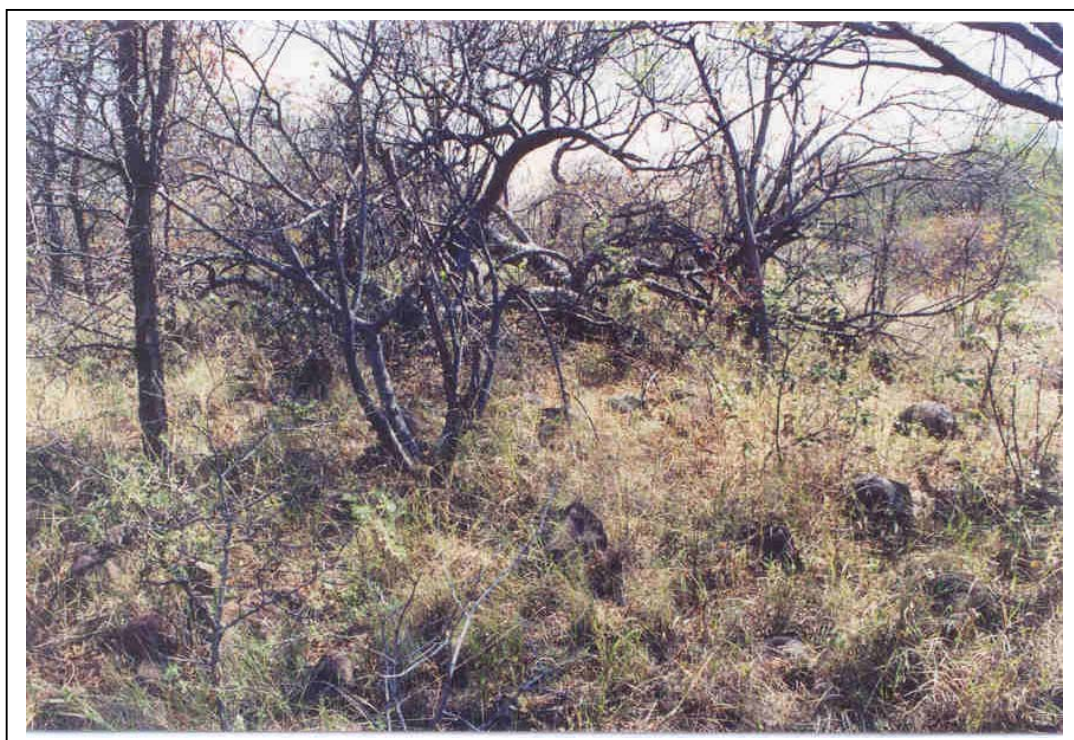
Photograph 5: Site MaWit 003. Rocky surroundings

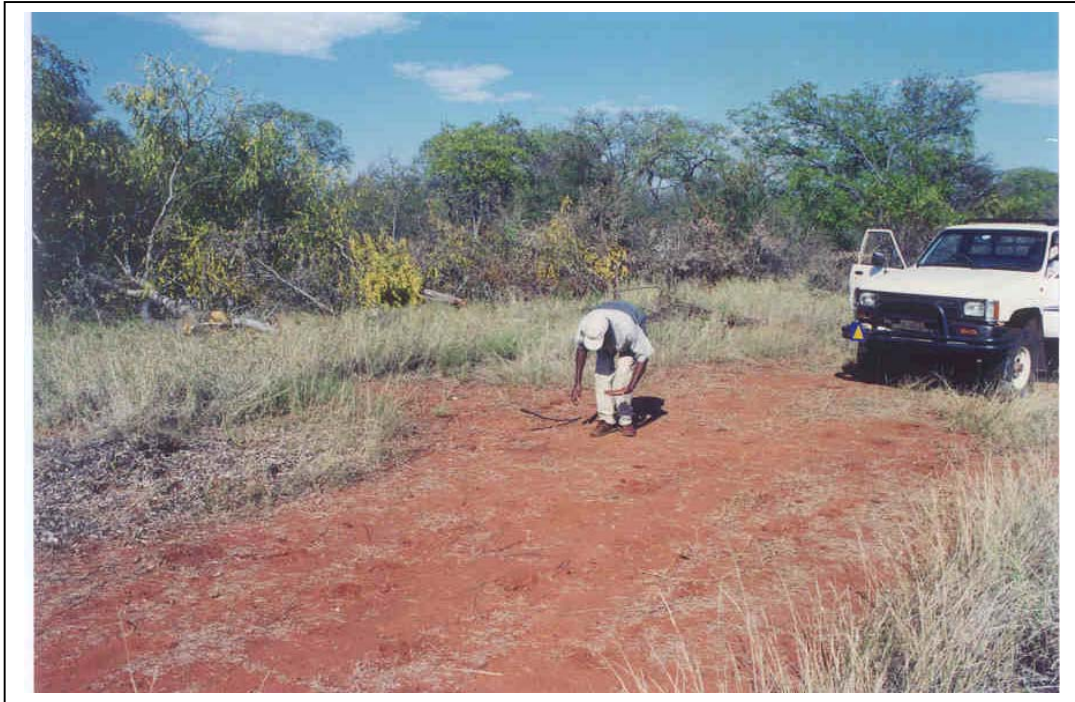
A small concentration of slag and tuyère fragments was found in the road (photo 6). The road was slightly graded open to expose scatter. The concentration measured approximately 20 m x 30 m but was of a very low density.

Photograph 6: Site MaWit 004. Small concentration of slag and tuyère fragments

iv. MaWit 004 (Score 3)

Indications of an iron production site abound here, and should be further investigated should the line pass here.

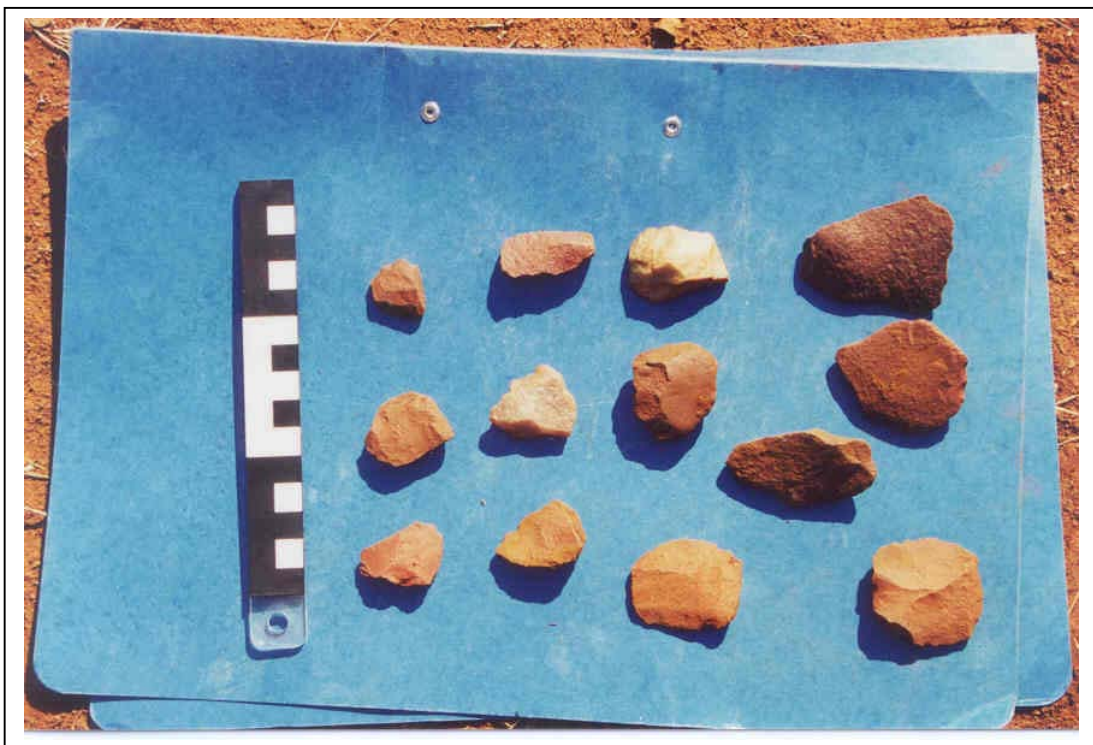
A low density scatter of stone tools was recorded in a sandy area in-between a stretch of exposed rocks. The stone tools consist of cores, flakes, scrapers and blades (Photograph 7). The area measured approximately 100 m x 100 m. Only a surface scatter was recorded with reworked cores. This is not considered as a production site.

Photograph 7: Site MaWit 005. A variety of stone tools

v. MaWit 005, MaWit 006 and MaWit 007 (Score 2)

These sites do not constitute manufacturing sites and, therefore, have little scientific or cultural value. The concentration of stone tools is common in this area and the impact of a single tower foundation on such sites is considered to be minimal.

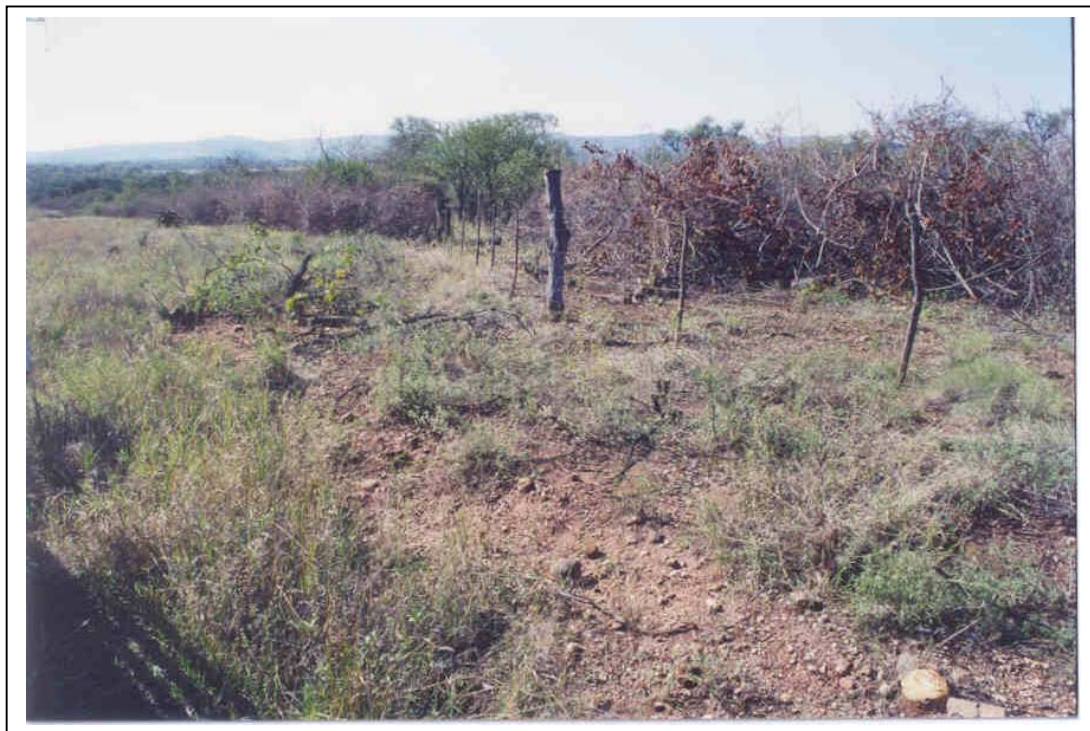
A concentration of Late Stone Age tools and microliths were recorded at this site (Photograph 8). The area was slightly disturbed due to development of infrastructure (fencing, a road and a powerline).

Photograph 8: Site MaWit 006. Late Stone Age tools and microliths

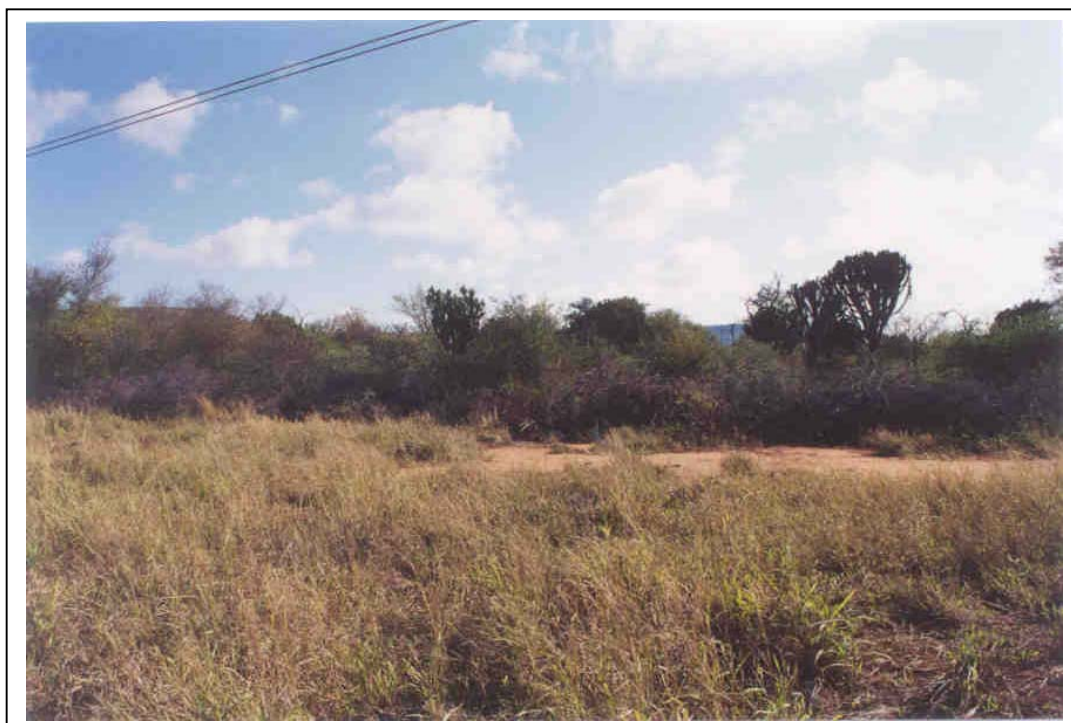
A low density scattering of Late Stone Age tools was recorded on this site (Photograph 9).

Photograph 9: Site MaWit 007. Scattering of Late Stone Age tools

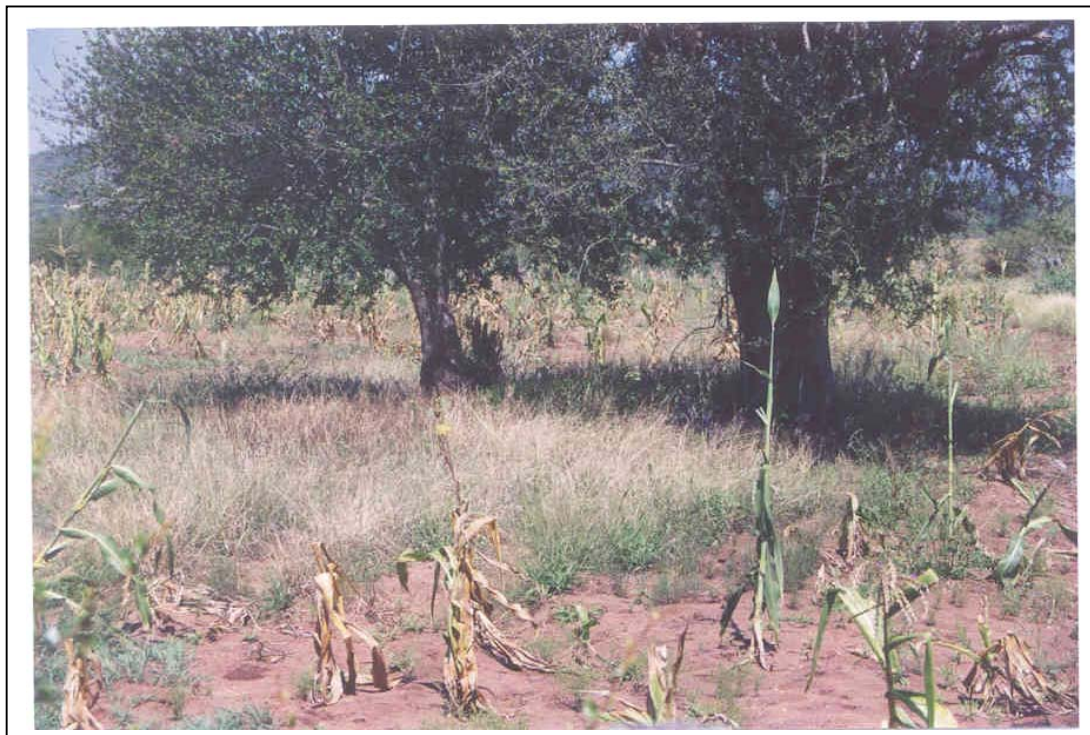
A cluster of eleven graves indicated by a paved stone outline dressing was recorded at this site (Photograph 10). These are located on a ploughed field approximately 80 m from the existing Matimba-Witkop NO 1 400 kV Transmission line.

Photograph 10: Site MaWit 009. Cluster of graves

vii. MaWit 009 (Score 3)

The community graveyard is an important aspect of the social fabric of the community and should preferably not be moved or altered.

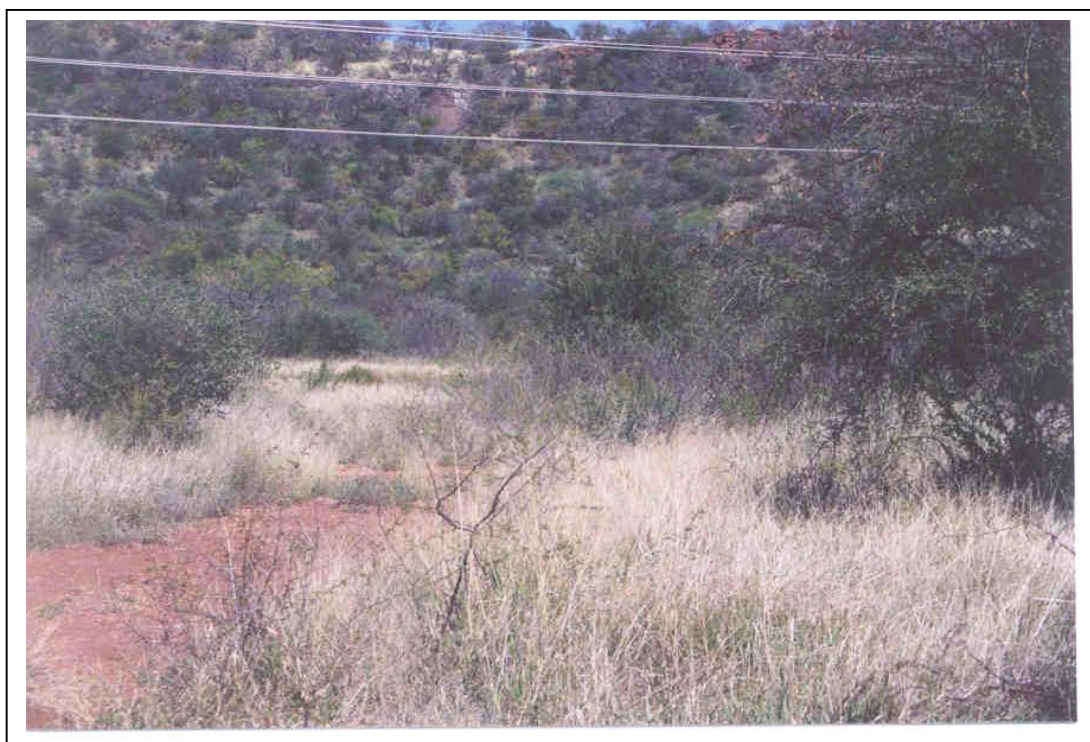
A dilapidated hut foundation and some scattered potsherds indicate the remains of an informal settlement at this site (Photograph 11). The settlement moved during the early 1960s to a formal village in the Vlakfontein region. The site covers a maximum of 10 ha. The site was destroyed and damaged by the construction of the road and existing Transmission line.

Photograph 11: Site MaWit 010. Remains of an informal settlement

viii. MaWit 010 (Score 2)

The inhabitants of this informal settlement moved to a formal settlement approximately 3 km to the north-east of the site during the 1970s. Interviews with local inhabitants indicated that no graves were located close to the site or within the site itself. The site has little or no scientific or cultural value.

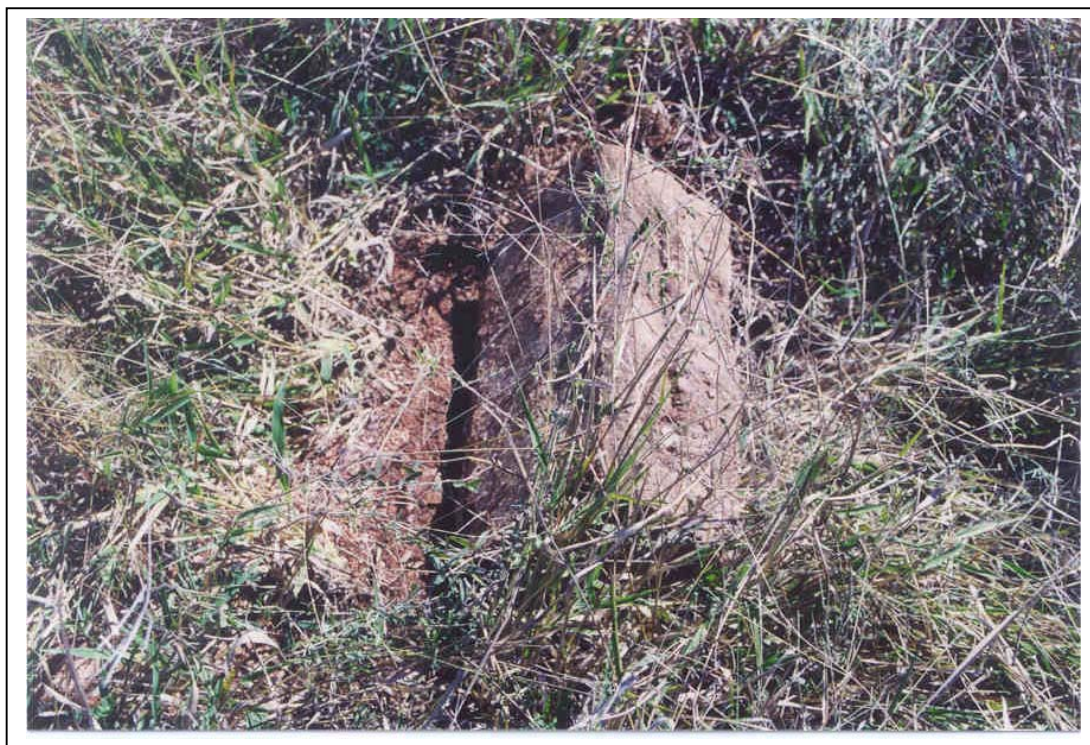
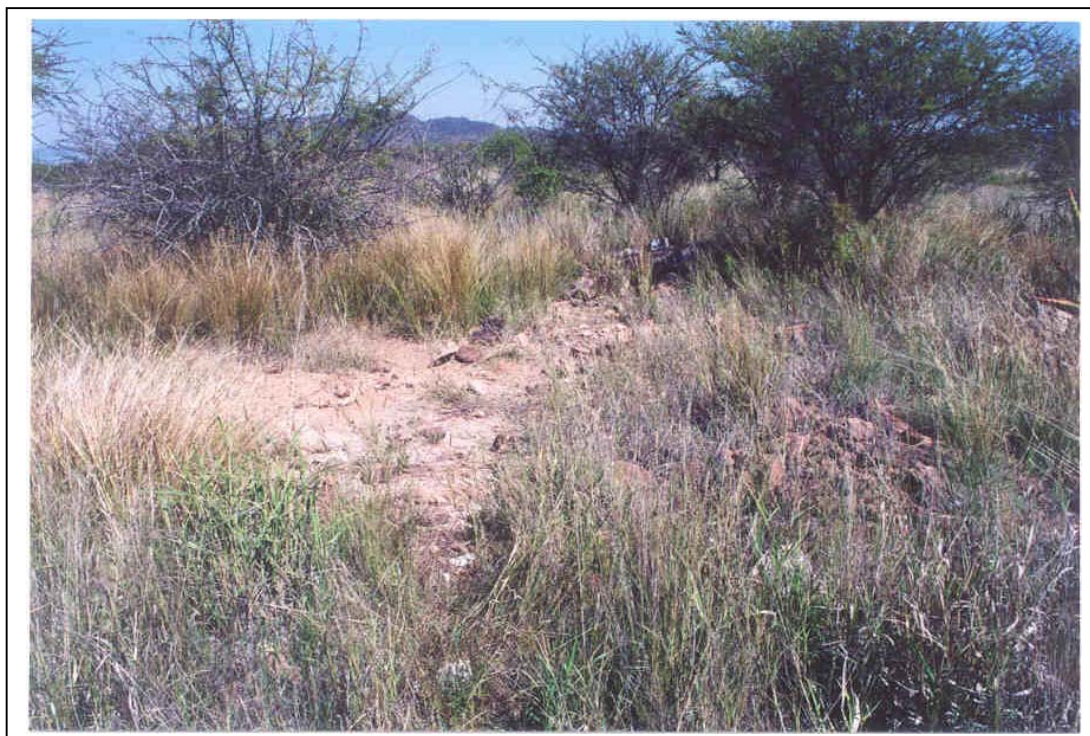
Large amounts of European type structures were recorded in a 3 – 4 ha area at this site (Photographs 12 and 13). Several porcelain and metal remains were recorded. Most of the inhabited area is defined by cacti and large tracts of pioneer plant growths (Photograph 14). The document studies to indicate that these were the ruins of the Dorsland settlement that was

abandoned during the 1960s. Although no reference to a graveyard could be found, it is highly likely that graves will be located close to this settlement.

Photograph 12: Site MaWit 011. European type structures and remains

Photograph 13: Site MaWit 011. European type structures and remains

ix. MaWit 011 (Score 3)

The main concern in this area will be the locality of graves. Should the line pass here, the locality of these will have to be determined.

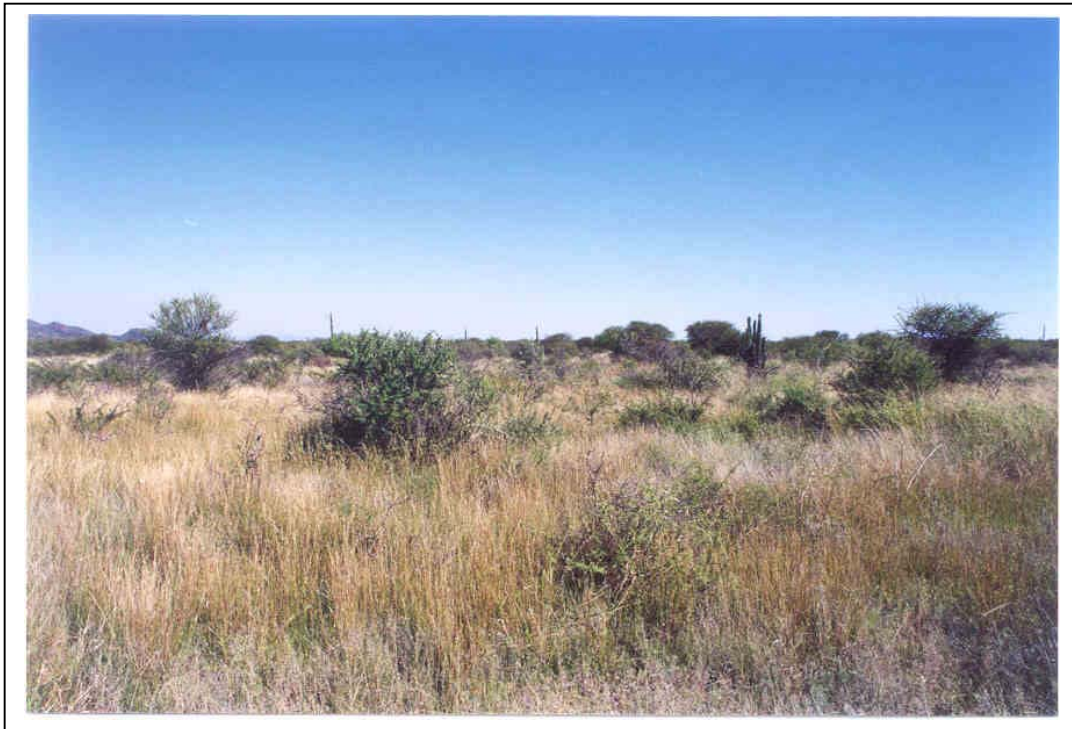
Photograph 14: Site MaWit 011. Cacti and pioneer plant growth

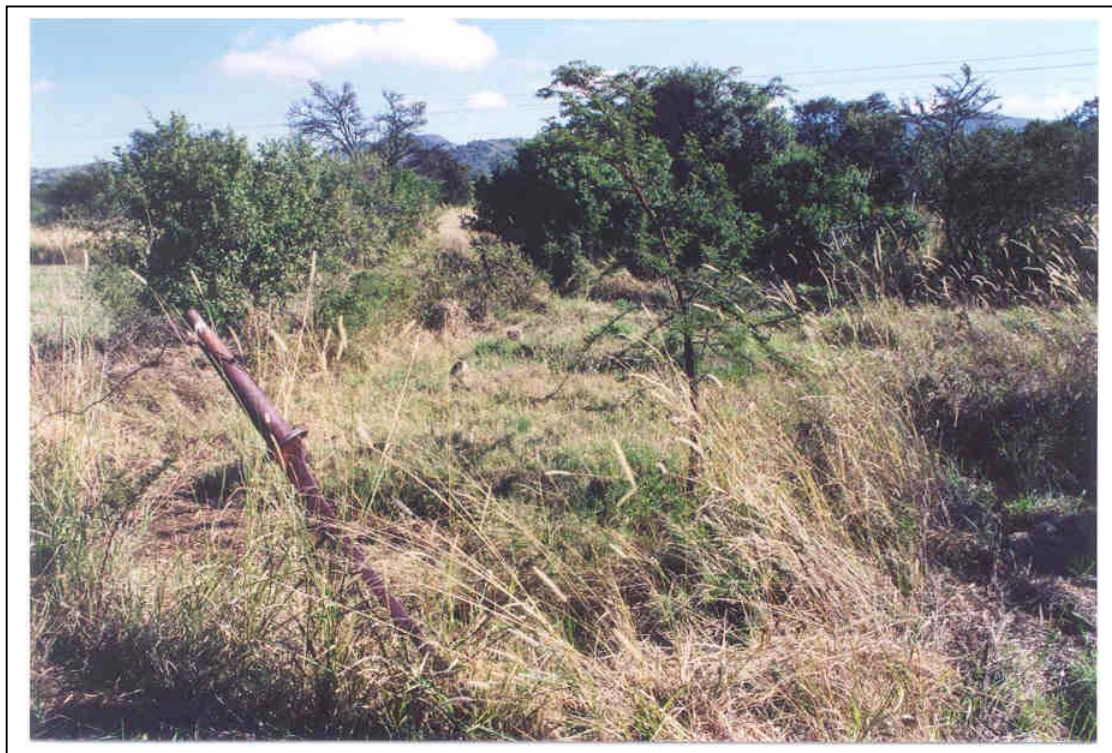
An historic fenced-in graveyard with 3 graves was recorded close to tower 542-543 on the northern side of Witkop Substation (Photograph 16). The graveyard and the layout seems to indicate that the graveyard is of Western or European origin. No names were indicated on the headstones.

Photograph 16: Site MaWit 013. Historic graveyard

xi. MaWit 013 (Score 3)

The graveyard probably forms part of the farm settlements around this area. The next of kin of these graves could possibly be located. Provided that the graves are not disturbed and access to them are not inhibited, they should not pose any problems for the proposed line.

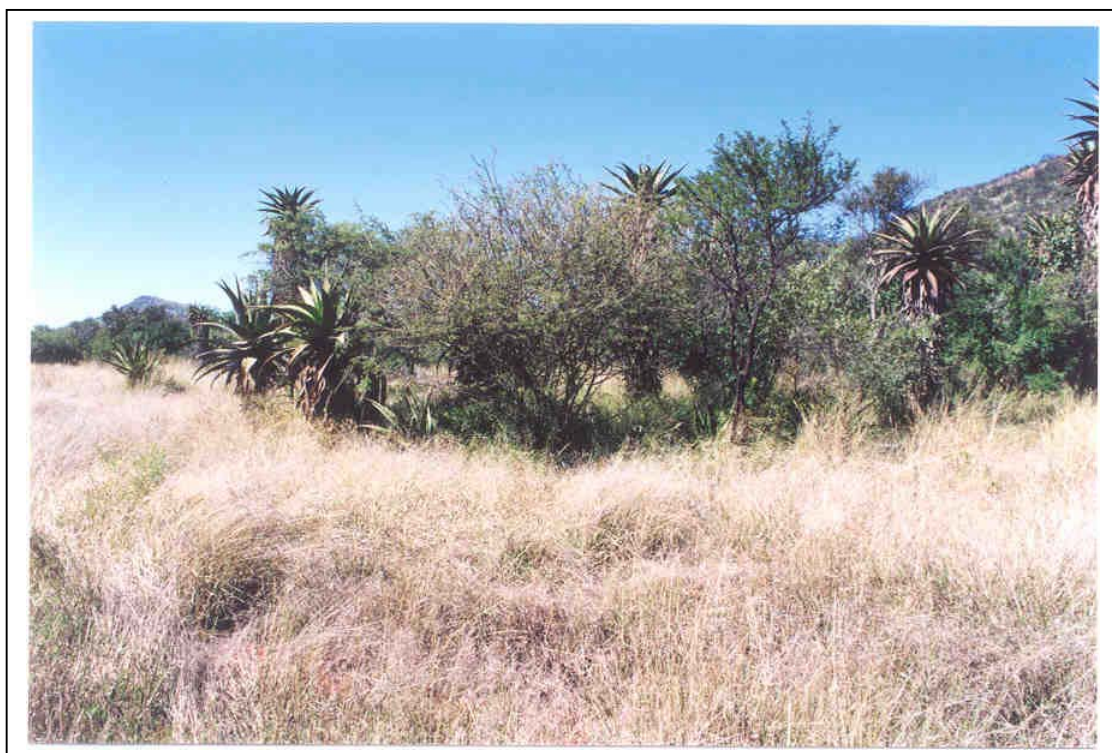
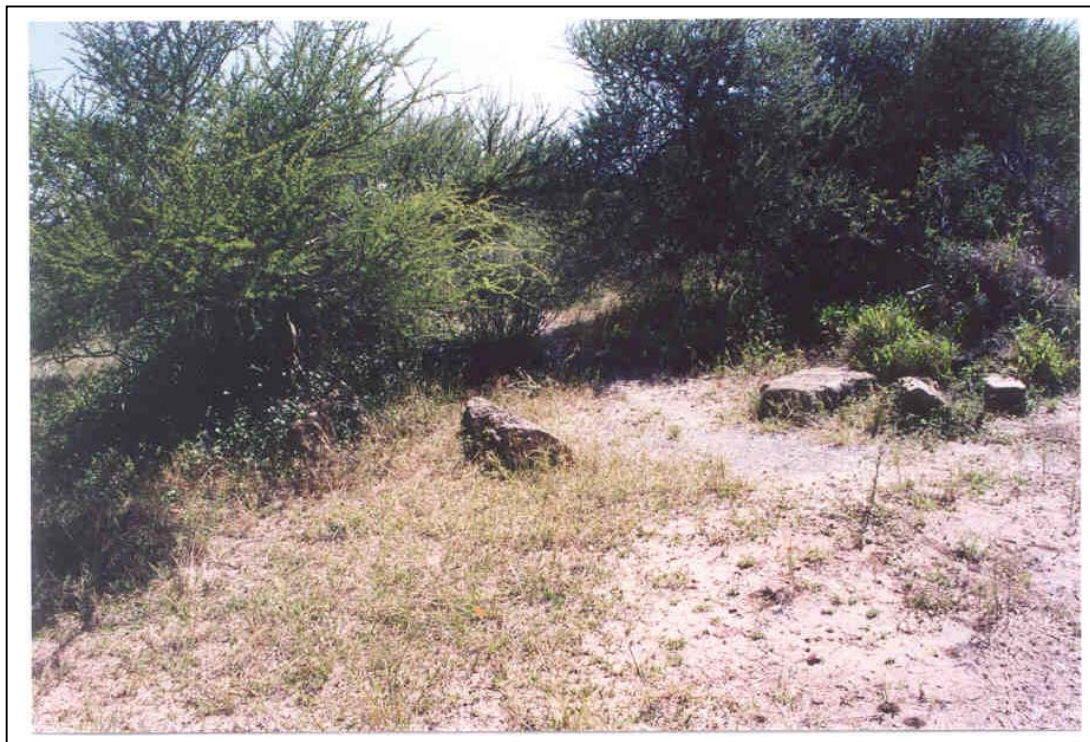
A large area on the northern side of the valley running from Witkop Substation towards the N1 shows indications of habitation. This was most likely a Late Stone Age site and there is a strong possibility of gravesites being located here (Photographs 17 and 18).

Photograph 17: Site MaWit 014. Late Stone Age site

Photograph 18: Site MaWit 014. Late Stone Age site

xii. MaWit 014 (Score 3)

Very little structural remains were recorded at this site. This lack of hut remains and stone walling would suggest that these might have been Ndebele settlements of the late 1800s. The affected area spans approximately 2 – 3 ha, and has previously been damaged. Although the site has some scientific value, it contains very little material remains and would, therefore, not be a significant research site. However, should the line pass through here, it would be important to identify any graves in the surrounding area.

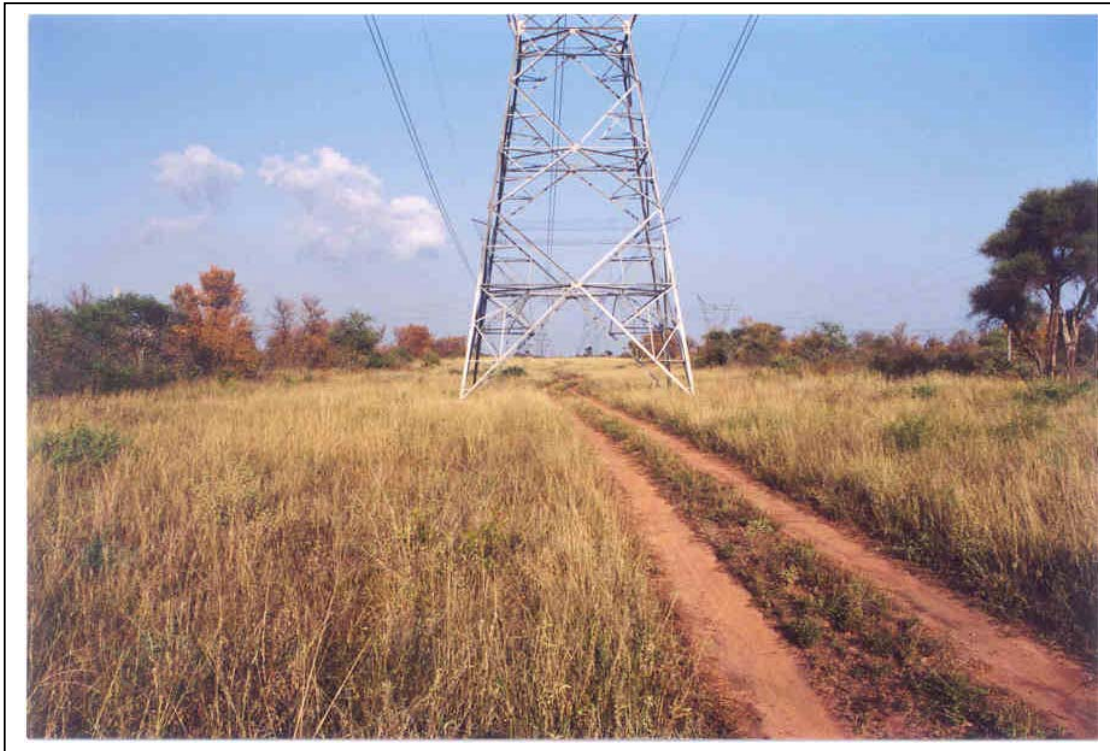
Should similar structures be used as in the existing line, the surface effect of these will be minimal and the information lost through these excavations is negligible.

Photograph 20: Impact: placement of tower foundations
