Biophysical Specialist Study Report for the Bravo 4 Power Line Route Alternatives

Draft Report

This is a report compiled for Zitholele
Consulting

ESC 228-4

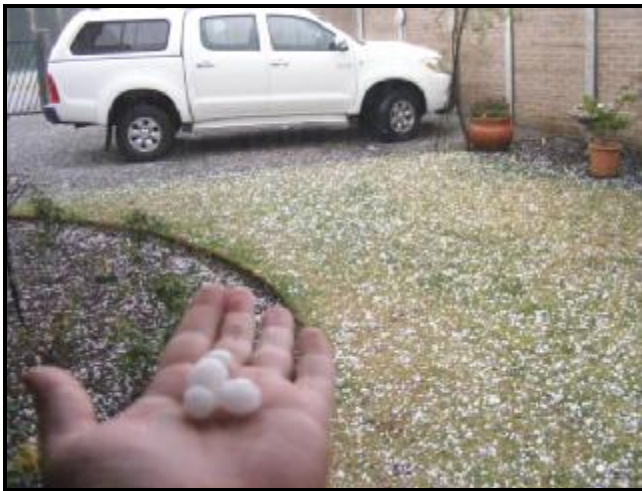
Figure 5: Hail stones from a storm event in November 2008 (Secunda)

The region experiences frequent frosts, with mean frost days of 41 days, winds are usually light to moderate, with the prevailing wind direction north-westerly during the summer and easterly during winter. In addition to frost the area is prone to hail storms during the summer time. Such a storm was experienced during the site visits and the hail stones are illustrated in Figure 5 below.

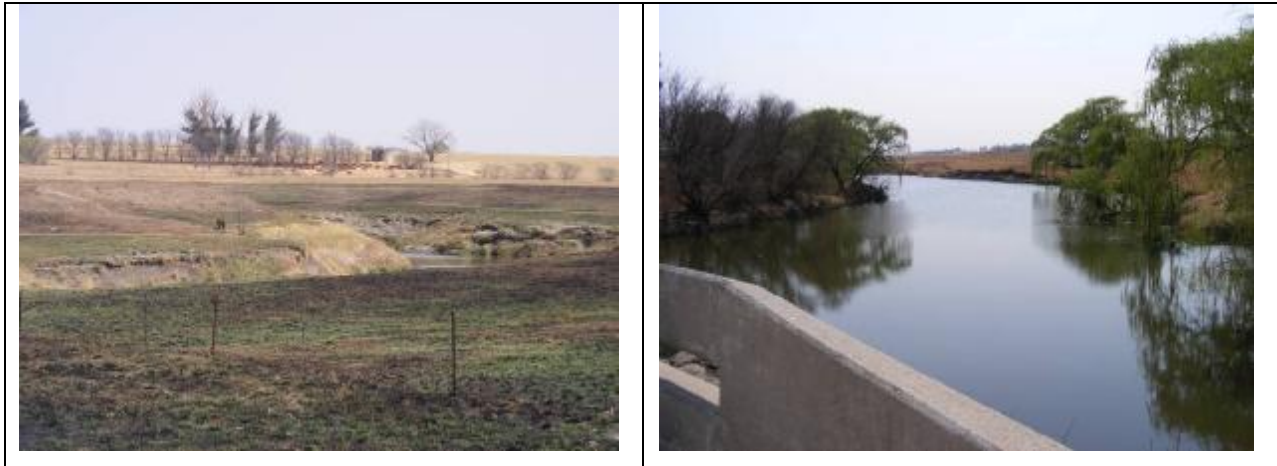
The Waterval River along which a significant section of Alternative 1 is aligned.

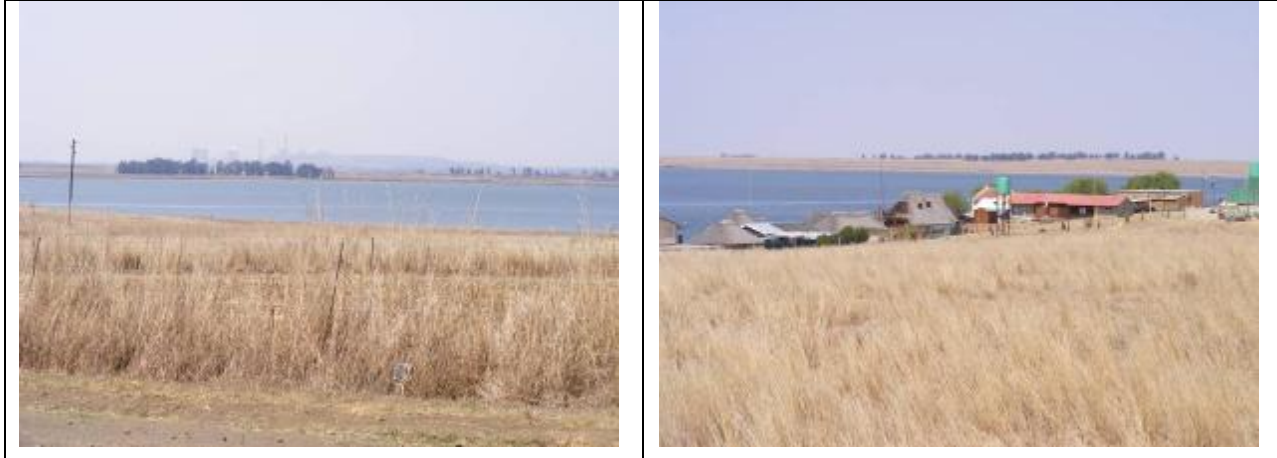
Leeupan, a significant water body found along the Alternative 2 alignment. Note Secunda in the background (left) and the angling club (right).

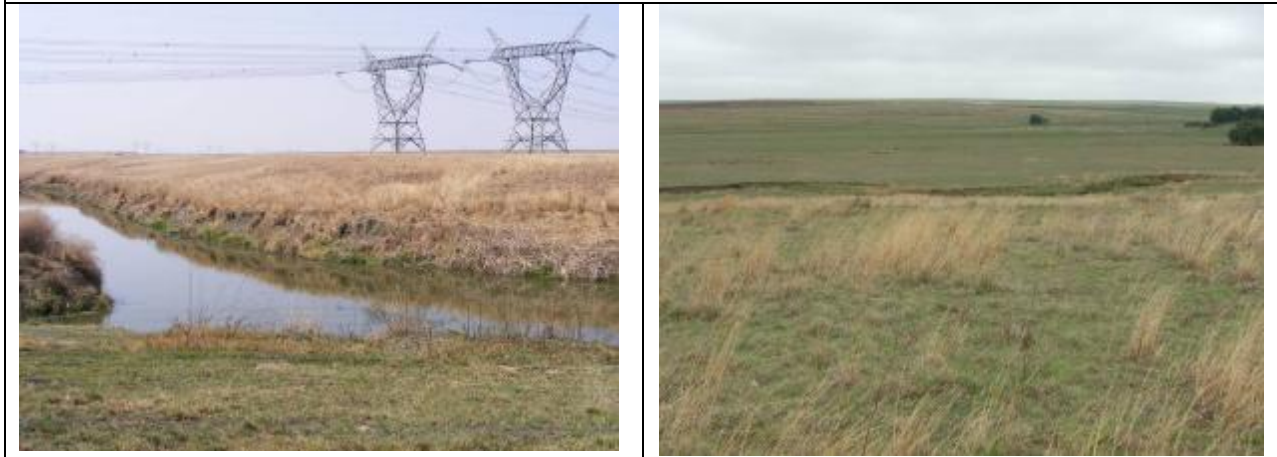
Waterval River showing existing power line crossings

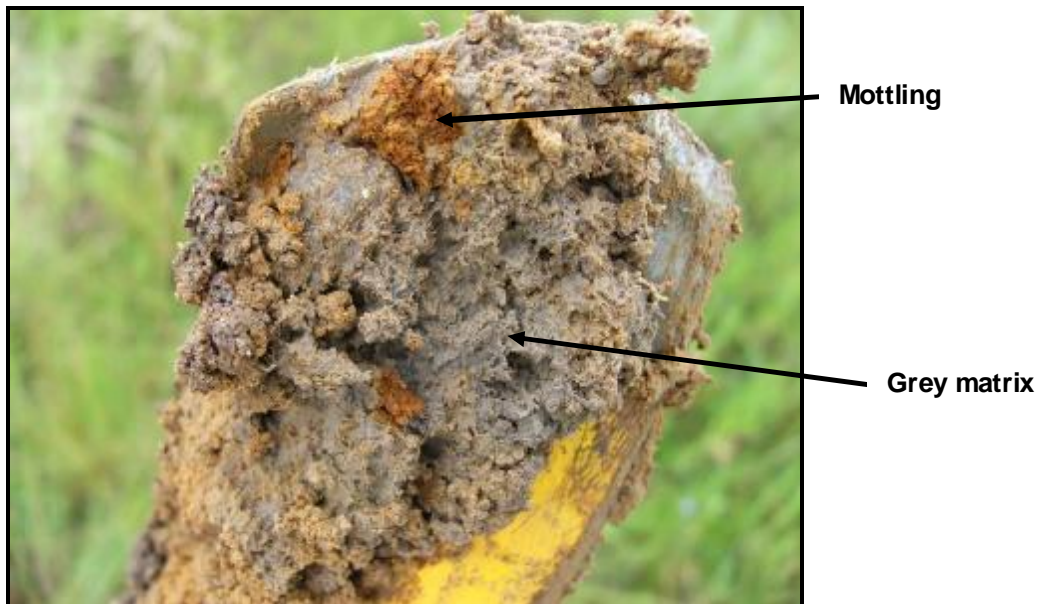
Figure 13: Soft plinthic B-horizon.

- Ü Has undergone localised accumulation of iron and manganese oxides under conditions of a fluctuating water table with clear red-brown, yellow-brown or black strains in more than 10% of the horizon;
- Ü Has grey colours of gleying in or directly underneath the horizon; and
- Ü Does not qualify as a diagnostic soft carbonate horizon.

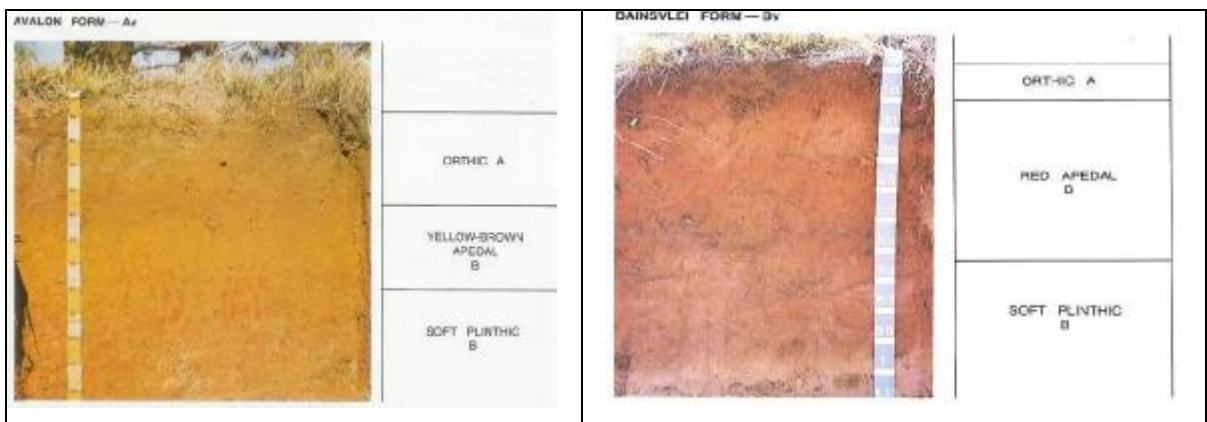
Figure 14: Avalon and Bainsvlei Soil Forms (Soil Classification, 1991)

These soils are found lower down the slopes than the Clovelly and Hutton soils and indicate the start of the soils with clay accumulation.
