ENVIRONMENTAL IMPACT ASSESSMENT FOR THE CONSTRUCTION AND UPGRADING OF THE PROPOSED BRAAMHOEK ACCESS ROADS

FINAL EXTENDED SCOPING REPORT

February 2006

FINAL EXTENDED SCOPING REPORT FOR THE PROPOSED CONSTRUCTION
AND UPGRADING OF INTERNAL AND EXTERNAL ACCESS ROADS FOR THE
BRAAMHOEK PUMPED STORAGE SCHEME

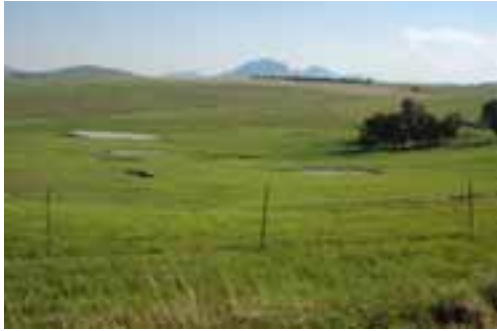
Plate 9: General topography associated with upper reservoir area

The topography of the proposed site is typical of the Drakensberg escarpment (**Figure 2-6**). The Upper Reservoir site (Bedford farm) is situated at an altitude of 1700 mamsl and consists of rolling grassland, with incised drainage lines (**Plate 9**).

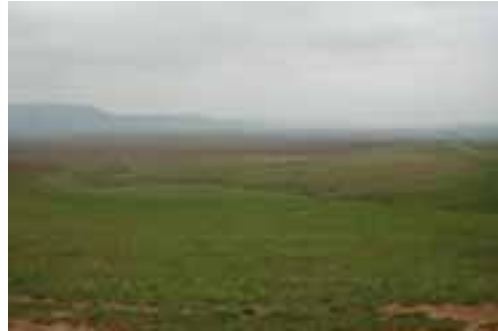
Plate 10: General topography associated with lower reservoir area

The Lower Reservoir (Bramhoek farm) is situated in the foothills of the Drakensberg escarpment at an altitude of 1220 mamsl, in typical grassland with rolling hills, small streams, erosion gullies and a few farm dams (**Plate 10**).

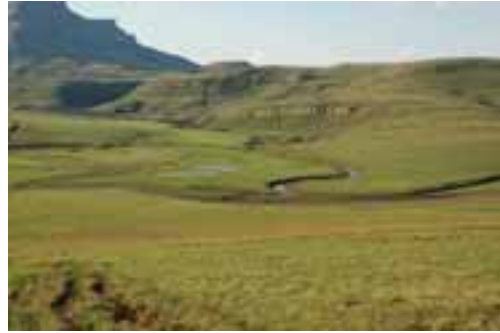
Plate 12: Head waters to the Wilge River

In the area of the access roads to the Upper Reservoir site, local relief is of the order of 100 m. Low, flat topped koppies and spurs characterise the landscape and have resulted from the strong structural influence of flat-lying strata of the Karoo Supergroup, particularly the Rooinek Sandstone, which outcrops extensively in the area. Locally, streams have incised through the sandstone to depths of up to 50 m, forming small

waterfalls and narrow valleys, one of which is a headwater of the Wilge River and contains the Upper Reservoir site (**Plate 12**).

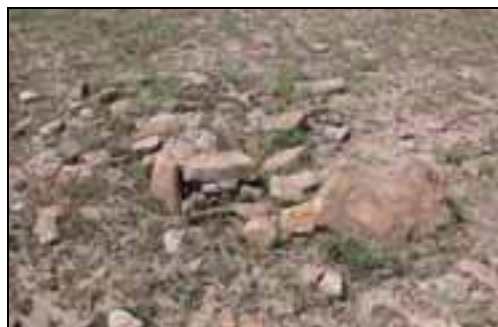
Plate 19: The stone structure from site BH1 can be seen

Unidentifiable stone structure situated on top of the Drakensburg (**Plate 19**). The structure, which is orientated along the north-south axis, is not associated with any other cultural material or features. The structure is situated some distance away from the road, and no negative impact is expected. Furthermore, the structure does not form part of a formal settlement. As a result, **BH1** is of **Low Significance**.

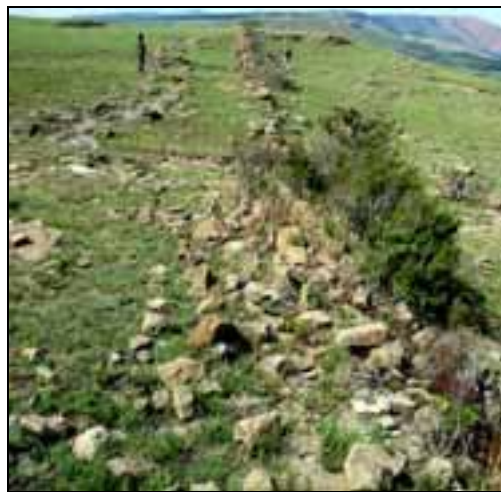
Plate 20: General view of the long stone wall

The site consists of stonewall which was packed in a straight line. The feature is approximately 20 m in length. The wall is double-packed, and is located on the mountain's scarp (**Plate 20**). From the 2829BC BESTERS map it is evident that **BH2** is located close to the western boundary of the farm Oulsten 8510. The feature can therefore be described as an old farm boundary. The existing road of the Braamhoek Pass passes over the site. The stonewall is already impacted upon by the Braamhoek Pass road and although it might be older than 60 years, it is not a unique feature in the landscape. As a result, **BH2** is of **Low Significance**.

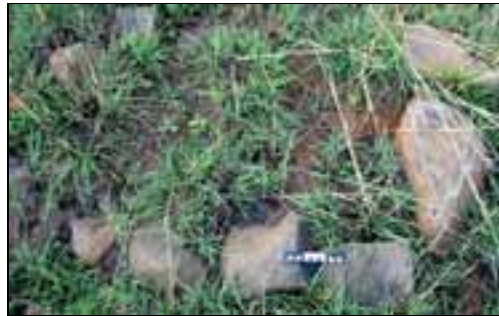
Plate 21: Stone-lined structure which may be a grave

- A stone-lined structure orientated along the east-west axis which may be a grave (**Plate 21**).
- One terrace wall.
- Two rectangular foundation structures.

The dwelling foundations are associated with farm labourer housing. These foundations are not significant. However, a worst case scenario, wherein the stone-

lined structure is indeed a grave, was used to assess the site significance. As a result the site is given a **High Significance** rating.

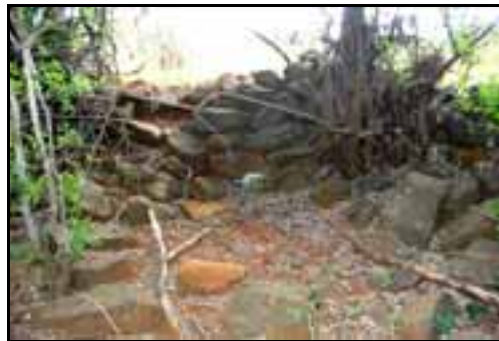
Plate 22: A portion of the stone kraal is visible in this photograph

This site is associated with **Site BH3**, and consists of a rectangular stone cattle kraal (**Plate 22**). Two enclosures were added to the outer wall of the kraal and are interpreted as keeps for small livestock. The site is situated close to a small stream. Associated material culture consists of a broken lower grinder. This rectangular stone structure interpreted as a cattle kraal dates from the relative recent past and is not a unique feature. Therefore, **BH4** is of **Low Significance**.

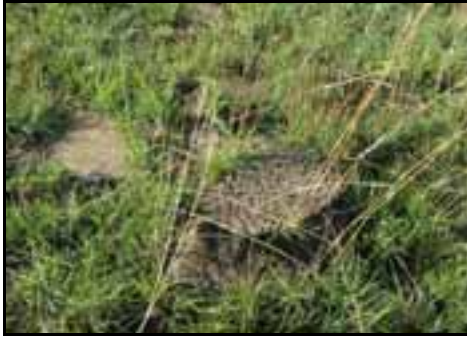
Plate 23: The disturbed stonewall at Site BH5 is barely visible

This is the location of a highly disturbed stonewall foundation. A number of undecorated potsherds were observed in the surrounding area. The general area is characterised by sheet erosion.

The possibility exists that this stone foundation formed part of a Late Iron Age/Historic settlement. The walling was most probably robbed to construct the more recent structures from Site BH3 and Site BH4. Due to the disturbed nature of the site, BH5 is of **Low Significance**.

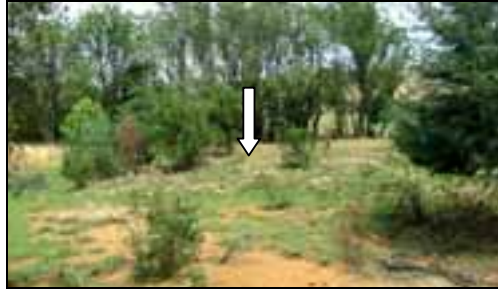
Plate 24: General view of the site. The foundation is indicated

The site consists of the old Bramhoek farmstead (**Plate 24**). The farmstead comprises the following structures:-

The farmstead is associated with planted vegetation such as poplars. If the road alignment is changed so that the line of the planned road moves closer to the farmstead, suitable mitigation measures must be undertaken. The site is of **Moderate Significance**.

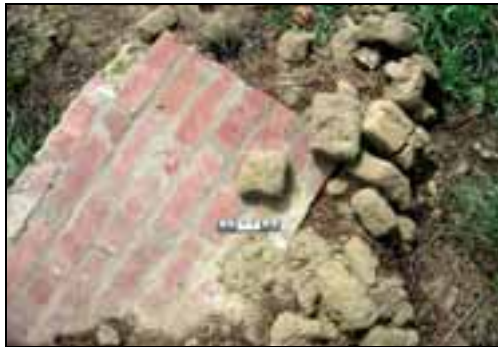
Plate 25: Remains of the farm dwelling. Note the mud bricks as well as the more conventional bricks (with cement)

- Rectangular foundation structure that appears to have been the dwelling. Mud bricks as well as more conventional bricks were observed here, indicating that the original dwelling may have been quite old (**Plate 25**).
- Small rectangular wagon shed and stables comprising a stone and mortar foundation structure with a mud brick extension on top (**Plate 26 and 27**). The mud brick sections of the inner and outer walling were plastered. The structure's doorframes and supporting cross-beams are all made of wood, while the roof is missing.

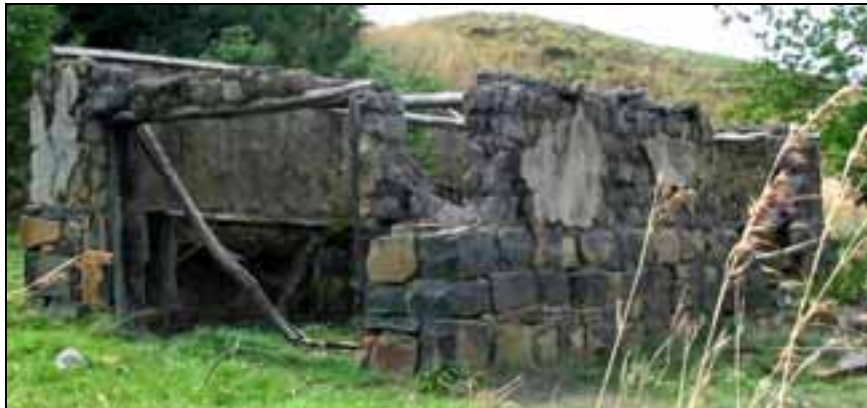
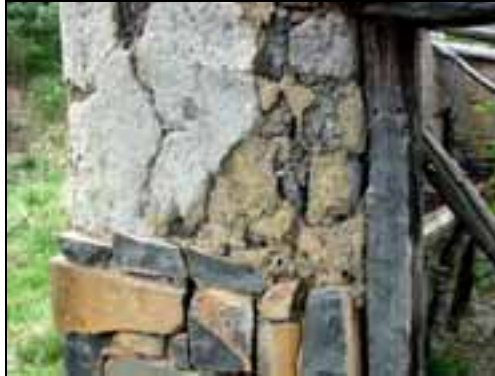
Plate 26: The remains of what used to be the farmstead's wagon shed and stables

Plate 27: The remains of what used to be the farmstead's wagon shed and stables

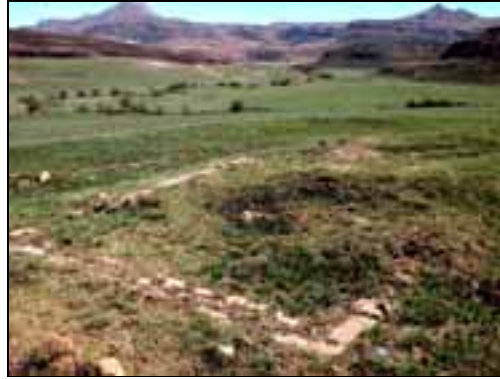
Plate 33: One of the rectangular foundation structures can be seen in the foreground.

A number of stone foundation structures are located on a west-facing slope overlooking a non-perennial stream (**Plate 33**). These structures are located directly adjacent to the northern fence of the road.

The oldest available map on which the site is shown is the 2829AB GROOTHOEK Topographical Sheet that was printed in 1965. This map furthermore made use of aerial photography undertaken in 1955. The Harrismith sheet of the 1:125 000 series undertaken of the Orange Free State, and which was surveyed in 1908, reveals that the site did not exist as early as that (National Archives, Maps, 3/671). The topographical sheet shows the site to have been a school. An archival file located in the Free State Archives mentions the existence of the so-called Fullerton Native Farm School, also known as the Nelsonskop Berlin Mission School (VAB, 1/1/111, N25/4/3). As this file contains documents and reports of the school for the period 1930 to 1961, it is safe to say that the school was probably established in 1930. The site is therefore older than 60 years. **Site BH10** is of **Low to Moderate Significance**.

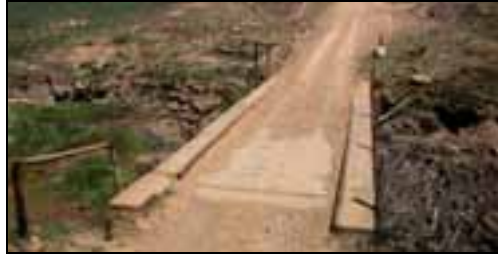
Plate 34: General view of the bridge

The site consists of a reinforced concrete bridge over the Wilge River (**Plate 34** and **35**). The bridge was located on the road between Collins Pass and Harrismith, on what used to be Chatsworth 388 (the section on which the bridge is located is today known as Wilgerivier 319). Comparing the map that was surveyed in 1908 (National Archives, Maps, 3/671) with the topographical map that was surveyed in 1964, it becomes evident that the bridge was not constructed over the original drift, but slightly west of it. During 1908 the drift was described as being “much used”.

During the mid-1920s a number of bridges were constructed in the Orange Free State by the Union of South Africa’s Public Works Department, who were based at the Union Buildings in Pretoria. The bridge at **Site BH11** is one of these constructions. The construction of the bridge commenced on 17 May 1926, and was completed before 10 September 1927. This means that the bridge is older than 60 years, and as a result protected by the legislation. The bridge can therefore not be altered, disturbed or demolished without a permit issued by the heritage authority. Although the bridge is older than 60 years, and represents an infrastructural element of the area’s transport development history, a number of such bridges were constructed during the 1920s. As a result the bridge can not be seen as unique.

The site is given a **Low** to **Moderate significance** rating.

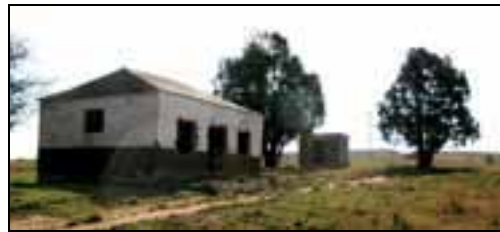
Plate 38: The building from BH14

The site consists of a building that may be older than 60 years, since it appears the building has been constructed between 1908 and 1965. The building is constructed of bricks and has a corrugated iron roof (**Plate 38**). The condition of the structure is poor, with all windows and doors having been removed. **BH14** is of **Low to Moderate Significance**.

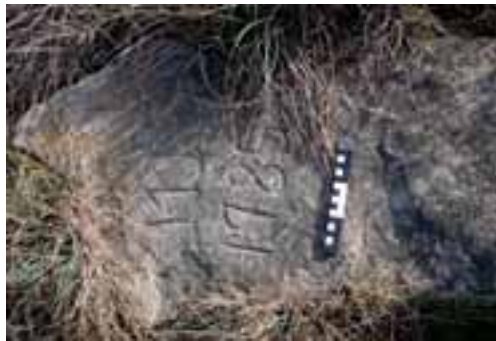
The site consists of an upright boulder associated with a headstone-shaped stone (**Plate 39**) on which the following inscription was made: "MJ 1985" (**Plate 40**). The upright boulder itself bears another inscription, and although it is quite weathered seems to read "15-12-85". The site located approximately 12 meters from the road fence. The inscriptions and stones seem to indicate the presence of a grave or memorial to a deceased. A possibility may be that the feature acts as a memorial to a person who had died in a car accident on the road.

Plate 40: Headstone-shaped stone with inscription

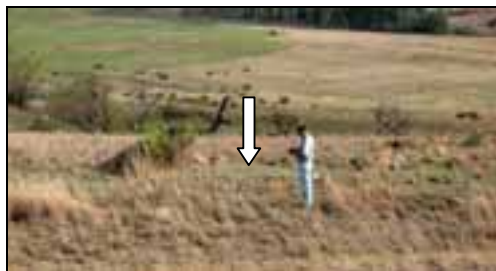
A single rectangular foundation structure was observed here (**Plate 41**). The structure is situated to the east of the road, and directly adjacent to the fence. **BH16** is of **No Significance**.

Plate 41: The position of the foundation structure is indicated with an arrow

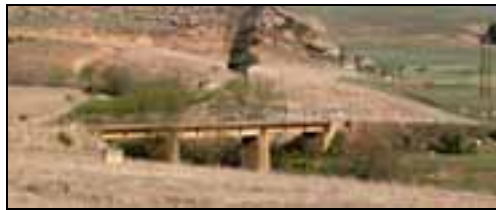
The site consists of a reinforced concrete bridge over the Wilge River at a place known as Schaapdrift (**Plate 42**). The bridge is located on what used to be the road between Ladysmith and Harrismith. Comparing the map that was surveyed in 1908 (National Archives, Maps, 3/671) with the topographical map dating from 1965, it becomes evident that the bridge was not constructed over the original drift, but a short distance south of it. The 1908 map also indicates that the drift over which the road crossed at the time, was “much used.”

The construction of the bridge during the mid-1920s means that the bridge is older than 60 years, and as a result protected by the legislation. The bridge can therefore not be altered, disturbed or demolished without a permit issued by the heritage authority. The bridge is more unique than the one from Site BH11. This is because it is a larger, more imposing structure consisting of two supports and three spans. Furthermore, the association of the bridge with C. Van Riet Lowe also supports a higher significance. The site is given a **Moderate to High Significance** rating.

Plate 42: Bridge over the Wilge Spruit.

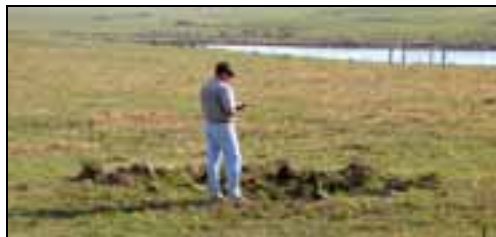
A single oval-shaped stone feature was observed here (**Plate 43**). The feature is approximately three meters in diameter, and some 11 meters from the road fence. **BH18** is of **No Significance**.

Plate 43: Small oval-shaped feature

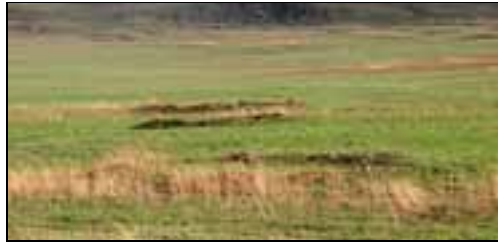
The site consists of numerous circular Iron Age stone enclosures (**Plate 44**) located in a valley. The existing gravel road transects the site and these enclosures were observed on both sides of the road. Although an inspection of the gravel road and its sides were undertaken for a large portion of the site, no ash middens or exposed cultural material could be identified. **BH19** is of **Moderate Significance**.

Plate 44: General view of the site from the road. Note the many enclosures that are visible.

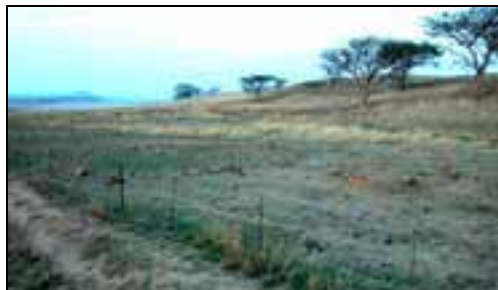
Two stone structures are located here (**Plate 45**). One of the structures is rectangular, the other one circular. The site appears to be the remains of a recent-historic farm worker dwelling. The site is located close to the road fence. **BH21** is of **Low Significance**.

Plate 45: The two stone structures can be seen

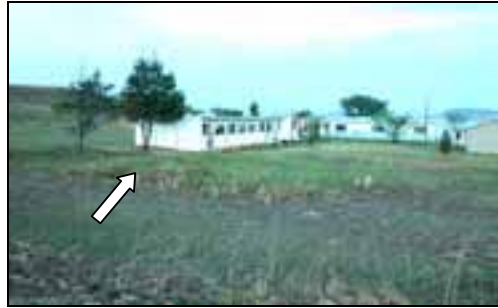
A cemetery containing five stone-packed graves are located approximately 15 meters from the road fence (**Plate 46**). The cemetery is associated with buildings that appear to be a school. **BH22** is of **High Significance**

Plate 46: The arrow indicates the position of the five stone-packed graves.

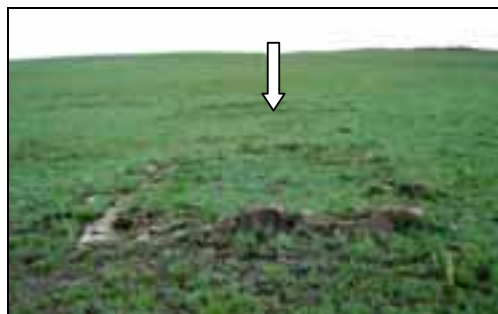
The site consists of two stone foundation structures located at the north-eastern foot of a small rise (**Plate 47**). The structures appear to be historic-recent worker housing. At present the age of the structure are unknown. The possibility exists for them to be older than 60 years. No cultural material was observed in the surrounding area.

A worst case scenario was used to evaluate the site's significance. In this scenario it was assumed that the structures are older than 60 years, thereby providing the site with a **Low to Moderate Significance** rating. Should the structures not be older than 60 years, the site will have no heritage significance.

Plate 47: The rectangular structure is visible in the foreground, while the arrow indicates the circular structure.

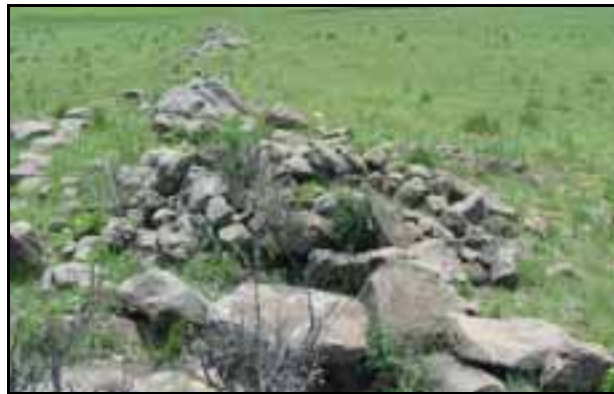
The site consists of a small circular stone structure located on the dyke (**Plate 48**). No cultural material was observed in the surrounding area. At present the age of the structure is unknown. The possibility exists for the structure to be older than 60 years, and possibly even older than 100 years.

The structure is located in a strategic location just before the start of the De Beers Pass. The desktop study has shown the De Beers Pass to have already existed in 1847. The strategic importance of the De Beers Pass, as well as its location on what had been for a long time the boundary between the Boer Republic of the Orange Free State and the British Colony of Natal, has led various military and police posts to be established in the vicinity. Furthermore, during the Anglo Boer War of 1899-1902, the passes over the Drakensberg were manned by both Boer and British forces during various stages of the conflict.

A worst case scenario was used to evaluate the site's significance. In this scenario it was assumed that the structure is older than 60 years, thereby providing the site with a **Low to Moderate Significance** rating.

Plate 48: The small stone circle is visible adjacent to the dolerite dyke
