AUDIT REPORT No.4
For
FREEDOM PARK SUBSTATION AND 160M 88KV LOOP IN-OUT POWERLINE
NEAR RUSTENBURG, NORTH WEST PROVINCE

Audit date: 25 May 2016

ENVIRONMENTAL AUDIT COMPILED BY:
Envirolution Consulting (Pty) Ltd
PO Box 1898
Sunninghill
2157
Tel: (086) 144 4499
Fax: (086) 162 6222
E-mail: info@envirolution.co.za

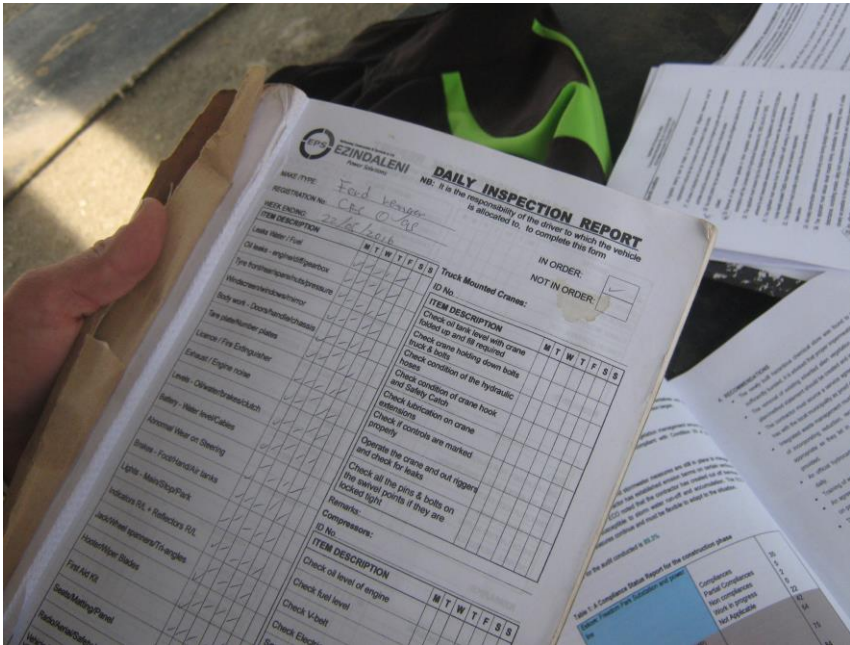
On enquiry from the ECO the ESS provided an oil leak monitoring and plant maintenance checklist that is utilized daily to monitor any leaks from vehicles and plant on site. However, the ECO noted some hydrocarbon containing drums were directly on the ground outside of drip trays at the substation site. The ECO deems this as unacceptable and recommends these be kept in a appropriate bund facility.

<p>Photo 1: Oil leak detection system is in place.</p>

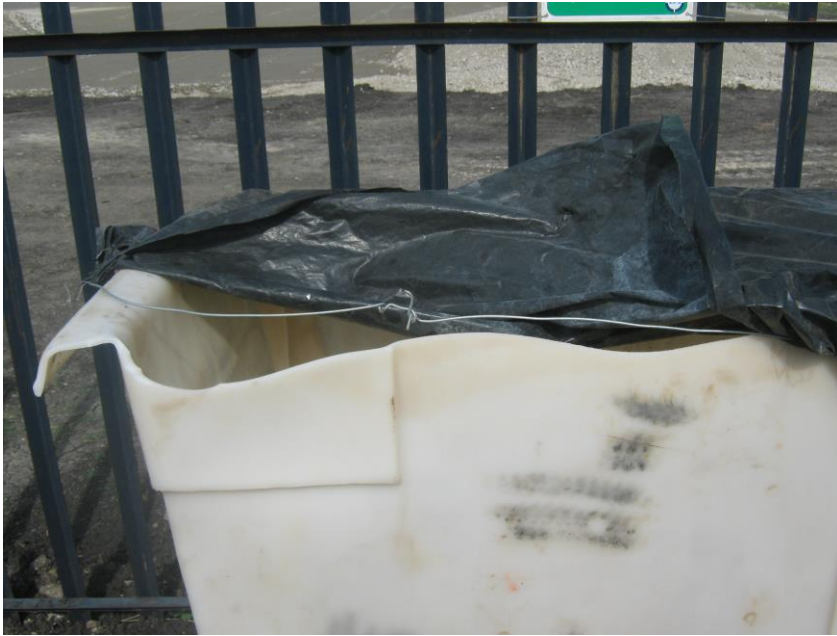
On inspection the ECO did not note any evidence of implementing an Integrated Waste Management approach during construction. The ECO again established that an Integrated waste management approach is not followed by means of no particular strategy in place for waste minimisation (reduce, re-use), waste separation (general, hazardous, plastic, etc). During the sit

down meeting at the site, the ECO discussed this concern with both the EEO and Ezindloleni site supervisor (ESS). The ECO further noted that the two bins dedicated for general and hazardous waste respectively still did not have acceptable appropriate lids. The ECO was once again promised that the lids will be acquired soon. On enquiry about the hazardous waste and contaminated soil disposal the ESS advised that the nearest licenced hazardous waste facility is based in Johannesburg and that currently the hazardous waste is kept in the hazardous waste bin and hasn't been transported to Johannesburg due to its small quantity.

Photo 2: Waste bins still don't have acceptable lids.

- Integrated waste management must be satisfactorily practised to encourage the principle of incorporating reduction, recycling, re-use. The current waste bins covers are still not appropriate as they let in storm water. Proper lids or new bins altogether must be provided.

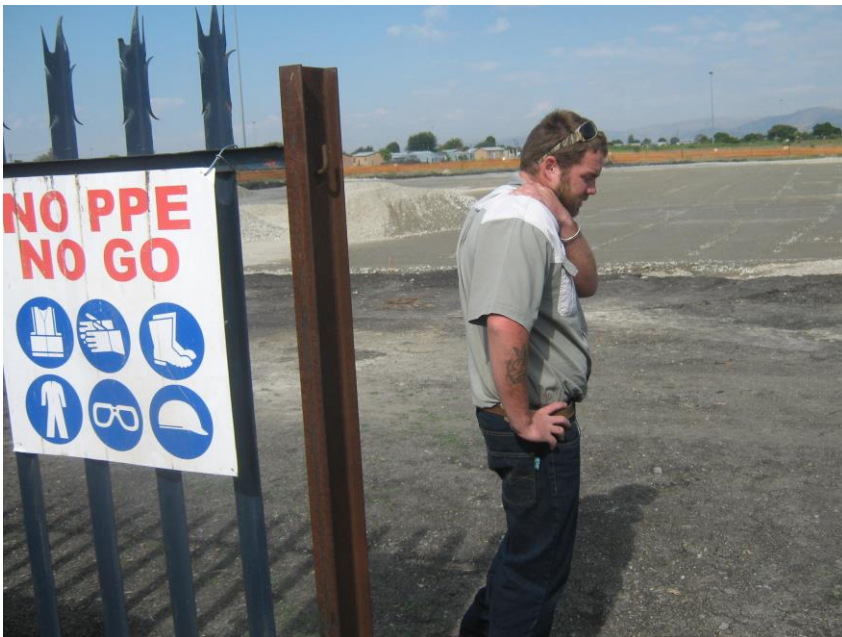
Photo 3: Staff should wear PPE at all times when entering the site.

- The manual removal of alien vegetation propagating shall be removed and continually monitored.
- PPE shall be worn by all personnel that is on site at all times.

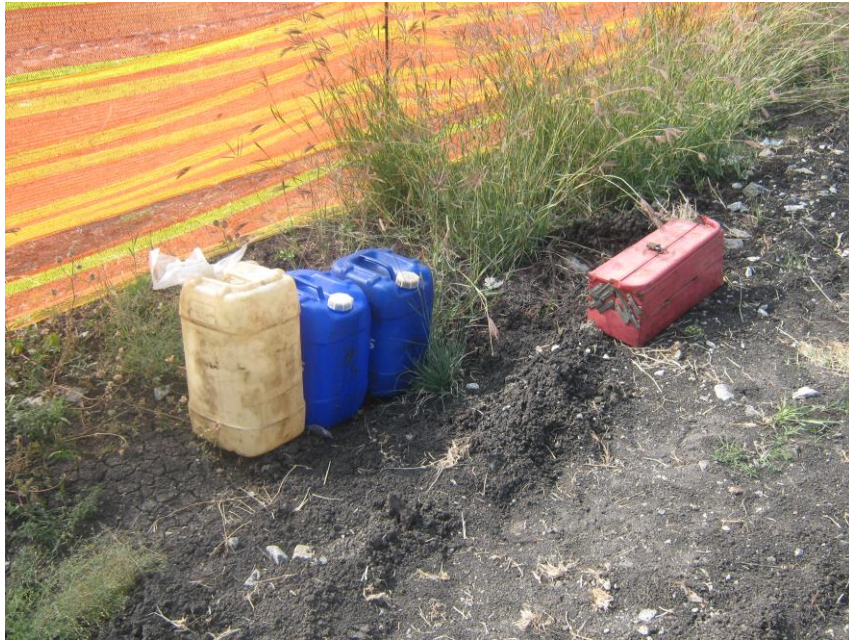
Photo 4: Hydrocarbon containing drums stored directly on ground at the site.

- No hydrocarbon drums should be placed directly on the ground at any given time.
- The EMPr and the EA must be used as a blue print, to ensure sound environmental management of this development takes place.

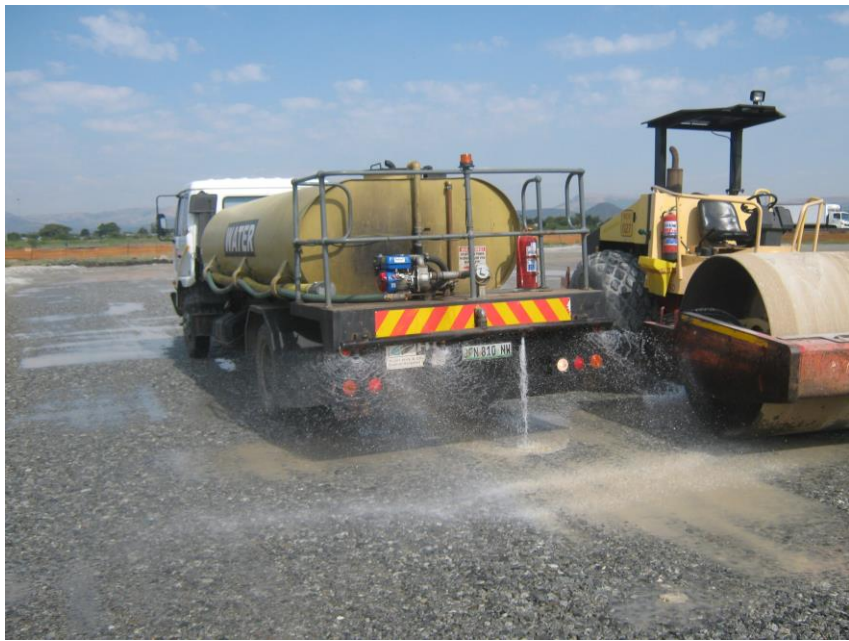
The ECO enquired where the water tanker is sourcing its water. The ESS advised they are sourcing from Impala Mine; however there is no proof of this agreement with Impala mine or proof of legal sourcing of water on file. The ECO recommends that proper steps be taken in legally sourcing water for current construction activities. The ECO requests that proof of legal water sourcing be obtained.

Photo 5: Proof of legal water sourcing must be obtained.

- All parked TLBs shall utilise drip trays underneath.
- An agreement the contractor has with Impala mine on sourcing water for the water tanker must be provided as proof of legal sourcing on paper and filed.

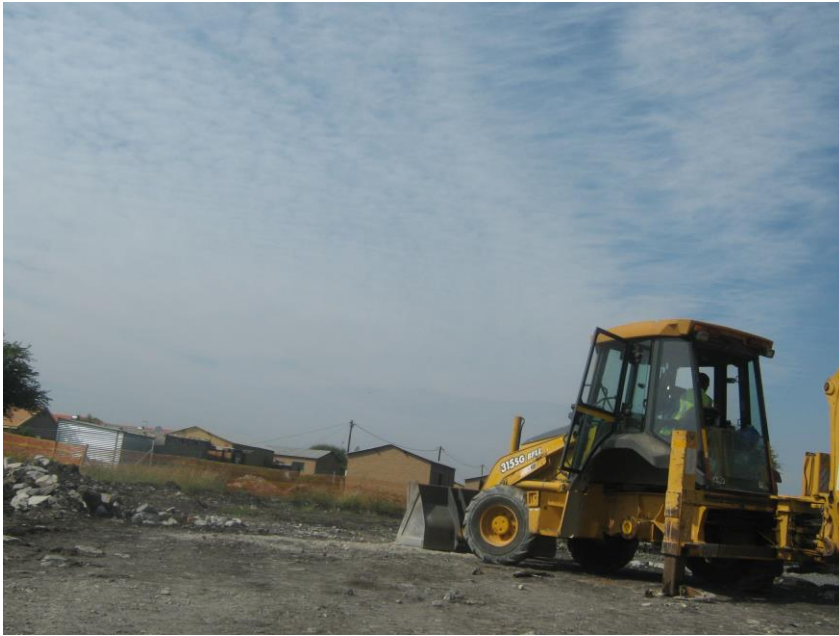
Photo 6: TLB parked without drip tray.

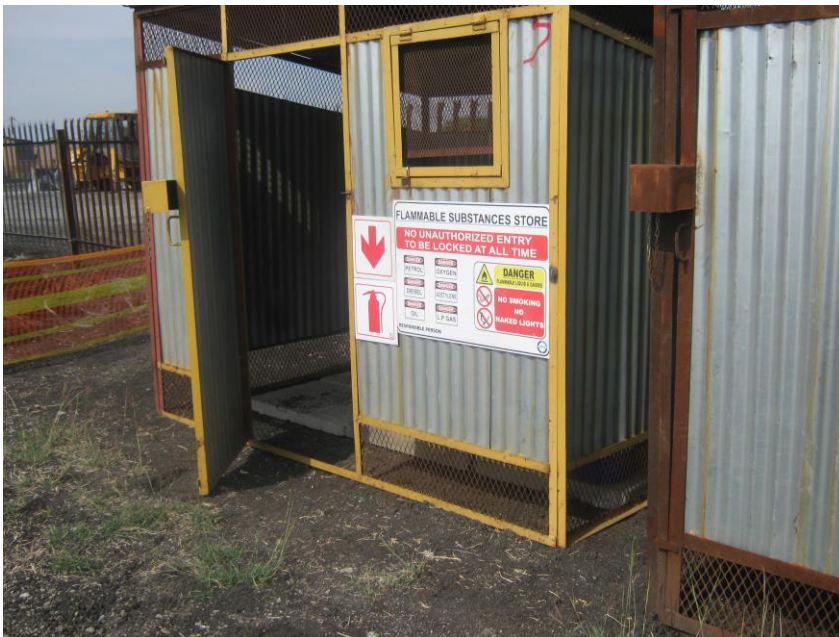
The ECO noted that the hazardous materials store has been built is still in its current state as the previous audit. The bunding of this store is not sufficient to contain any spillages that may occur and thus has the potential to contaminate the ground. The ESS again committed to having the hazardous store to acceptable standard. The ECO would like to emphasize that the hazardous store facility must conform to acceptable standards and a MSDS must be created by the next audit .

Photo 7: Hazardous material store still has not been rebuilt to have proper bunding.

- The newly built hazardous chemical store was found to be unsatisfactory as it is still not sufficiently bunded, it is advised that proper impermeable bunding be built.

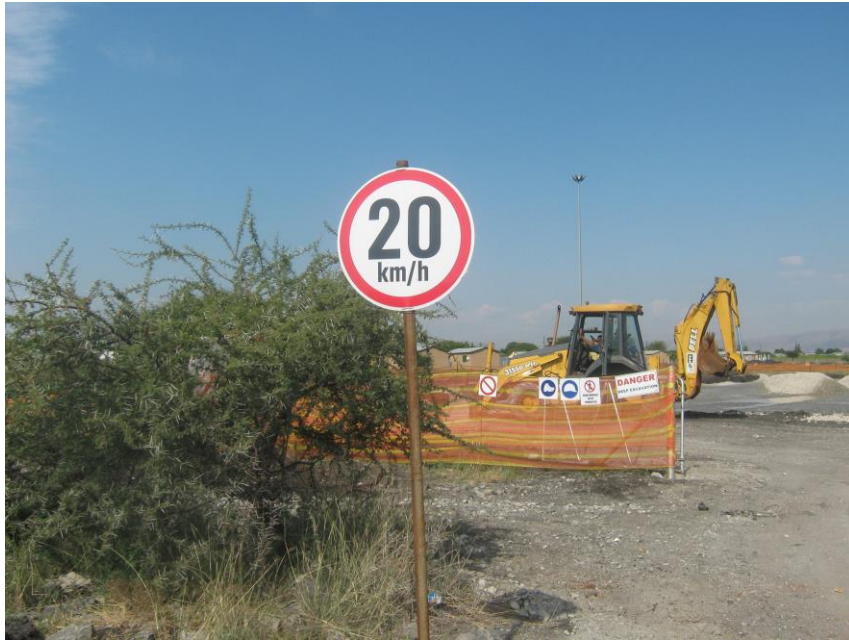
Photo 8: Safety warning signage in place.

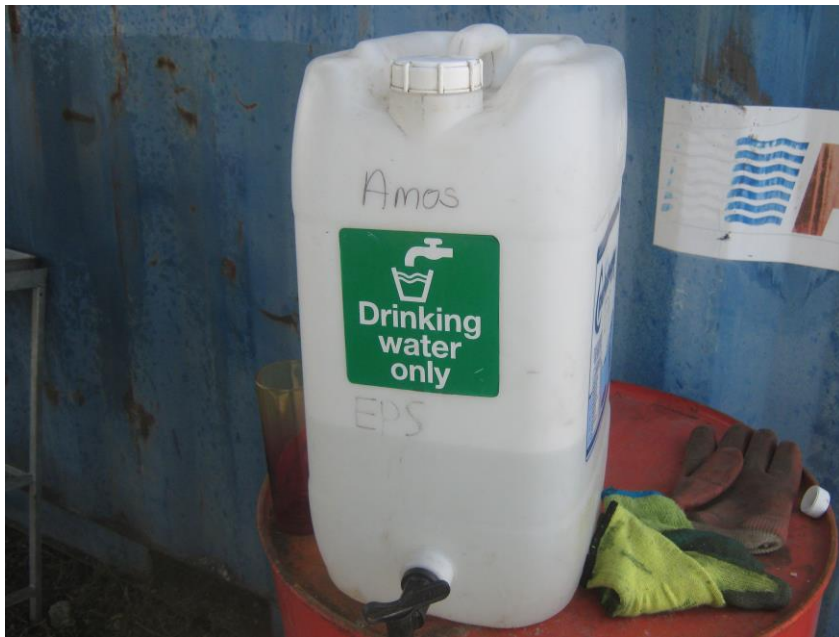
Photo 9: Drinking water provided for staff.
