AUDIT REPORT No.5
For
FREEDOM PARK SUBSTATION AND 160M 88KV LOOP IN-OUT POWERLINE
NEAR RUSTENBURG, NORTH WEST PROVINCE

Audit date: 23 June 2016

ENVIRONMENTAL AUDIT COMPILED BY:
Envirolution Consulting (Pty) Ltd
PO Box 1898
Sunninghill
2157
Tel: (086) 144 4499
Fax: (086) 162 6222
E-mail: info@envirolution.co.za

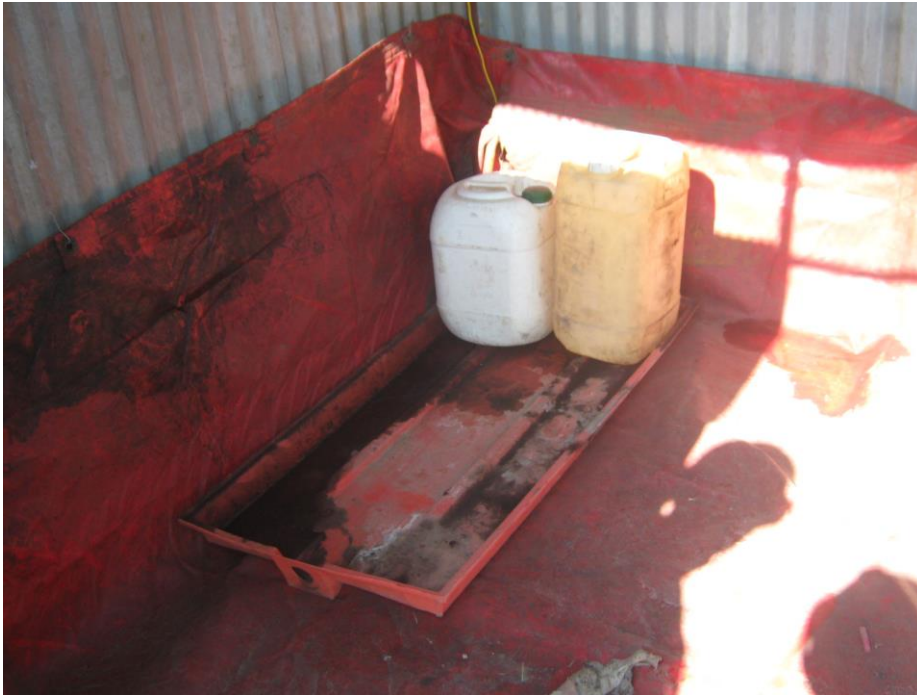
The ECO again noted some hydrocarbon containing drums were directly on the ground outside of drip trays at the site camp yard as per the last audit. The ECO deems this as unacceptable and recommends these be stored in an appropriate bund facility. The ECO was not provided with proof of emergency spill kit training.

Photo 3:
Hydrocarbon
containing
drums stored
directly on
ground at the
site.

Hazardous content Management	The ECO again noted some hydrocarbon containing drums were directly stored on the ground outside of drip trays at the site camp yard as per the last audit.	The ECO deems this as unacceptable and recommends these be stored in an appropriate bund facility.	A similar finding was observed on the previous audit assessment.

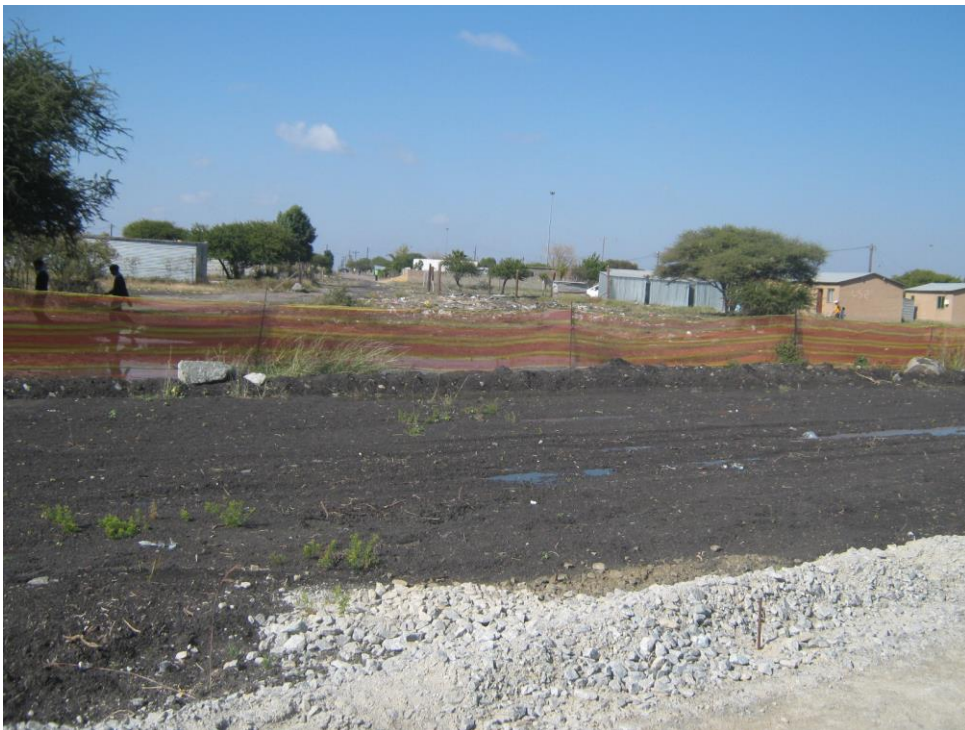
As mentioned before on inspection the ECO noted that berms are in place to control both storm water sewer contaminated water. The contractor has established erosion berms on certain sections of the site to curb erosion. The ECO advises that these control measures continue and must be flexible to adapt to the situation.

Photo 6: Berms keeping the sewage contaminated water away from the construction site.
