Basic Assessment Report And Environmental Management Programme

for Environmental Authorisation for the Proposed
Rehabilitation and Phytoremediation Plantation at the Eskom
Kilbarchan Colliery, Newcastle, KwaZulu-Natal

Report Type:	BAR and EMP Report
Project Name:	Basic Assessment Report and Environmental Management Programme Report for the Rehabilitation and Construction of a Phytoremediation Plantation at the Kilbarchan Colliery
Project Code:	ESK 3520

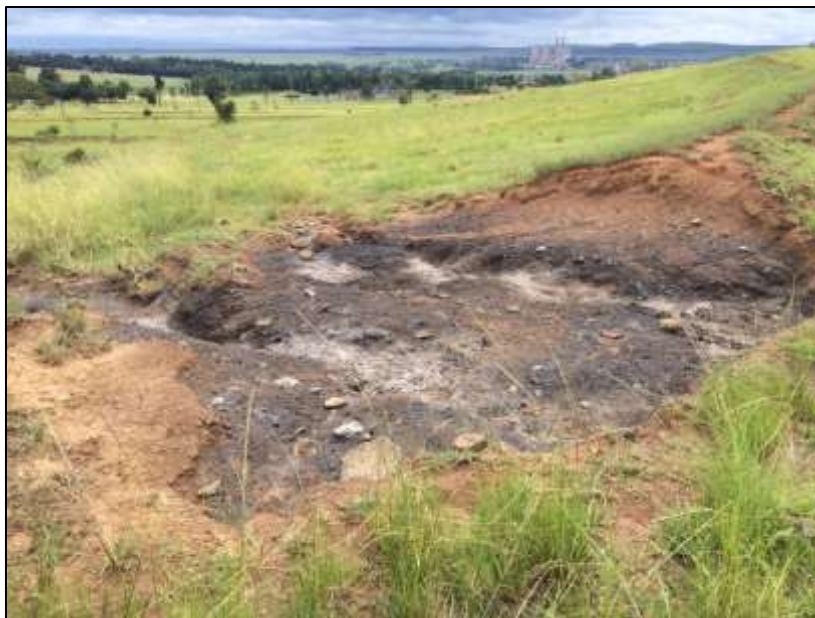
The vegetative cover on the slopes of the Discard Dump is relatively sparse, although a satisfactory diversity of grass species, conducive to the establishment of sustainable grass cover, is present. The current cover, however, is inadequate in terms of basal cover and vegetation vigour to prevent erosion from occurring. There are significant patches of denuded vegetation where sheet erosion is taking place and, as a result, the underlying discard material is exposed in several areas on the dump, as indicated in Figure 5-3.

Currently Eskom is undertaking maintenance of the Discard Dump by applying additional soil cover over the entire area of the dump which will contribute to a more sustainable vegetation cover in the long-term. The Discard Dump needs to be rehabilitated again due to erosion issues as well as high compaction and a limited soil layer (less than 150 mm in places). It is proposed that all rehabilitation / maintenance / aftercare activities will be focussed on the areas where the original rehabilitation efforts have failed specifically where signs of erosion has occurred as a result of overgrazing.

Figure 5-3: Sheet erosion and underlying discard material on the Discard Dump

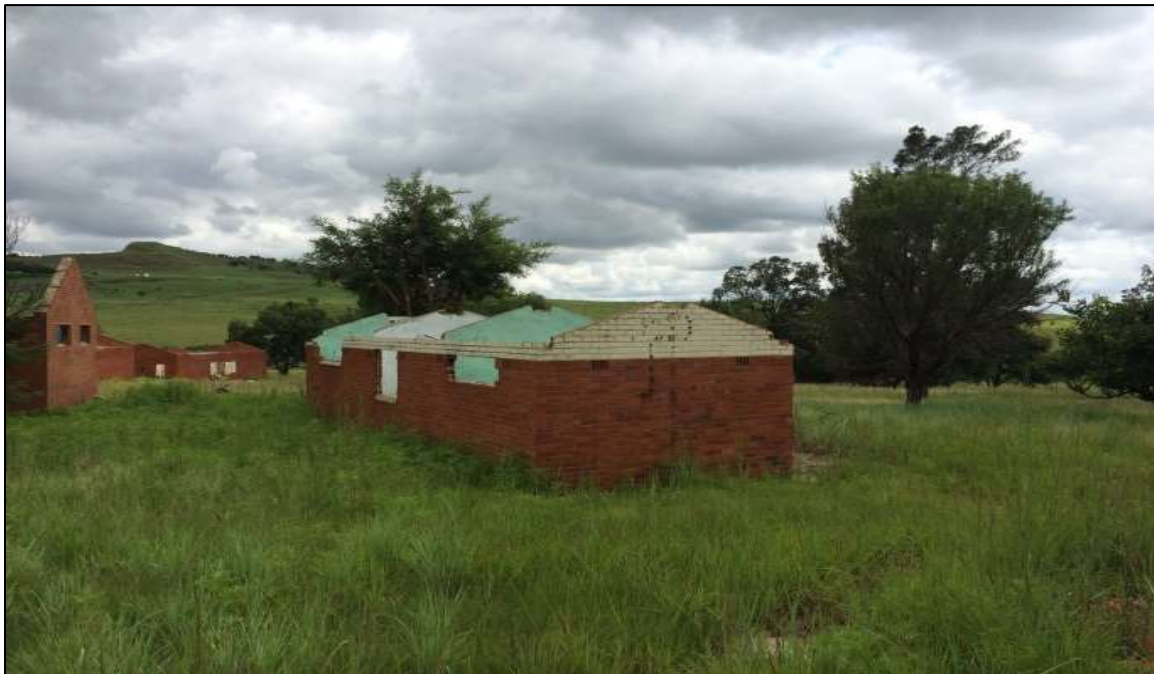
Decommissioned surface infrastructure is located approximately 500 m north of the Discard Dump and includes buildings and a decommissioned WWTP. The buildings have been stripped and vandalised of all value and only the brick and concrete structures remain. The decommissioned infrastructure and its foundations will need to be demolished, all rubble removed off site and the area rehabilitated to ensure there are no health and safety issues. This is the responsibility of Blazing Sun. An example of the remnant infrastructure on site is included in Figure 5-5.

Figure 5-5: Remnant infrastructure north of the Discard Dump

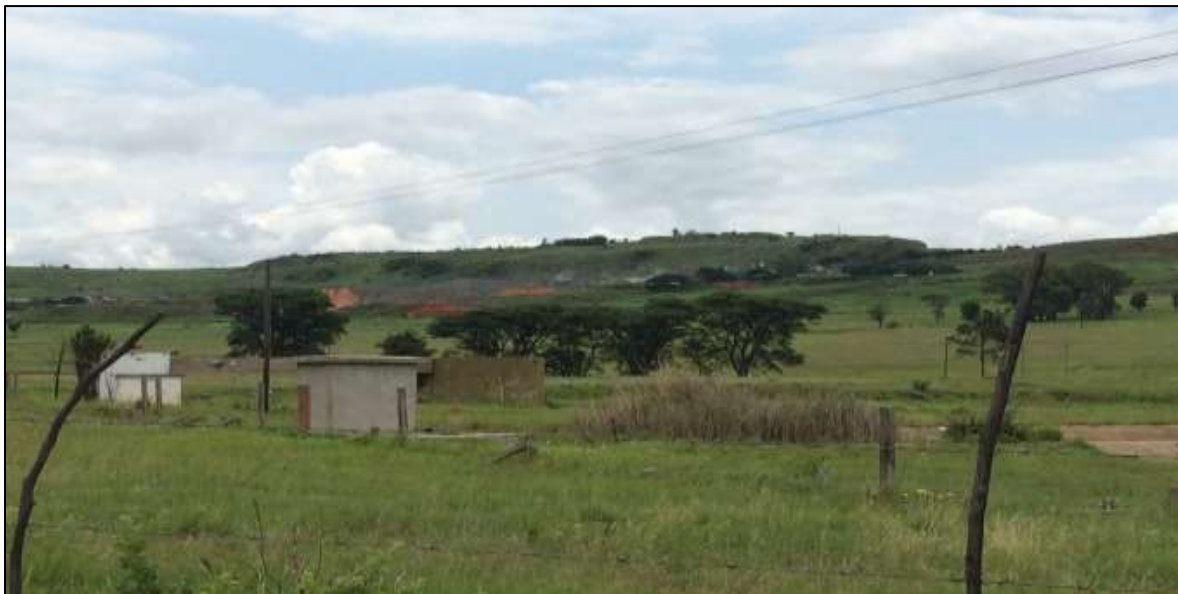
A decommissioned WWTP remains to the north of the Discard Dump, adjacent to the remnant infrastructure listed above. The decommissioned WWTP has been fenced off to prevent public access. Due to the presence of sewage, soil remediation will need to occur in addition to the removal of infrastructure and rehabilitation thereafter. The WWTP was included in the Agreement of Sale to Blazing Sun and the liability thereof does not belong to Eskom. An example of the decommissioned WWTP on site is included in Figure 5-6.

Figure 5-6: Decommissioned WWTP north of the Discard Dump

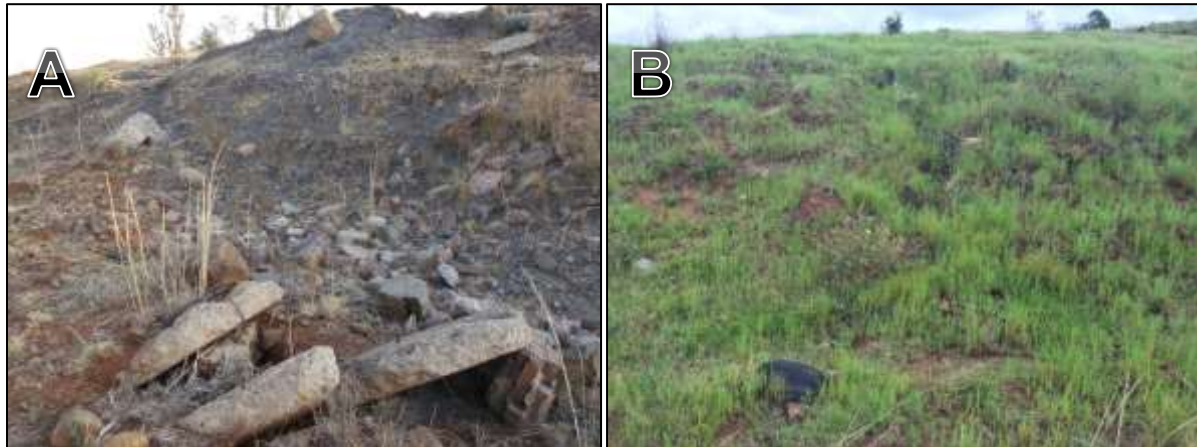
Two apparent landfill sites were identified in the project area consisting of waste materials such as tyres, concrete and other refuse. One landfill site is located on the western flank of the Discard Dump, with the second landfill site being located to the east of the Discard Dump between the N11 highway and the Ingagane River, as depicted in Figure 5-7.

The full extent of the landfill sites, as well as the nature of materials contained within the landfills, will have to be ascertained before the sites can be closed. The western landfill site is subject to erosion, with the eastern landfill site displaying evidence of subsidence and both requiring rehabilitation. The possibility of Polychlorinated Biphenyls (PCBs) and asbestos being buried within these landfill sites poses a potential risk to the successful rehabilitation of Kilbarchan Colliery.

Figure 5-7: Landfill sites (A: Located to the east of the N11 and Discard Dump; and B: Located to the west of the Discard Dump)

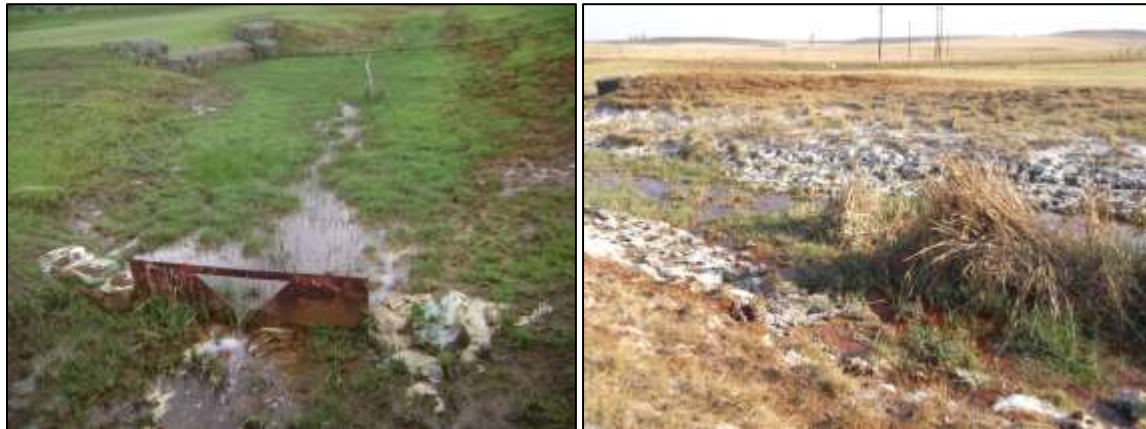
Decant of mine affected water began at the defunct Kilbarchan Colliery in April, 2004 (Proxa, 2014), with decant predominantly taking place to the east, south and southeast of the Discard Dump. Decant is a result of a combined flow of seepage from the Discard Dump and underground and Open Pit sections of Kilbarchan Colliery (Proxa, 2014). In addition, a number of existing water monitoring locations have become decant locations, three of which have been identified at the southern foot of the Discard Dump. The mine affected water is negatively impacting on the receiving catchment area. Decant to the southeast of the Discard Dump is depicted in Figure 5-8. In an effort to remove the heavy metals from the mine affected water, Eskom has set up a pre-treatment facility (Figure 5-9) located at foot of the discard dump. However further water treatment is still required to ensure the water currently being released is treated to an acceptable standard prior to discharging it to the environment.

Figure 5-8: Decant emanating southeast of the Discard Dump

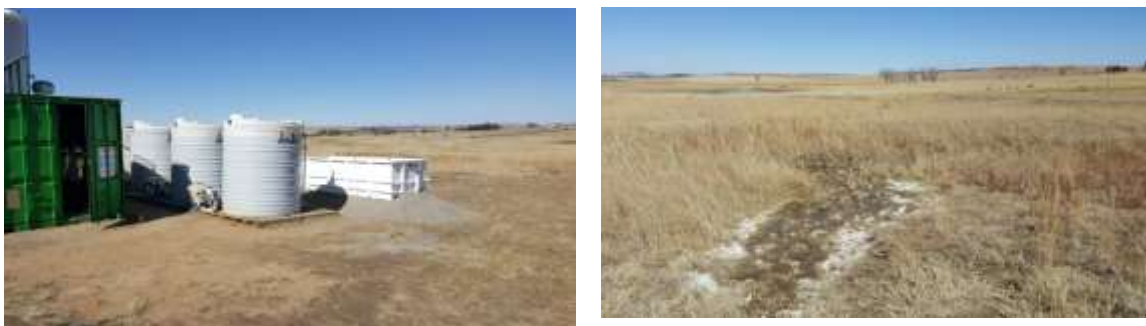
Figure 5-9: Pre-treatment Facility

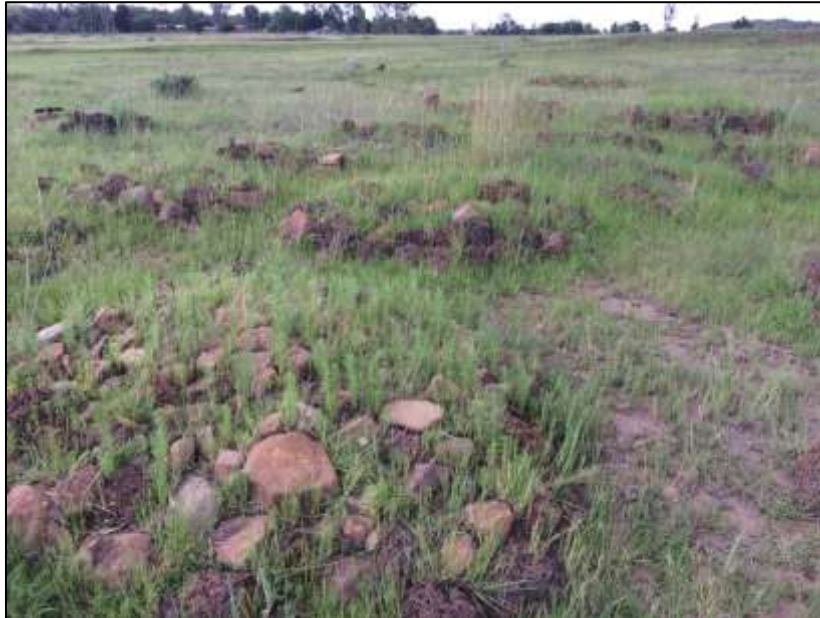
A graveyard was identified during the site visit in 2015 and is located on the border of Open Pit area 2 (Plan 3, Appendix A). There are no potential impacts expected to occur on the identified graveyard due to its location to the Open Pit 2. Should further rehabilitation activities be required at Open Pit area 2, the graveyard site may need to be fenced off to ensure that any potential impacts are prevented. All requirements in terms of the National Heritage Resources Act, 1999 (Act No. 25 of 1999) (NHRA) will be implemented should further activities be required near Open Pit 2.

Figure 5-10: Graveyard located at Open Pit area 2

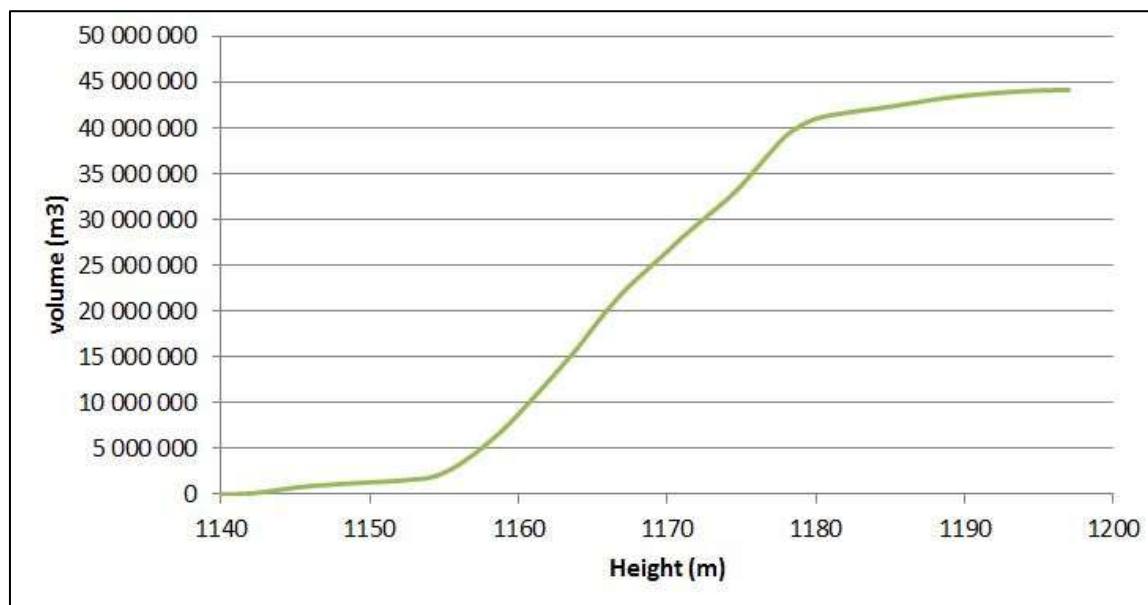
The underground coal seam floor elevations are indicated in Plan 6, Appendix A, with the stage curve displayed in Figure 11-1. The maximum storage capacity of the underground mining voids is 44 million m³ and is obtained at an underground coal seam elevation of 1 190 metres above mean sea level (mamsl), assuming an average coal seam of 3.5 m and an extraction rate of 50%.

The underground mining voids that have been backfilled with fly ash from the Ingagane Power Station have not been considered in the stage curve as information is not available regarding the volumetric amount of ash that was backfilled. The backfilled zones are only a small portion of the underground voids, and are unlikely to affect the accuracy of the stage curve adversely.

Figure 11-1: Stage curve for the underground workings at Kilbarchan Colliery

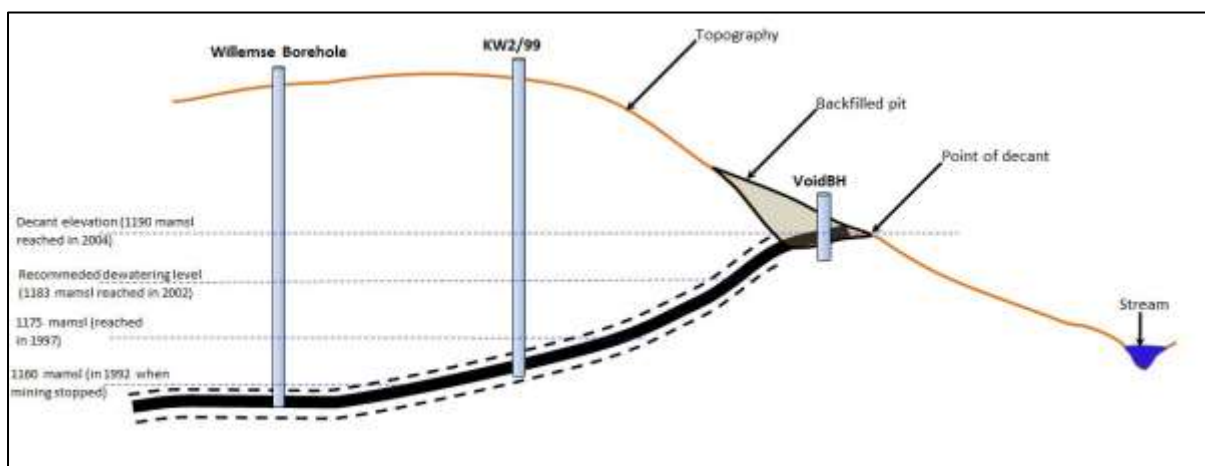
A schematic diagram indicating the flooding of the underground workings is displayed in Figure 11-3. Kilbarchan Colliery took twelve years to flood, taking cognisance of the water level in 1992 (20% of the underground voids). This translates into an average influx/recharge rate of 4 000 m³ per day, reiterating the conclusion reached by Hodgson (2006). It should be noted, however, that the recharge rate can change in the future based on possible subsidence.

Figure 11-3: A simplified conceptual model of the underground workings

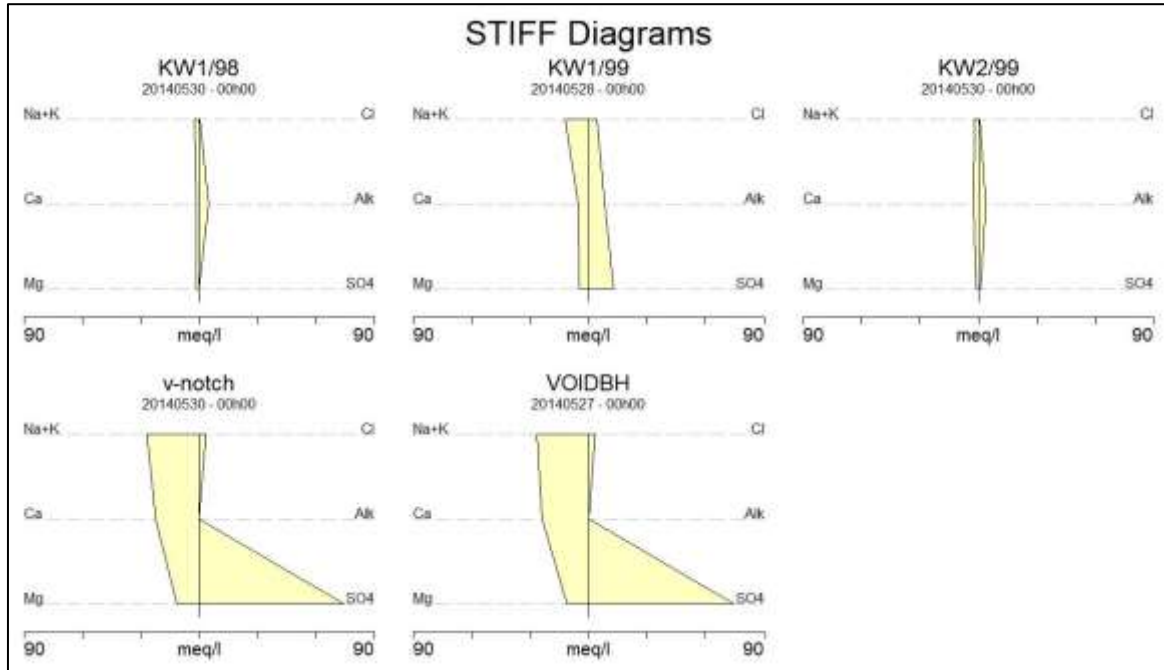
Figure 11-4: Stiff diagram of the hydrocensus boreholes

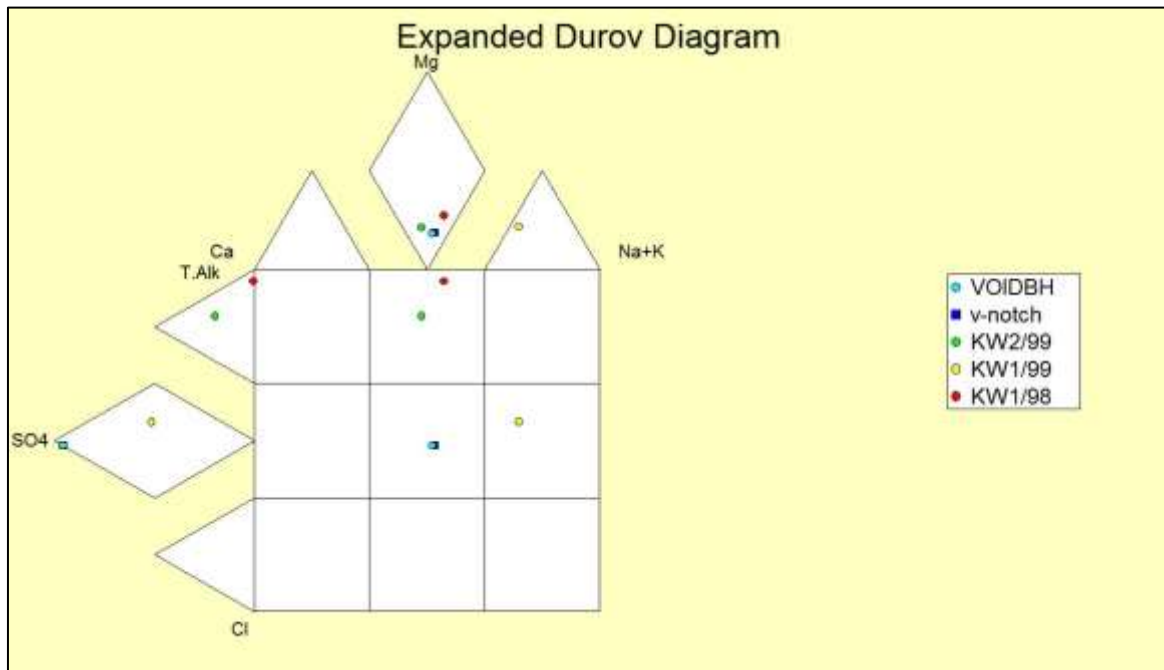
Figure 11-5: Expanded Durov diagram of the hydrocensus boreholes

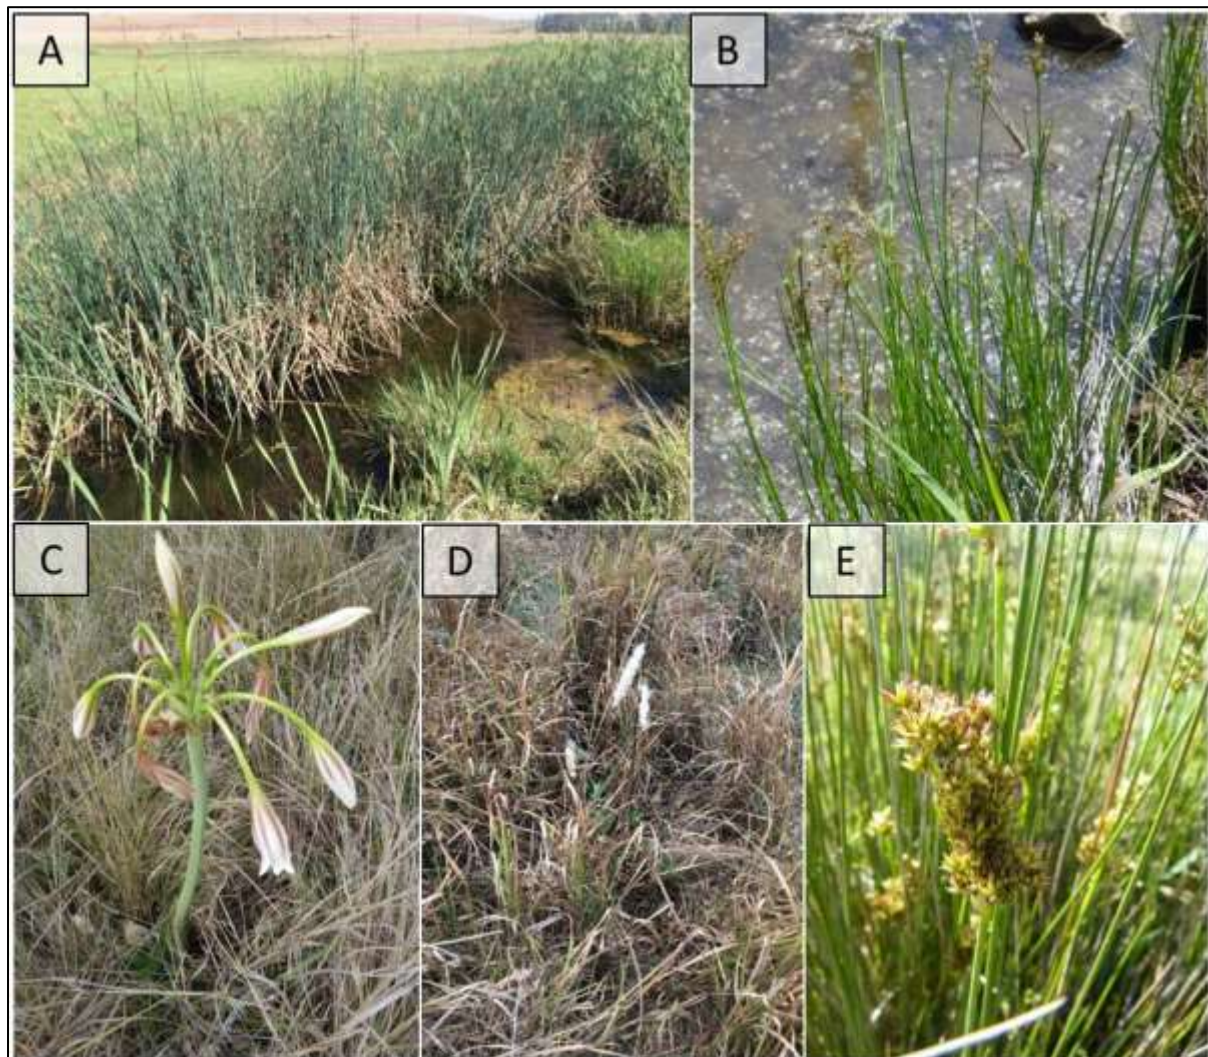
The wetlands were dominated in the areas of open water by typical wetland vegetation such as *Typha capensis* (common Bulrush), *Schoenoplectus corymbosus* and *Juncus spp.* These areas were not in abundance and mostly restricted to the Ingagane River and the section of tributary wetlands close to the river. The wetland indicator grass *Imperata cylindrica* (Cottonwool Grass) was widespread throughout the site and was a major indicator in areas outside of the permanent wetland bodies. The wetland ecosystems had a variety of forbs, contributing to biodiversity of these areas; of which most were found in the Ingagane River floodplain wetlands and wetlands in connection to it. One of these was the *Crinum bulbispermum* (Orange River Lilly), which is listed as a Declining species according to IUCN and is protected in Kwazulu-Natal (Figure 11-6).

Figure 11-6: Examples of wetland flora observed: A) *Schoenoplectus corymbosus*; B) *Juncus* spp.; C) *Crinum bulbispermum* (Orange River Lilly); D) *Imperata cylindrica* (Cottonwool Grass); & E) *Cyperaceae* spp (Sedge).

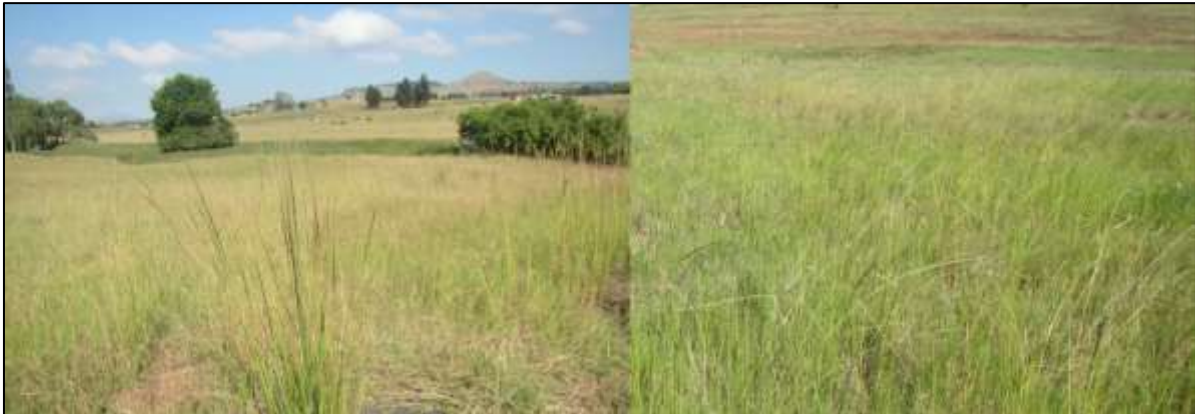
The project site consists predominantly of Rehabilitated Grasslands in varying stages of colonisation, with an example of the community displayed in Figure 11-7. Species diversity was low, although the basal groundcover was found to be adequate (greater than 30%). The dominant species within the Rehabilitated Grasslands were *Sporobolus africanus* (African

Figure 11-7: Landscape examples of the Rehabilitated Grassland

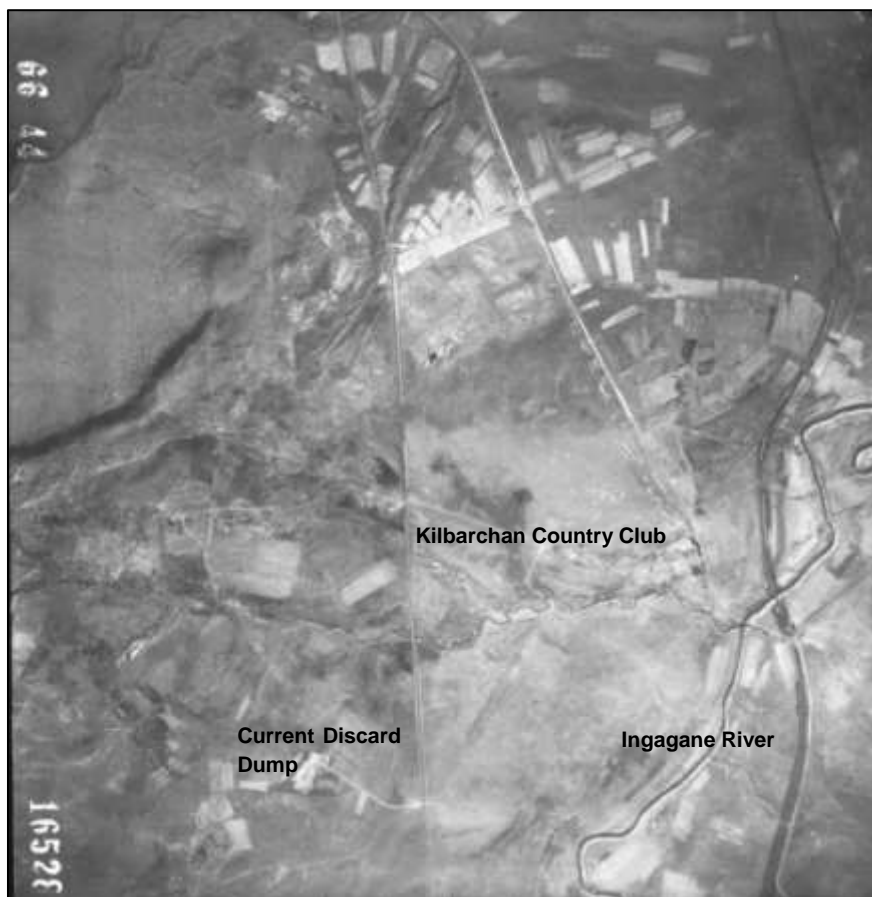
The project area was dominated by agricultural fields and open grazing land in 1944 (Figure 11-9), with documents pertaining to Kilbarchan Colliery and its associated infrastructure, including employee quarters, hospital, school and overall plans for the Colliery, being available from 1955. Construction of the Ingagane Power Station began in 1959 and was completed in 1963 (Leech, 2003). Development in the area had increased by 1970, with the construction of Kilbarchan village and the growth in mining activities in the surrounding areas, as depicted in Figure 11-10.

Figure 11-9: 1944 Aerial photograph of Kilbarchan Project Area
