# Environmental Impact Assessment Kusile 60-year Ash Disposal Facility

## Specialist Assessment: Aquatic Ecosystems

**PROJECT:** Environmental Impact Assessment for the Proposed Kusile 60-year Ash Disposal Facility. Specialist Assessment: Aquatic Ecosystems

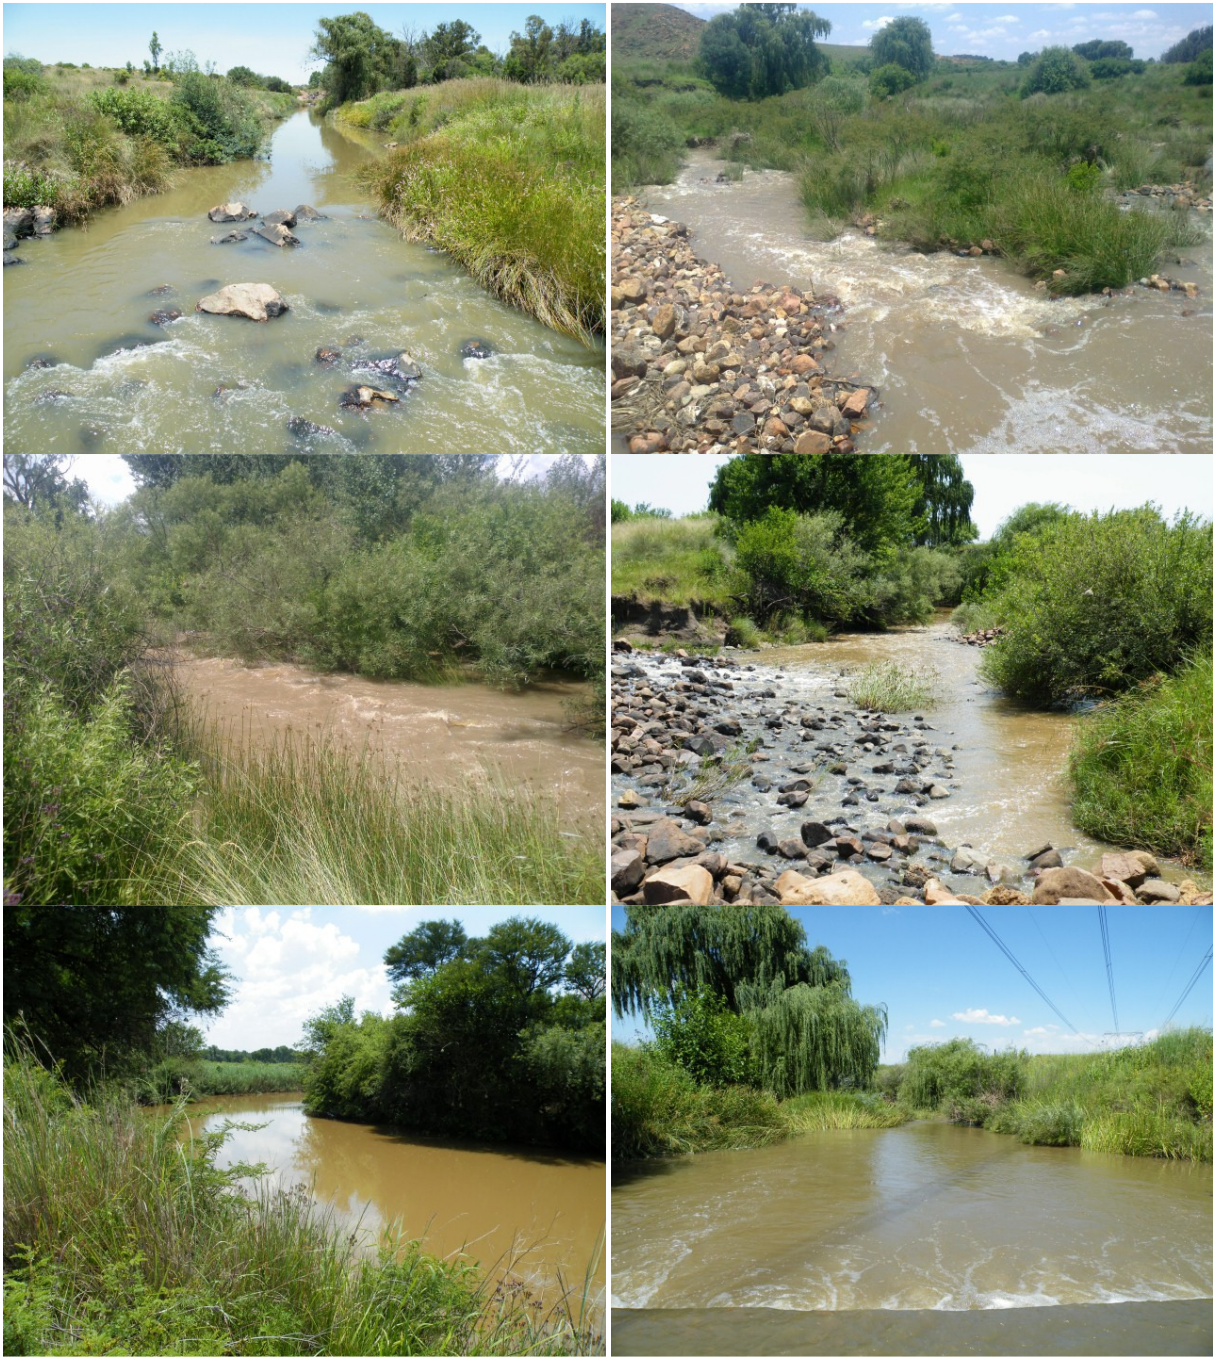
**Figure 6-1. Wilge River aquatic sampling sites. Rows 1: W1 and W2, Row 2: W3 and W4, Row 3: W5**

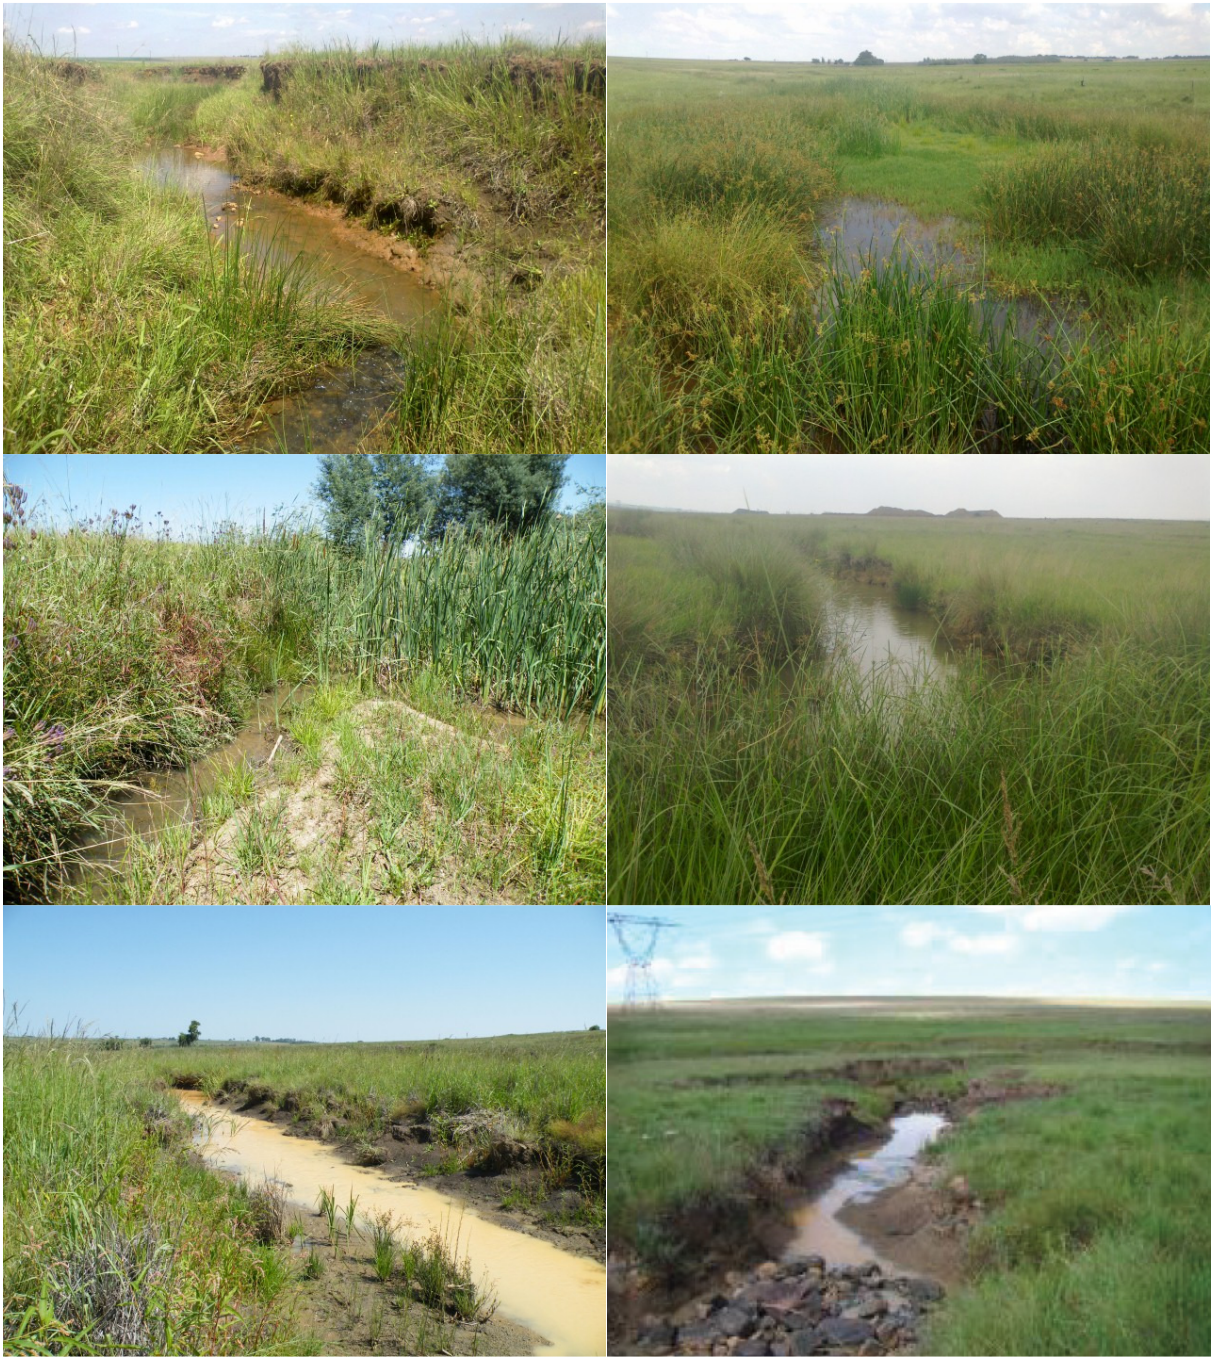
**Figure 6-2. Aquatic sampling sites along Wilge River tributaries. Row 1: Sites T1 and T2, Row 2: Row 3: KF1 and KF2, Row 4: KF3 and T4**

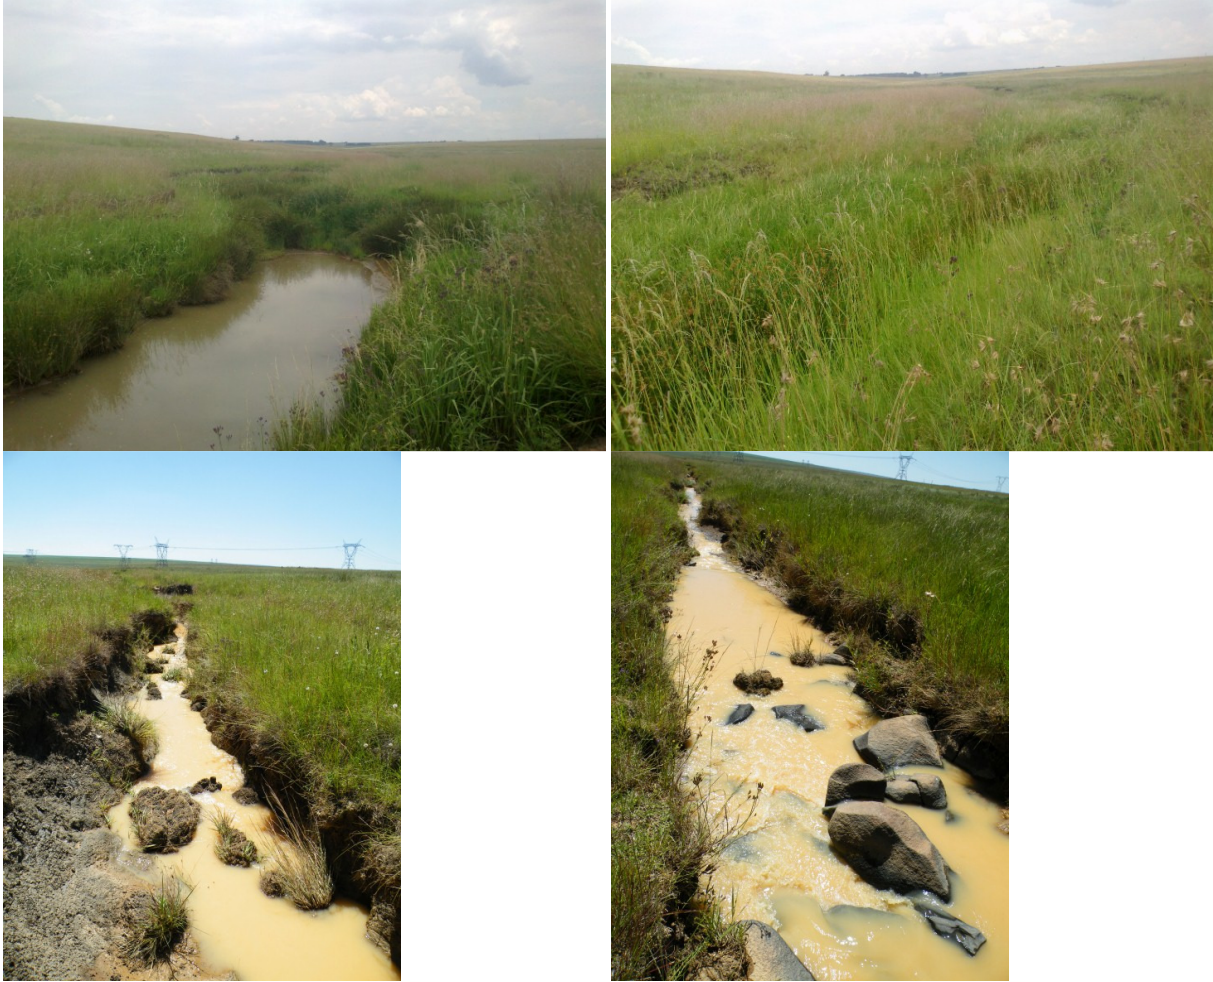
**Figure 6-3. Sampling sites along the Klipfonteinspruit tributaries: Holspruit (site HS) (top row) and the Kusile tributary (site KUS) which drains away from the Kusile Power Station (bottom row).**

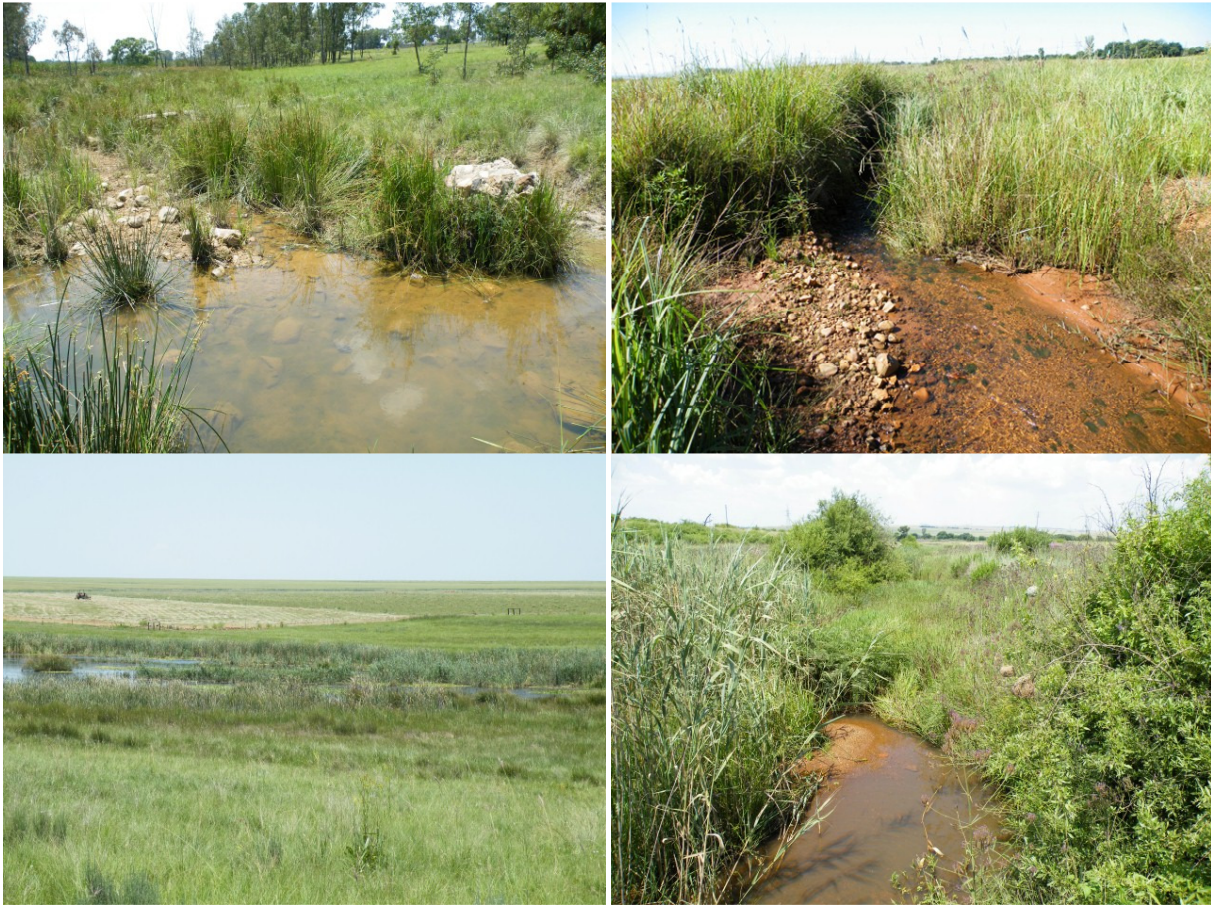
**Figure 6-4. Aquatic sampling sites within tributaries draining away from Alternative B: Sites B1 and B2 (top row) and sites B3 and B4 (bottom row)**

The tributaries draining away from Alternative B were all considered to be Moderately Modified (PES C) in terms of habitats (Table 6-5, Figure 6-4). The main impacts were due to the construction of farms dams which altered flows (decreased volumes but increased velocities) and caused erosion of beds and banks.

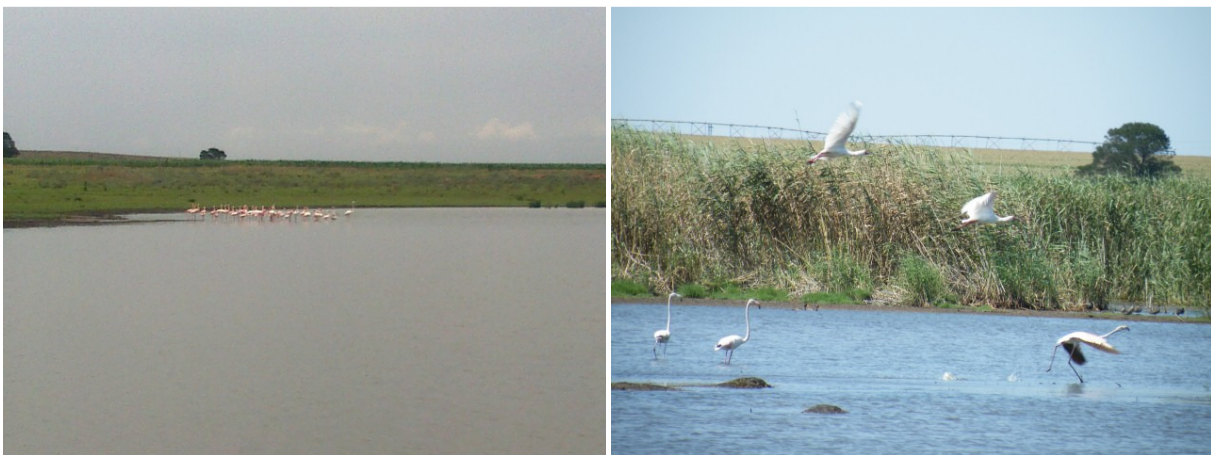
**Figure 6-5. Seasonal Pans within Alternative F and adjacent to Alternative B.**

The habitat integrity of the seasonal pans (Figure 6-5) was assessed as part of the Wetland Assessment Report.
