October 2013

ILISO CONSULTING (PTY) LTD

# Aquatic Assessment for the Kusile Ash Dump and Aquatic Impact Assessment

**Report Number.** 13615420-12376-1

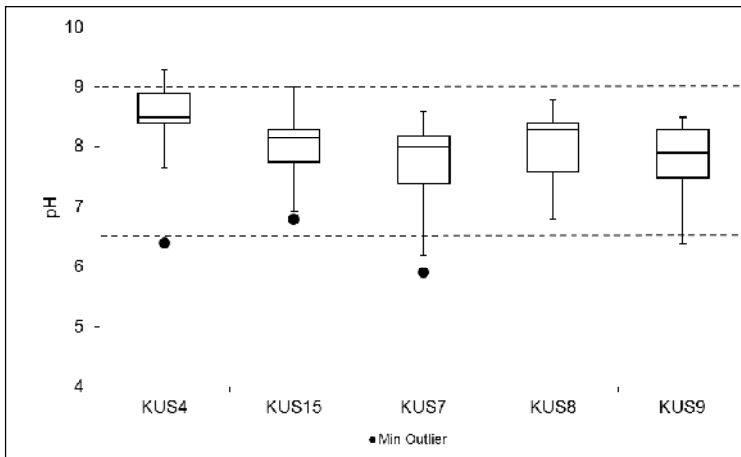
Figure 4: Historical pH values observed in the project area (excluding the three additional sites) from March 2010 to August 2013 (dashed lines indicate guideline values. ● Minimum Outlier)

Historical pH results were assessed from March 2010 to present for sites that have been previously monitored. The trend indicated both spatial and temporal fluctuations in the pH values within the tributaries that drain towards the Wilge River (Figure 4). Historically pH values have been mostly alkaline throughout the catchment. Based on comparison with long term results, recent pH values were considered to be largely natural and were not regarded as having a limiting effect on aquatic biota. There is high variation in the pH values at all the sites, with sites KUS4, KUS7 and KUS15 indicating minimum outliers below the TWQR guidelines (Figure 4). This may have been attributed to various runoff events from the surrounding agricultural activities at the time of those surveys.

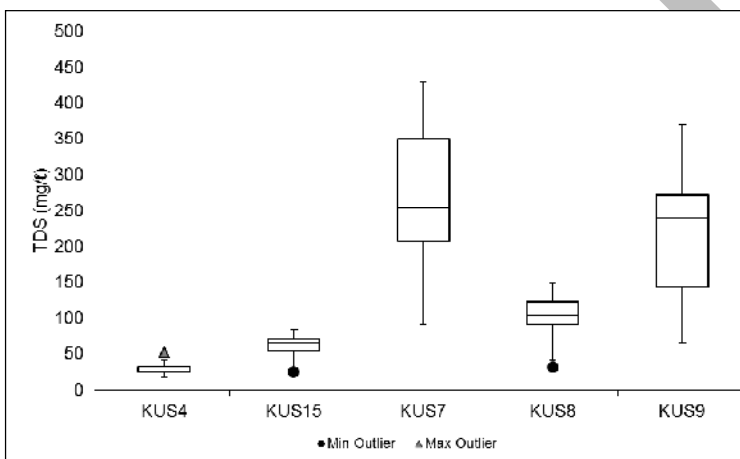
Figure 6: Historical TDS values observed in the project area (excluding the three additional sites) from March 2010 to August 2013 (● Minimum Outlier, ▲ Maximum Outlier)

concentrations were noted at sites KUS7 and KUS9 along the Klipfonteinspruit (Figure 6), while the lowest TDS concentrations were recorded at the most upstream site (KUS4) (Figure 6).

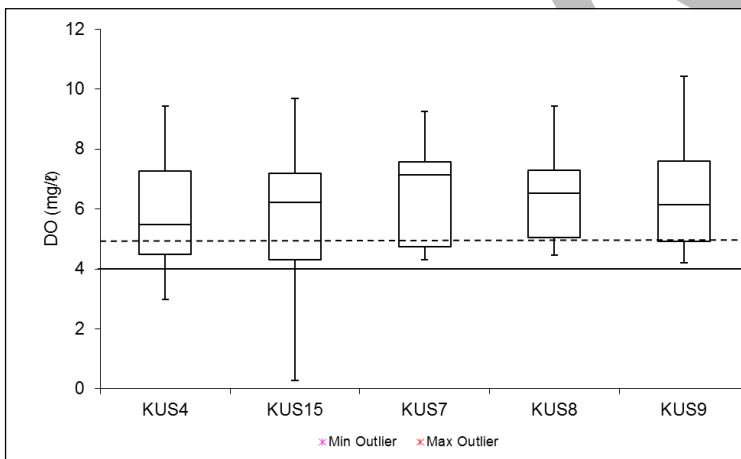
Figure 8: Historical DO concentration values observed in the project area (excluding the three additional sites) from March 2010 to August 2013 (dashed line indicates guideline limit, solid line indicates lower limit for the protection of fish)

Historical data was compared spatially and temporally along the tributaries in the study area and indicated high variation in the data (Figure 8). The graph further illustrates that low DO concentrations are not uncommon in the project area (Figure 8). This trend is likely associated with these tributaries being located in the upper region of the Highveld where the gradient is generally flat and thus are not characterised by typical rocky riffle or cascade habitats. Low water levels and limited to no flow conditions is the general characteristic of these tributaries in the study area, contributing to low DO concentrations. Furthermore, these tributaries often contain large quantities of algal blooms, a sign of eutrophication associated with nutrient enrichment which also contributes to low DO concentrations throughout the catchment.

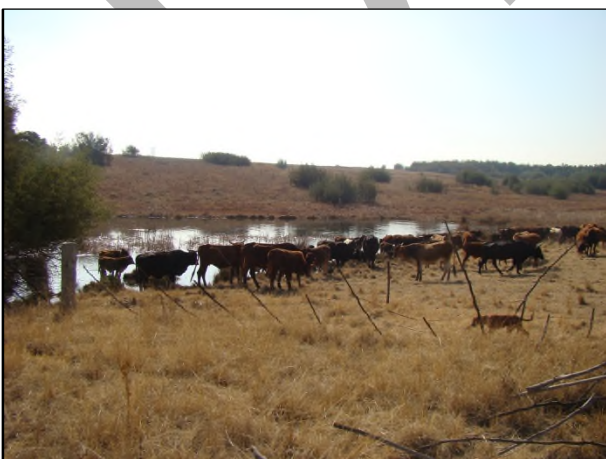
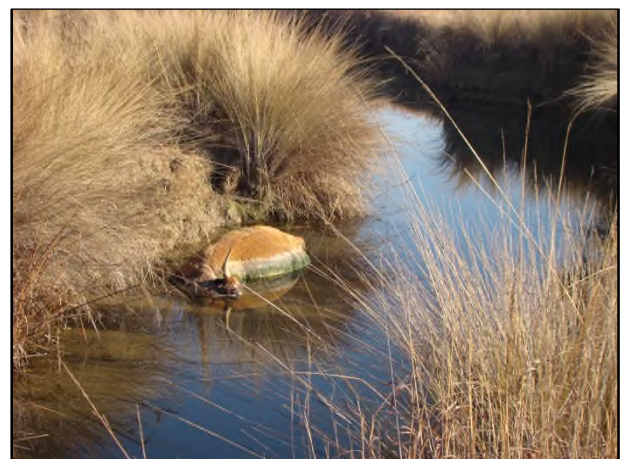
Figure 12: Cattle roaming around site KUS4

Figure 13: Deceased cow within the tributary at site KUS7

Overgrazing and trampling was evident throughout the project area and surrounds. The overgrazing of the ground cover results in higher runoff velocities that transport particulates and result in erosion (Figure 12 and Figure 13).

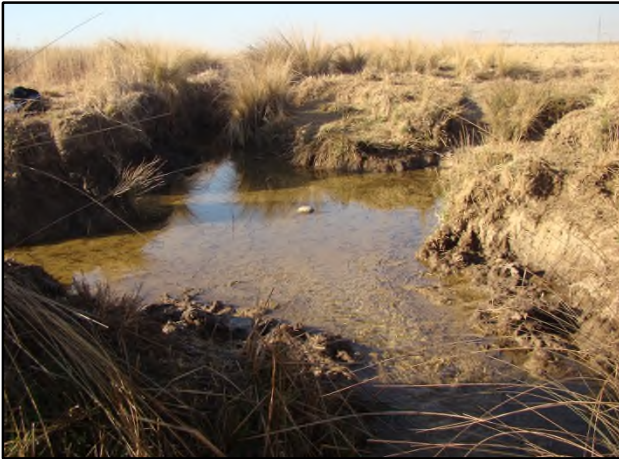
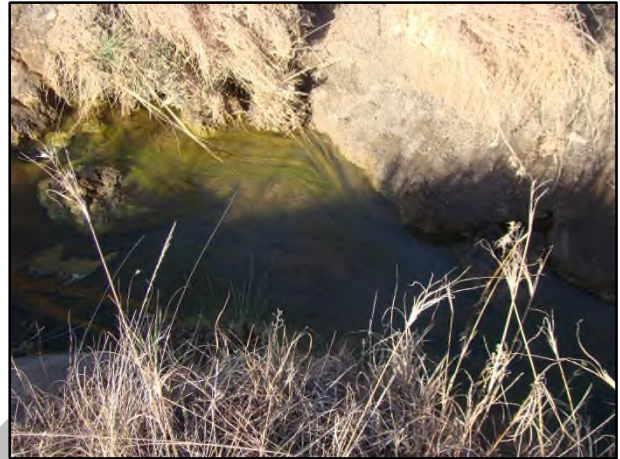
Figure 14: Nutrient input resulting in filamentous algal blooms in the river systems

A further concern is the level of nutrient input into the river systems due to the high level of agricultural activities within the project area. High nutrient levels are contributing to algal bloom formations at various sites, a clear sign of eutrophic conditions (Figure 14).

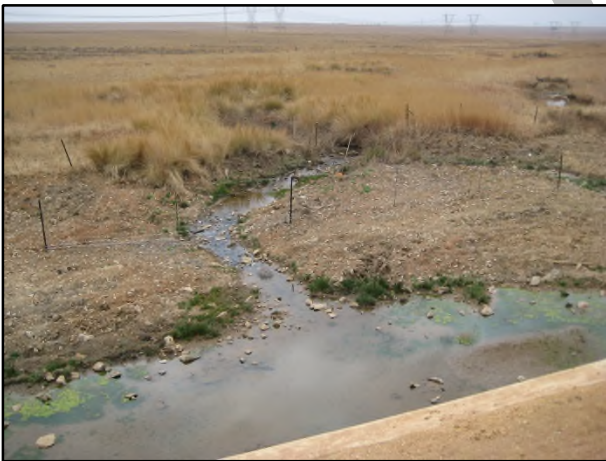
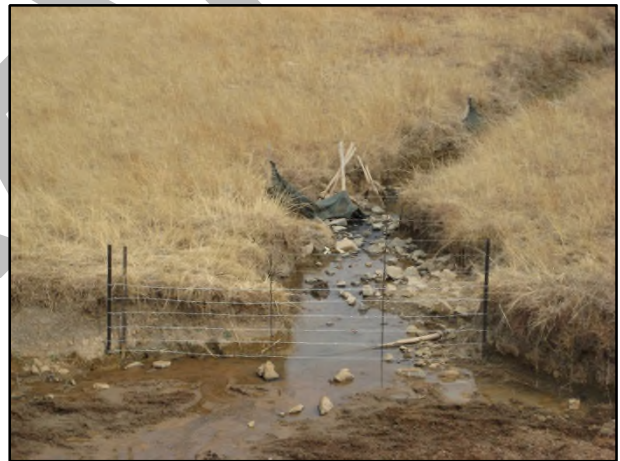
Figure 15: Constructed bridges continue to contribute to high sedimentation levels, particularly during the wet season

Overgrazing coupled with the construction of road and bridges (Figure 15) has contributed to the considerable amount of bank and head cut erosion at various sites in the project area (Figure 16).

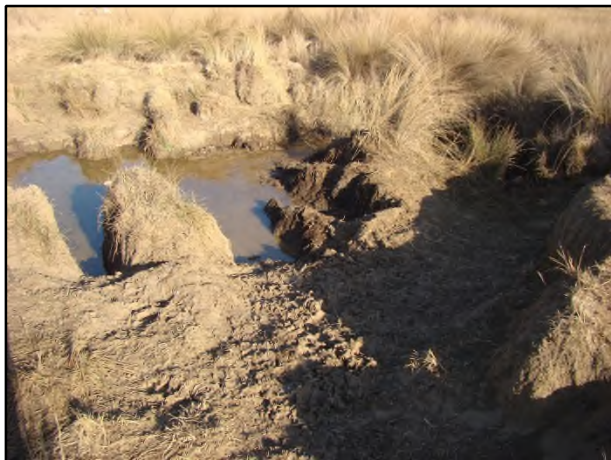
Site KUS7

Figure 16: Bank and head cut erosion observations

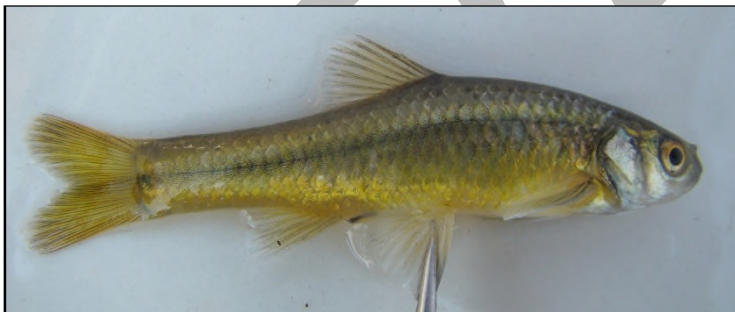
Figure 23: *Barbus anoplus*, one of the most abundant fish species sampled in the project area. The golden colour indicates a reproductive male.

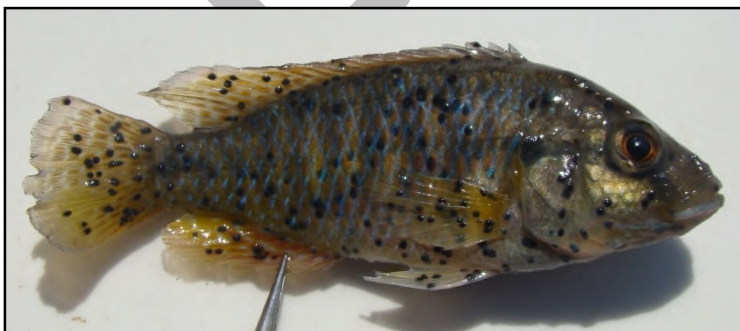
Figure 24: *Pseudocrenilabrus philander*, one of the most abundant fish species sampled in the project area. This individual further illustrates trematode cysts embedded in the fish's tissue

A large number of the individuals sampled during the August/September 2013 survey, showed signs of abnormalities and heavy parasite loads. The prevalence was considerably higher in *B. anoplus* which showed the highest infection rates (Figure 24 and Figure 25).

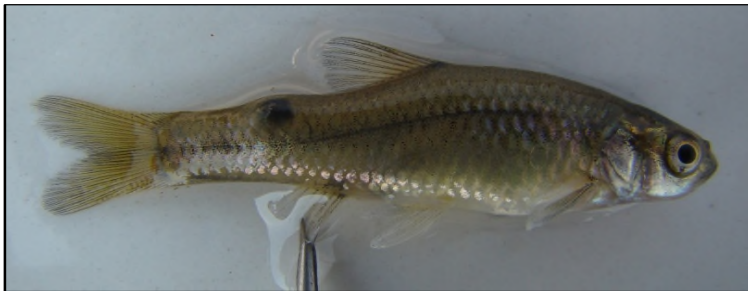
*Barbus anoplus*

Figure 25: Trematode cysts embedded in the fish's tissue
