Geotechnical and Thermal Report

**GEOTECHNICAL ASSESSMENT AND
THERMAL INVESTIGATION AT THE
MATIMBA POWER STATION ASH
DISPOSAL FACILITY, LEPHALALE,
LIMPOPO PROVINCE**

Jeffares & Green (Pty) Ltd

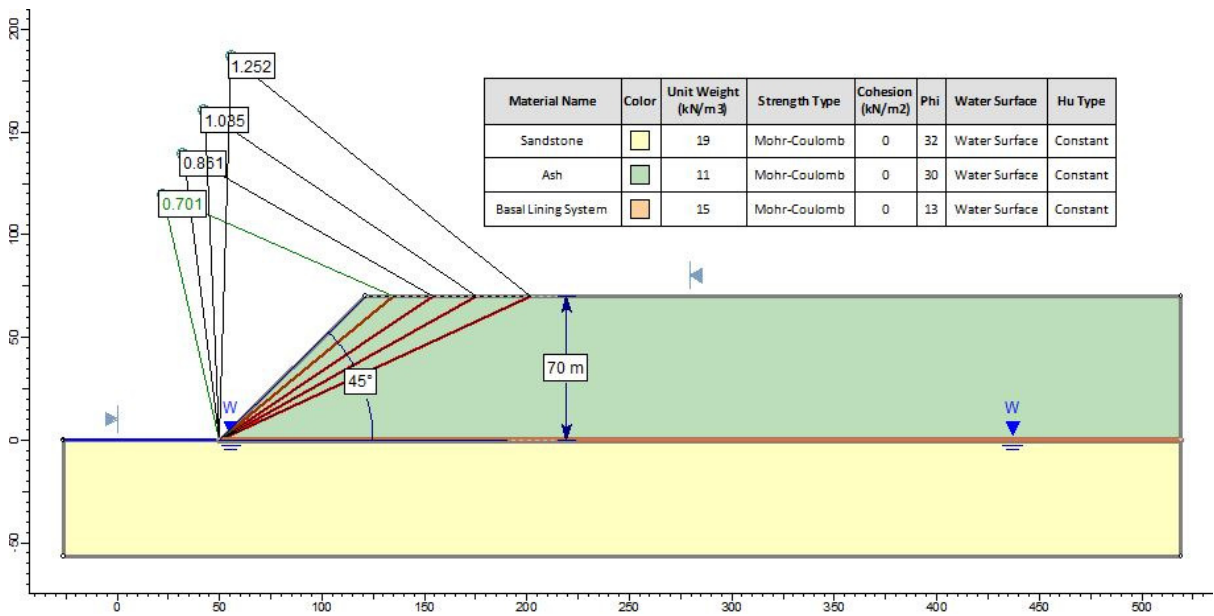
Figure 23 - Block Failure for Assessment A with a slope gradient of 1V:1H

Figure 23 illustrates the results of numerous slope stability analyses at various angles of block failures and shows that increasing the angle of the slope will result in A FoS less than one. The results prove that the slope angle should remain lower than 1V:2H in order to reach suitable long term stability.

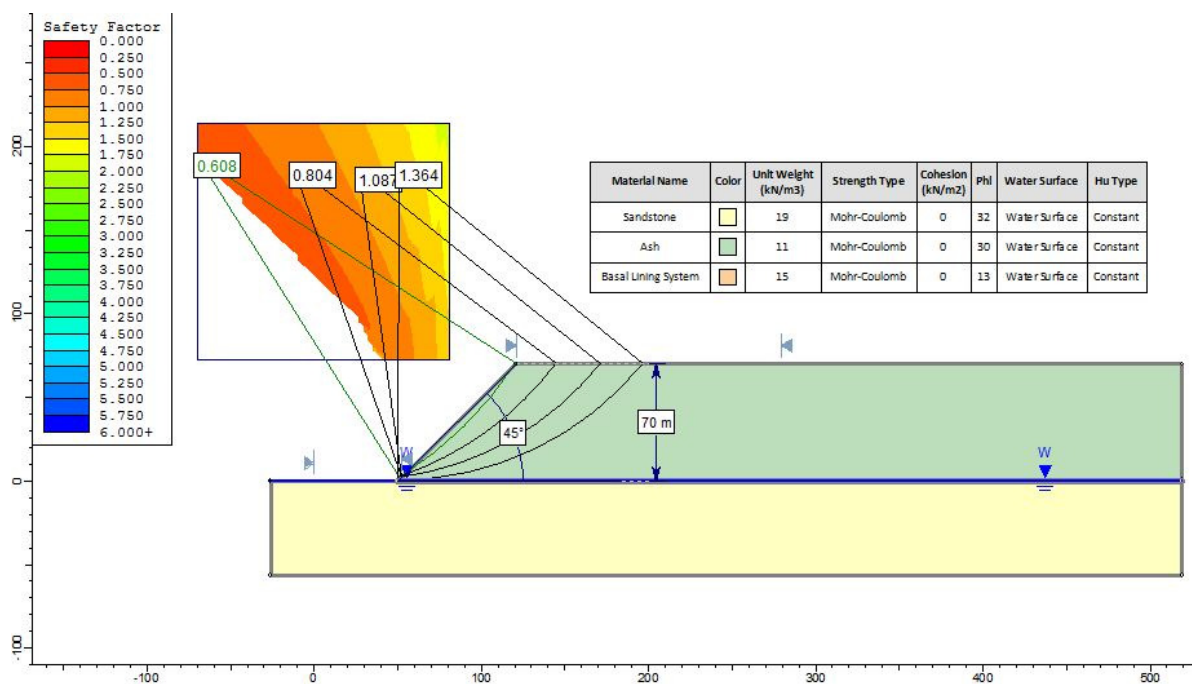
Figure 25 – Circular Slip Failure for Assessment A with a slope gradient of 1V:1H

Figure 25 depicts the results of a slope stability analysis with a slope gradient of 1V:1H. From the results it was found that the FoS is less than one. Therefore the assumption can be made that a 1V:1H slope is too steep to establish sufficient stability.
