**Verifications and Walkthrough report for the Construction of Eskom  
132kV Powerline from Ngwedi substation to Styldrift substation and  
Construction of a 132kV powerline from Ngwedi substation to  
Bakubung substation, North West Province.**

**Date: July 2016**

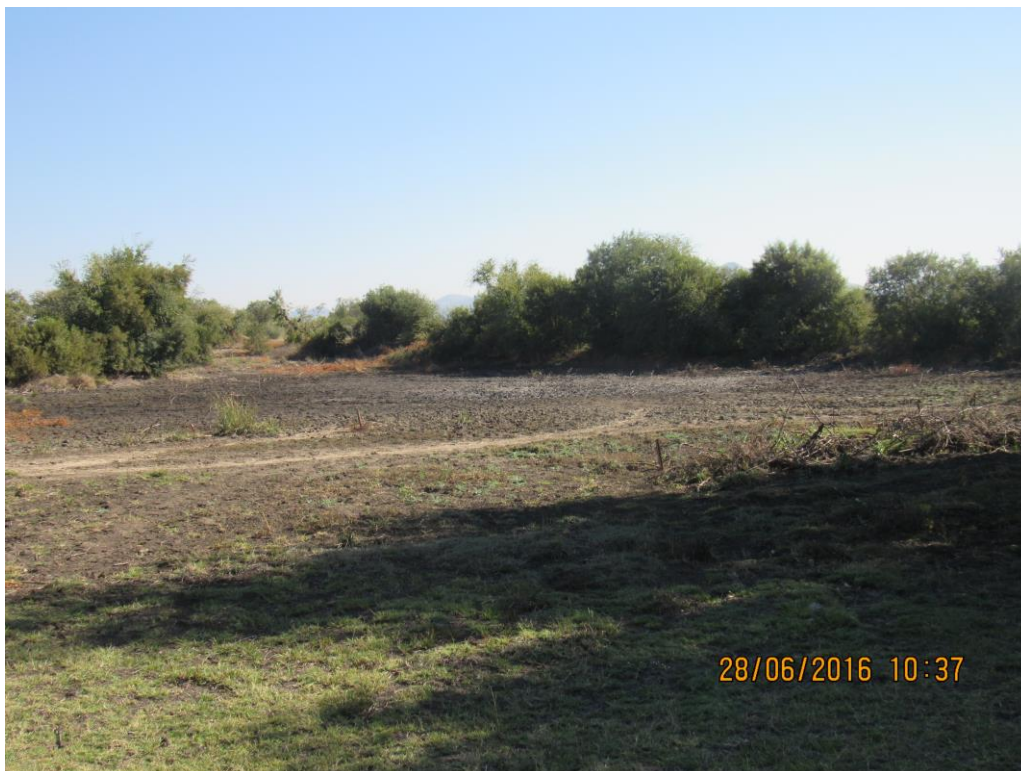
There are number of sensitive areas observed within the study area; (1) At pole 8 (pan/pond observed), (2) Between Ngwedi substation and Pole 9 to the Styldrift on the North westerly direction, a non-perennial stream has been observed and the powerline will cross 4 times. (3) Ngwedi-Bakubung powerline will cross once the Elands river between pole number 17 and 18 going North Westerly direction of the Bakubung substation.

**Figure 1; the pan/pond between pole 17 and 18 of the Ngwedi-Bakubung powerline.**

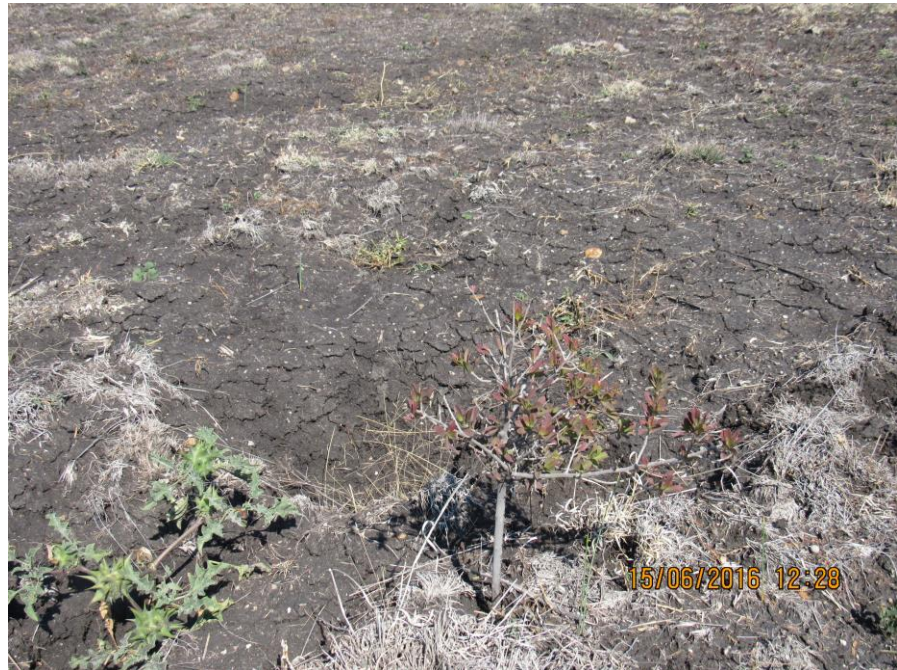
**Figure 2; Non-perennial stream between poles 8 and 9 along the Ngwedi-Styldrift Powerline**

Both alignments start from Ngwedi substation following the same route in a North-easterly direction, both crossing over a non-perennial stream between pole 8, 9 and 10 and then diverging thereafter. While the Ngwedi- Styldrift powerline runs straight in Northerly to the Styldrift substation, the Ngwedi-Bakubung powerline bends in a South Westerly backward direction towards the Ngwedi Substation then turn straight to the Bakubung substation.

- From an ecological perspective, the route is a viable option because of the limited need to clear large quantities of natural vegetation. Minimum clearing for the servitude will be needed. Some trimming of branches may be needed. It is suggested that the point near the stream is moved to the east to lower the impact on the waterway.

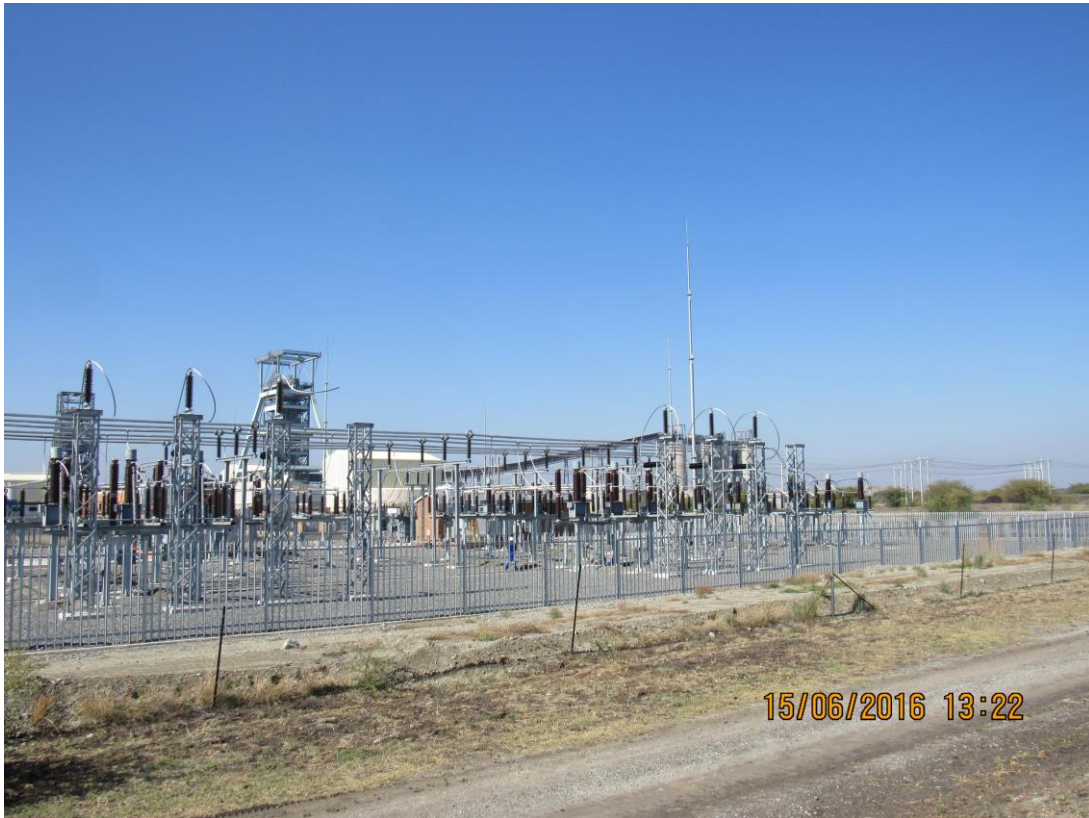
**Figure 3; Styldrift Substation**

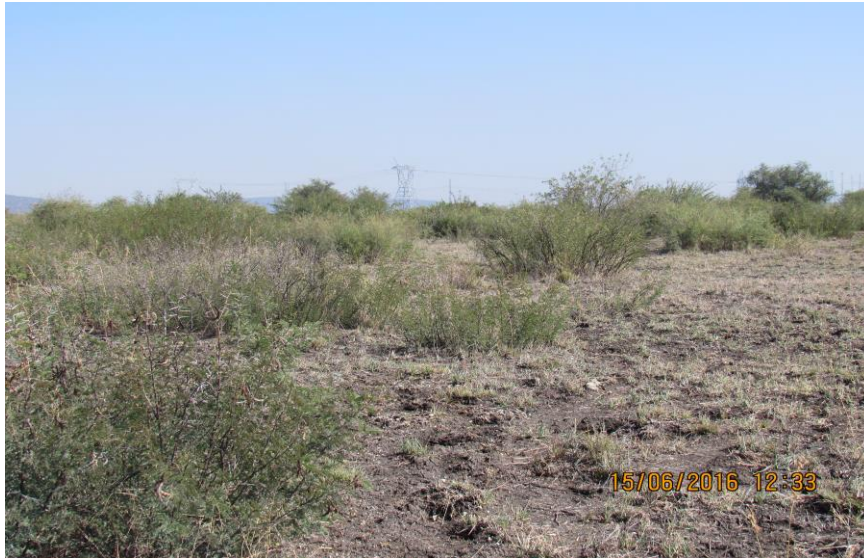
**Figure 5; Low shrubs areas and small trees dominated by *Acacia karoo***

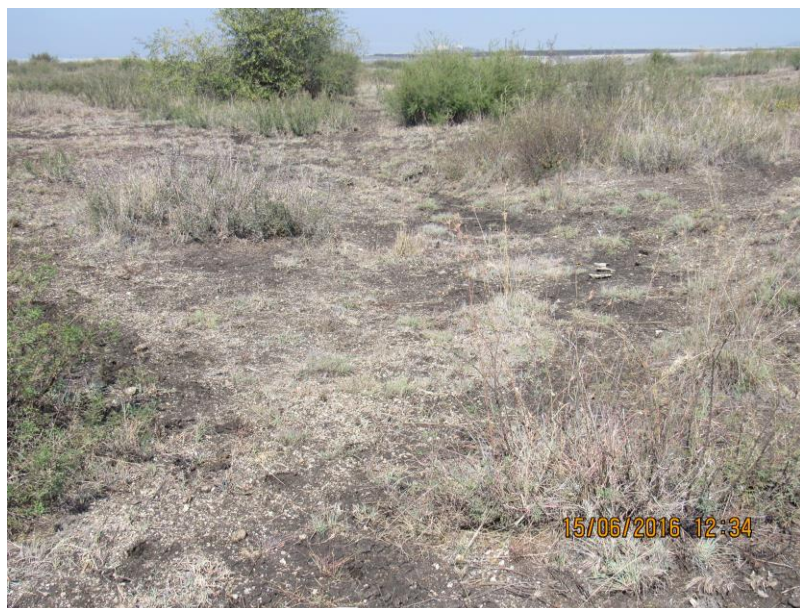
**Figure 6; Grassveld areas dominated by *Ziziphus macronata*, *Acacia karoo*. The vegetation can be regarded as Grassveld with low shrubs and small trees of the study side**

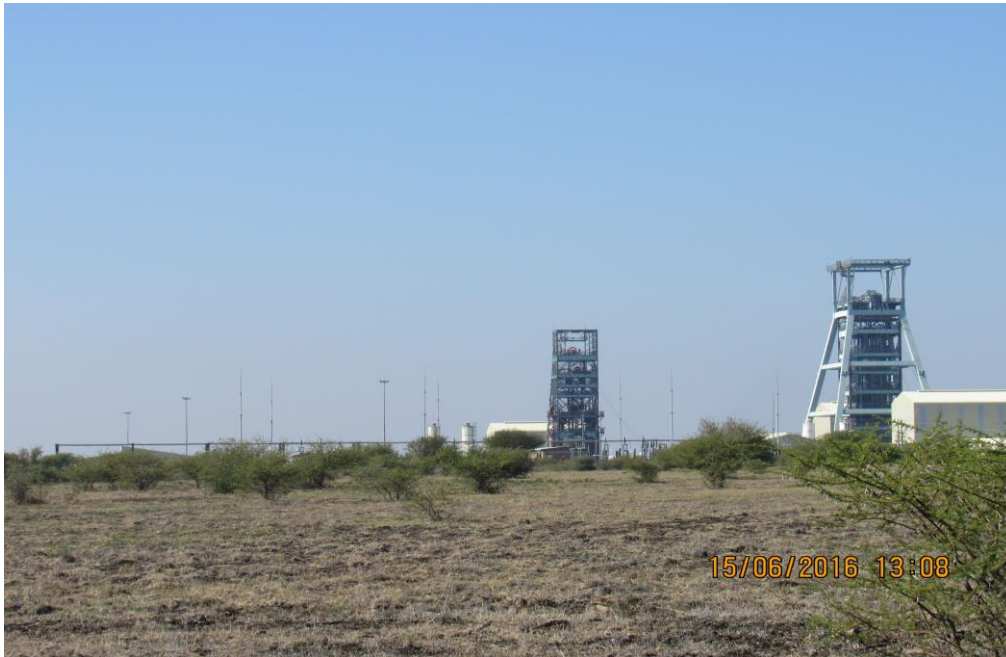
**Figure 7; vegetation within the Styldrift mining complex vicinity**

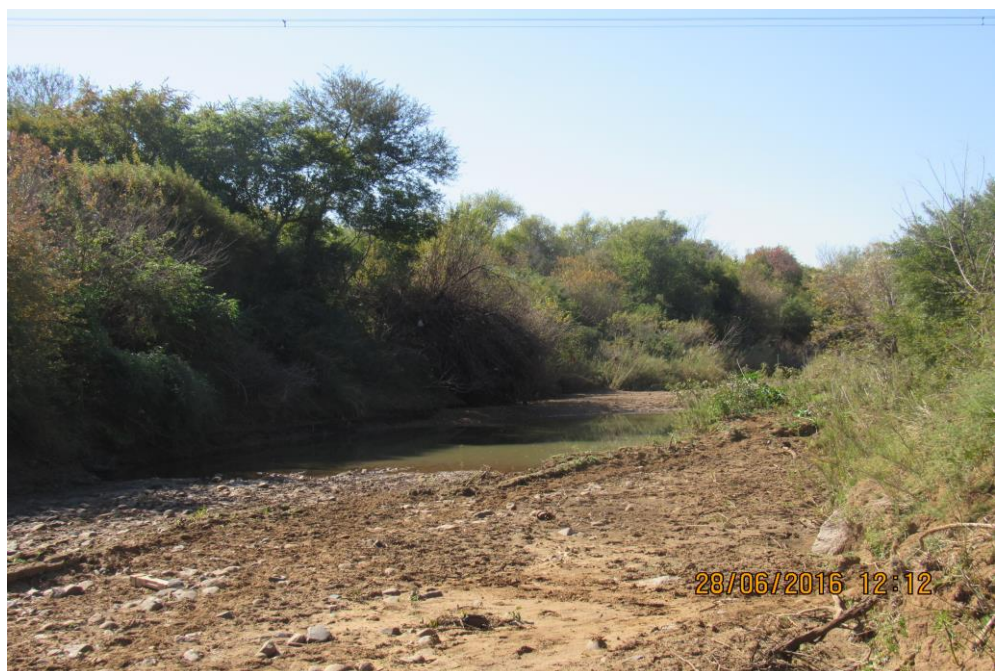
**Figure 8; Eland river crossings (water use license has been applied parallel to EIA studies)**

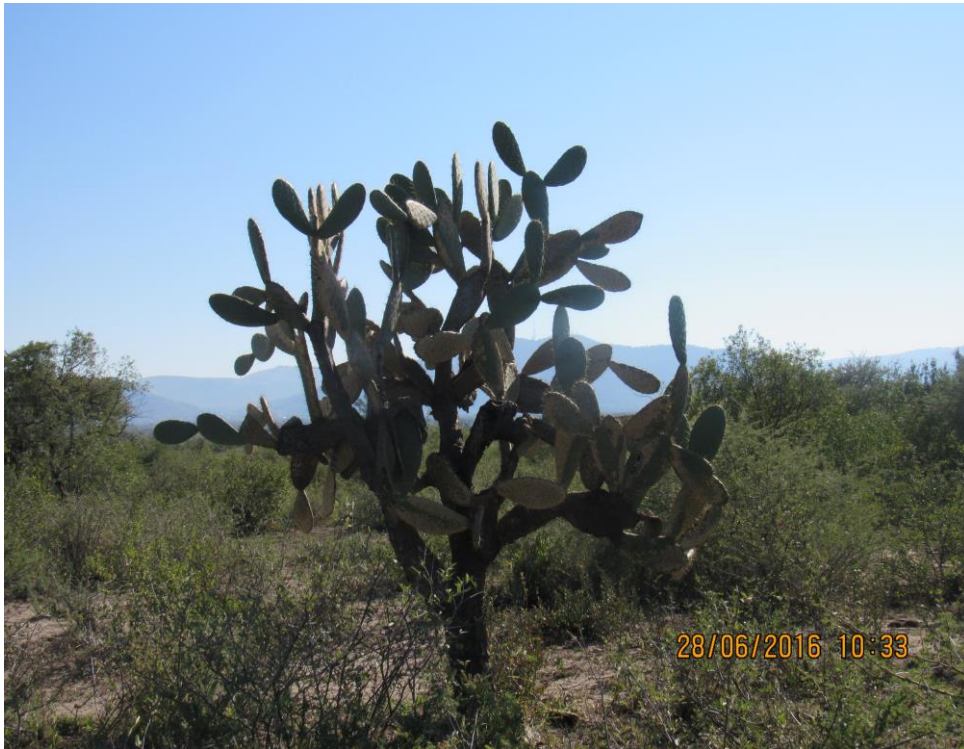
<i>Dichrostachys cinerea</i>	Declared weed	Bush encroachment,	<p>Disturbance as well as killing of serpentines by uneducated crews</p> <p>The activity (Powerlines) will have no real impact on biodiversity processes. The only possible impact can be oil or fuel spillages that can occur during construction or the installation and maintenance of the transformers. It is always suggested that fuel and oil must not be stored on site during the construction phase and that containment dams or berms are constructed around transformers. In addition, a clear plan how to manage accidental spills be included in the ECO report for the project</p>
<i>Ricinis communis</i>	Declared weed	Category 2 weed/invader	
<i>Solanum mauritium</i>	Declared weed	Category 1 invader	
<i>Melia azedarach</i>	Declared weed	Category 3 invader	
<i>Opuntia ficus indica</i>	Declared weed	Category 3 invader

**Figure 9; *Opuntia ficus indica* observed on site along the Ngwedi Bakubung powerline route**
