Our Reference: ESK-OUTD-COR-004

PROPOSED ESKOM OUTENIQUA-OUTDSHOORN 132KV POWERLINE INSTALLATION: SECTION 21 (c) & (i) APPLICATIONS

ANNEXURE 1: SUMMARY OF SITE INVESTIGATION

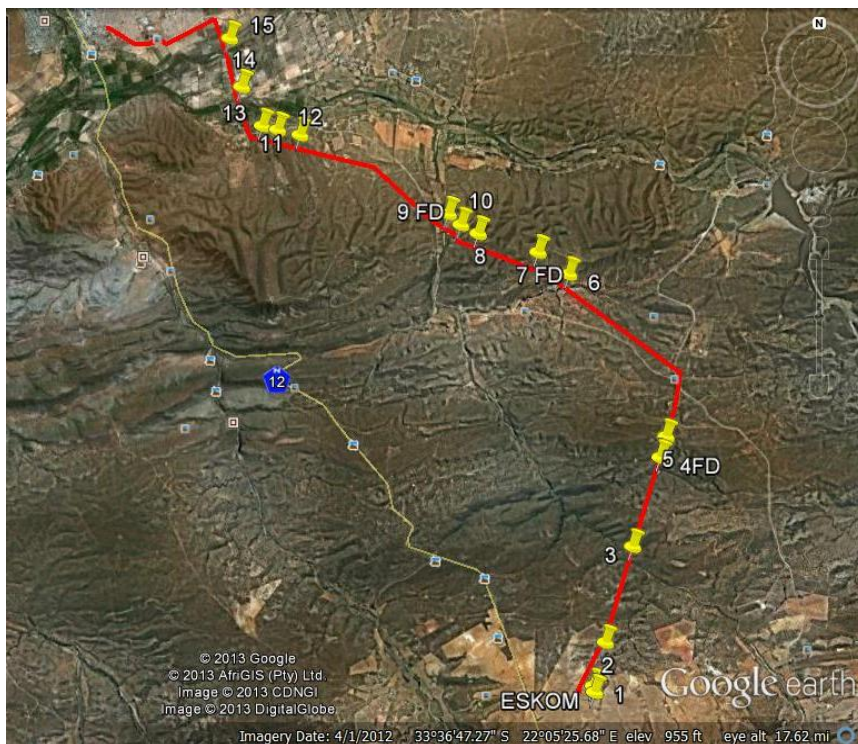
Figure 1: ESKOM OUTENIQUA - OUTDSHOORN 132KV POWERLINE ROUTE

After consultation with yourself on 26 April 2013, we conducted a site visit to all the affected water courses along the Red Route to assess the potential impact of the power line pylons on the beds and banks or potential flow impediments. 15 potential impact sites were identified for the site visit as depicted in the figure below:

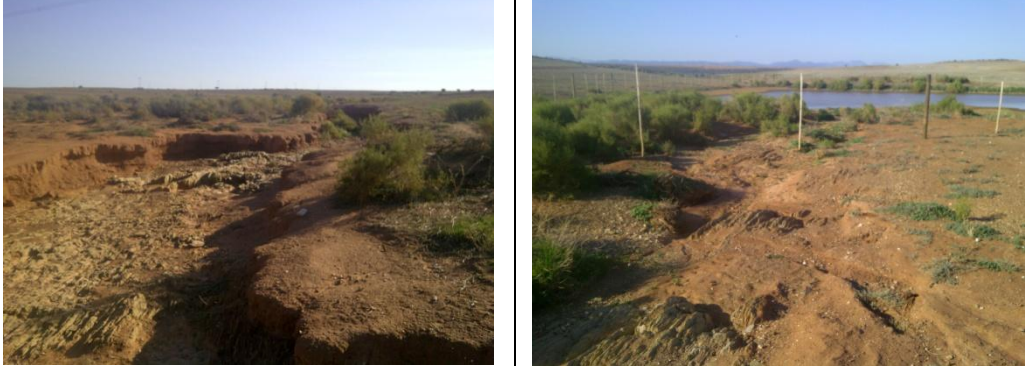
CROSSING NO 1			
NAME	Unnamed Tributary of Tributary		
COORDINATES	X: 33°45'49.22"S	Y: 22°21'20.64"E	
QUARTERNARY DRAINAGE			
FARM	PORTION: 2	FARM: 27	
OWNER	Martin Truter Trust		
POSTAL ADDRESS	PO Box 862, Oudtshoorn, 6620		
CONTACT NUMBERS	TEL: 044 272 7024	FAX:	
DESCRIPTION:	Eroded, dry, shallow, donga running into earth dam. No aquatic life visible. No riverine vegetation visible.		
PHOTOS:

STATUS:	RIVER	TRIBUTARY ✓	
PYLON LOCATION	>100m	<100m	>32m ✓ <32m
SECTION 21 (i) REQUIRED:	YES		NO ✓
MOTIVATION	Small, dry and shallow eroded donga. No aquatic life visible. No riverine thicket visible. Possible to span tributary without impacting the drainage line.

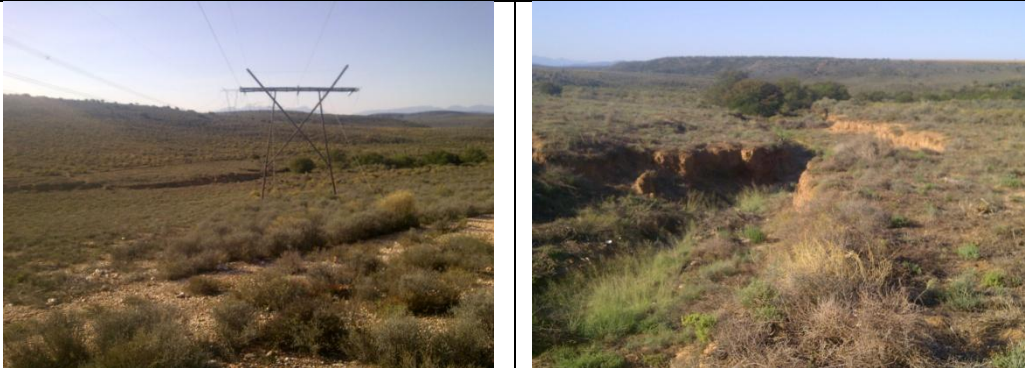
CROSSING NO 2			
NAME	Unnamed Tributary of Doring River		
COORDINATES	X: 33°45'13.41"S	Y: 22°21'32.89"E	
QUARTERNARY DRAINAGE			
FARM	PORTION: 2	FARM: 27	
OWNER	Martin Truter Trust		
POSTAL ADDRESS	PO Box 862, Oudtshoorn, 6620		
CONTACT NUMBERS	TEL: 044 272 7024	FAX:	
DESCRIPTION:	Eroded, dry, shallow, donga running below earth dam. Aquatic life possible. Some riverine vegetation visible.		
PHOTOS:

STATUS:	RIVER	TRIBUTARY ✓	
PYLON LOCATION	>100m	<100m	>32m ✓ <32m
SECTION 21 (i) REQUIRED:	YES		NO ✓
MOTIVATION	Small, dry and shallow eroded donga. Limited riverine thicket visible. Possible to span tributary without impacting the drainage line as per existing power line.

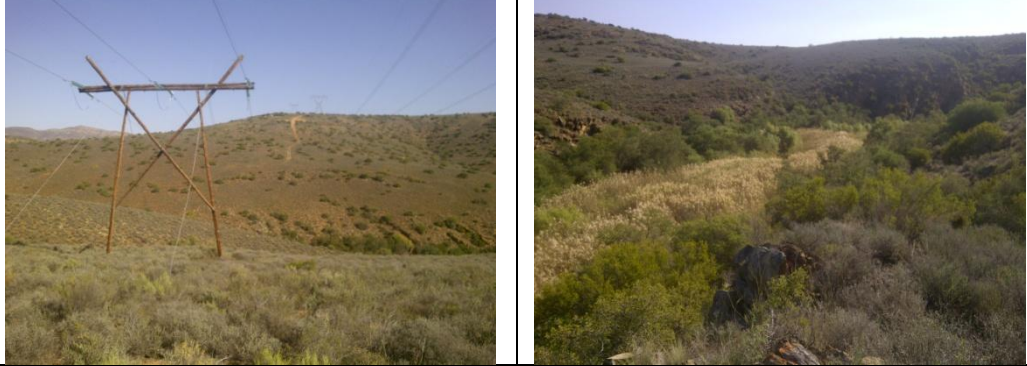
CROSSING NO 3				
NAME	Doring River (South)			
COORDINATES	X: 33°43'54.35"S	Y: 22°22'1.38"E		
QUARTEARNARY DRAINAGE				
FARM	PORTION: Remainder	FARM: 19		
OWNER	Joli Farming and Allied Activities CC			
POSTAL ADDRESS	PO Box 163, De Rust, 6650			
CONTACT NUMBERS	TEL: 021 788 6085	FAX:		
DESCRIPTION:	Flowing river in deep ravine. Aquatic life assumed. Dense riverine vegetation and trees present.			
PHOTOS:

STATUS:	RIVER ✓	TRIBUTARY		
PYLON LOCATION	>100m ✓	<100m	>32m	<32m
SECTION 21 (i) REQUIRED:	YES	NO ✓		
MOTIVATION	Existing pylons span ravine by more than 100m both sides and well outside 1:100 year flood line without affecting the riverine vegetation, beds or banks of the river.

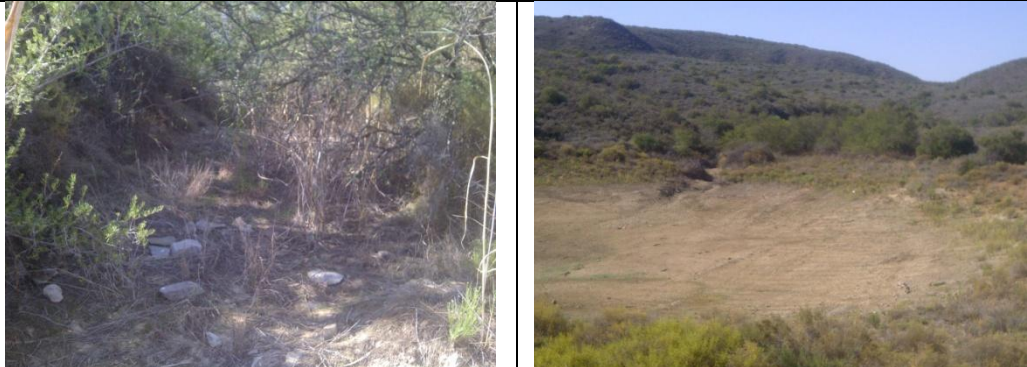
CROSSING NO 4				
NAME	Unnamed Tributary of Doring River			
COORDINATES	X: 33°42'40.44"S	Y: 22°22'29.12"E		
QUARTEARNARY DRAINAGE				
FARM	PORTION: Remainder	FARM: 19		
OWNER	Joli Farming and Allied Activities CC			
POSTAL ADDRESS	PO Box 163, De Rust, 6650			
CONTACT NUMBERS	TEL: 021 788 6085	TEL: 021 788 6085		
DESCRIPTION:	Dry, shallow, stream running below earth dam. Aquatic life possible. Riverine vegetation visible below dam.			
PHOTOS:

STATUS:	RIVER	TRIBUTARY ✓		
PYLON LOCATION	>100m	<100m	>32m ✓	<32m
SECTION 21 (i) REQUIRED:	YES	NO ✓		
MOTIVATION	Small, dry and shallow stream. Limited riverine thicket visible. Possible to span tributary without impacting the stream or dam.

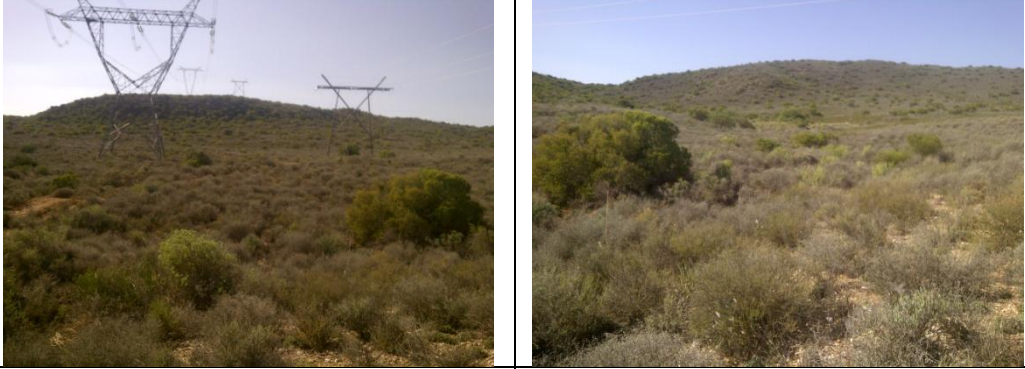
CROSSING NO 5			
NAME	Tributary of Tributary of Doring River		
COORDINATES	X: 33°42'23.02"S	Y: 22°22'34.75"E	
QUARternary DRAINAGE			
FARM	PORTION: Remainder	FARM: 19	
OWNER	Joli Farming and Allied Activities CC		
POSTAL ADDRESS	PO Box 163, De Rust, 6650		
CONTACT NUMBERS	TEL: 021 788 6085	FAX:	
DESCRIPTION:	Barely noticeable drainage line with no evidence of flowing water.		
PHOTOS:

STATUS:	RIVER	TRIBUTARY ✓	
PYLON LOCATION	>100m	<100m	>32m ✓ <32m
SECTION 21 (i) REQUIRED:	YES	NO ✓	
MOTIVATION	Existing pylons span drainage line well outside 32m buffer zone and has no affect on riverine vegetation, beds or banks of the drainage line.

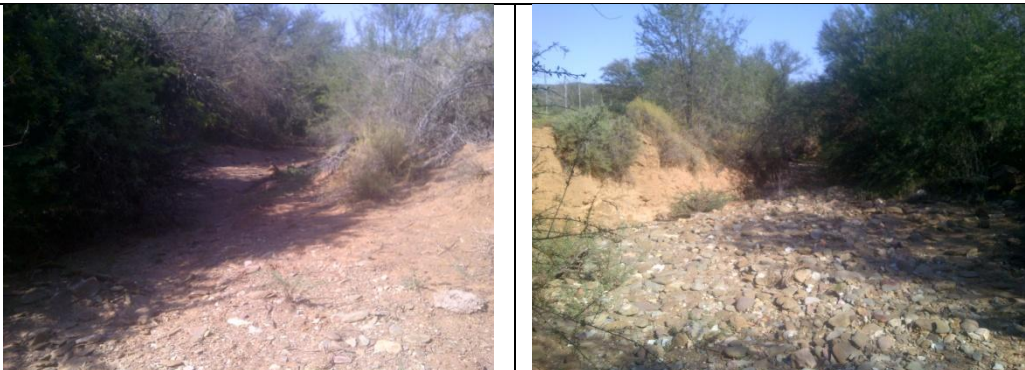
CROSSING NO 6			
NAME	Tributary of Doring River		
COORDINATES	X: 33°40'8.14"S	Y: 22°20'57.73"E	
QUARternary DRAINAGE			
FARM	PORTION: Remainder	FARM: 168	
OWNER	Bennie Stander		
POSTAL ADDRESS	PO Box 450, Oudtshoorn, 6620		
CONTACT NUMBERS	TEL: 044 272 5046	CEL: 082 824 6834	
DESCRIPTION:	Well defined, narrow river bed with evidence of occasional flooding and well developed river thicket and trees.		
PHOTOS:

STATUS:	RIVER	TRIBUTARY ✓	
PYLON LOCATION	>100m	<100m	>32m ✓ <32m
SECTION 21 (i) REQUIRED:	YES	NO ✓	
MOTIVATION	Existing pylons span narrow tributary well outside 32m buffer zone and has no affect on river thickets, trees, beds or banks of the tributary.

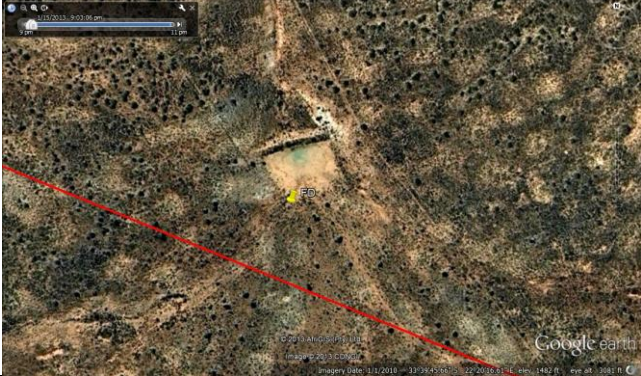
CROSSING NO 7				
NAME	Dam			
COORDINATES	X: 33°39'50.06"S		Y: 22°20'26.12"E	
QUARternary DRAINAGE				
FARM	PORTION: Remainder		FARM: 168	
OWNER	Bennie Stander			
POSTAL ADDRESS	PO Box 450, Oudtshoorn, 6620			
CONTACT NUMBERS	TEL: 044 272 5046		CEL: 082 824 6834	
DESCRIPTION:	Dry dam.			
PHOTOS:

STATUS:	RIVER N/A		TRIBUTARY	
PYLON LOCATION	>100m N/A	<100m	>32m	<32m
SECTION 21 (i) REQUIRED:	YES		NO ✓	
MOTIVATION	Power line route misses dam location. This application not necessary.

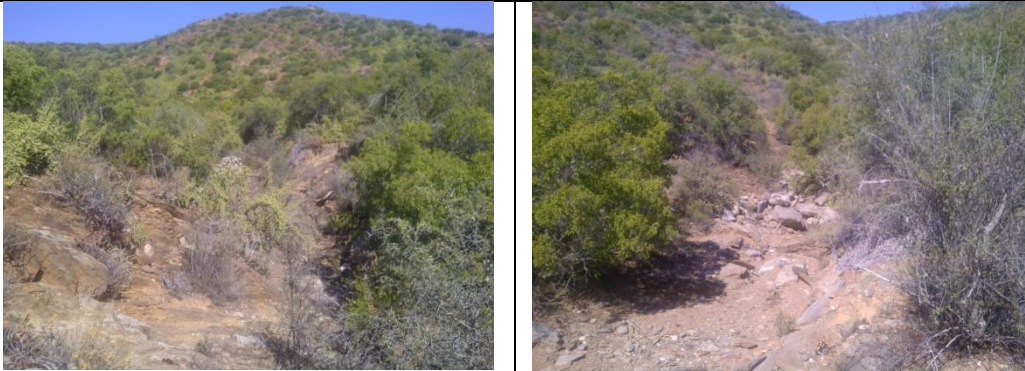
CROSSING NO 8				
NAME	Tributary of Doring River			
COORDINATES	X: 33°39'34.28"S		Y: 22°19'26.03"E	
QUARternary DRAINAGE				
FARM	PORTION: 10		FARM: 139	
OWNER	Morne Jonker			
POSTAL ADDRESS	PO Box 599, Oudtshoorn, 6620			
CONTACT NUMBERS	TEL: 044 203 3071		CEL: 083 584 5121	
DESCRIPTION:	Short, well defined, narrow river bed with steep banks and some river thickets.			
PHOTOS:

STATUS:	RIVER		TRIBUTARY ✓	
PYLON LOCATION	>100m	<100m	>32m ✓	<32m
SECTION 21 (i) REQUIRED:	YES		NO ✓	
MOTIVATION	Pylons can easily span narrow valley well outside 32m buffer zone and should have no affect on river thickets, beds or banks of the tributary.

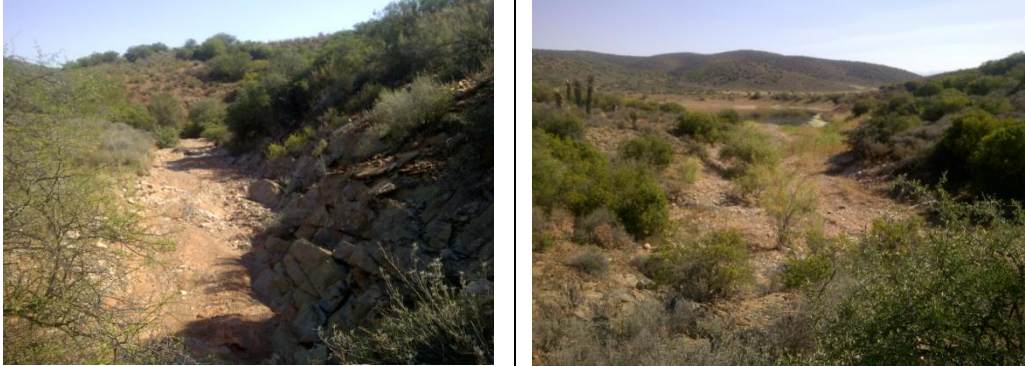
CROSSING NO 9			
NAME	Dam on tributary of Doring River		
COORDINATES	X: 33°39'26.90"S	Y: 22°19'8.71"E	
QUARternary DRAINAGE			
FARM	PORTION: 10	FARM: 139	
OWNER	Morne Jonker		
POSTAL ADDRESS	PO Box 599, Oudtshoorn, 6620		
CONTACT NUMBERS	TEL: 044 203 3071	CEL: 083 584 5121	
DESCRIPTION:	Larger tributary flowing into a dam. Dry, but with clear signs of flooding. Well developed riverine vegetation along the banks. Steep valley slopes.		
PHOTOS:

STATUS:	RIVER	TRIBUTARY ✓	
PYLON LOCATION	>100m	<100m	>32m <32m ✓
SECTION 21 (i) REQUIRED:	YES ✓		NO
MOTIVATION	Pylons of turn point on power line route possibly closer than 32m from top of dam and river bank. Pylon position will be above full water supply level of dam.

We therefore recommended that Section 21 (i) applications be drawn up for the above 4 river crossings and submitted for processing to the Department of Water Affairs and once the final pylon positions are known the applications be amended to the reflect the exact pylon coordinates.

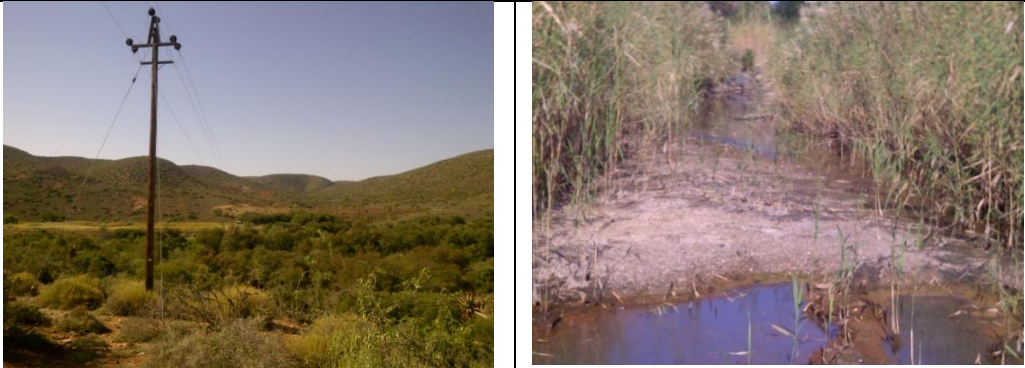
CROSSING NO 10			
NAME	Doring River (North)		
COORDINATES	X: 33°39'17.72"S	Y: 22°18'56.16"E	
QUARternary DRAINAGE			
FARM	PORTION: 10	FARM: 139	
OWNER	Heinrich Jonker - Kumquat Pty Ltd		
POSTAL ADDRESS	PO Box 599, Oudthoorn, 6620		
CONTACT NUMBERS	TEL: 044 203 3071	CEL: 083 584 5121	
DESCRIPTION:	Medium sized river with sandy river bed, wide flood plain, multiple channels with reed beds and trees.		
PHOTOS:

STATUS:	RIVER ✓	STATUS:	
PYLON LOCATION	>100m	<100m ✓	>32m <32m
SECTION 21 (i) REQUIRED:	YES ✓		NO
MOTIVATION	Pylons will be within 100m from river's edge in the absence of 1:100 year flood lines.

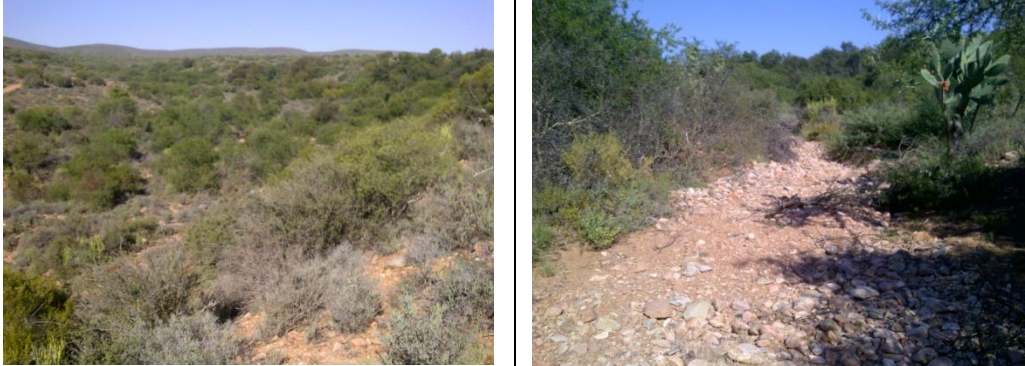
CROSSING NO 11			
NAME	Tributary of Kammanassie River		
COORDINATES	X: 33°38'11.98"S	Y: 22°16'25.65"E	
QUARTERNARY DRAINAGE			
FARM	PORTION: 74	FARM: 141	
OWNER			
POSTAL ADDRESS			
CONTACT NUMBERS			
DESCRIPTION:	Medium sized, well defined, dry river bed with wide valley banks and plenty of river thicket and trees.		
PHOTOS:

STATUS:	RIVER	TRIBUTARY ✓	
PYLON LOCATION	>100m	<100m	>32m ✓ <32m
SECTION 21 (i) REQUIRED:	YES	NO ✓	
MOTIVATION	Pylons can easily span valley well outside 32m buffer zone and should have no affect on river thickets, beds or banks of the tributary.

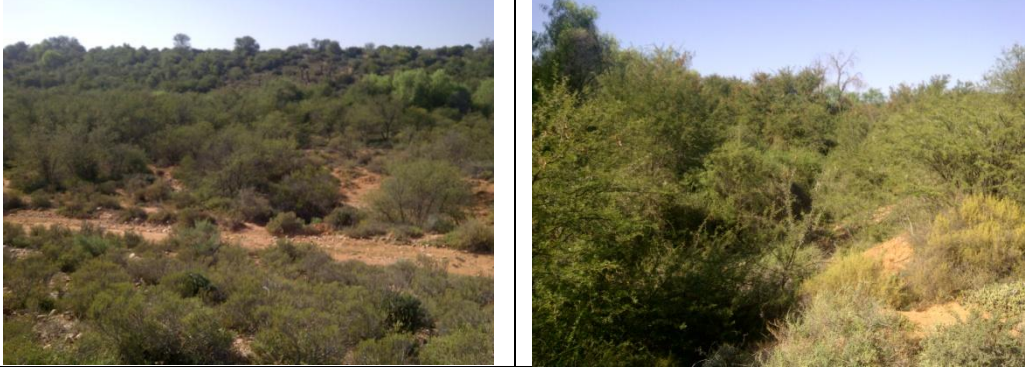
CROSSING NO 12			
NAME	Tributary of Kammanassie River		
COORDINATES	X: 33°38'7.51"S	Y: 22°16'2.99"E	
QUARTERNARY DRAINAGE			
FARM	PORTION: 74	FARM: 141	
OWNER			
POSTAL ADDRESS			
CONTACT NUMBERS			
DESCRIPTION:	Small, well defined, dry river bed with wide valley banks and plenty of river thicket and trees.		
PHOTOS:

STATUS:	RIVER	TRIBUTARY ✓	
PYLON LOCATION	>100m	<100m	>32m ✓ <32m
SECTION 21 (i) REQUIRED:	YES	NO ✓	
MOTIVATION	Pylons can easily span valley well outside 32m buffer zone and should have no affect on river thickets, beds or banks of the tributary.

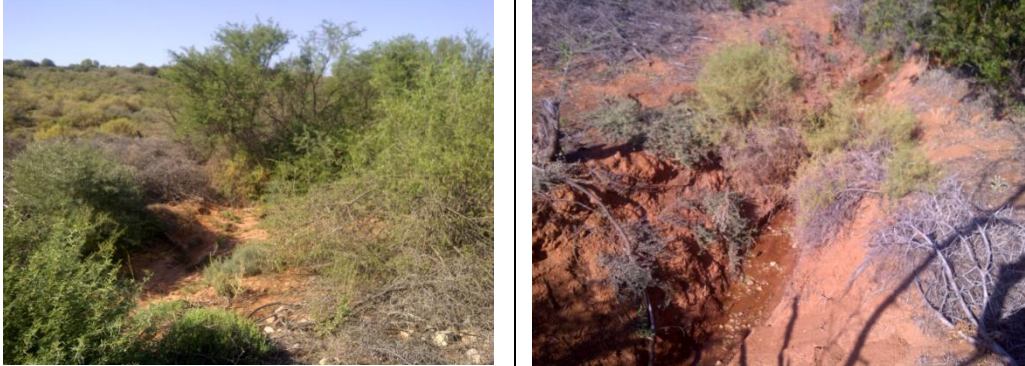
CROSSING NO 13			
NAME	Tributary of Kammanassie River		
COORDINATES	X: 33°38'4.32"S	Y: 22°15'47.46"E	
QUARTERNARY DRAINAGE			
FARM	PORTION: 74	FARM: 141	
OWNER			
POSTAL ADDRESS			
CONTACT NUMBERS			
DESCRIPTION:	Very small, shallow, eroded river bed with a little bit of water. Poorly defined valley and narrow strip of riverine thicket.		
PHOTOS:

STATUS:	RIVER	TRIBUTARY ✓	
PYLON LOCATION	>100m	<100m	>32m ✓ <32m
SECTION 21 (i) REQUIRED:	YES	NO ✓	
MOTIVATION	Pylons can easily span valley well outside 32m buffer zone and should have no affect on river thickets, beds or banks of the tributary.

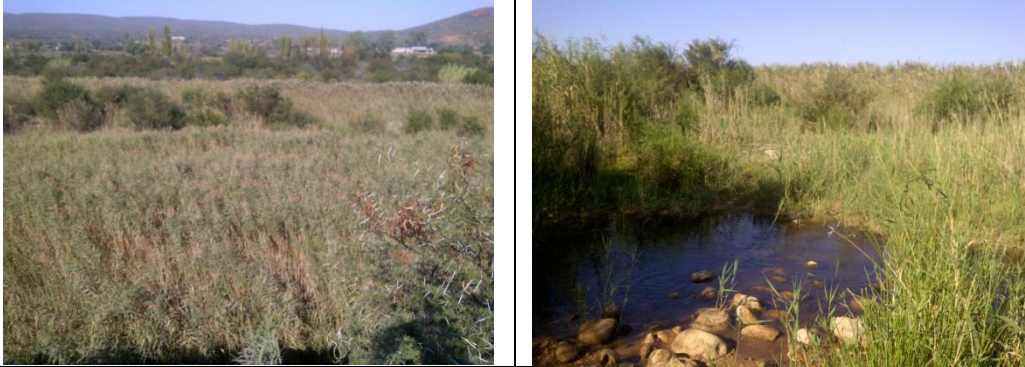
CROSSING NO 14			
NAME	Kammanassie River		
COORDINATES	X: 33°37'31.57"S	Y: 22°15'26.47"E	
QUARTERNARY DRAINAGE			
FARM	PORTION: 36	FARM: 141	
OWNER	Provincial Government, Western Cape		
POSTAL ADDRESS	Private Bag X9078, Cape Town		
CONTACT NUMBERS	TEL: 044 272 6077	Cel: 082 653 9888	
DESCRIPTION:	Medium sized river with multiple channels, wide flood plain, reed beds and trees lining river.		
PHOTOS:

STATUS:	RIVER ✓	TRIBUTARY	
PYLON LOCATION	>100m	<100m ✓	>32m <32m
SECTION 21 (i) REQUIRED:	YES ✓	NO	
MOTIVATION	Pylons will be within 100m from river's edge in the absence of 1:100 year flood lines.

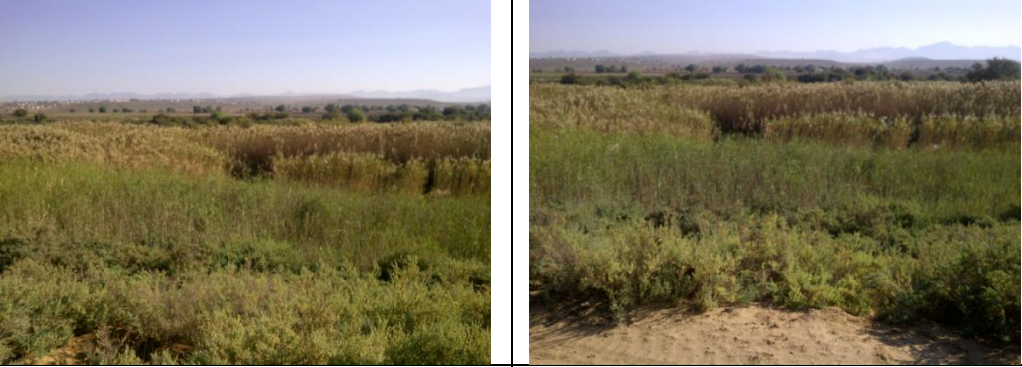
CROSSING NO 15			
NAME	Olifants River		
COORDINATES	X: 33°36'51.03"S	Y: 22°15'14.30"E	
QUARternary DRAINAGE			
FARM	PORTION: 72	FARM: 141	
OWNER	Leon Nortier Boerdery Trust		
POSTAL ADDRESS	PO Box 356, Oudthoorn, 6620		
CONTACT NUMBERS	TEL: 044 272 6418	CEL: 082 517 1404	
DESCRIPTION:	Medium sized river with multiple channels, wide flood plain, reed beds and trees lining river.		
PHOTOS:

STATUS:	RIVER ✓		STATUS:
PYLON LOCATION	>100m	<100m ✓	>32m <32m
SECTION 21 (i) REQUIRED:	YES ✓		NO
MOTIVATION	Pylons will be within 100m from river's edge in the absence of 1:100 year flood lines.
