Syferkuil – Rampheri Project

BIODIVERSITY ASSESSMENT

**Terrestrial Ecological Assessment and Aquatic (Wetland) Assessment
of the Syferkuil-Rampheri Power Line, Rampheri CNC, Syferkuil
Substation and CNC and Thabampoopo-Syferkuil Line Upgrade**

JUNE 2016

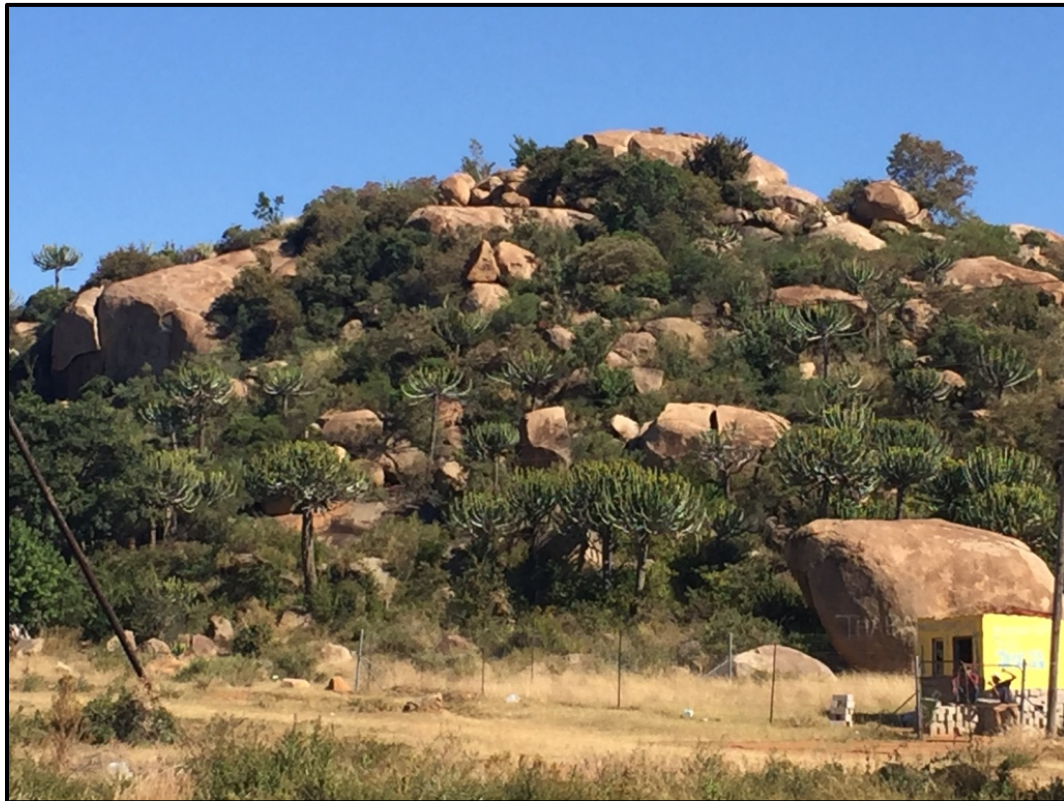
Photo 5: Granite koppies with dominant *Euphorbia cooperi* (Transvaal candelabra). These koppies are sensitive 'No-Go' zones.

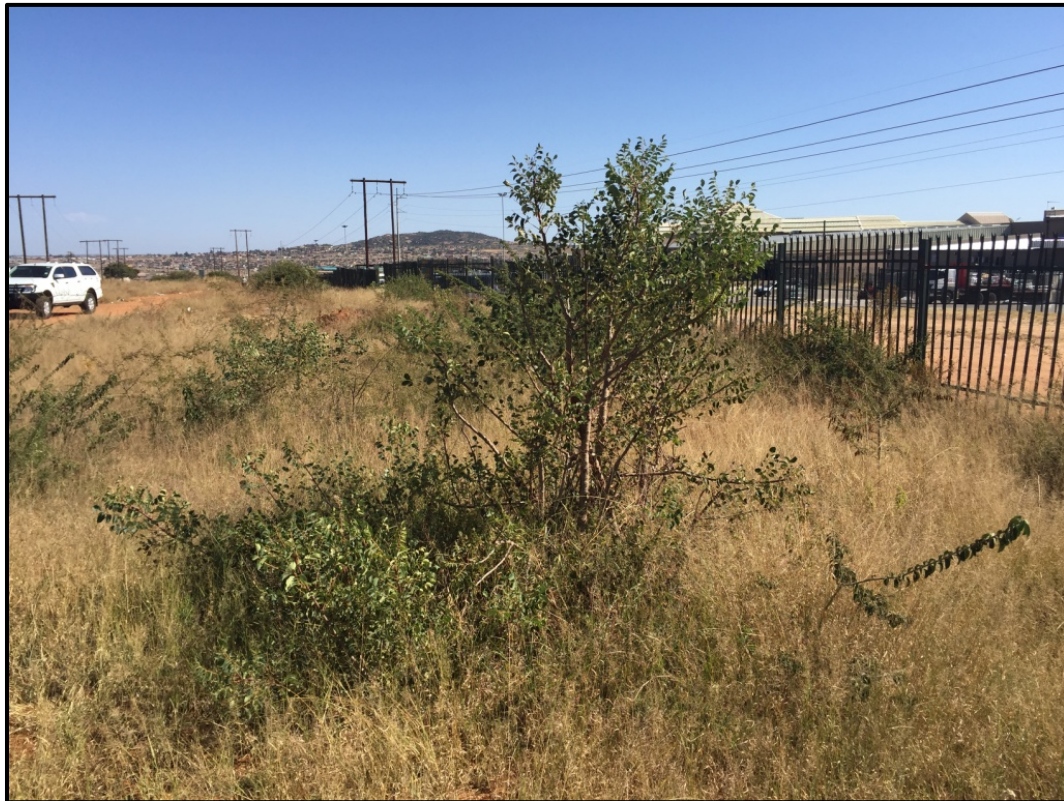
The marula (*Sclerocarya birrea subsp. caffra*) is a protected tree and was observed in the study area. This included near the Thabampo Substation, within the powerline corridor.

Photo 7: Young, marula tree (protected tree) in the Thabamoopo-Syferkuil servitude

- There are protected trees (marula) within the powerline corridors.
- It is recommended that a final walk-through be undertaken to fine-tune final line alignment and pole positions for the powerlines to avoid sensitive areas and protected trees.

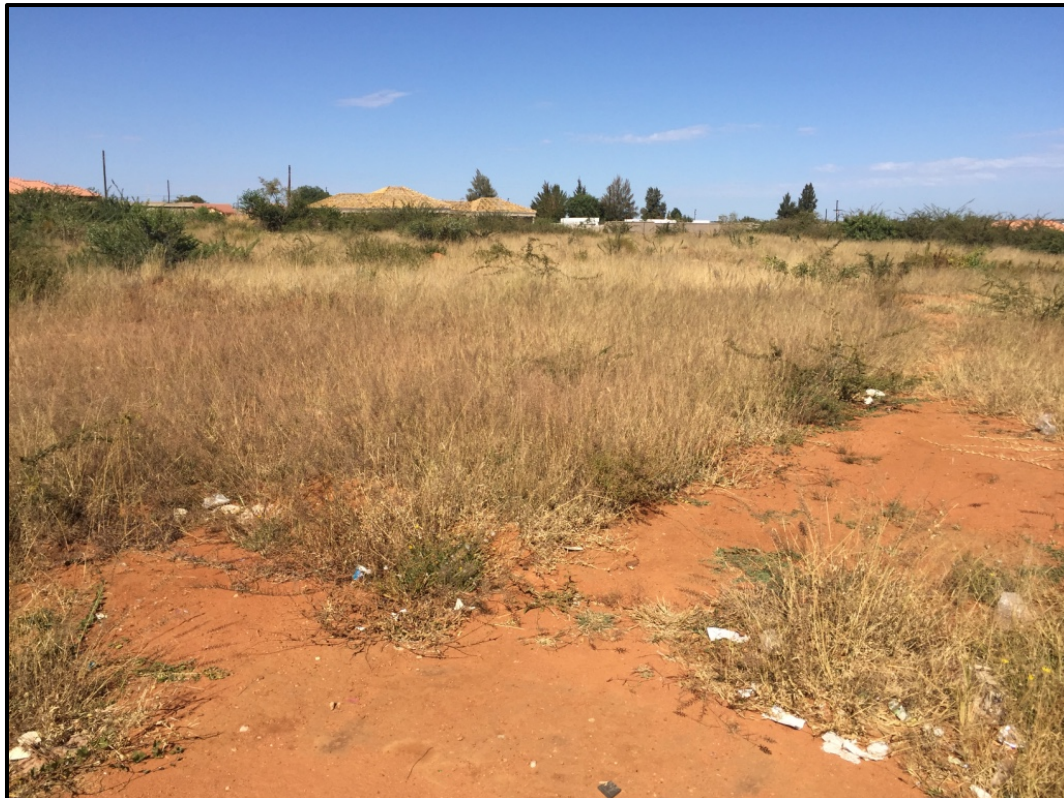
Photo 8: Typical open veld area between houses in the powerline servitudes in the built-up areas. Few trees, veld degraded and full of litter

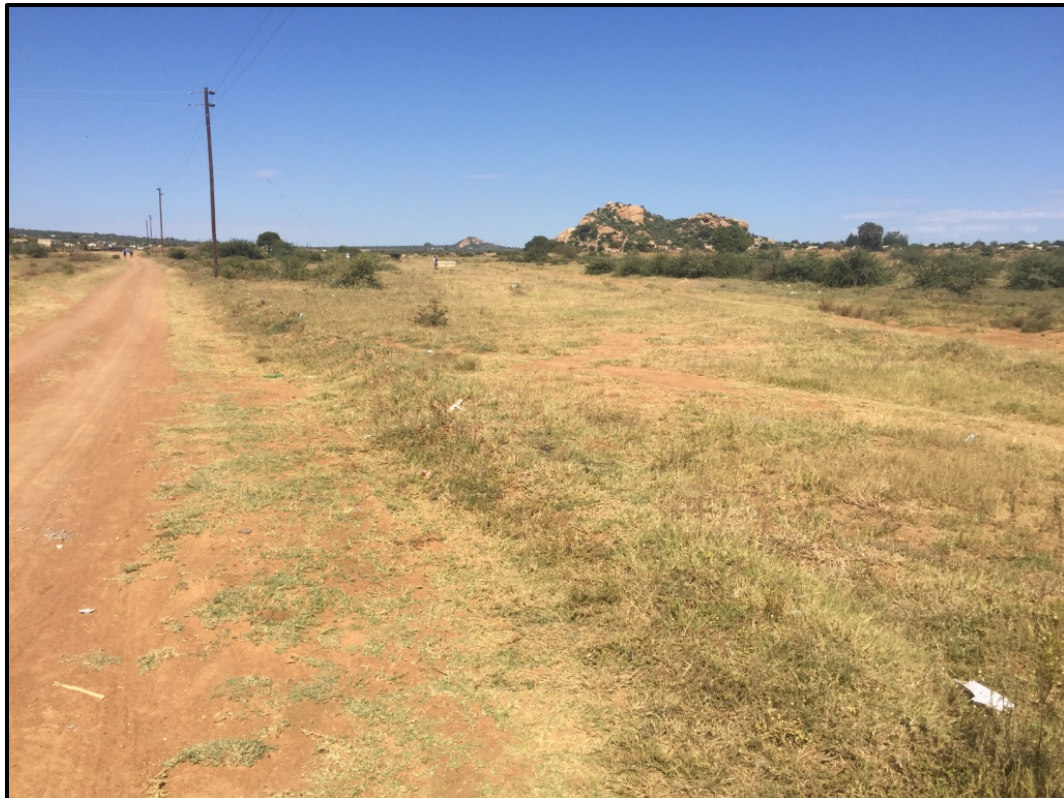
Photo 10: Syferkuil-Rampheri line servitude just south of the R71, looking south. The open veld in this area is degraded and resources such as wood over-utilised

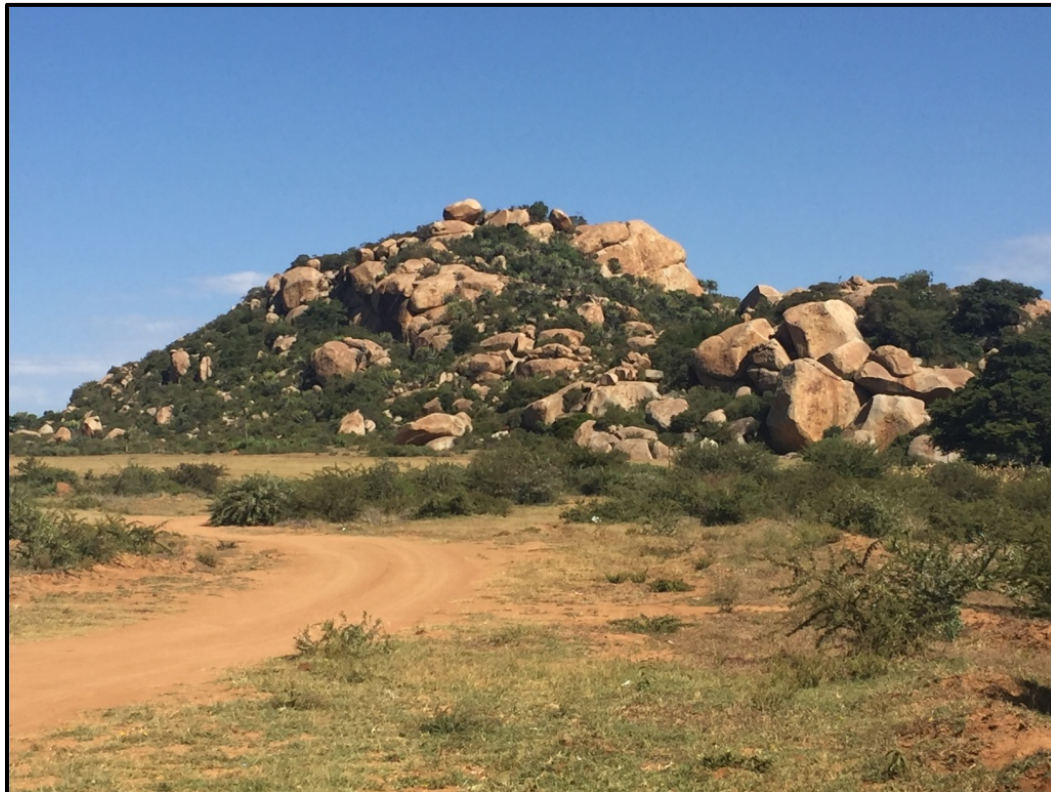
Photo 11: Granite koppies scattered throughout the study area (1km corridor). These koppies are sensitive, 'no-go' zones.

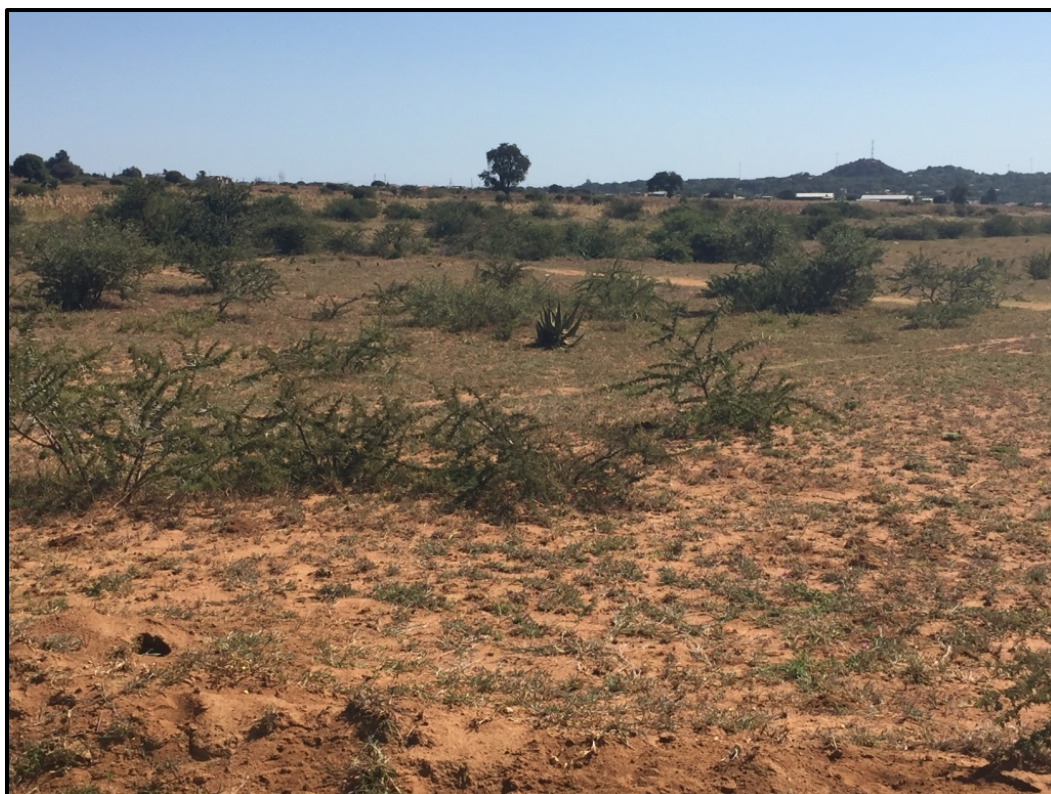
Photo 12: Open veld areas in the north of the study area. Veld is over-grazed and tree over-exploited, leaving degraded open veld. Recent drought has also had a very negative impact on vegetation cover

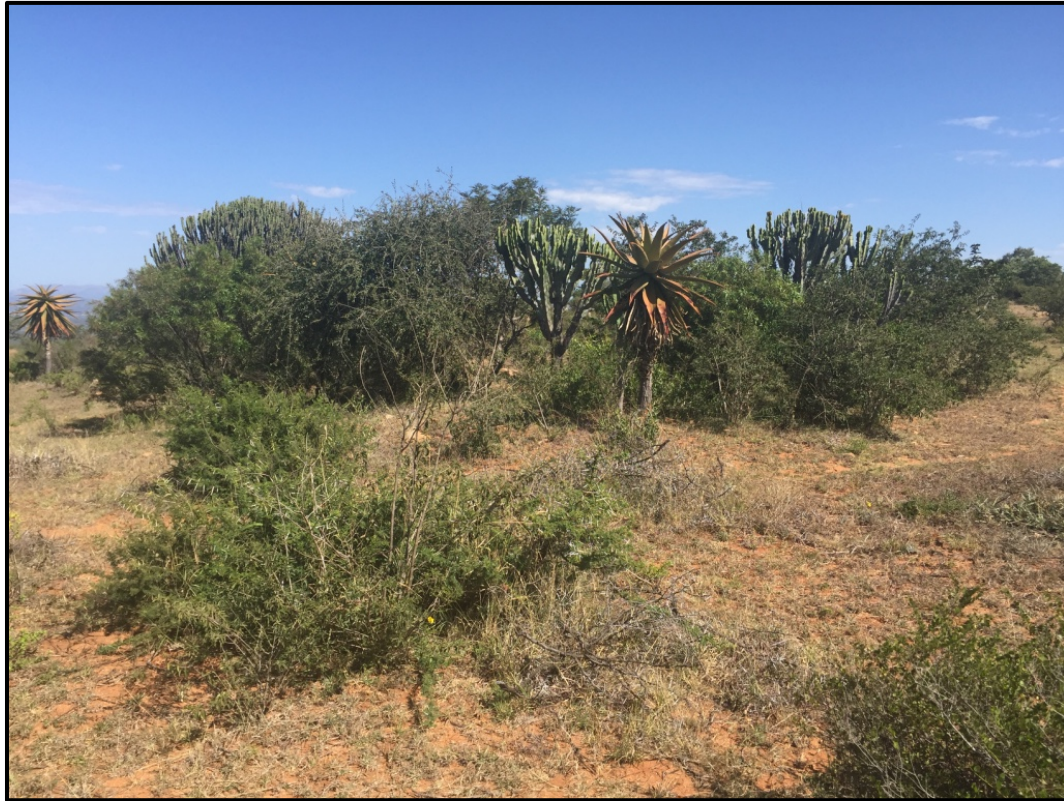
Photo 15: *Aloe marlothii* and *Euphorbia ingens*, are mainly confined to rocky outcrops. However, there are plants scattered throughout the main servitude areas as seen in this photo. These need to be avoided

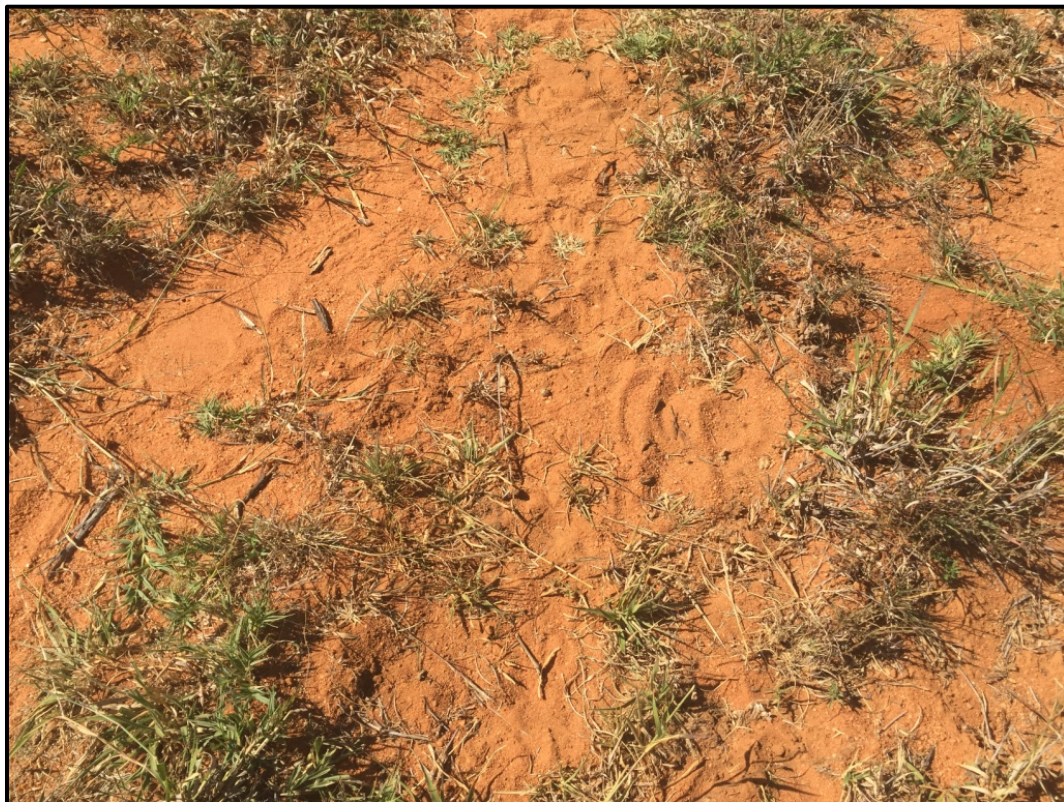
Photo 17: Structureless (fine), red sandy soils, typical of the study area

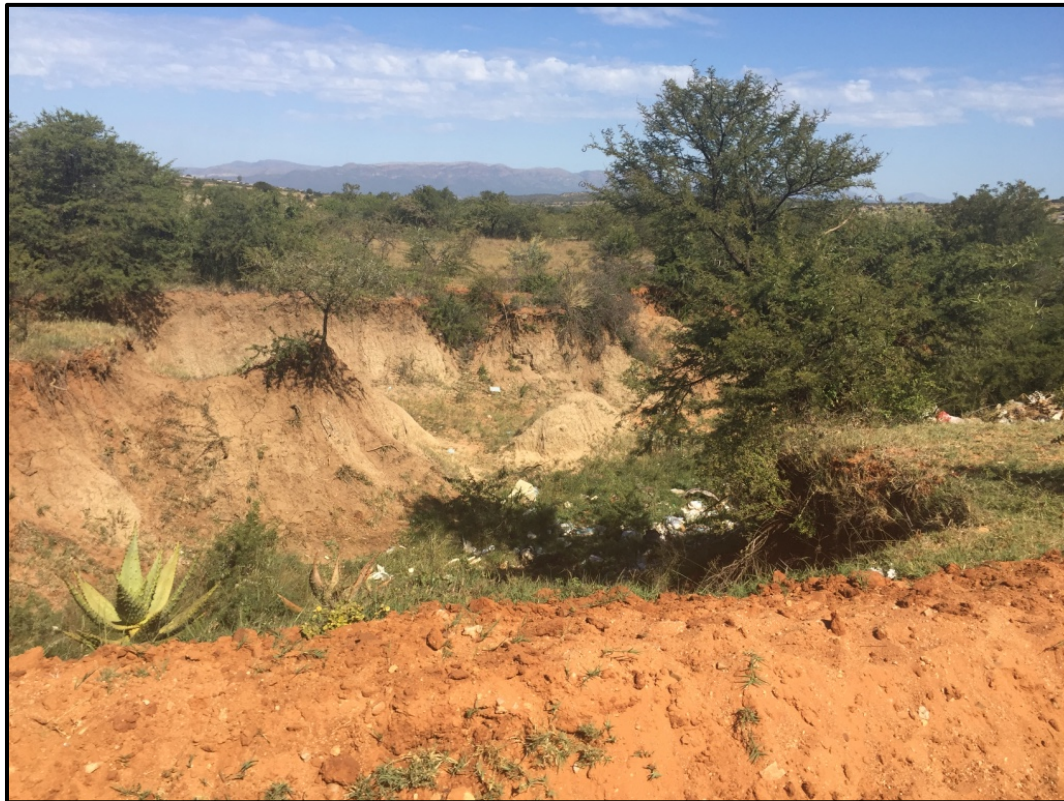
Erosion and donga formation is a bit of a problem, especially in the southern half of the study area where the topography at times can be steeper. The donga and surface erosion is linked to surface rainwater run-off near streams or steep ravines. These dongas / erosion lines in affect become drainage lines and as such need to be avoided were possible.

Photo 18: Donga formation in the south of the study area. Erosion can be a problem in areas with a steeper gradient

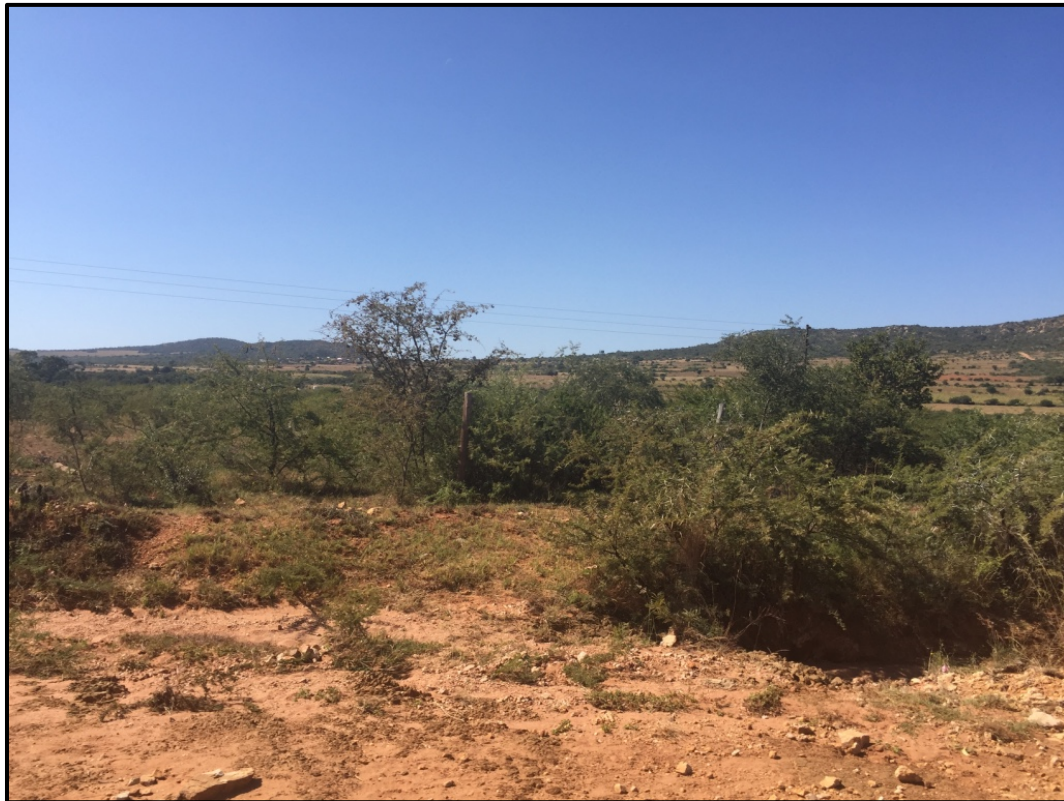
Photo 20: Open veld, with lack of grass, showing signs of stormwater run-off erosion in the foreground, which is common in the study area
