MONTHLY ECO COMPLIANCE REPORT – JULY 2022

ESKOM WOESTALEEN 132KV CHIKADEE POWERLINE

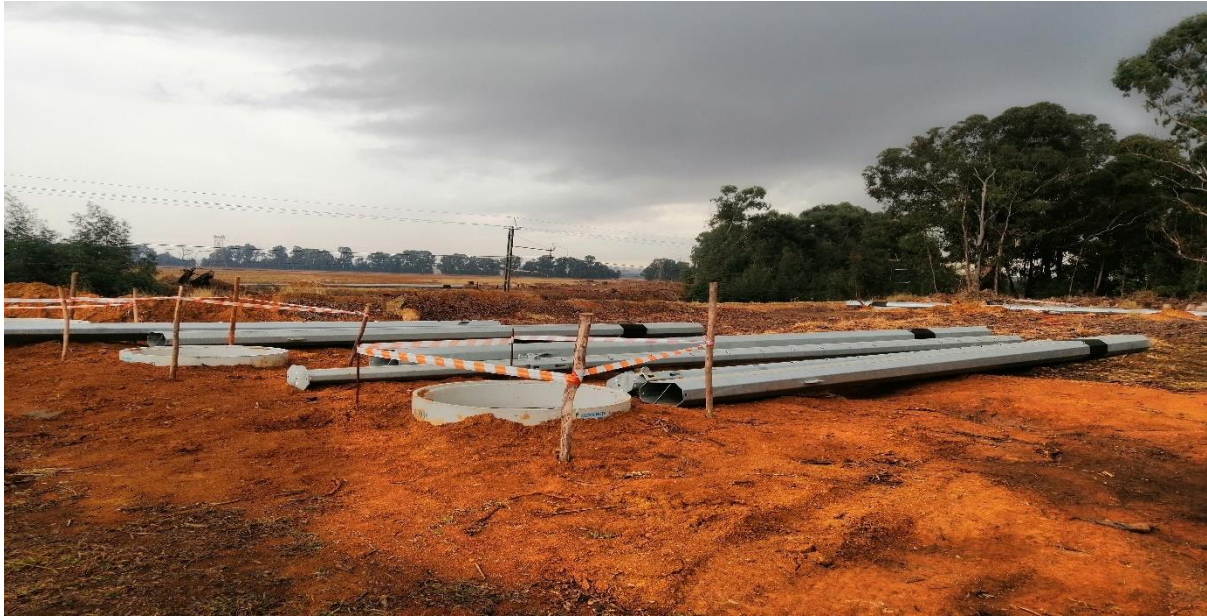
Figure 3: Fitted concrete rings into excavations and placement of steel poles.

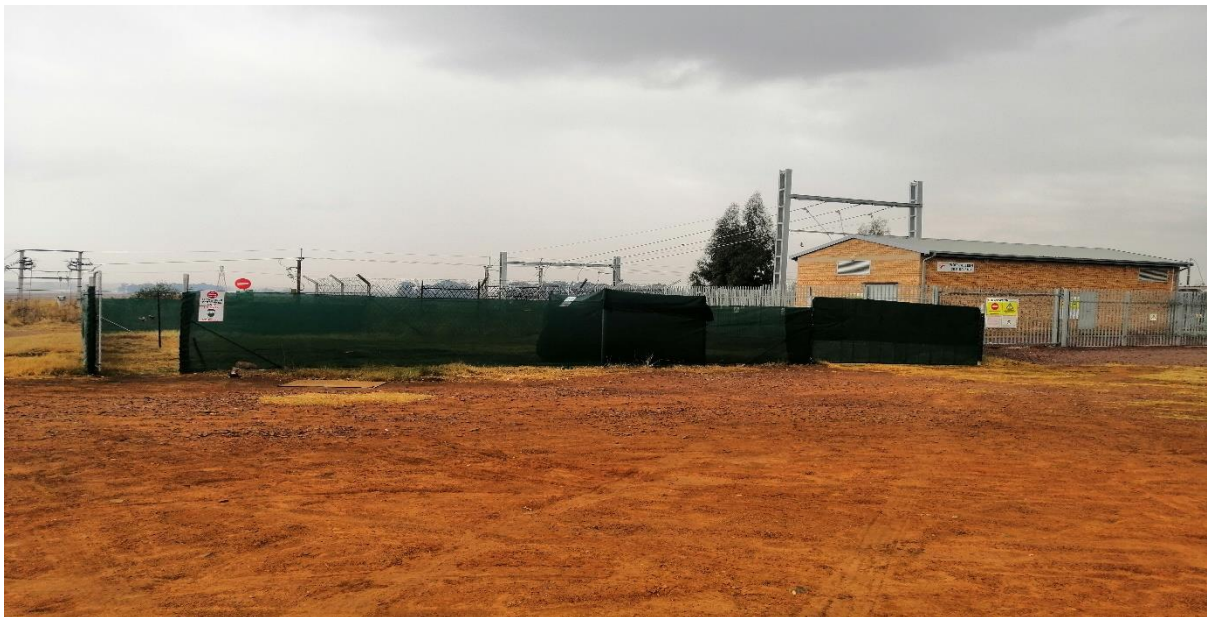
Figure 4: Removal of site office, security guard post and chemical ablution facilities.

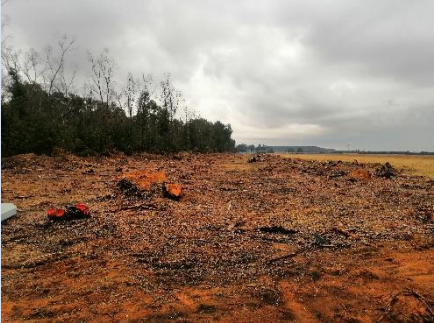
NC No.	Resp. Party	Ref:#	Requirement	Description	Recommendation	Photo Reference
008	Contractor/ Applicant	EMPr 23	Ensure that no litter, refuse, wastes, rubbish, rubble, debris and builders wastes generated on the premises be placed, dumped or deposited on adjacent/surrounding properties during or after the construction period of the project are disposed of an approved at dumping site as approved by the Council.	Cleared vegetation has not been neatly stored on one side of the servitude	The applicant reported that the landowner would make use of the cleared vegetation. It is however recommended that the cleared vegetation be neatly stacked on one side of the servitude as stated in the EMPr.

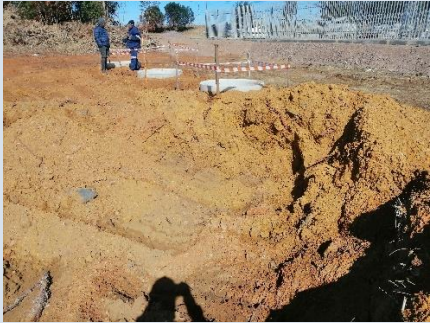
Concern #:	EA & EMPr Ref.	Requirement	Description	Recommendation	Status	Photographic Record
NC 005	EMPr 23	Topsoil (the upper 25 cm of soil) is an important natural resource; where it must be stripped, never mix it with subsoil or any other material, store and protect it separately until it can be re-applied, minimise handling of topsoil.	Topsoil mixing was noted in soil stockpiles, no separate stockpiling of topsoil.	Topsoil must always be stored separately to promote vegetation regrowth during rehabilitation. This was communicated to the contractor during this audit.	Open
