Proposed Construction of a New 400 kV Line From Bravo Power Station to Lulamisa (Kyalami) Substation (Bravo 3)

General wetland rehabilitation- and monitoring plan to mitigate the
construction and operational related impacts
May 2016

Drafted by
Limosella Consulting Pty Ltd
Reg No: 2014/023293/07
Email: antoinette@limosella.co.za
Cell: +27 83 4545 454
www.limosella.co.za

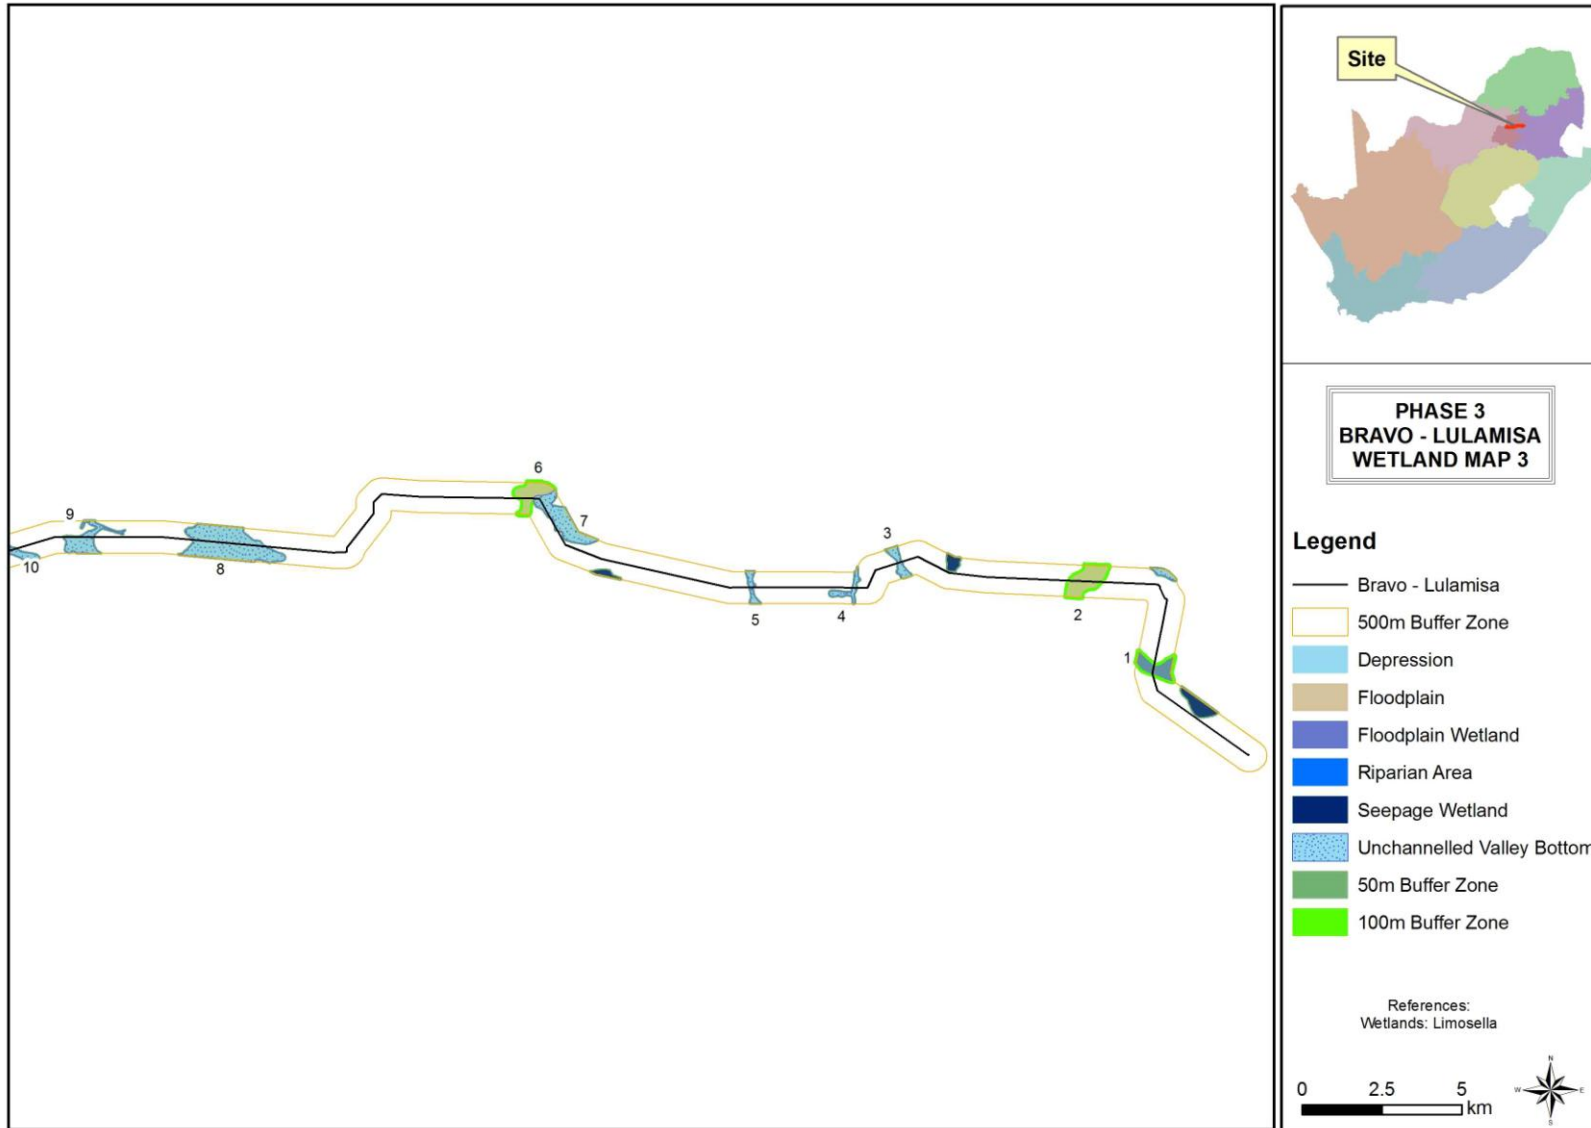
Figure 4: Wetland types and riparian areas delineated along the proposed route, including recommended buffer zones, eastern section
