SUBMISSION OF KENDAL POWER STATION'S EMISSIONS REPORT FOR THE MONTH OF NOVEMBER 2024.

KENDAL POWER STATION'S EMISSIONS REPORT FOR THE MONTH OF NOVEMBER 2024

KENDAL POWER STATION MONTHLY EMISSIONS REPORT

Atmospheric Emission License 17/4/AEL/MP312/11/15

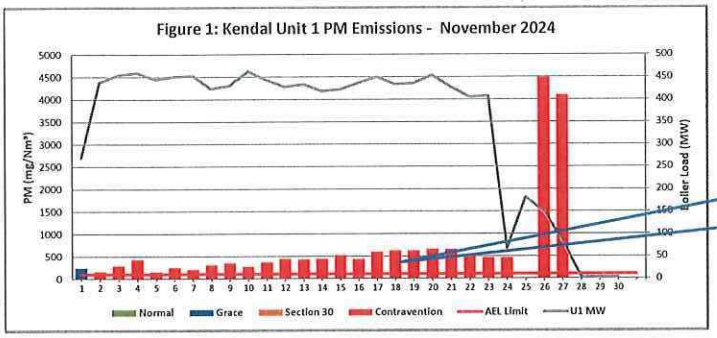
High emissions can be attributed to F22 transformer that was faulty, F44,46 Secondary voltage that was low, Unit was on fuel support, Precip conveyor 13 was standing with all k/gates shut, SO3 plant was also on hold mode due to low BET's.

Findings: F22 transformer that was faulty, F44,46 Secondary voltage that was low, Unit was on fuel support, Pcp 13 was standing with all k/gates shut, SO3 plant was also on hold mode due to low BET's.
- Resolution: Plant repaired

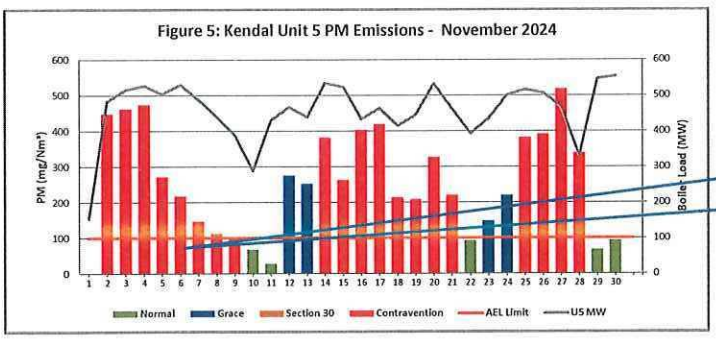
Figure 5: Kendal Unit 5 PM Emissions - November 2024

High emissions can be attributed to poor ESP performance, F12,22,32,33,34,42,43,44 CE rappers 2 LH & 2,3,4 RH tripping on overload because of DHP that was standing causing ash backlog.

Findings: High emissions can be attributed to poor ESP performance, F12,22,32,33,34,42,43,44 CE rappers 2 LH & 2,3,4 RH tripping on overload, DHP that was standing that was causing ash backlog.
- Resolution: Plant repaired.

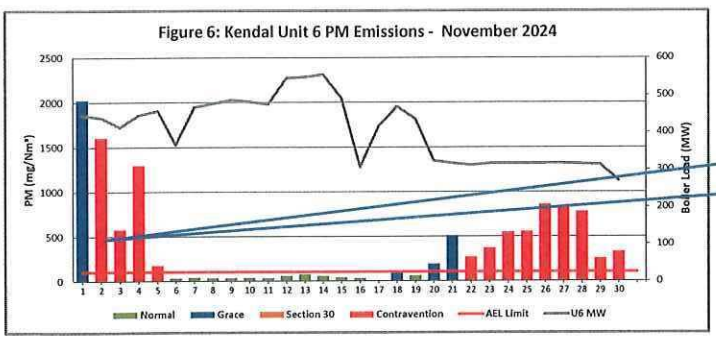
Figure 6: Kendal Unit 6 PM Emissions - November 2024

High emissions can be attributed to the DHP that was standing causing ash backlogs.

Findings: High emissions can be attributed to the DHP that was standing, ash backlogs.
- Resolution: Plant repaired.
