Camden Power Station

ROUTINE MONITORING PHASE 57
APRIL 2014

Project no.: 220-22-mon.697
Current Phase: Ph57 Final Report
Report no.: RVN 697.2/1471

Final Report - Routine Monitoring Phase 57

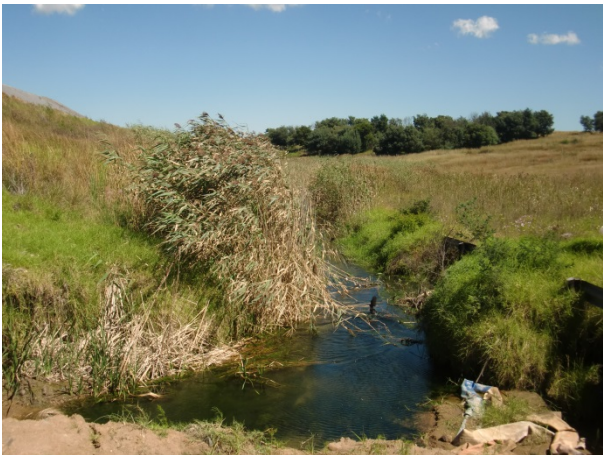
Photo 4. – Water level in Canal C17.

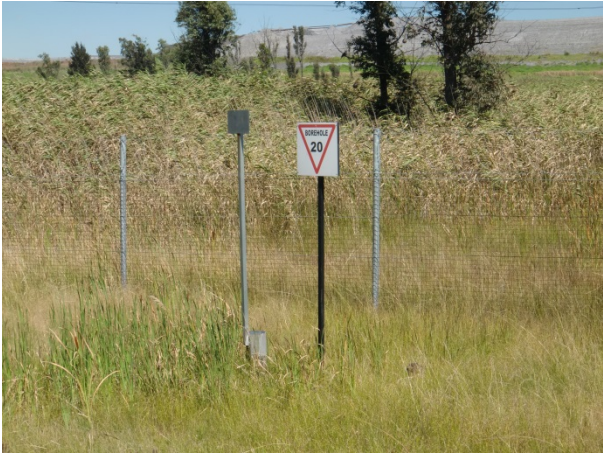
Photo 7. – Artesian borehole B20

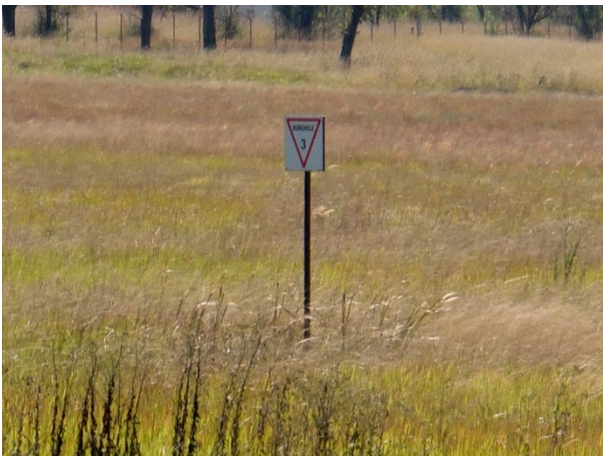
Photo 10. – Artesian borehole B03.

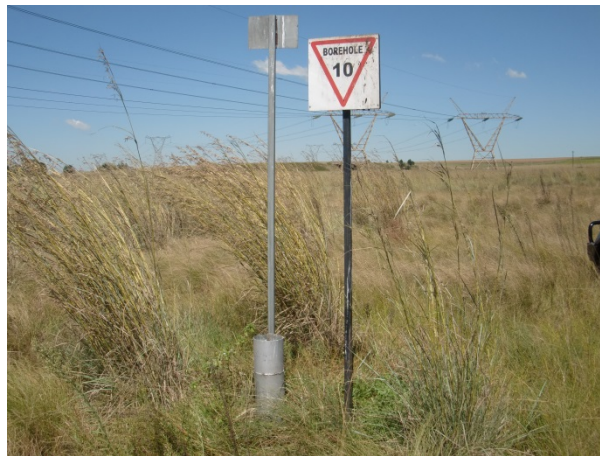
Photo 11. – Borehole B22 with wrong number plate.

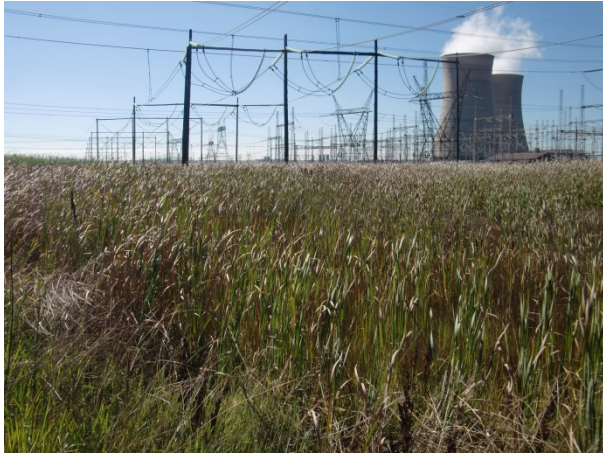
Photo 13. – Seepage at S03.

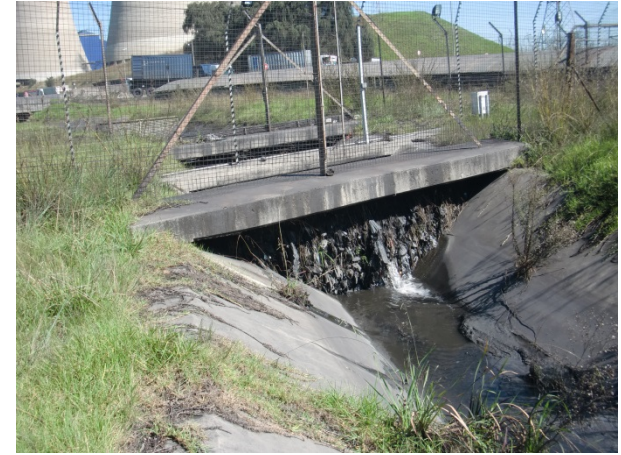
Photo 21. – Debris between the fences at canal C11.

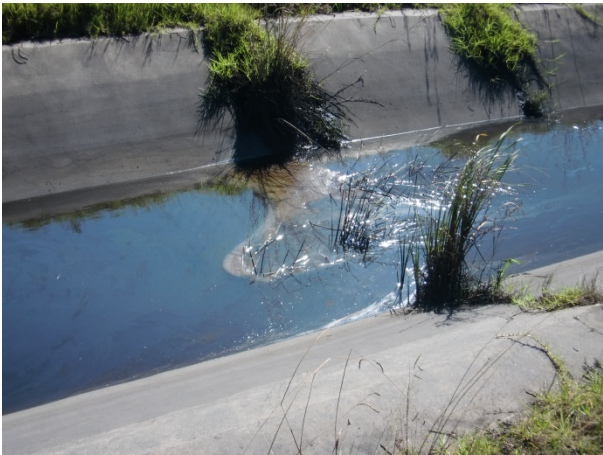
Photo 22. – Oil in canal C11.

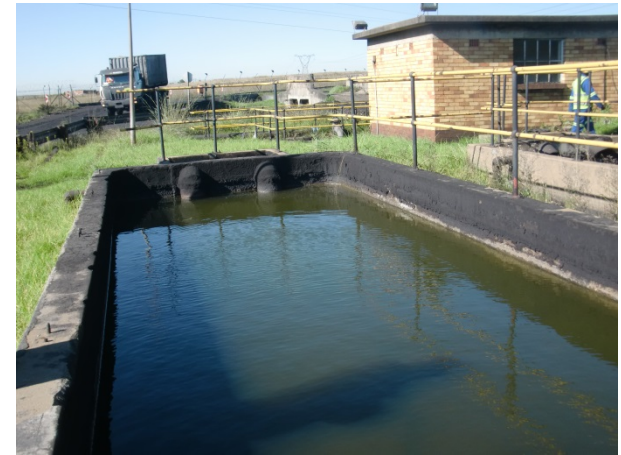
Photo 24. – Oil and silt in sump P11.

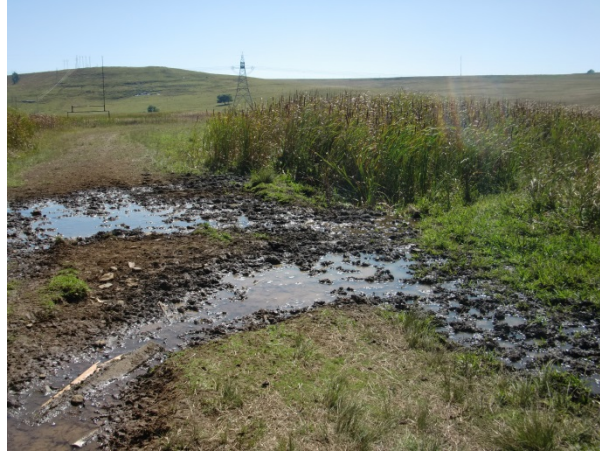
Photo 26. – Seepage at canal C26.
