Komati Power Station
HYDROLOGICAL & GEOHYDROLOGICAL BASELINE STUDY
DECEMBER 2008

KOMATI POWER STATION

Project no.: 149-14-ghd.537
Current Phase: Final V1.2
Report no.: RVN 537.5/909

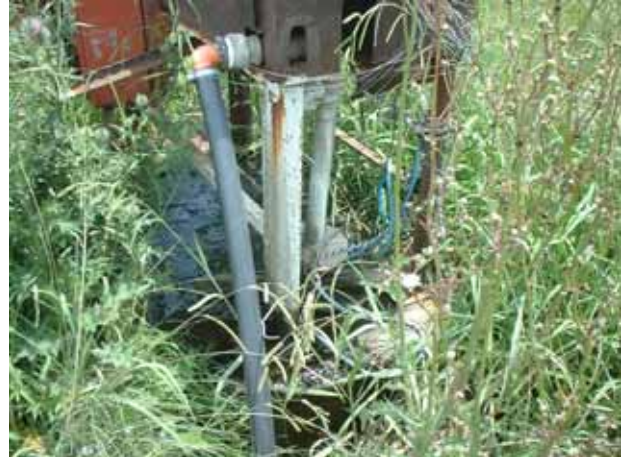
Photo 51. BB15

BB15	29.49044	-26.05852	1629	Hydrocensus Borehole	Broodsnyersplaas 25/28	H De Beer	Borehole	~	0.350	165	Submersible	Domestic Drink	50	~	Good working condition
BB16	29.50683	-26.07076	1642	Hydrocensus Borehole	Broodsnyersplaas 25/1	P Storm	Borehole	~	0.320	165	Hand pump	Domestic Drink	~	~	Good working condition
BB17	29.49821	-26.07593	1639	Hydrocensus Borehole	Broodsnyersplaas 25/5	P Storm	Borehole	66.0	0.000	165	Submersible	Domestic Drink	60	24.00	Good working condition
BB18	29.49867	-26.07736	1642	Hydrocensus Borehole	Broodsnyersplaas 25/5	P Storm	Borehole	85.0	0.000	165	None	~	~	Dry	Dry hole
BB19	29.49741	-26.07693	1639	Hydrocensus Borehole	Broodsnyersplaas 25/5	P Storm	Borehole	~	0.100	165	Hand pump	Domestic Drink	~	~	Good working condition
BB20	29.48213	-26.08393	1622	Hydrocensus Borehole	Broodsnyersplaas 25/3	D Lee	Borehole	26.1	0.100	165	Submersible	Domestic Drink	50	14.10	Good working condition

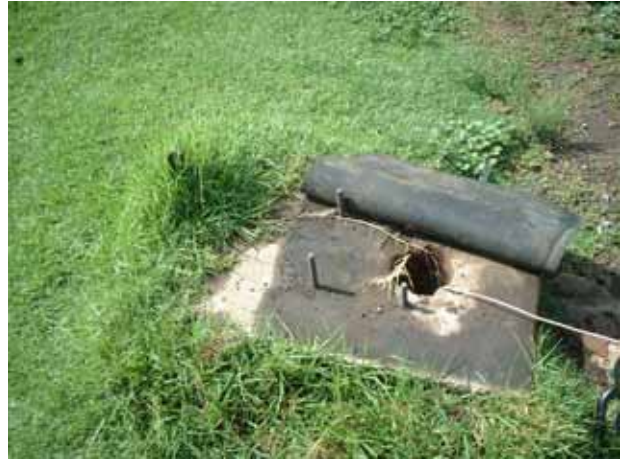
Photo 57. BB21

BB21	29.47954	-26.10598	1636	Hydrocensus Borehole	Geluk 26/7	MCL Dippenaar	Borehole	26.8	0.200	150	None	~	~	2.20	No Equipment
BB22	29.47907	-26.10586	1635	Hydrocensus Borehole	Geluk 26/7	MCL Dippenaar	Borehole	~	0.000	165	Submersible	Domestic Drink	50	~	Good working condition
BB23	29.47905	-26.10632	1636	Hydrocensus Borehole	Geluk 26/7	MCL Dippenaar	Borehole	11.0	0.230	165	Submersible	Domestic Drink	40	4.50	Broken
BB24	29.47125	-26.11574	1655	Hydrocensus Borehole	Goedeheop 46/3	F Schoeman	Borehole	~	0.300	165	Submersible	Domestic Drink	50	15.00	Good working condition
BB25	29.47127	-26.11574	1655	Hydrocensus Borehole	Goedeheop 46/3	F Schoeman	Borehole	26.5	0.300	165	Submersible	Domestic Drink, Livestock	50	20.50	Good working condition
BB26	29.47783	-26.11699	1659	Hydrocensus Borehole	Bultfontein 187/2	K Van Rensburg	Borehole	6.1	0.100	100	None	~	~	Dry	Dry hole
BB27	29.47912	-26.11710	1660	Hydrocensus Borehole	Bultfontein 187/2	K Van Rensburg	Borehole	42.0	0.440	150	Submersible	Domestic Drink, Livestock	50	32.00	Good working condition

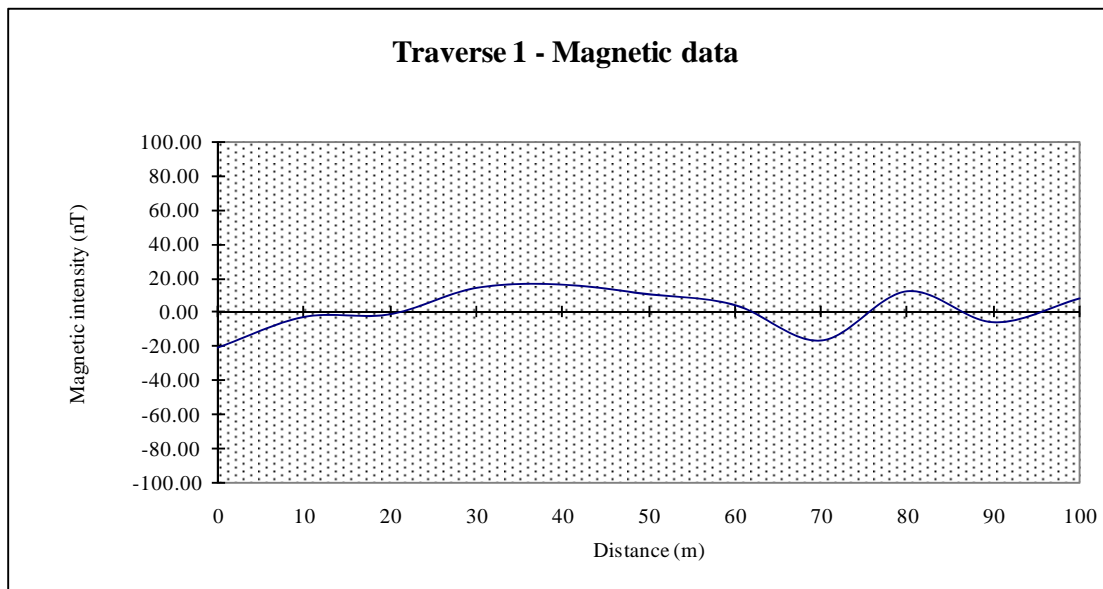
Figure 4. S-N magnetic profile of Traverse 1.

The anomalies recorded on Traverse 1 and 2 generally had low amplitudes (40 nT) and were observed at only single stations. Most of these anomalies might be due to the presence of metal objects such as poles, pipes and fences. No magnetic anomalies of any significance were recorded on these two traverses.

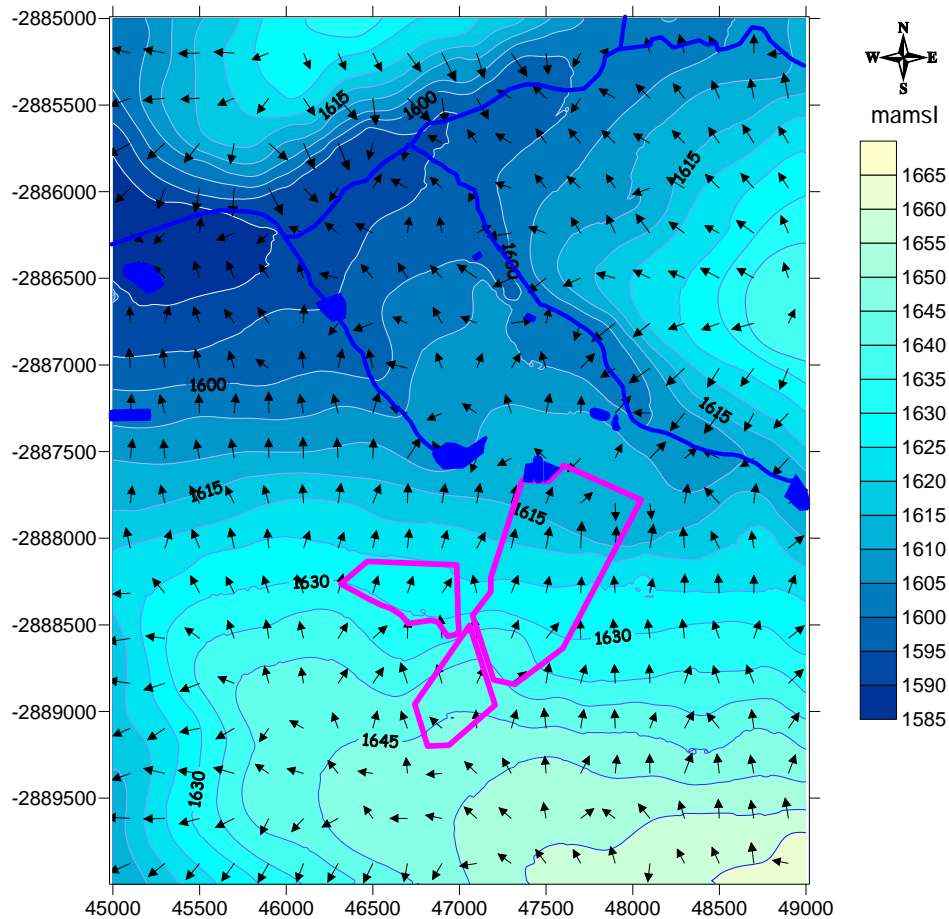
Figure 13. Simulated Pre-Operational Phase groundwater levels and flow directions (Bayesian Interpolation)

Due to the unavailability of pre-operations groundwater data the water levels measured at uninfluenced sites during December 2008 were used for the Bayesian interpolation of groundwater level data for the initial conditions (refer to Figure 13). The same water level data with the exception of the affected areas were used to do Bayesian interpolation for the current ground water level distribution (Figure 14) The elevated topography and groundwater levels associated with the surface structures were incorporated in the current 2008 interpolation.

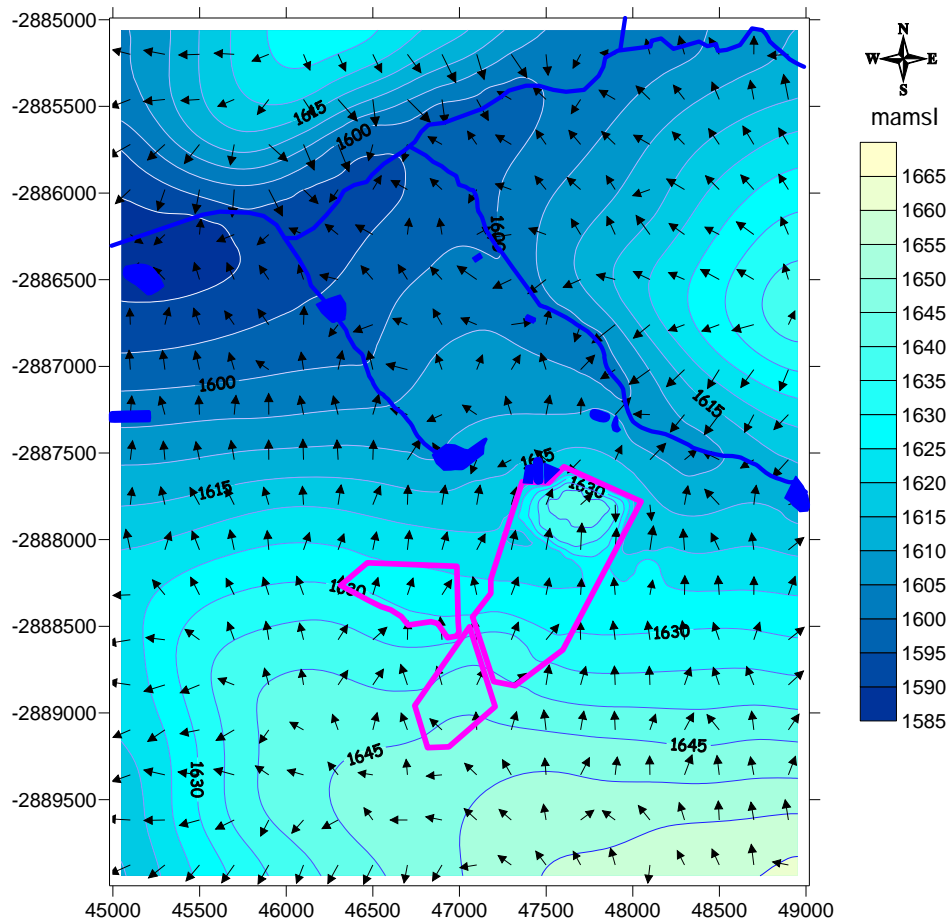
Figure 14. Simulated current (2008) groundwater levels and flow directions (Modelled Water Table))

Limited access to boreholes because of installed equipment resulted in water levels that were measured at only nineteen boreholes during the hydrocensus. Two boreholes were dry. There is only one set of data available for the water levels of the monitoring boreholes at the Power Station. Groundwater contours with groundwater elevations in meters above mean sea level (mamsl) can be seen in Figure 14.

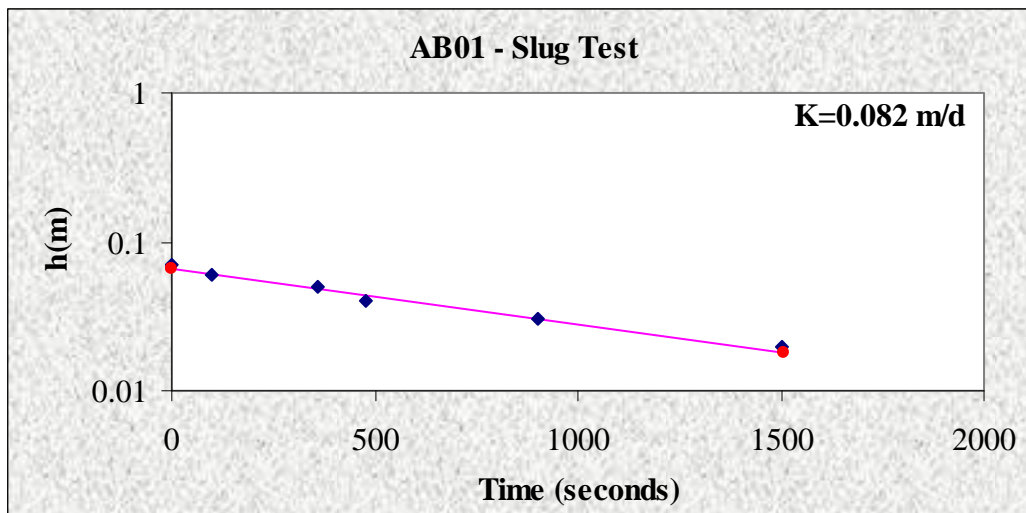
Figure 15. Results of the permeability test performed on AB01.

These observations suggest that the rocks on and in the vicinity of Komati Power Station generally have low permeabilities and hydraulic conductivities. The presence of preferential pathways, such as fractured zones, might be present in the region and may cause marked increases in the hydraulic conductivities. Migration of groundwater and/or contaminants can be expected to be high along such pathways. Permeability tests were not performed during this investigation on boreholes located on the neighbouring farms due to the presence of equipment in the boreholes.
