**Infinity Consulting**  
**Sandriver Middle Reaches**

**General Geological and Environmental  
Observations.**  
**Compiled by Frank Silberbauer**  
**November 2011**

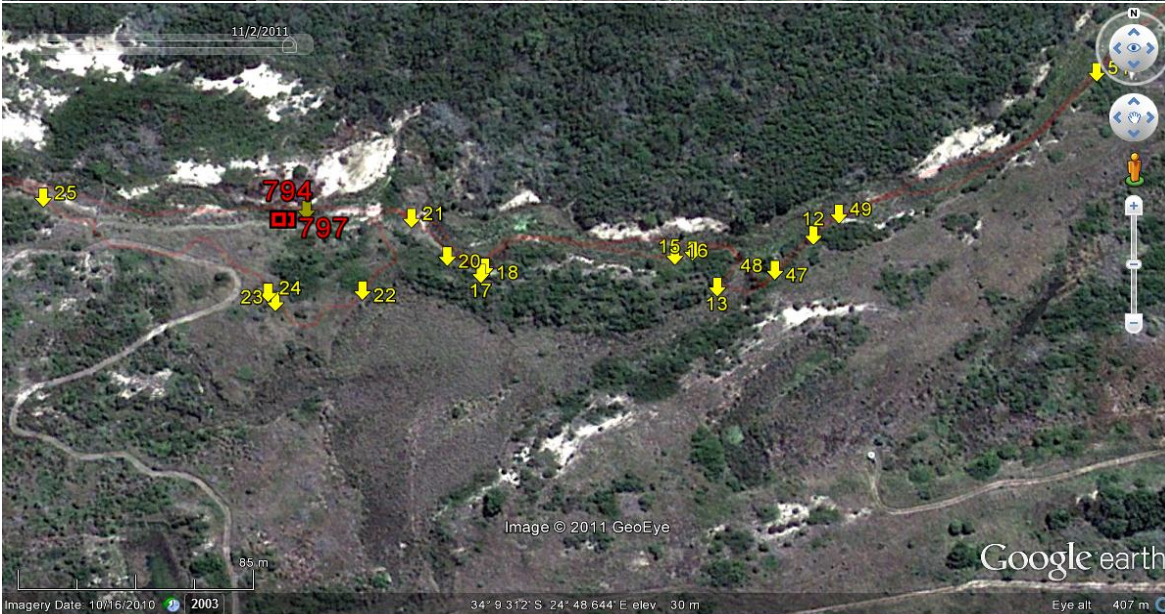
The arrows show the positions of the slides discussed in this report. The two points in red are the GPS coordinates of photos 794 & 797 taken by Dr. Ellery. This section is adjacent to 'Lionel's Dam'

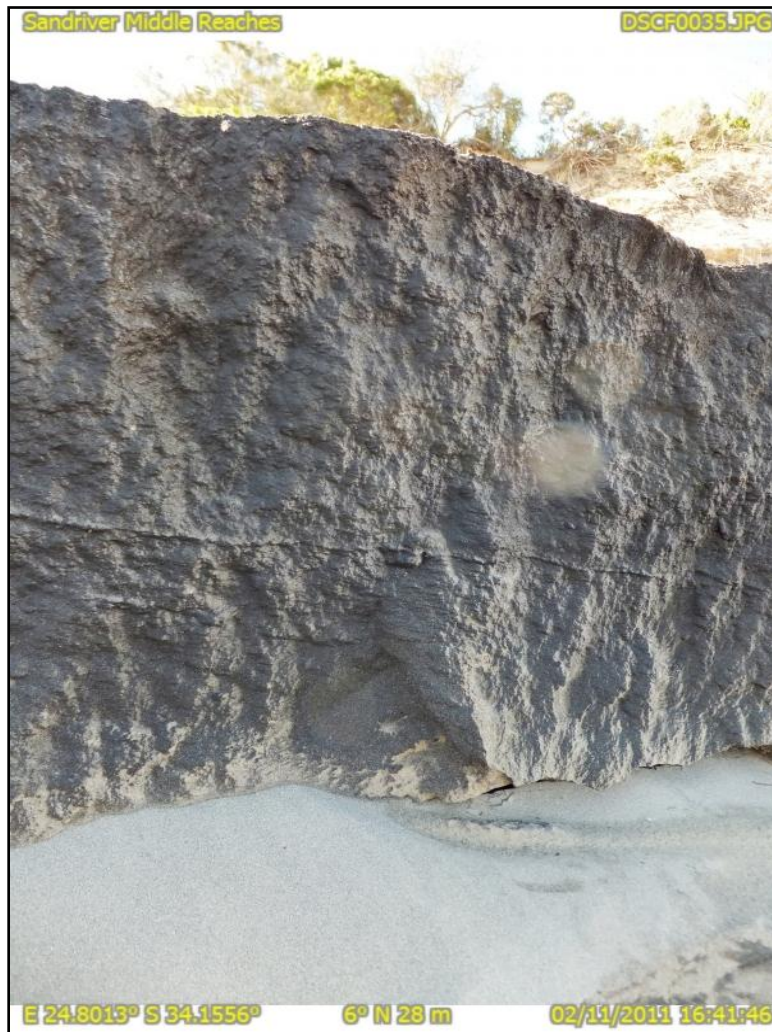
Attributes	
Title	Sandriver Middle Reaches
Comment	A clear view of a section of the landsurface shown in the previous slide (34)
Latitude	S 34.1556°
Longitude	E 24.8013°
Elevation	28 m
Photo Direction	6° N
Date Time Stamp	02/11/2011 16:41:46
File Name	DSCF0035.JPG

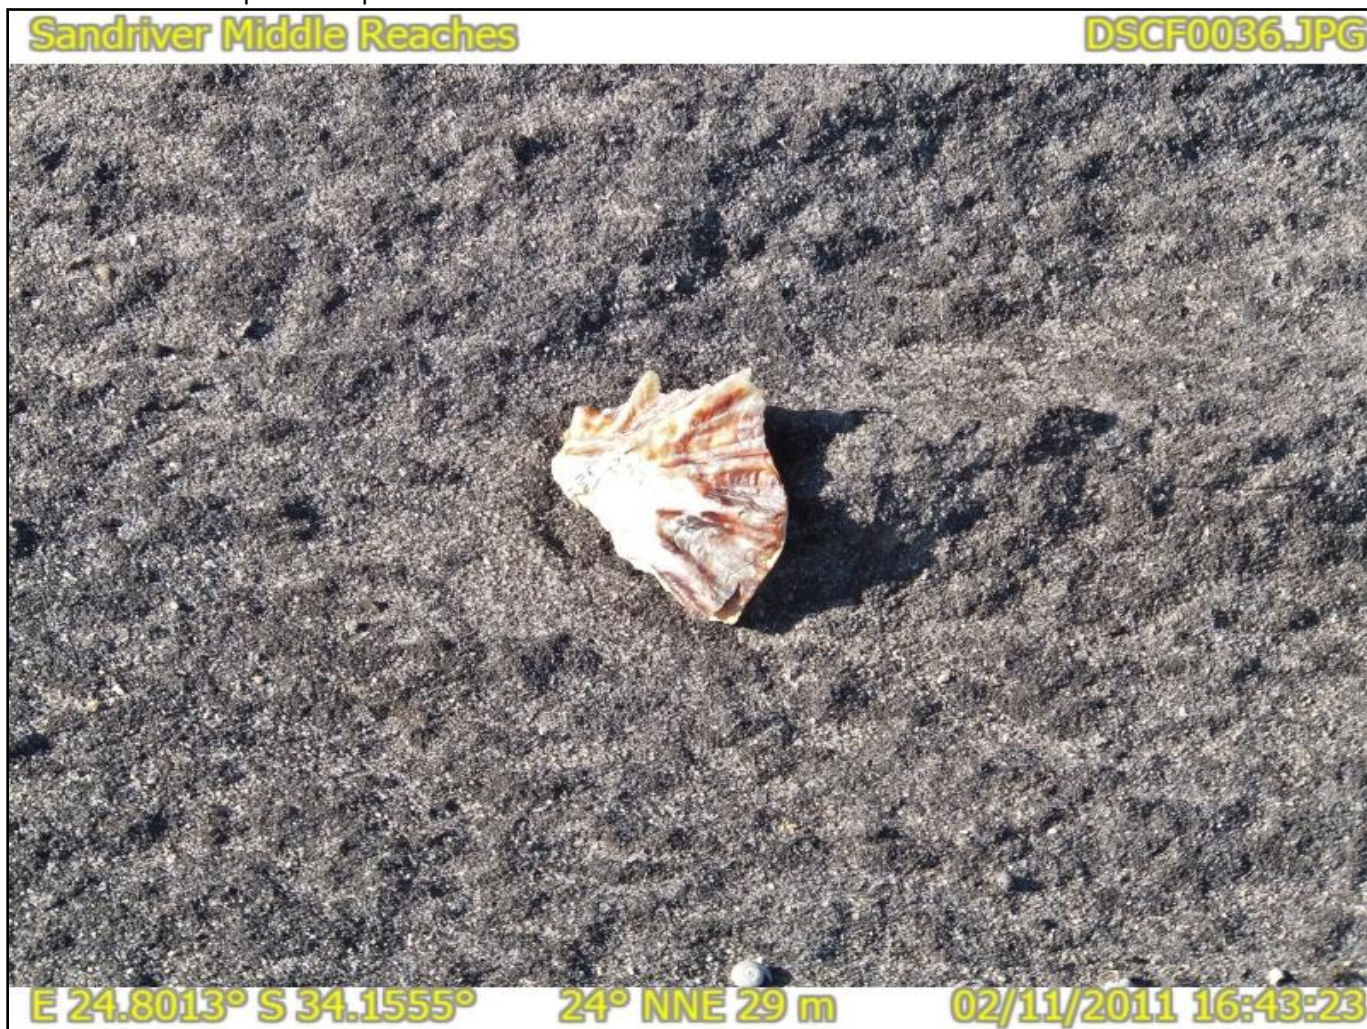
A Patella sp. shell exposed as a result of water and wind erosion on the Pleistocene landsurface.

Attributes	
Title	Sandriver Middle Reaches
Comment	A Patella sp. shell exposed as a result of water and wind erosion on the Pleistocene landsurface.
Latitude	S 34.1555°
Longitude	E 24.8013°
Elevation	29 m
Photo Direction	24° NNE
Date Time Stamp	02/11/2011 16:43:23
File Name	DSCF0036.JPG

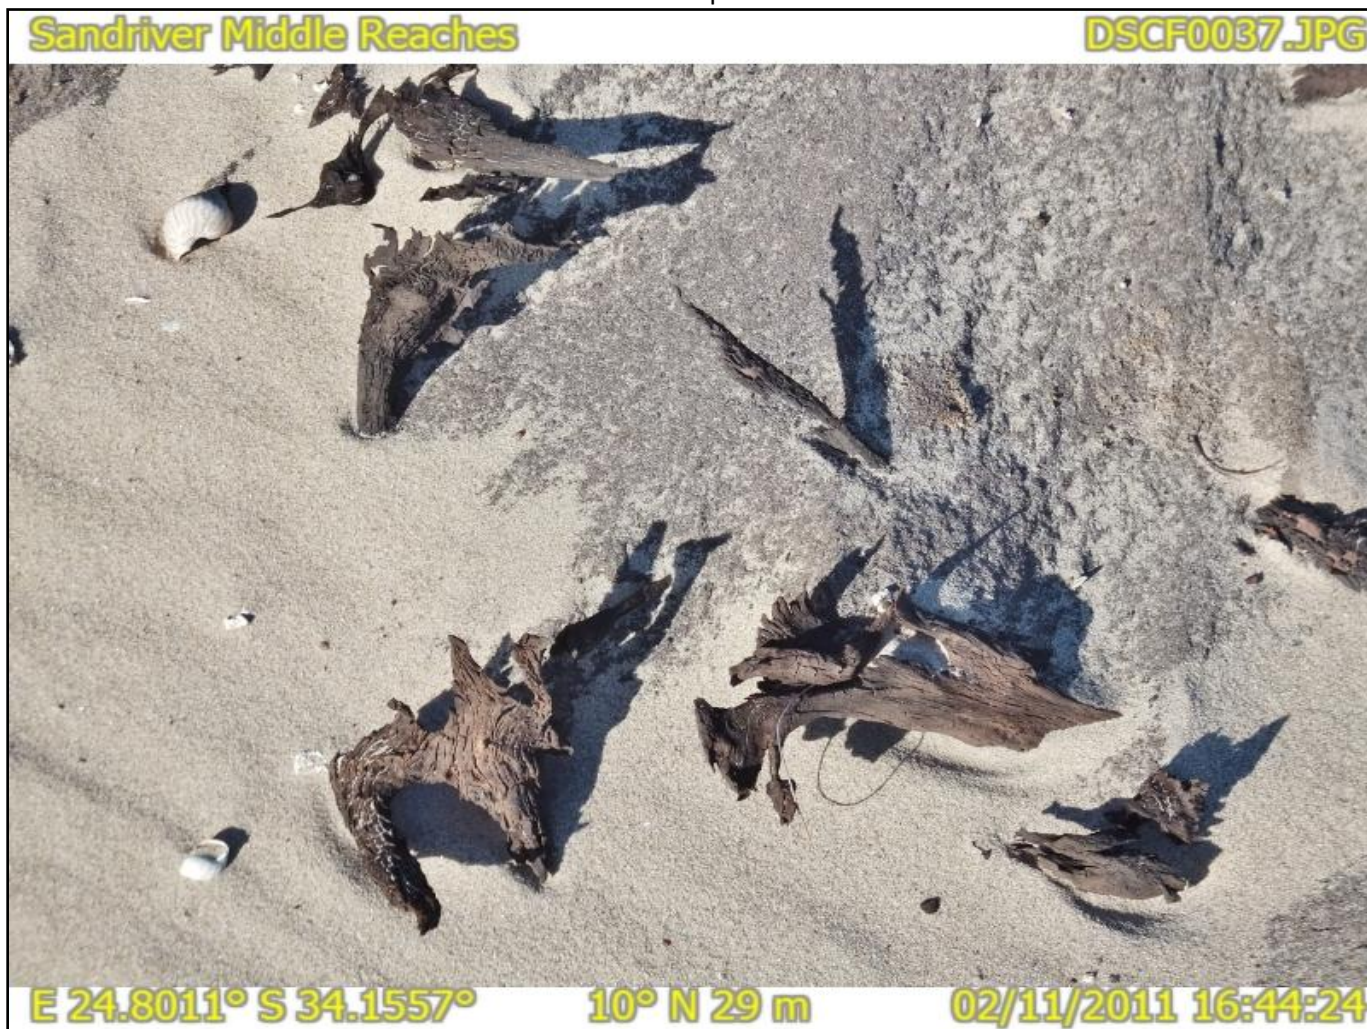
A similar view of timber which are present within this landsurface.

Attributes	
Title	Sandriver Middle Reaches
Comment	A similar view of timber which are present within this landsurface.
Latitude	S 34.1557°
Longitude	E 24.8011°
Elevation	29 m
Photo Direction	10° N
Date Time Stamp	02/11/2011 16:44:24
File Name	DSCF0037.JPG

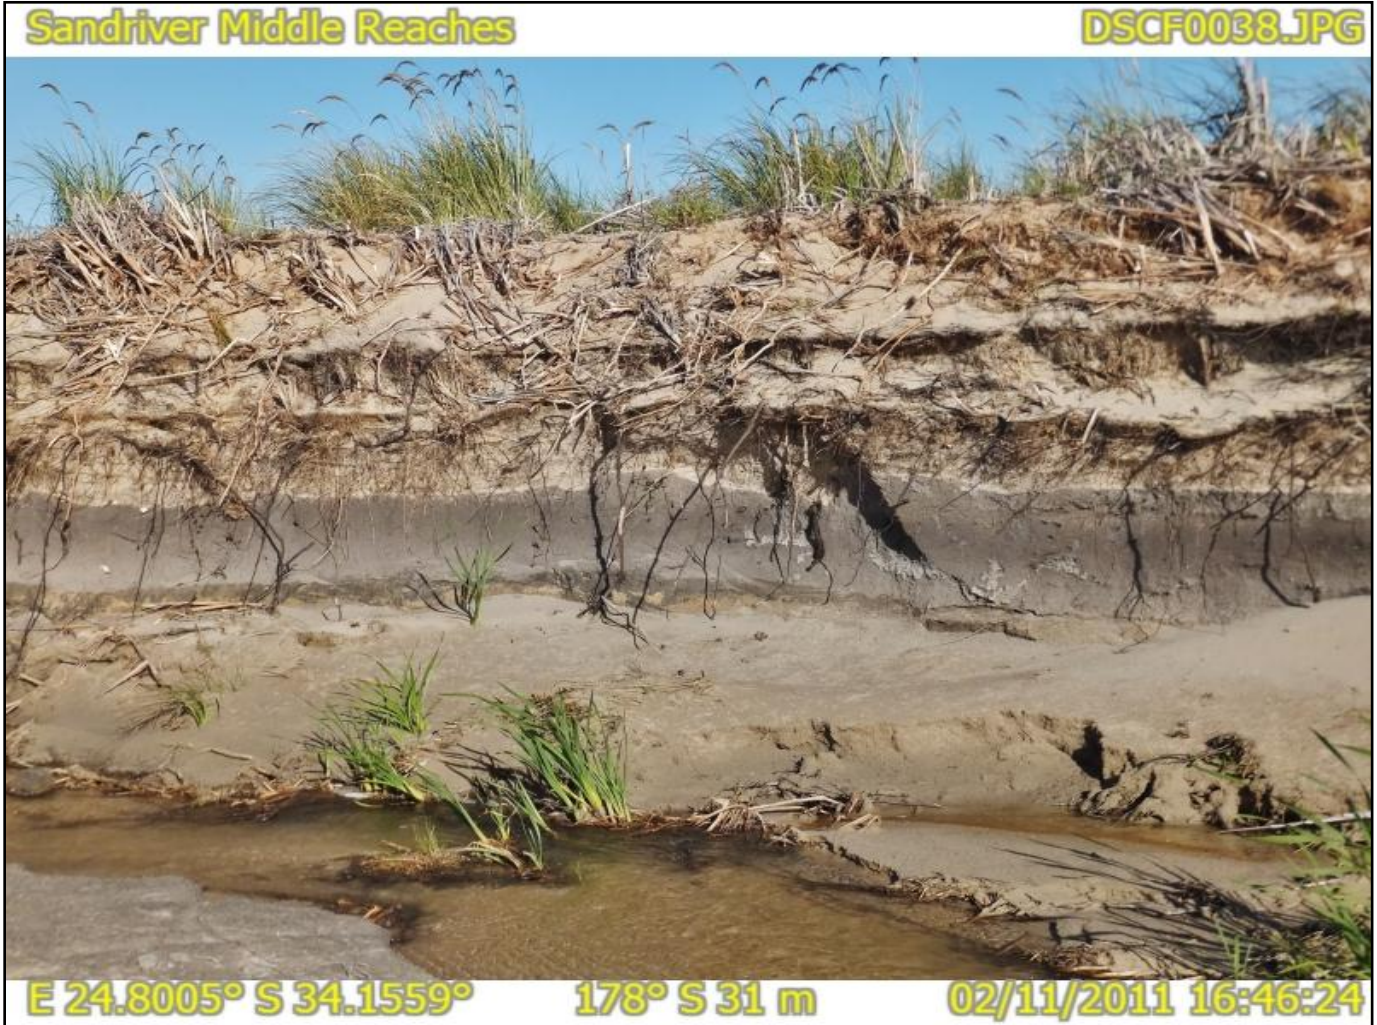
A view across the flow channel of the section cut showing the dune sands which overlay the Pleistocene land surface, represented by the dark band at the bottom.

Attributes	
Title	Sandriver Middle Reaches
Comment	A view across the flow channel of the section cut showing the dune sands which overlay the Pleistocene land surface, represented by the dark band at the bottom.
Latitude	S 34.1559°
Longitude	E 24.8005°
Elevation	31 m
Photo Direction	178° S
Date Time Stamp	02/11/2011 16:46:24
File Name	DSCF0038.JPG

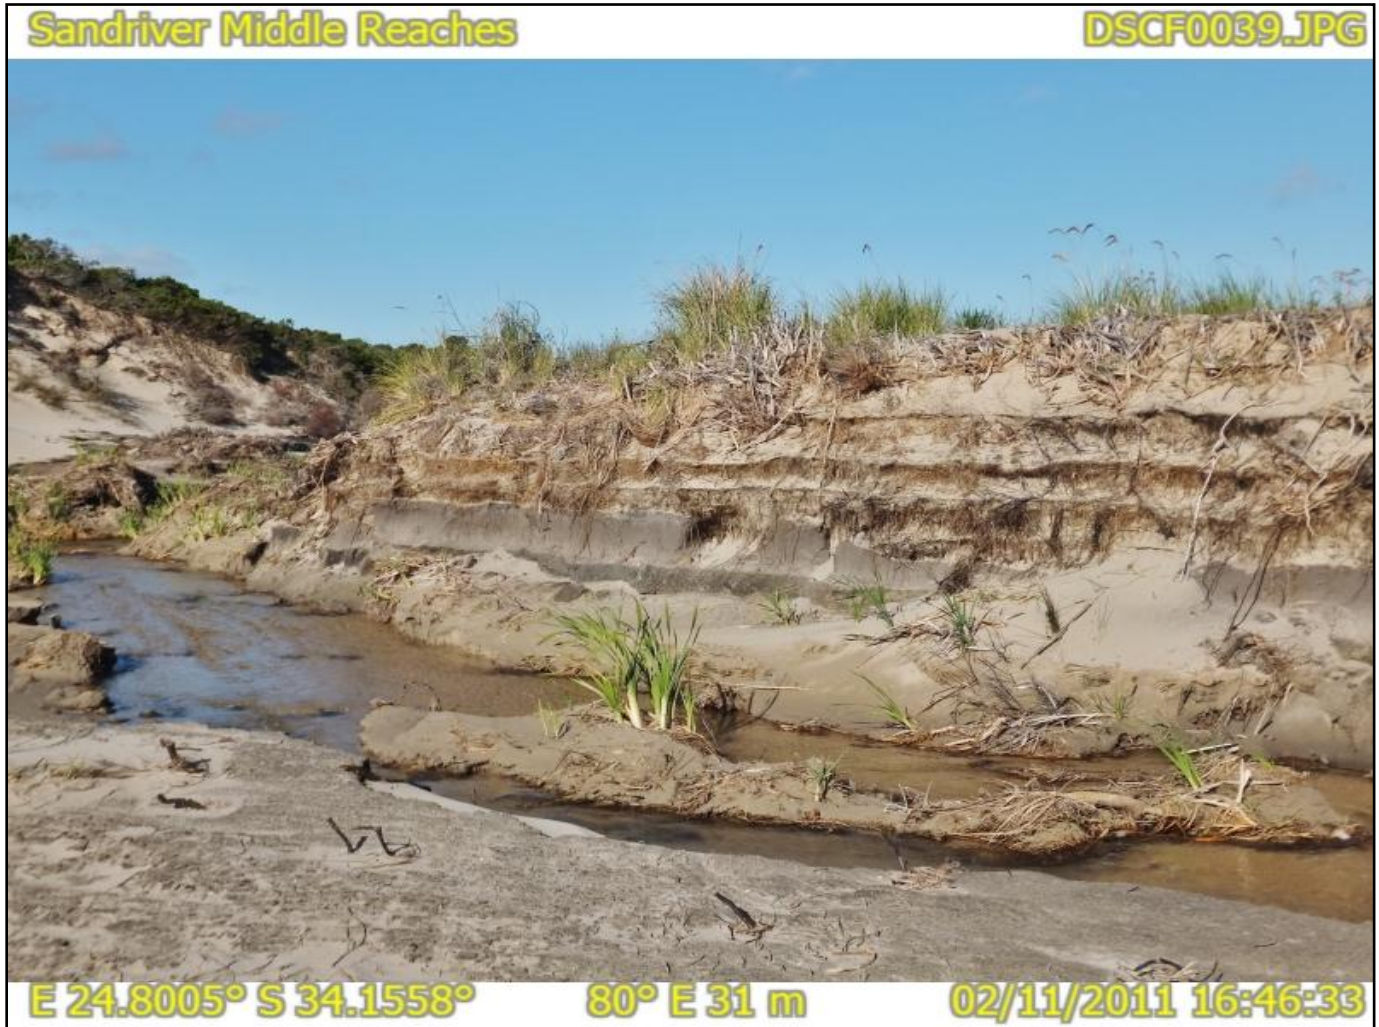
Another view of the same with a downstream angle.

Attributes	
Title	Sandriver Middle Reaches
Comment	Another view of the previous slide 38 with a downstream angle.
Latitude	S 34.1558°
Longitude	E 24.8005°
Elevation	31 m
Photo Direction	80° E
Date Time Stamp	02/11/2011 16:46:33
File Name	DSCF0039.JPG

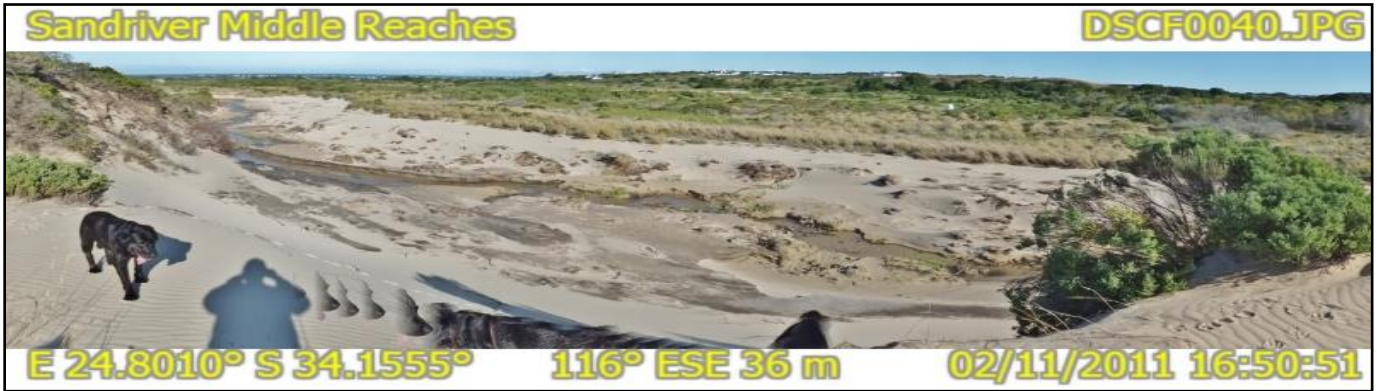
An elevated view of the area discussed in the previous slides.

Attributes	
Title	Sandriver Middle Reaches
Comment	An elevated view of the area discussed in slides 35 to 37.
Latitude	S 34.1555°
Longitude	E 24.8010°
Elevation	36 m
Photo Direction	116° ESE
Date Time Stamp	02/11/2011 16:50:51
File Name	DSCF0040.JPG

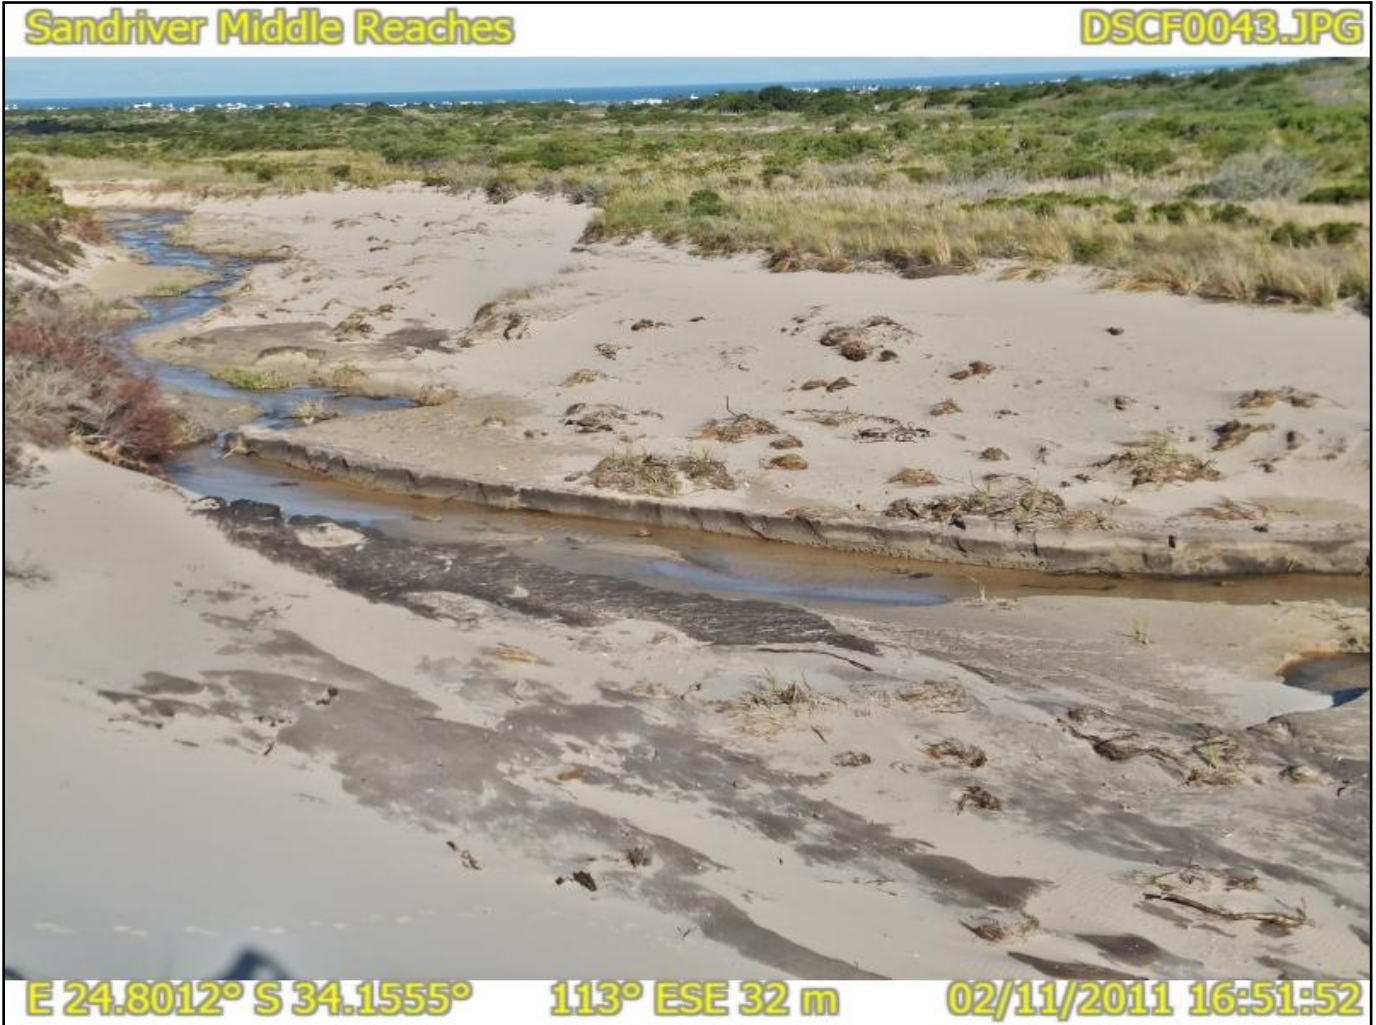
Ditto as previous but a close up.

Attributes	
Title	Sandriver Middle Reaches
Comment	Ditto as previous but a close up.
Latitude	S 34.1555°
Longitude	E 24.8012°
Elevation	32 m
Photo Direction	113° ESE
Date Time Stamp	02/11/2011 16:51:52
File Name	DSCF0043.JPG

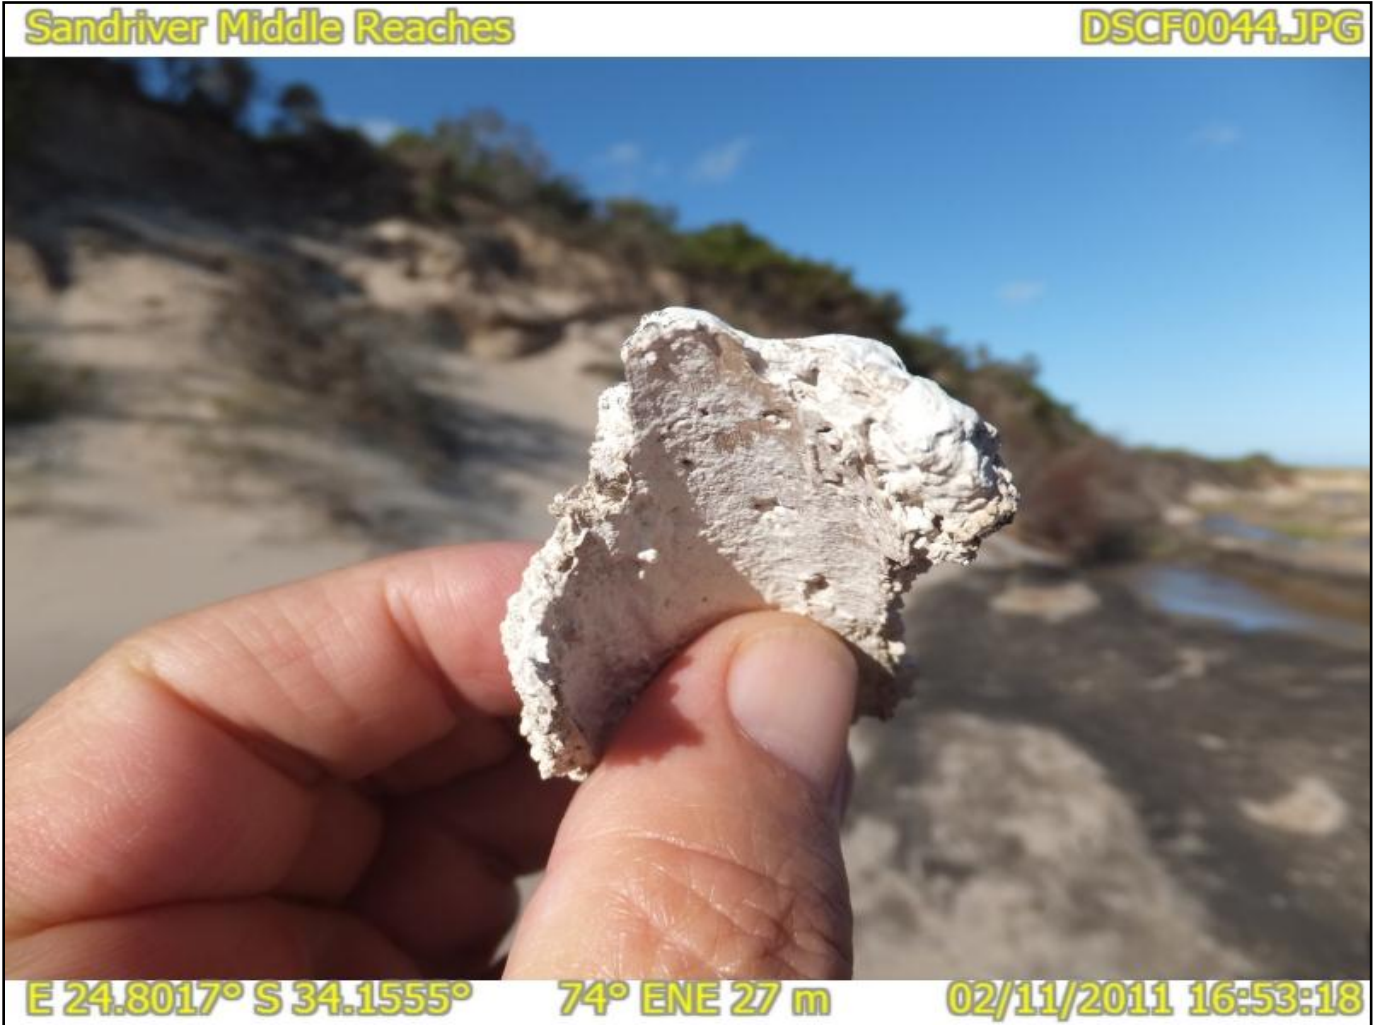
A fragment of a calcarious sheath covering of a root. These are common in this area.

Attributes	
Title	Sandriver Middle Reaches
Comment	A fragment of a calcarious sheath covering of a root. These are common in this area.
Latitude	S 34.1555°
Longitude	E 24.8017°
Elevation	27 m
Photo Direction	74° ENE
Date Time Stamp	02/11/2011 16:53:18
File Name	DSCF0044.JPG

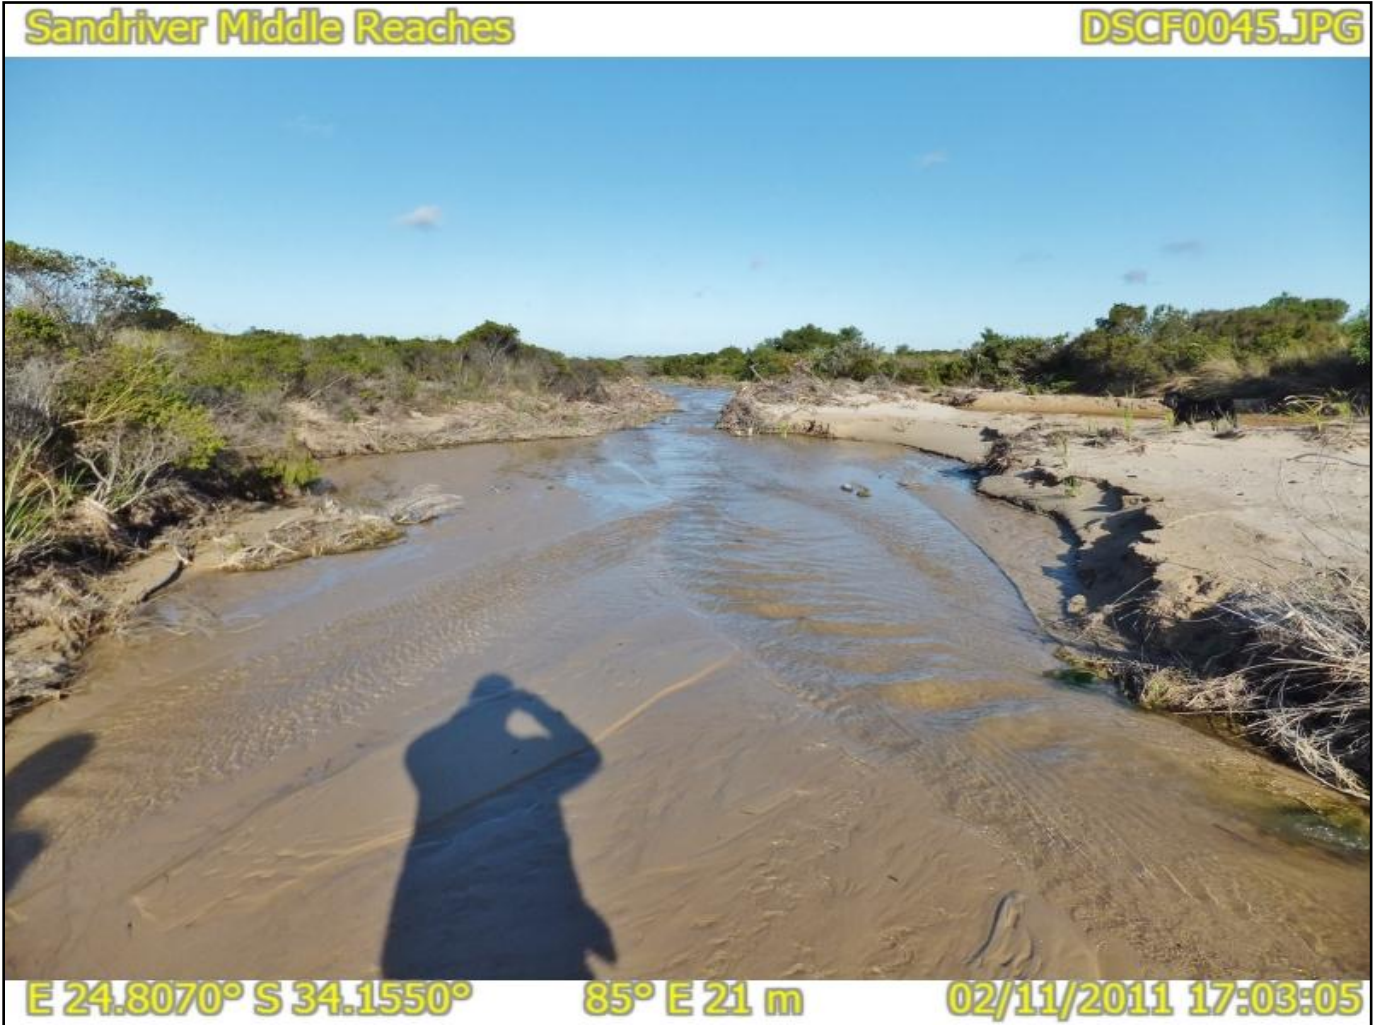
A view downstream at the confluence of the 'Old' and 'New' flow channel.

Attributes	
Title	Sandriver Middle Reaches
Comment	A view downstream at the confluence of the 'Old' (to the right rear of slide) and 'New' flow channel (foreground).
Latitude	S 34.1550°
Longitude	E 24.8070°
Elevation	21 m
Photo Direction	85° E
Date Time Stamp	02/11/2011 17:03:05
File Name	DSCF0045.JPG

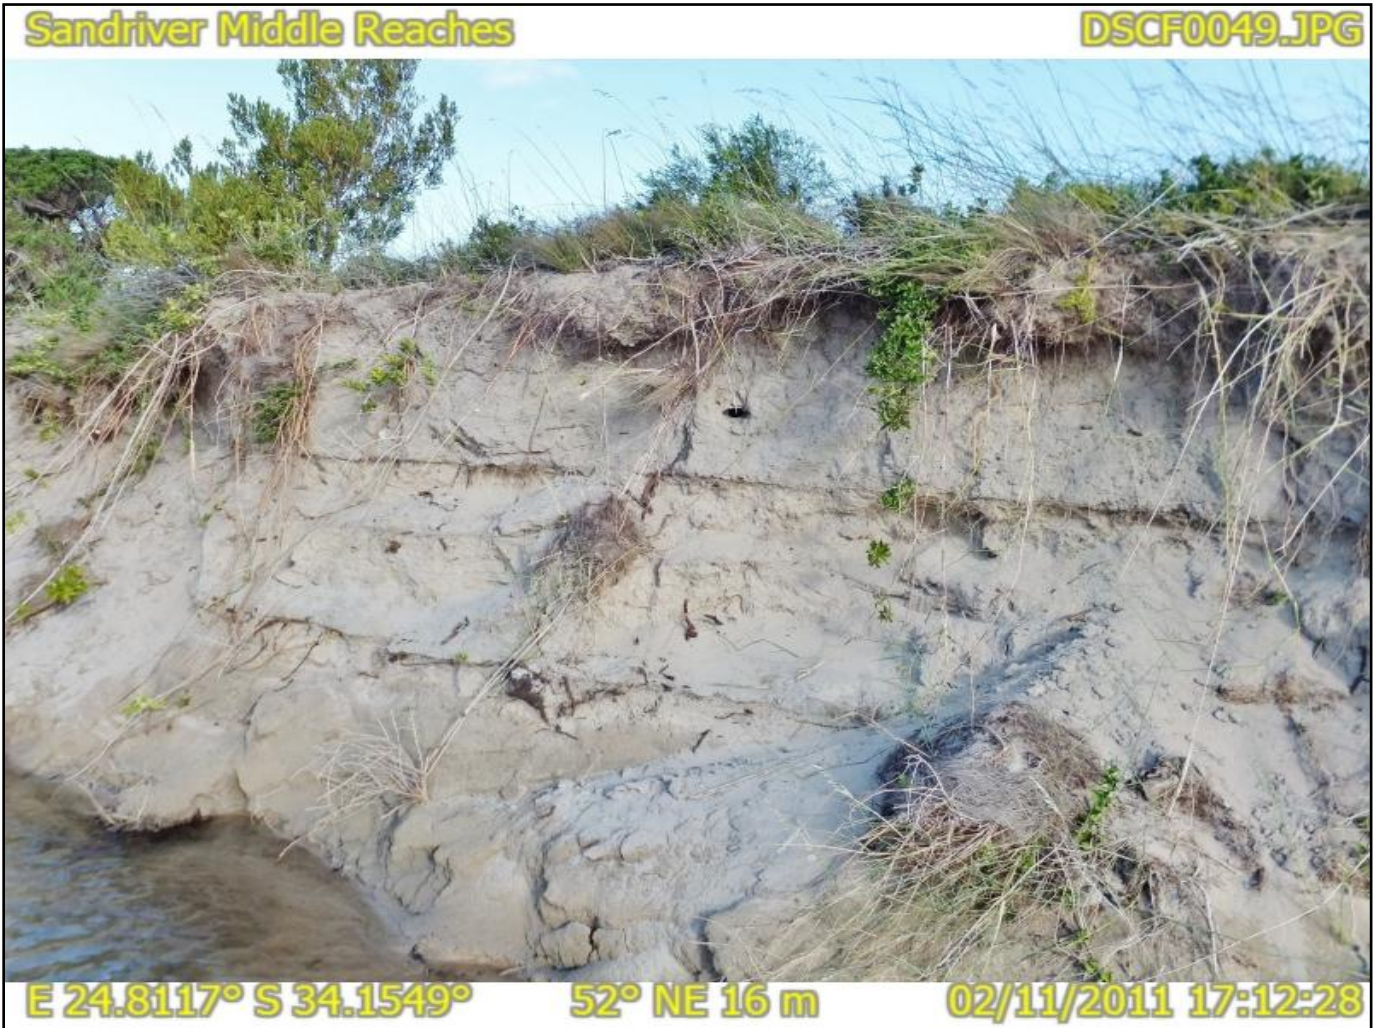
Attributes	
Title	Sandriver Middle Reaches
Comment	A more general view of the same further 68m downstream.
Latitude	S 34.1549°
Longitude	E 24.8117°
Elevation	16 m
Photo Direction	52° NE
Date Time Stamp	02/11/2011 17:12:28
File Name	DSCF0049.JPG

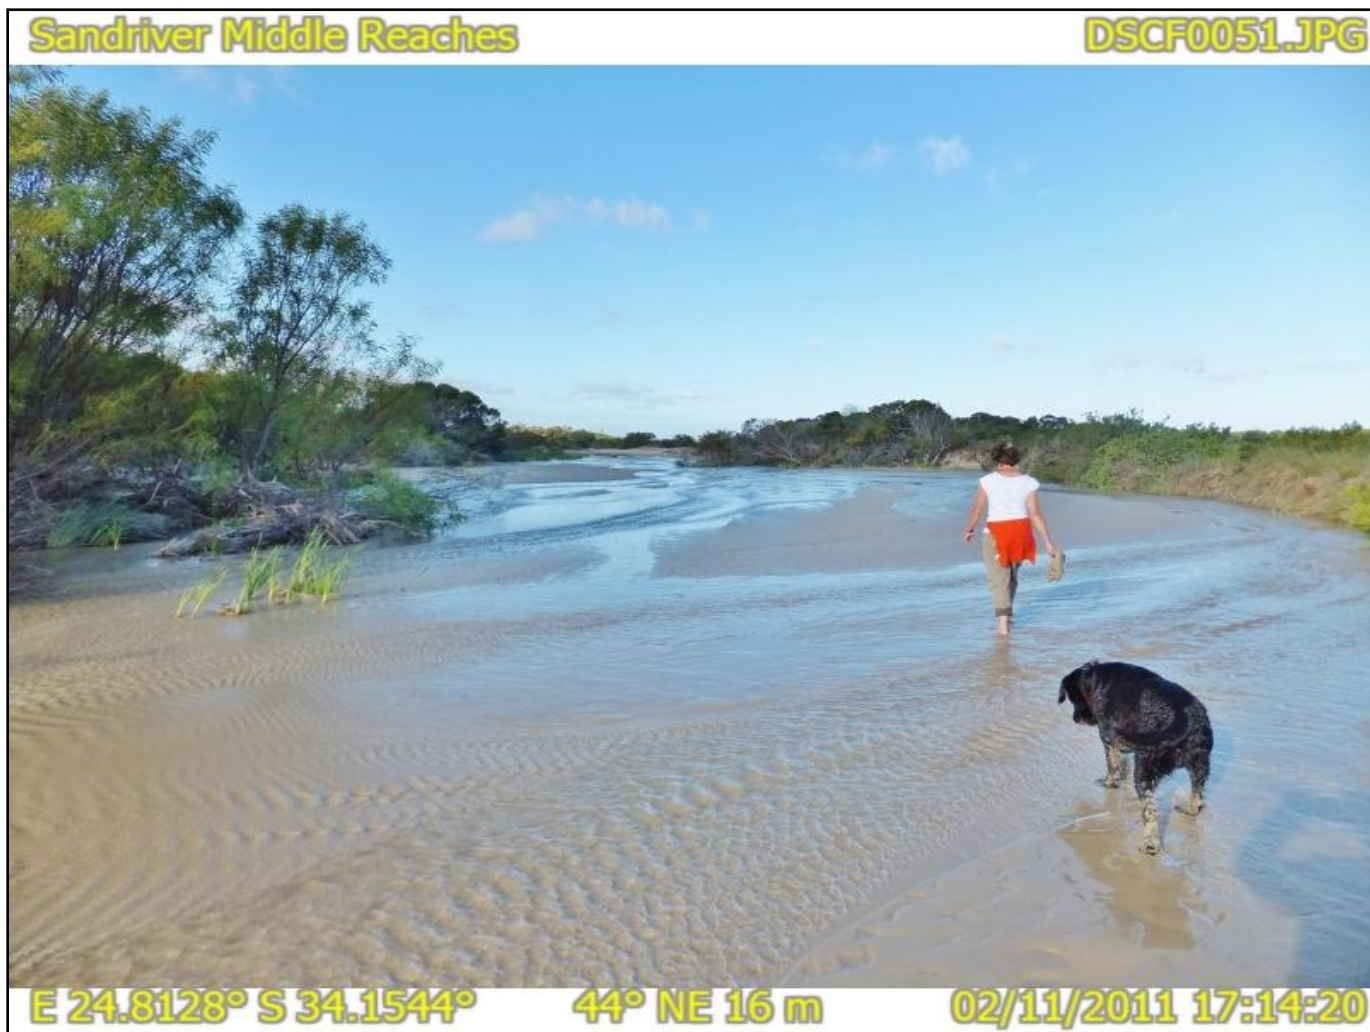
Attributes	
Title	Sandriver Middle Reaches
Comment	The main flow channel of the Sandriver broadens and flattens out at this point.
Latitude	S 34.1544°
Longitude	E 24.8128°
Elevation	16 m
Photo Direction	44° NE
Date Time Stamp	02/11/2011 17:14:20
File Name	DSCF0051.JPG

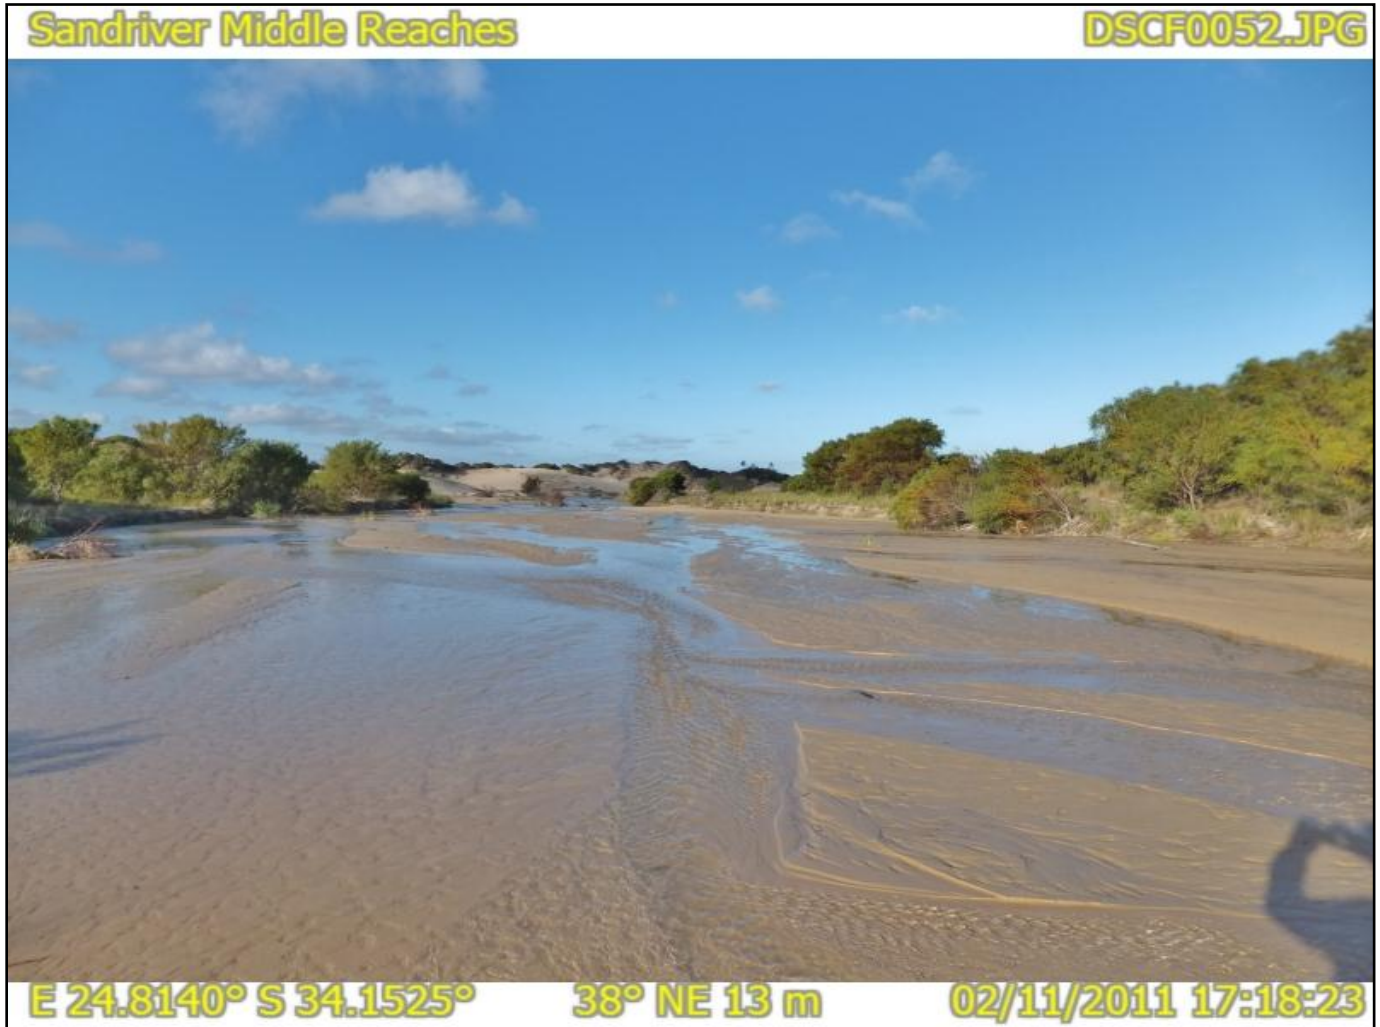
Ditto as previous with the northern dune of the sand mine in the distance.

<b>Attributes</b>	
Title	Sandriver Middle Reaches
Comment	Ditto as previous with the northern dune of the sand mine in the distance.
Latitude	S 34.1525°
Longitude	E 24.8140°
Elevation	13 m
Photo Direction	38° NE
Date Time Stamp	02/11/2011 17:18:23
File Name	DSCF0052.JPG

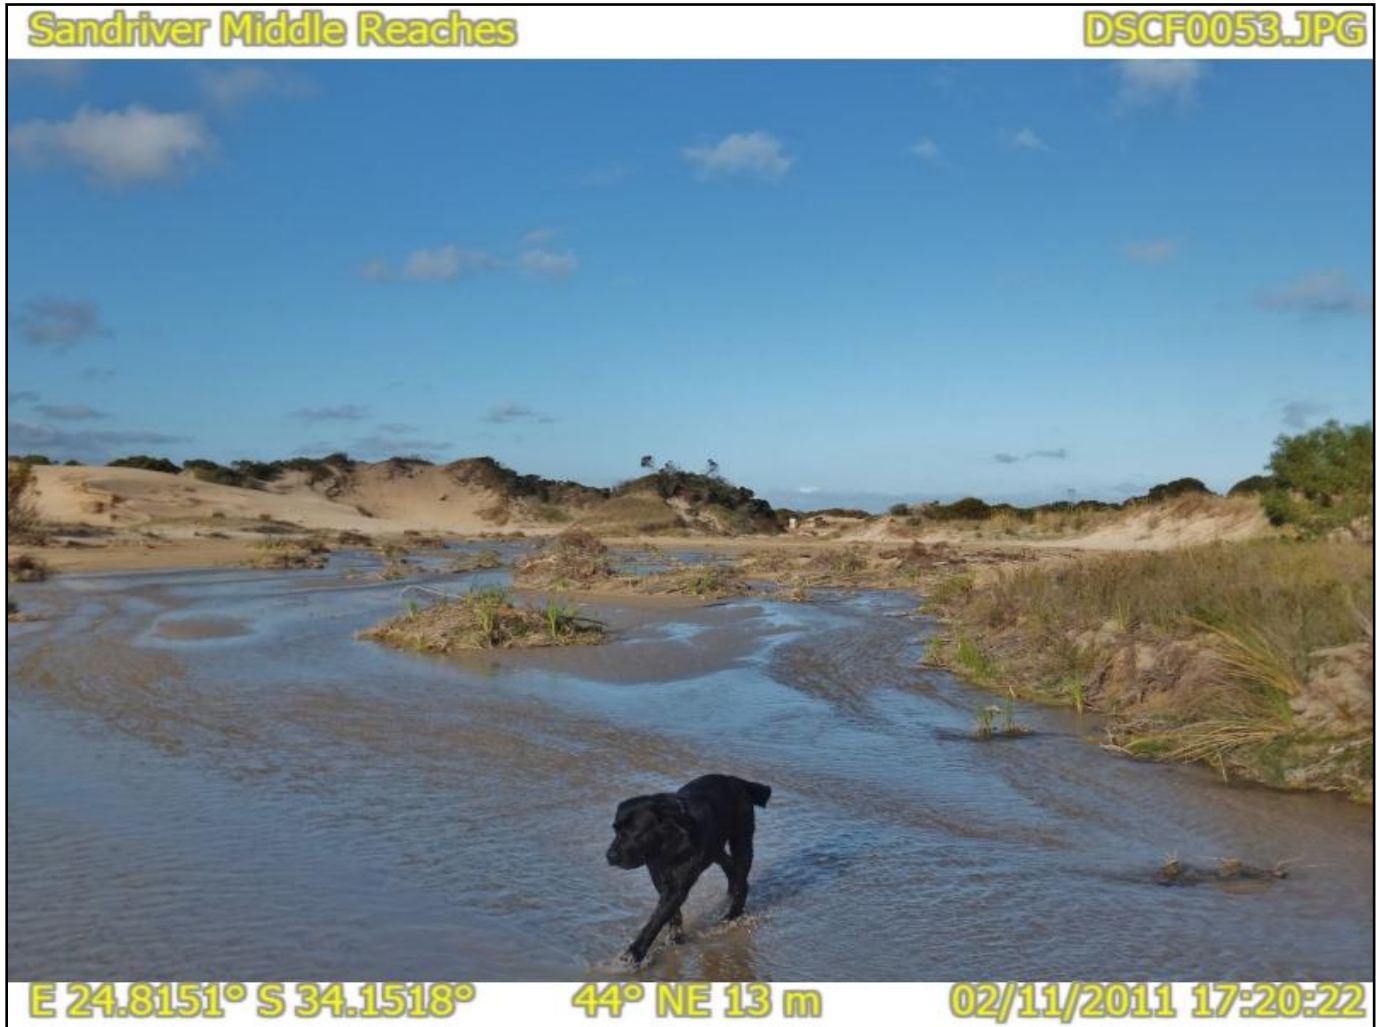
View towards from further down to moving to the east where the causeway is situated.

Attributes	
Title	Sandriver Middle Reaches
Comment	View towards from further down to moving to the east where the causeway is situated.
Latitude	S 34.1518°
Longitude	E 24.8151°
Elevation	13 m
Photo Direction	44° NE
Date Time Stamp	02/11/2011 17:20:22
File Name	DSCF0053.JPG
