Ref: Kendal Power Station AEL (17/4/AEL/MP312/11/15)

**SUBMISSION OF KENDAL POWER STATION'S EMISSIONS REPORT FOR THE MONTH OF AUGUST 2025.**

# KENDAL POWER STATION MONTHLY EMISSIONS REPORT Atmospheric Emission License: 17/4/AEL/MP312/11/15

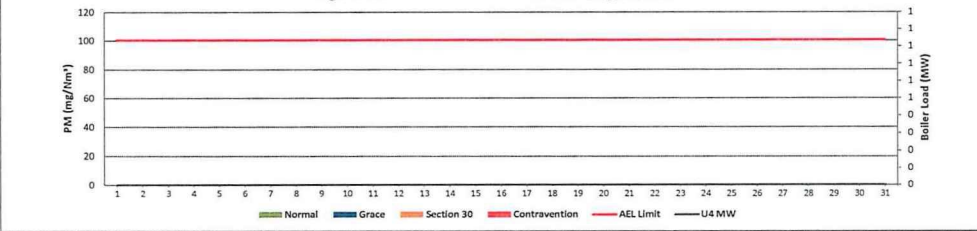
Figure 4: Kendal Unit 4 PM Emissions - August 2025

High PM emissions can be attributed to the sootblowing that was incomplete and the shutdown of PCP11-24 knife gates 1-4. Short circuits on F21 and F41, and an open output condition on F42.

Findings: High PM emissions can be attributed to the soothblowing that was incomplete and the shutdown of PCP11-24 knife gates 1-4. Short circuits on F21 and F41, and an open output condition on F42.

➤ Resolution: Plant repaired.
