APPENDIX D

ENVIRONMENTAL PERFORMANCE ASSESSMENT REPORT

**Tutuka Power Station Ash Disposal Facility
(ADF):
External Environmental Performance Assessment
as part of the Part 2 Exemption amendment application process to the
Exemption issued.
Audit Report**

26 July 2019

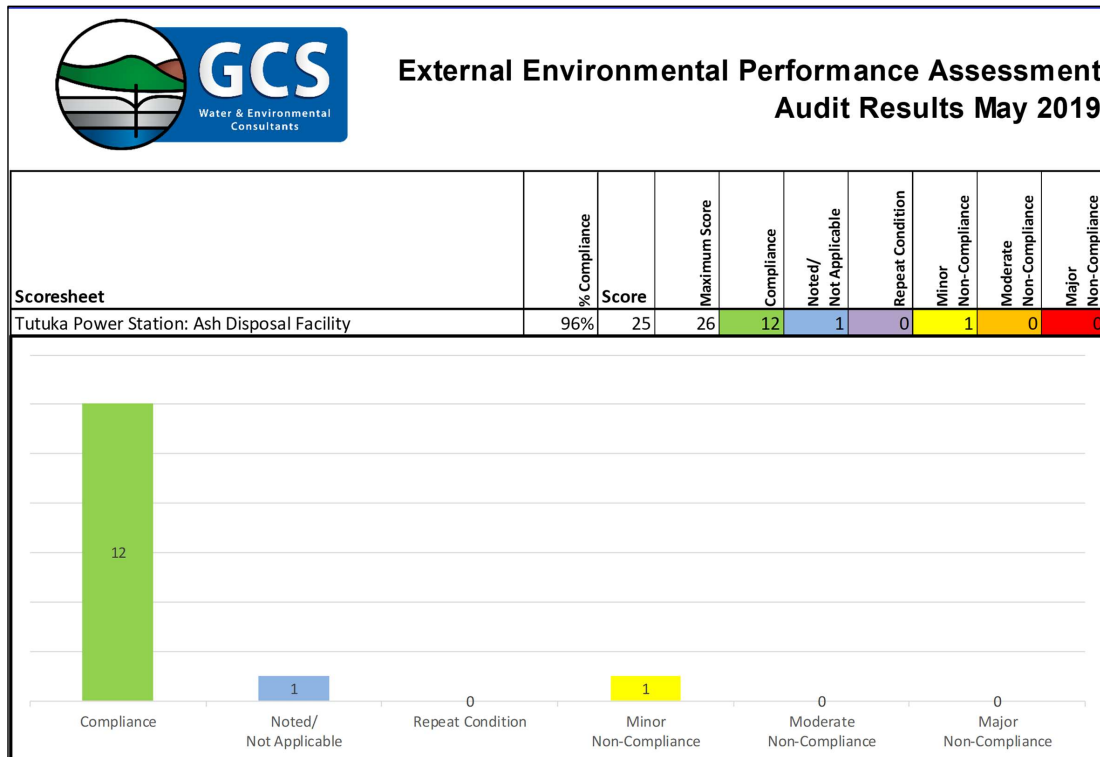
Figure 4-1: 2019 External EPA Audit Results for the ADF Project.

The graph within the table shows the number of non-compliances observed as well as the number of conditions repeated, noted or not applicable. It can be seen from the graph that Tutuka is compliant with the majority of the Exemption approval conditions.

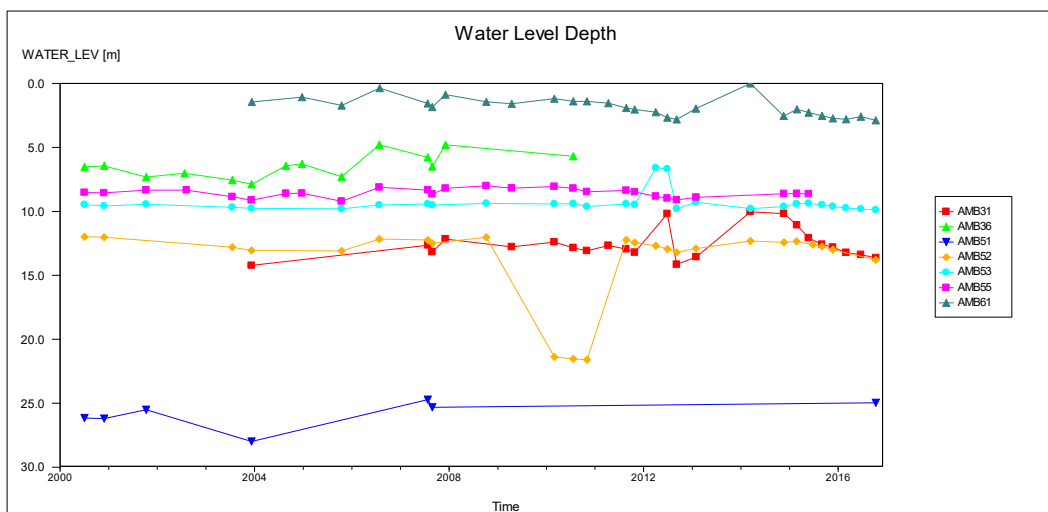
Figure 2. Water level depths (mbgl) of up gradient boreholes drilled upstream north and west to south-west of the ash stack.

The boreholes AMB31 and AMB51 are used for background purposes and are not within the natural drainage of the ash stack. The origin of ammonium may be attributed by agricultural purposes and cannot be regarded as a contravention of the WUL due to ashing activities. There was a sudden unaccounted increase in Mn at AMB51 since beginning of 2016. Continue monitoring to establish possible trends of both these parameters.

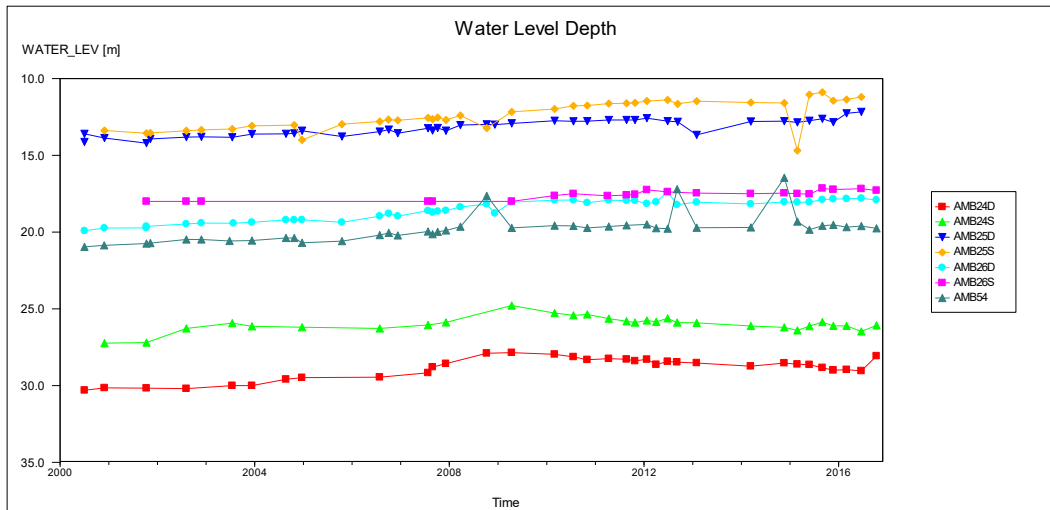
Figure 3. Water level depths (mbgl) of boreholes drilled on the ash stack.

Although the EC values and Mg, Ca, Cl and TDS concentrations are exceeded at AMB25D, AMB26D, AMB54 (only Mg and Cl), the trend graphs are stable, increasing slightly. As the purpose of these boreholes are to monitor the Hazardous Waste site, they had to be drilled directly into ash stack. The deep piezometers extend into the dolerite sill below the ash stack. Even in the presence of the ash stack, groundwater and groundwater drainage will tend to follow the historic stream system or paleochannel coming from the dam north of the ash stack. The groundwater in the sill occurs between the dolerite sill and thinly covered geology on top of it (so-called bedding plane fractures) where the borehole acts as a sump collecting this seepage. **It must be requested that the boreholes drilled into the ash stack be removed from the WUL as it can be expected that the ash stack would impact on the geology directly below it.**

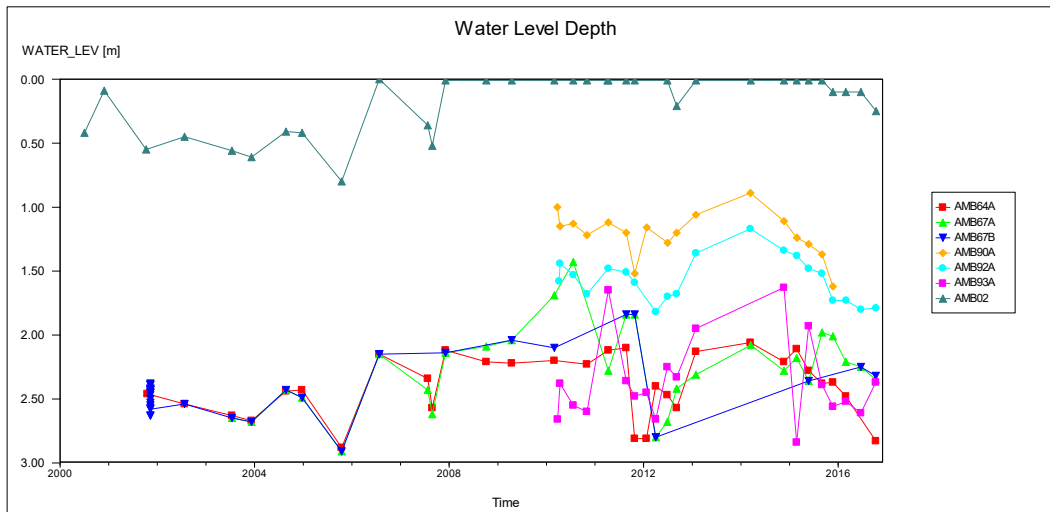
Figure 4. Water level depths (mbgl) of boreholes monitoring the south-western drainage system of ash stack.

Borehole AMB64 is 800m further south, and not close to streams indicating unaffected geology when not in close proximity to surface impacted sites. Borehole AMB02 is standing in the impacted stream (due to the silted southern dirty water trench which has been cleaned) running from the ash stack past boreholes AMB93 and AMB67. Increasing trends in some indicator element concentrations are noted, however, improvements are expected due to the cleaning of the southern dirty water trench.

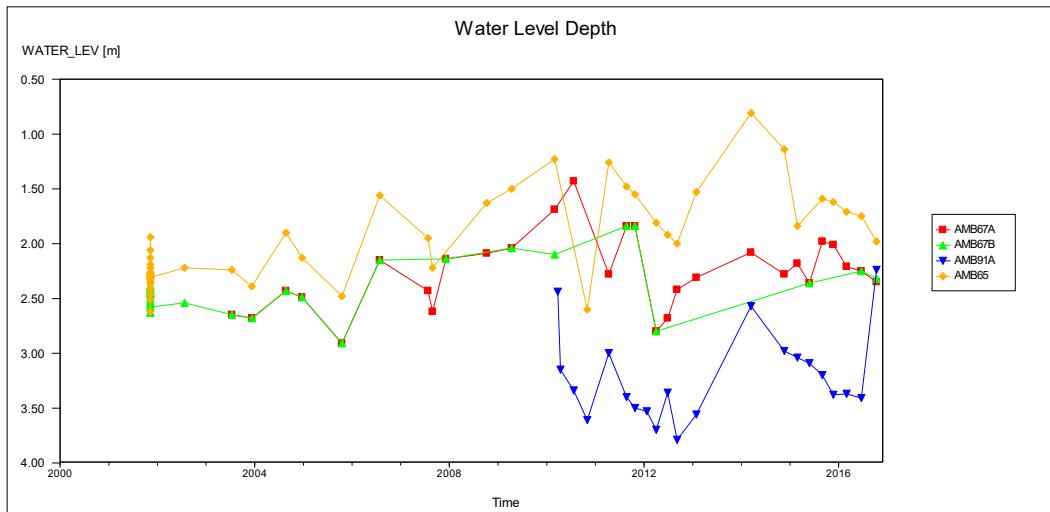
Figure 5. Water level depths (mbgl) of boreholes monitoring the south-eastern drainage system of Ash Stack.

Boreholes AMB65 and AMB91 are directly south of the ash stack below the eastern clean water diversion underneath the ash. The Na and F concentrations at AMB91A&B may be associated with geology. The trench has been cleaned and improvements are expected. The deep horizon is sampled below the sill reflecting possible impacts below the sill. The similar chemistry of the deep and shallow horizon may however reflect diffusion. **A clean/dirty water separation system must be installed. These boreholes must be plugged prior to extension of the ash stack. Future boreholes must be drilled as deep and shallow pairs to be able to distinguish between water from above and below the sill.**

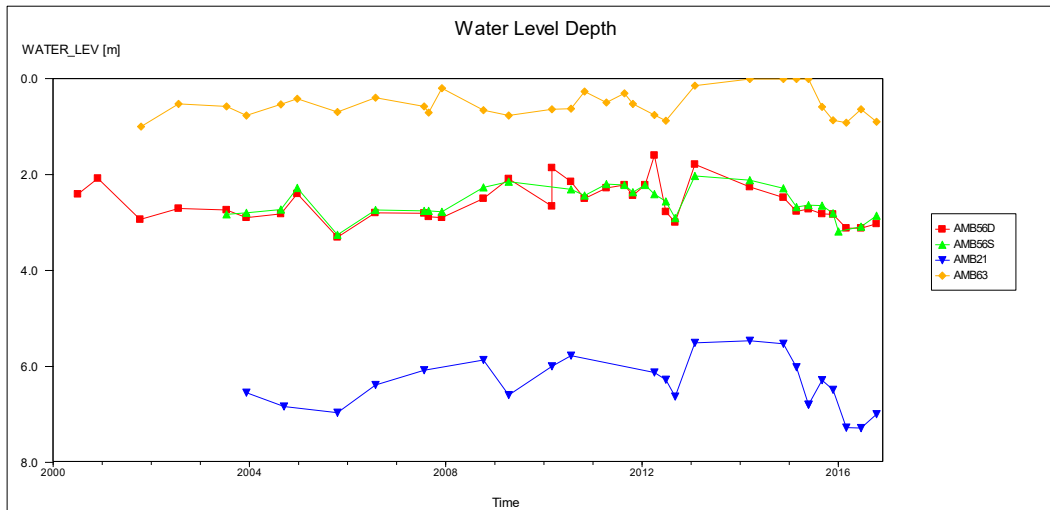
Figure 6. Water level depths (mbgl) of boreholes in the southern drainage system monitoring the dirty water dams.

Even though it might seem impacts from the second dirty water dam (either through overflows or seepage) are visible in the shallow piezometer of borehole AMB56, the absence of SO₄ (with a concentration of 11083 mg/L in the dam), this seems unlikely. The presence of Cl and NH₄ may be due to cattle utilizing the water directly below the dam wall. The farm is being evacuated. **Monitoring must continue in order to establish improvement and possible cause after evacuation of the land.**

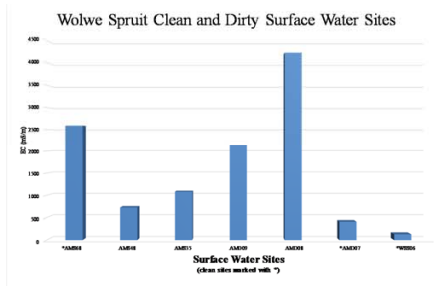
Figure 8. Bar charts of the electrical conductivity at sampling sites along the southern drainage system of the ash stack - Wolwe Spruit

The exceedances in Fluoride detected in boreholes AMB77 and AMB01 may be attributed to the fact that Fluoride is easily released (via ion exchange) from rocks through natural processes due to slight changes in chemistry or water table depth (artificial recharge which may arise from the clean water dam AMD07 or receding water table due to diminishing rainfall) dislodging fluoride from the geology as detected in boreholes AMB77 and AMB01. This may be a natural process.

Impacts upon the Wolwe Spruit may occur at the south-eastern corner of the ash stack in the absence of a clean/dirty separation system, which once again emphasize the **need for proper clean/dirty water separation.**

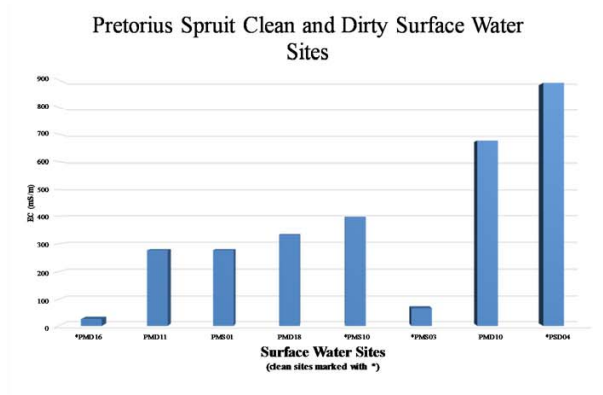
Figure 10. Pretorius Spruit EC bar Chart.

*PMS10	Tributary of Pretorius Vlei Spruit downstream of PMD18.	Down stream from PMD18.	Exceed	EC Cl F	8.4	397	744	116	124	427	1102	0.447	0.964	2820	25.4	0.00	0.001	0.582				0.071		This dam is downstream from PMD18 and is merely a reflection of this dam and upstream activities. The higher concentrations are probable due to concentration by evaporation. Regulate the water level of dam PMD11 and prevent overflows.

PMS01, PMD18 and PMS10 are all directly downstream from the dirty water dam PMD11. **This once again emphasizes the control of the water level of this dam.**

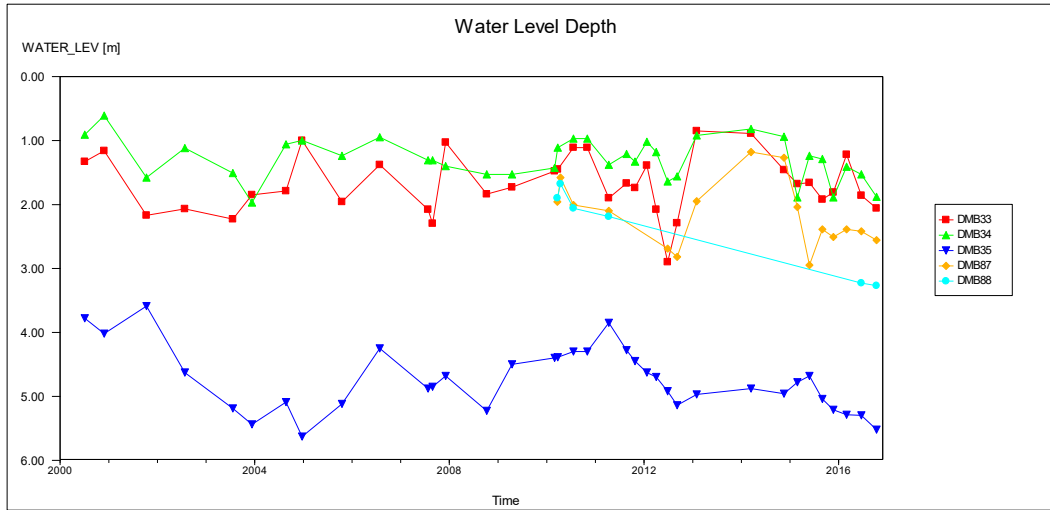
Figure 12. Water level depths (mbgl) of boreholes monitoring the Domestic Waste Site.

The occurrence of NH₄ upstream from DMB35 is uncertain. **It is recommended that a numerical model be constructed for the domestic waste site to quantify impacts detected at DMB33 or DMB34 (downstream from the site as natural drainage are not in the direction of this borehole).**

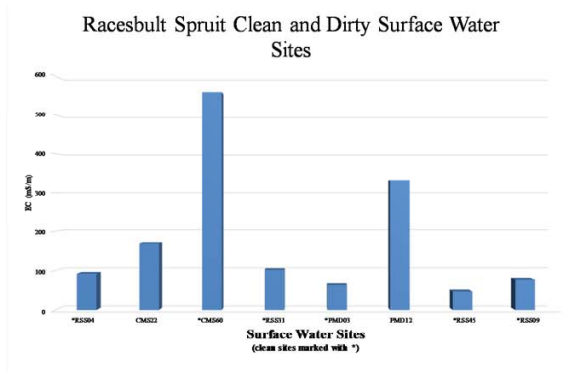
Figure 14. Racesbult Spruit EC bar Chart.

As the upstream qualities at RSS04 cannot be attributed to power station activities, it is unclear what the contribution of the power station activities are as the stream is already externally affected. The issue at CMS22 has been taken up with New Denmark Colliery. The only exceeding parameter of Na is at CMB71 (which is also exceeded at CMB70 and CMB10 as explained earlier. **This once again indicate that the WUL objectives must be amended to grouping boreholes of similar locality and geology together.**

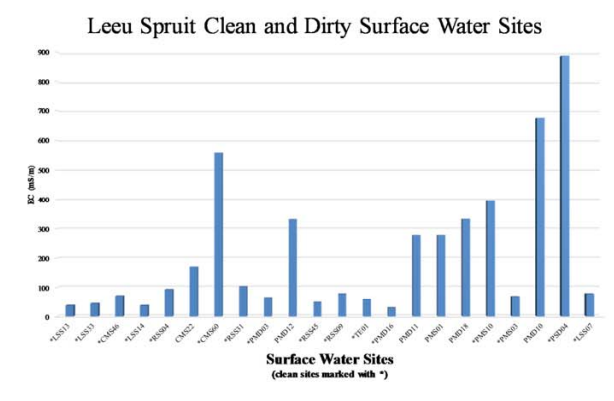
Figure 16. EC Bar charts of the Leeu Spruit (including tributaries).

Upstream qualities are already above the WUL quality objectives for EC. Although EC and Cl are the only elements exceeded at the downstream site LSS07, the concentration of SO₄ (which is not part of WUL objectives for surface water sites) has increased by 70 mg/L. The microbiological exceedance may be due to inadequate chlorination or cattle utilising the water. **Future samples are to be taken from the discharge point and not in-stream.**

Upstream qualities are already above the WUL quality objectives for EC. Although EC and Cl are the only elements exceeded at the downstream site LSS07, the concentration of SO₄ (which is not part of WUL objectives for surface water sites) has increased by 70 mg/L. These impacts are clearly from CMS60, PMD11 and PMD10.

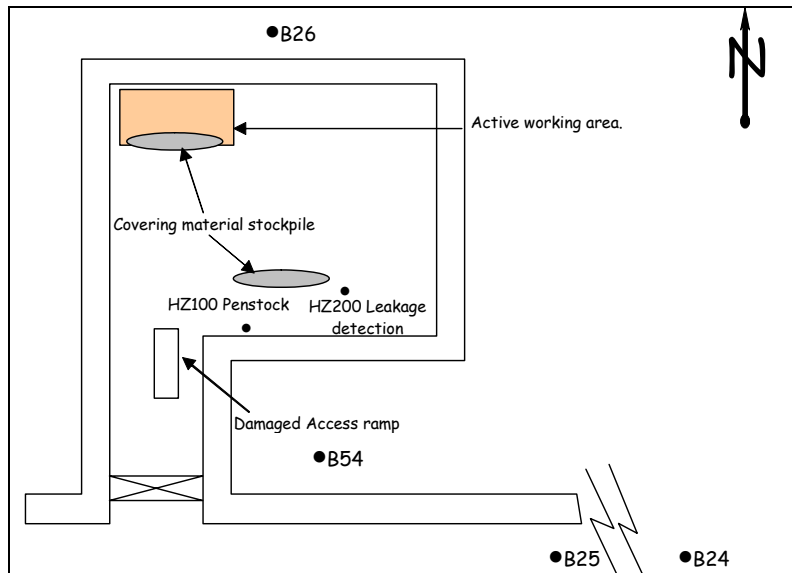
Figure 1. Site Plan and Monitoring Locations at Hazardous Waste Site.

The condition of the site was rated as Good due to the leaking of seepage from the top of the liner into the leakage detection sump and the absence of cell numbers against the fence. The site operation and day-to-day operations and management by the site SEA received a rating of Excellent. A rating of Excellent was awarded to the Environmental Department. External factors received a rating of Excellent as the pump-back system and sprayers are fully operational. The site received an overall rating of Excellent.
