**Tutuka Power Station Ash Disposal Facility
(ADF):
External Environmental Performance Assessment
as part of the Part 2 Exemption amendment application process to the
Exemption issued.
Audit Report**

06 September 2019

Eskom (Pty) Ltd

GCS Project Number: - 19-0217

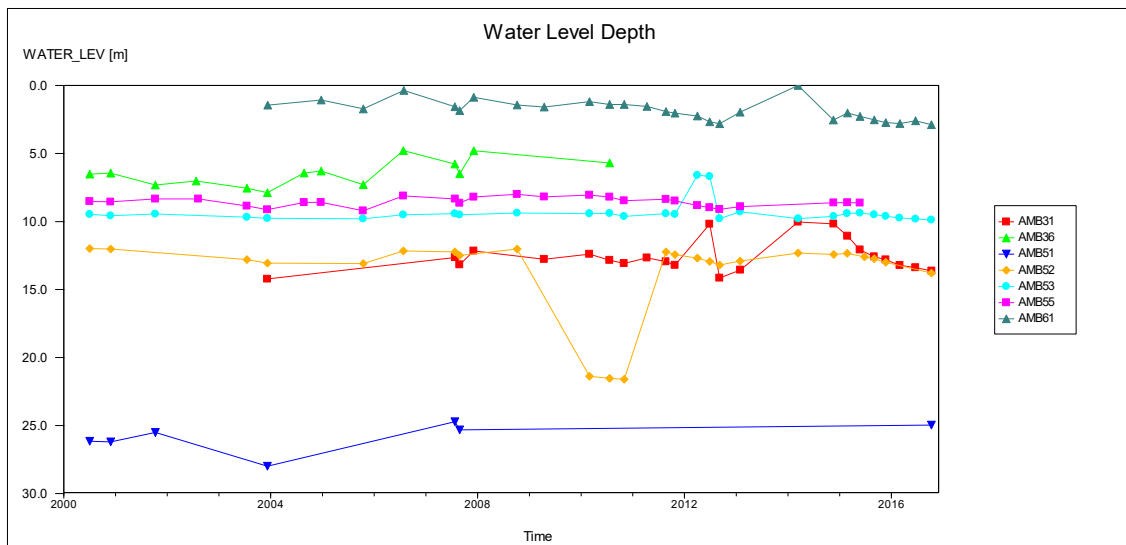
Figure 2. Water level depths (mbgl) of up gradient boreholes drilled upstream north and west to south-west of the ash stack.

The boreholes AMB31 and AMB51 are used for background purposes and are not within the natural drainage of the ash stack. The origin of ammonium may be attributed by agricultural purposes and cannot be regarded as a contravention of the WUL due to ashing activities. There was a sudden unaccounted increase in Mn at AMB51 since beginning of 2016. Continue monitoring to establish possible trends of both these parameters.

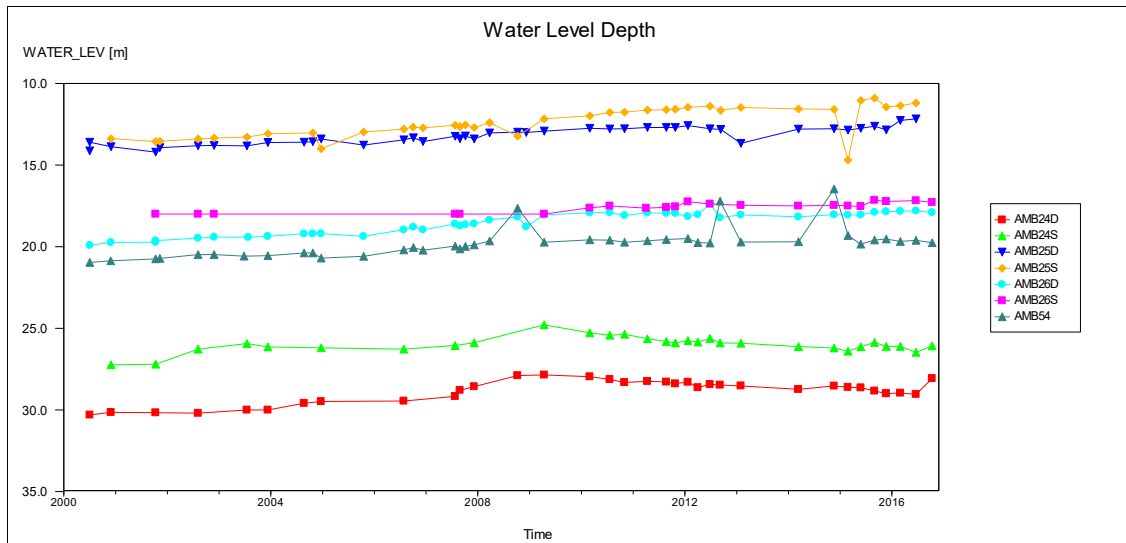
Figure 3. Water level depths (mbgl) of boreholes drilled on the ash stack.

Although the EC values and Mg, Ca, Cl and TDS concentrations are exceeded at AMB25D, AMB26D, AMB54 (only Mg and Cl), the trend graphs are stable, increasing slightly. As the purpose of these boreholes are to monitor the Hazardous Waste site, they had to be drilled directly into ash stack. The deep piezometers extend into the dolerite sill below the ash stack. Even in the presence of the ash stack, groundwater and groundwater drainage will tend to follow the historic stream system or paleochannel coming from the dam north of the ash stack. The groundwater in the sill occurs between the dolerite sill and thinly covered geology on top of it (so-called bedding plane fractures) where the borehole acts as a sump collecting this seepage. **It must be requested that the boreholes drilled into the ash stack be removed from the WUL as it can be expected that the ash stack would impact on the geology directly below it.**

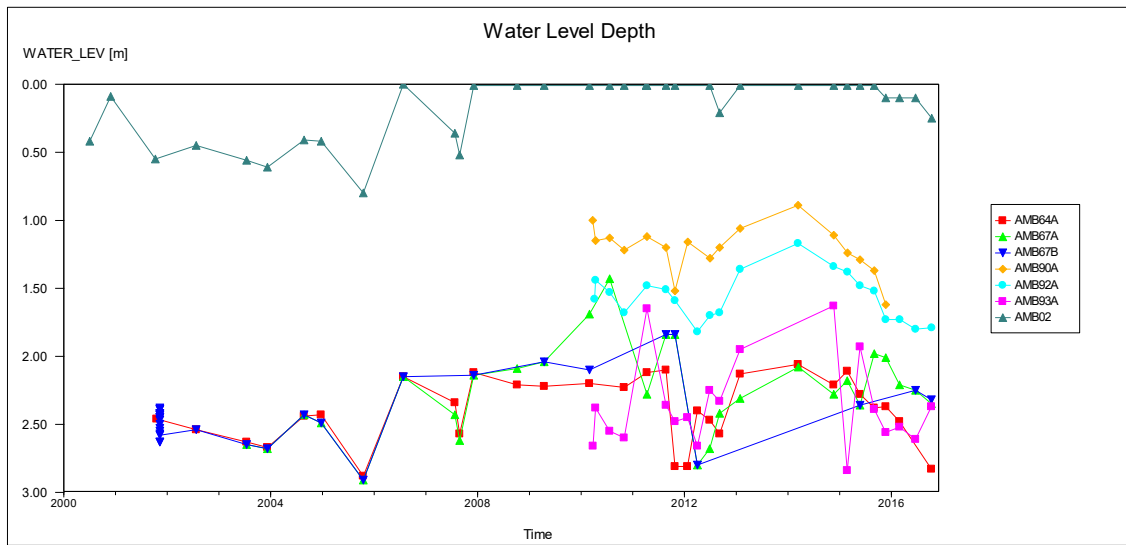
Figure 4. Water level depths (mbgl) of boreholes monitoring the south-western drainage system of ash stack.

Borehole AMB64 is 800m further south, and not close to streams indicating unaffected geology when not in close proximity to surface impacted sites. Borehole AMB02 is standing in the impacted stream (due to the silted southern dirty water trench which has been cleaned) running from the ash stack past boreholes AMB93 and AMB67. Increasing trends in some indicator element concentrations are noted, however, improvements are expected due to the cleaning of the southern dirty water trench.

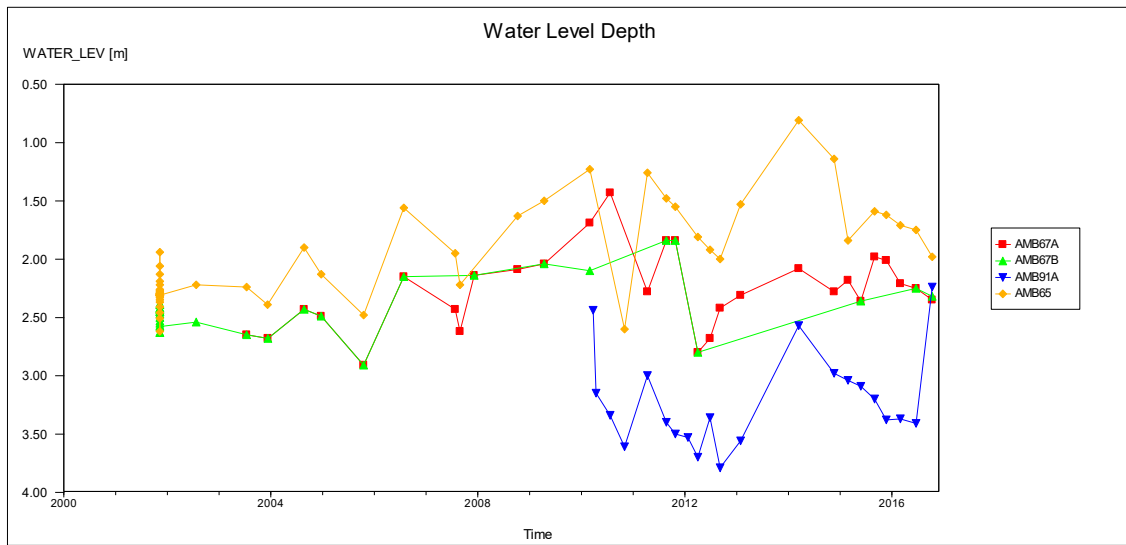
Figure 5. Water level depths (mbgl) of boreholes monitoring the south-eastern drainage system of Ash Stack.

Boreholes AMB65 and AMB91 are directly south of the ash stack below the eastern clean water diversion underneath the ash. The Na and F concentrations at AMB91A&B may be associated with geology. The trench has been cleaned and improvements are expected. The deep horizon is sampled below the sill reflecting possible impacts below the sill. The similar chemistry of the deep and shallow horizon may however reflect diffusion. **A clean/dirty water separation system must be installed. These boreholes must be plugged prior to extension of the ash stack. Future boreholes must be drilled as deep and shallow pairs to be able to distinguish between water from above and below the sill.**

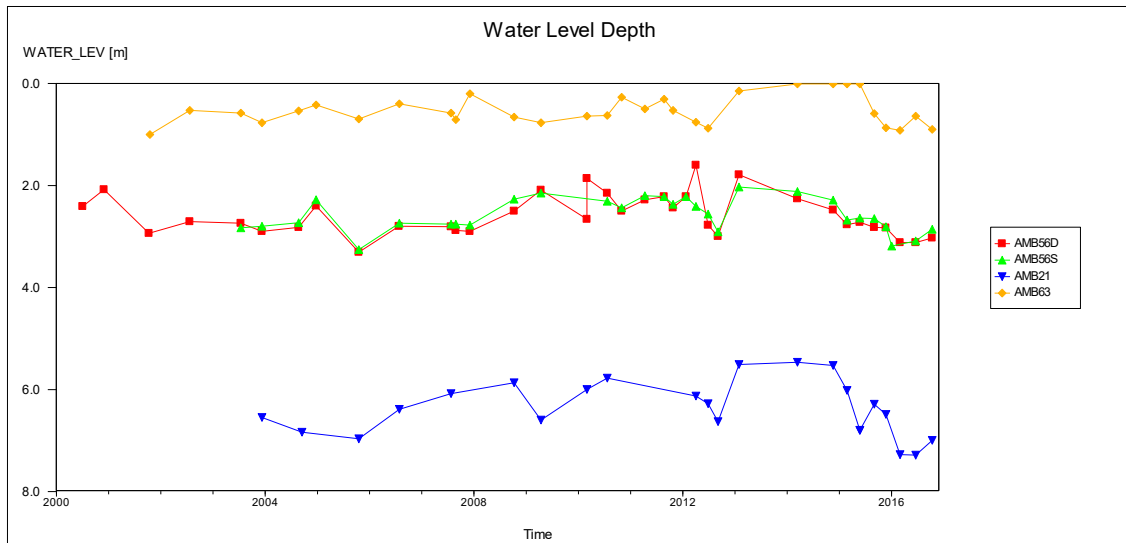
Figure 6. Water level depths (mbgl) of boreholes in the southern drainage system monitoring the dirty water dams.

Even though it might seem impacts from the second dirty water dam (either through overflows or seepage) are visible in the shallow piezometer of borehole AMB56, the absence of SO₄ (with a concentration of 11083 mg/L in the dam), this seems unlikely. The presence of Cl and NH₄ may be due to cattle utilizing the water directly below the dam wall. The farm is being evacuated. **Monitoring must continue in order to establish improvement and possible cause after evacuation of the land.**

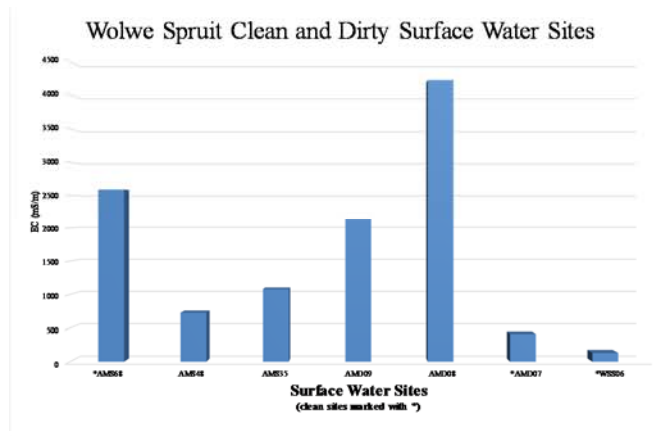
Figure 8. Bar charts of the electrical conductivity at sampling sites along the southern drainage system of the ash stack - Wolwe Spruit

The exceedances in Fluoride detected in boreholes AMB77 and AMB01 may be attributed to the fact that Fluoride is easily released (via ion exchange) from rocks through natural processes due to slight changes in chemistry or water table depth (artificial recharge which may arise from the clean water dam AMD07 or receding water table due to diminishing rainfall) dislodging fluoride from the geology as detected in boreholes AMB77 and AMB01. This may be a natural process.

Impacts upon the Wolwe Spruit may occur at the south-eastern corner of the ash stack in the absence of a clean/dirty separation system, which once again emphasize the **need for proper clean/dirty water separation.**

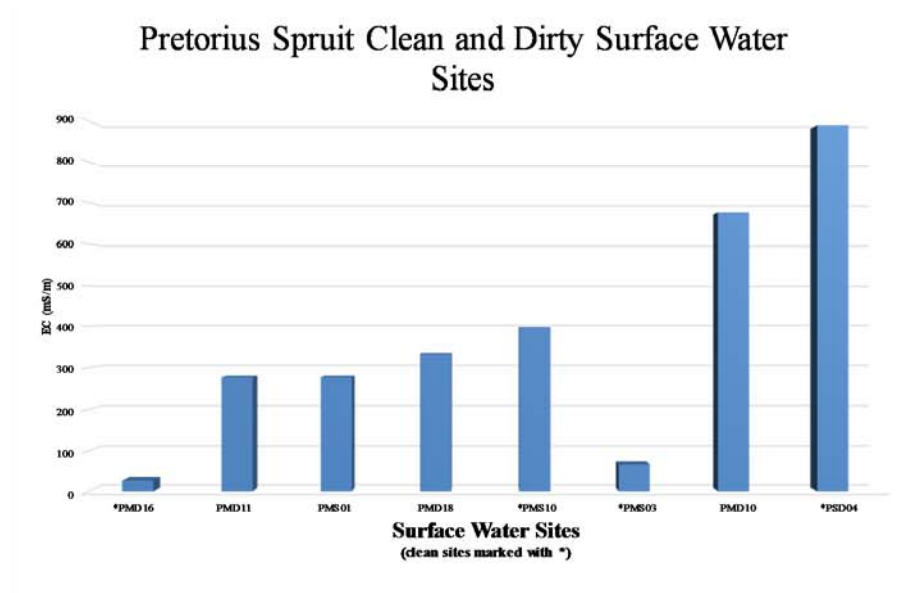
Figure 10. Pretorius Spruit EC bar Chart.

*PMS10	Tributary of Pretorius Vlei Spruit downstream of PMD18.	Down stream from PMD18.	Exceed	EC Cl F	8.4	397	744	116	124	427	1102	0.447	0.964	2820	25.4	0.00	0.001	0.582				0.071		This dam is downstream from PMD18 and is merely a reflection of this dam and upstream activities. The higher concentrations are probable due to concentration by evaporation. Regulate the water level of dam PMD11 and prevent overflows.

PMS01, PMD18 and PMS10 are all directly downstream from the dirty water dam PMD11. **This once again emphasizes the control of the water level of this dam.**

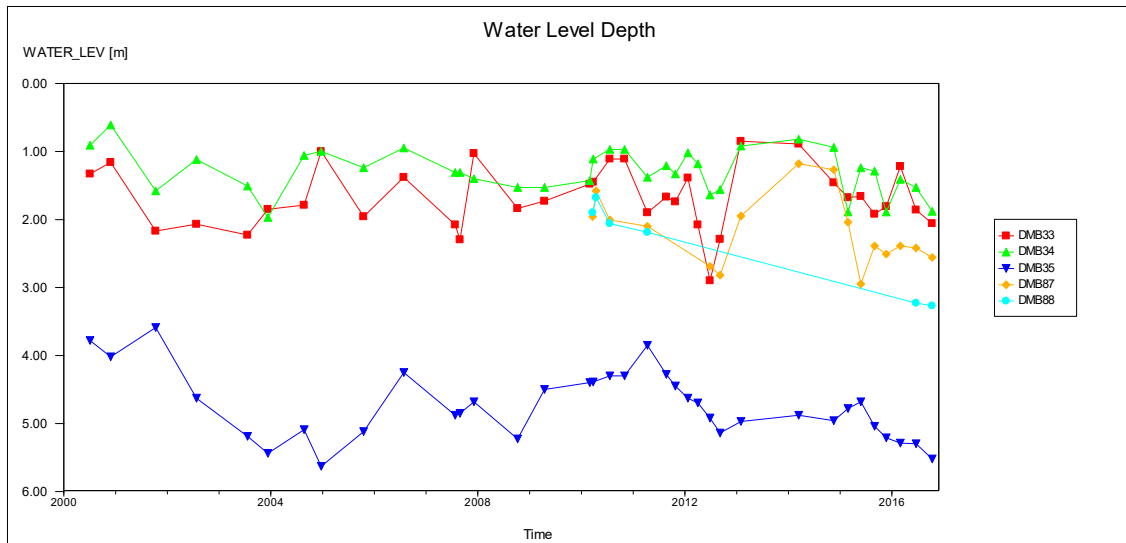
Figure 12. Water level depths (mbgl) of boreholes monitoring the Domestic Waste Site.

The occurrence of NH₄ upstream from DMB35 is uncertain. **It is recommended that a numerical model be constructed for the domestic waste site to quantify impacts detected at DMB33 or DMB34 (downstream from the site as natural drainage are not in the direction of this borehole).**

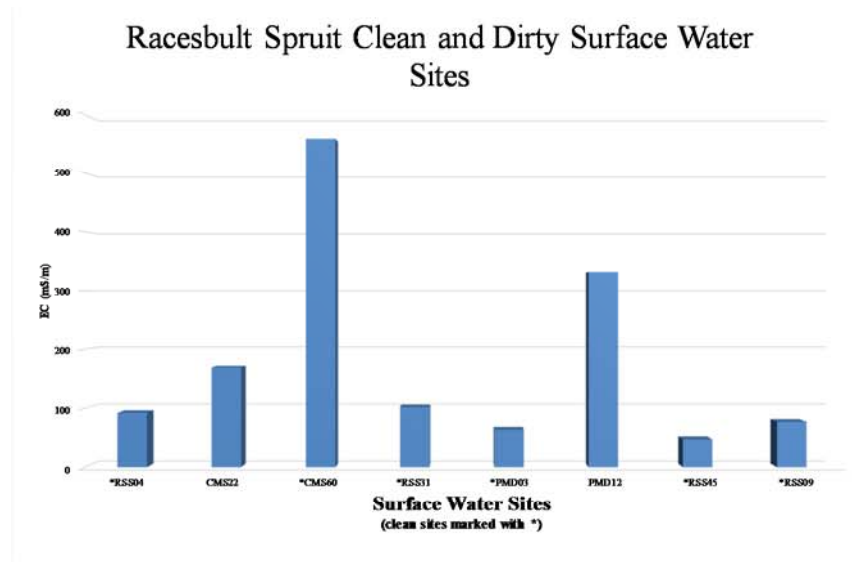
Figure 14. Racesbult Spruit EC bar Chart.

As the upstream qualities at RSS04 cannot be attributed to power station activities, it is unclear what the contribution of the power station activities are as the stream is already externally affected. The issue at CMS22 has been taken up with New Denmark Colliery. The only exceeding parameter of Na is at CMB71 (which is also exceeded at CMB70 and CMB10 as explained earlier. **This once again indicate that the WUL objectives must be amended to grouping boreholes of similar locality and geology together.**

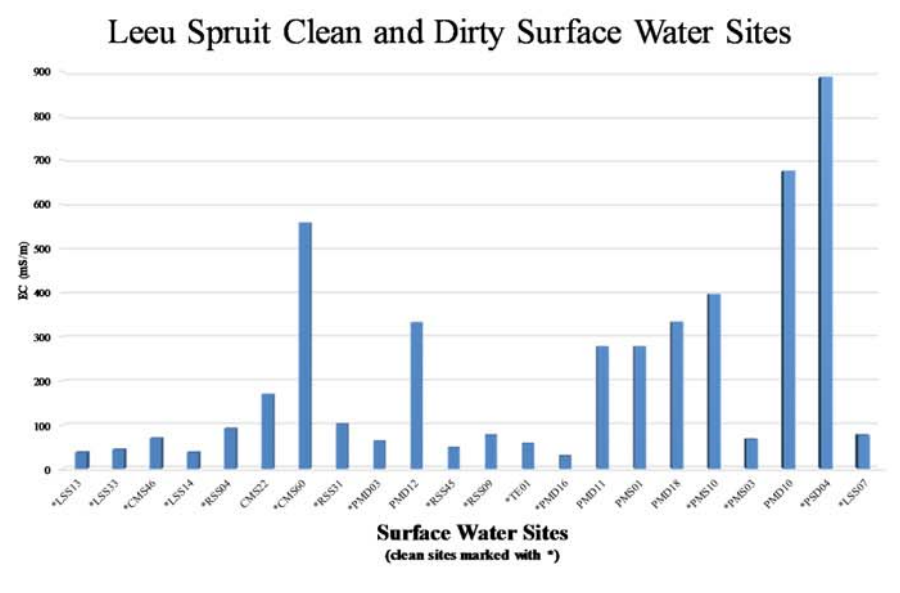
Figure 16. EC Bar charts of the Leeu Spruit (including tributaries).

Upstream qualities are already above the WUL quality objectives for EC. Although EC and Cl are the only elements exceeded at the downstream site LSS07, the concentration of SO₄ (which is not part of WUL objectives for surface water sites) has increased by 70 mg/L. The microbiological exceedance may be due to inadequate chlorination or cattle utilising the water. **Future samples are to be taken from the discharge point and not in-stream.**

Upstream qualities are already above the WUL quality objectives for EC. Although EC and Cl are the only elements exceeded at the downstream site LSS07, the concentration of SO₄ (which is not part of WUL objectives for surface water sites) has increased by 70 mg/L. These impacts are clearly from CMS60, PMD11 and PMD10.

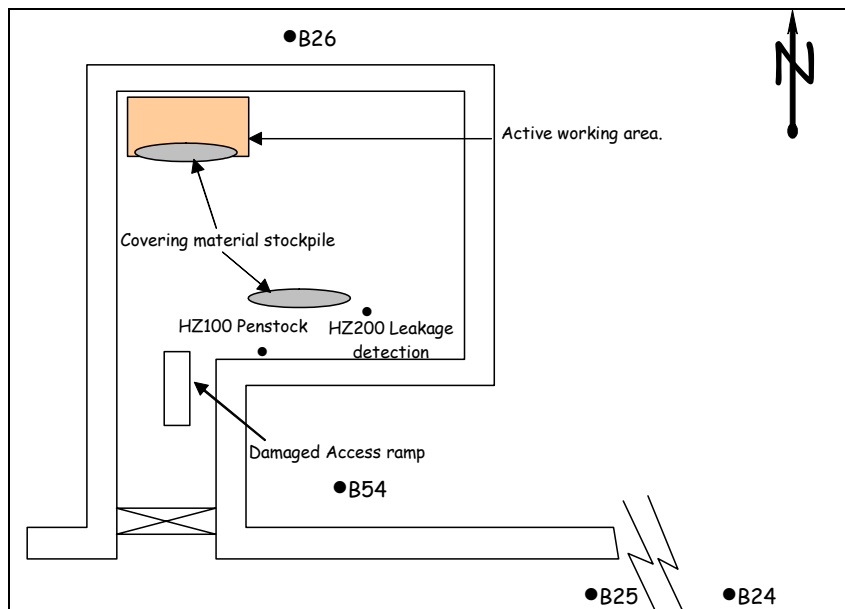
Figure 1. Site Plan and Monitoring Locations at Hazardous Waste Site.

A graphical representation of the site layout and the monitoring site positions is given in Figure 1.
