# APPENDIX C TEST PIT LOCATIONS & SOIL PROFILES

Site 5: Test Pit Positions and Soil Zones

# PROFILE SHEET TH2 Environment Impact Assessment - Eskom Proposed New General Landfill Facility, Lephalale Y -060886

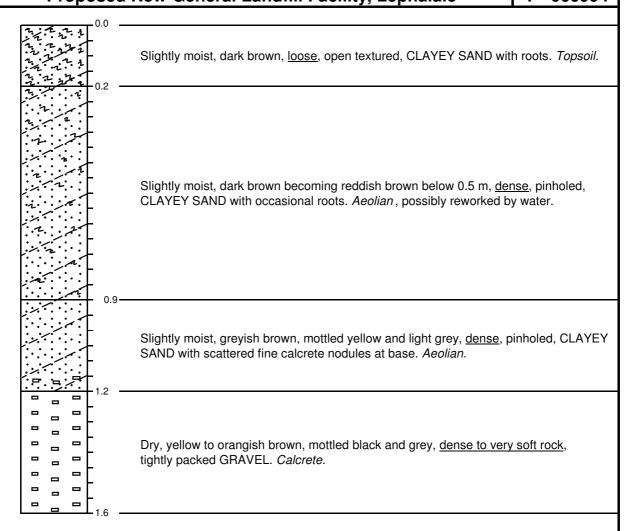
# PROFILE SHEET TH3 Environment Impact Assessment - Eskom Proposed New General Landfill Facility, Lephalale Y -060994

- 1. Bottom of hole at 1,6 m. Refusal on <u>very soft rock</u> calcrete gravel.
- 2. Hole stable.
- 3. No ground water seepage encountered.
- 4. Co-ordinates determined from Garmin hand-held GPS to WGS 84 system.

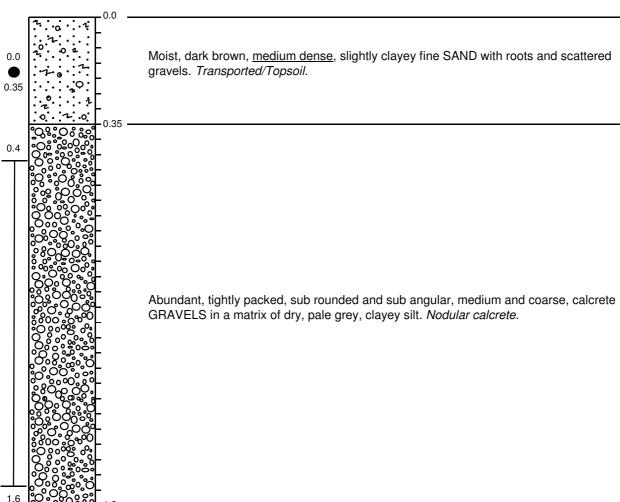
- 1. Bottom of hole at 1,6 m. Partial refusal on sandstone boulders.
- 2. No ground water seepage encountered.
- 3. Bulk sample taken between 0,4 to 1,6 m.
- 4. Disturbed sample taken between 0,0 to 0,35 m.
- 5. Co-ordinates determined from Garmin hand-held GPS to WGS 84 system.

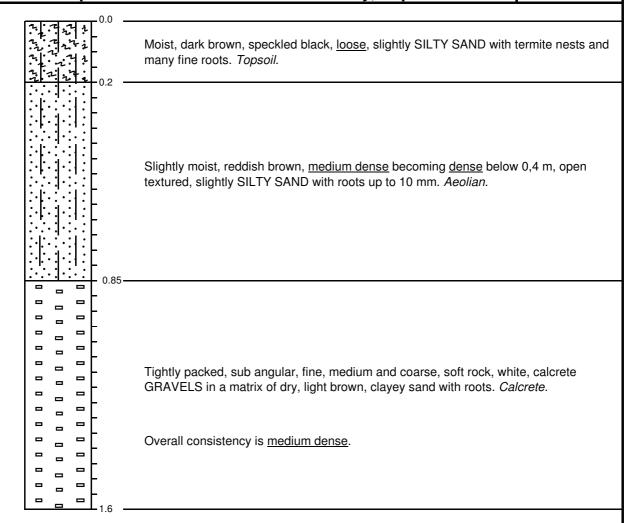
# PROFILE SHEET TH7 Environment Impact Assessment - Eskom Proposed New General Landfill Facility, Lephalale Y -060957

- 1. Bottom of hole at 1,6 m. Partial refusal on calcrete described above.
- 2. No ground water seepage encountered.
- 3. Co-ordinates determined from Garmin hand-held GPS to WGS 84 system.

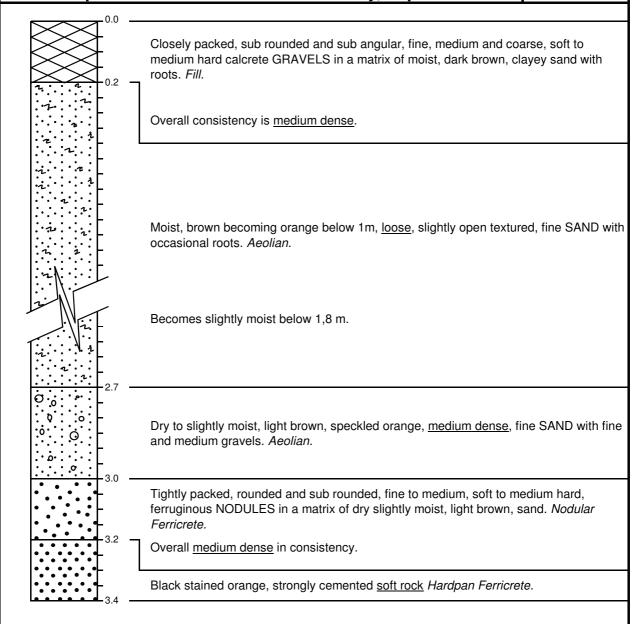
TH8

- 1. Bottom of hole at 3,4 m. Refusal on soft rock hardpan ferricrete.
- 2. No ground water seepage encountered.
- 3. Co-ordinates determined from Garmin hand-held GPS to WGS 84 system.

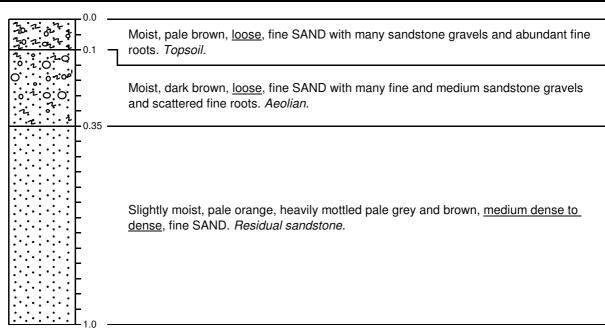
**TH11**

- 1. Bottom of hole at 1,0 m. Partial refusal on dense sandstone.
- 2. No ground water seepage encountered.
- 3. Co-ordinates determined from Garmin hand-held GPS to WGS 84 system.

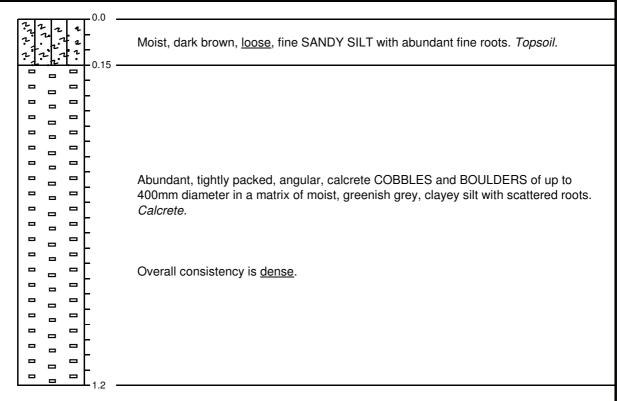
### PROFILE SHEET TH12 Environment Impact Assessment - Eskom X 2618707

- 1. Bottom of hole at 1,2 m. Refusal on very tightly packed calcrete boulders.
- 2. No ground water seepage encountered.
- 3. Co-ordinates determined from Garmin hand-held GPS to WGS 84 system.

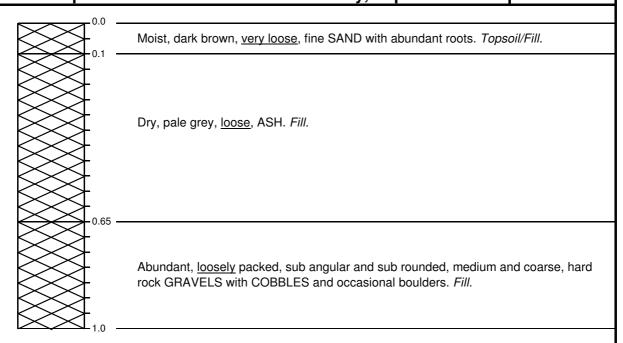
# PROFILE SHEET TH14 Environment Impact Assessment - Eskom Proposed New General Landfill Facility, Lephalale Y -060904

- 1. Bottom of hole at 1,0 m. Partial refusal on boulders.
- 2. No ground water seepage encountered.
- 3. Co-ordinates determined from Garmin hand-held GPS to WGS 84 system.

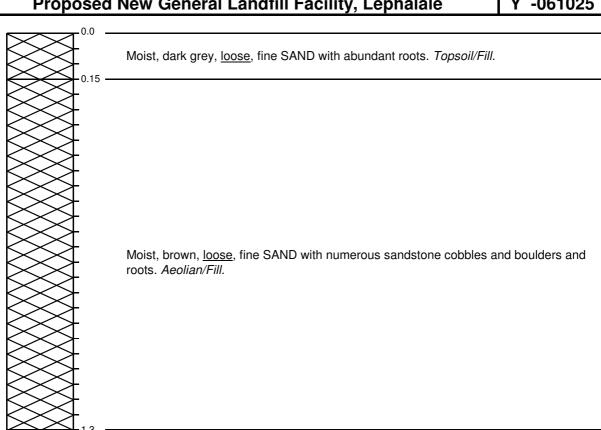
# PROFILE SHEET TH15 Environment Impact Assessment - Eskom Proposed New General Landfill Facility, Lephalale Y -061025

- 1. Bottom of hole at 1,3 m. Refusal on large sandstone boulders.
- 2. No ground water seepage encountered.
- 3. Co-ordinates determined from Garmin hand-held GPS to WGS 84 system.

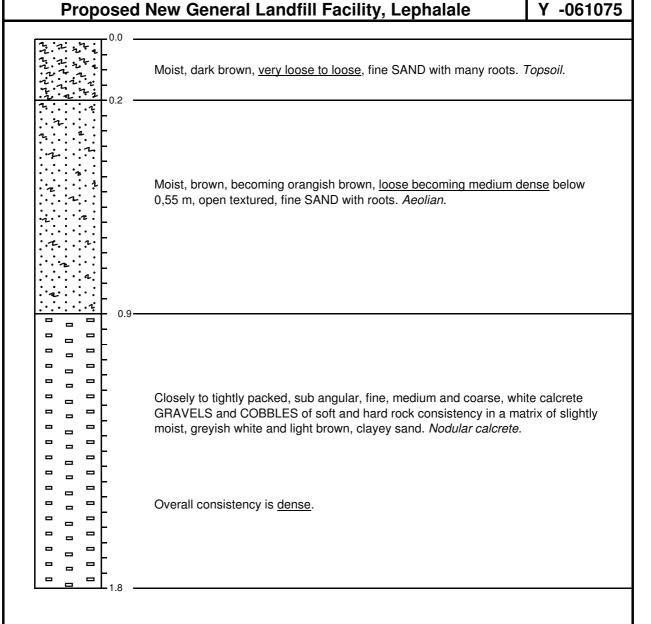
### PROFILE SHEET TH17 Environment Impact Assessment - Eskom posed New General Landfill Facility, Lephalale Y -061075

- 1. Bottom of hole at 1,8 m. Refusal on very dense calcrete.
- 2. No ground water seepage encountered.
- 3. Co-ordinates determined from Garmin hand-held GPS to WGS 84 system.

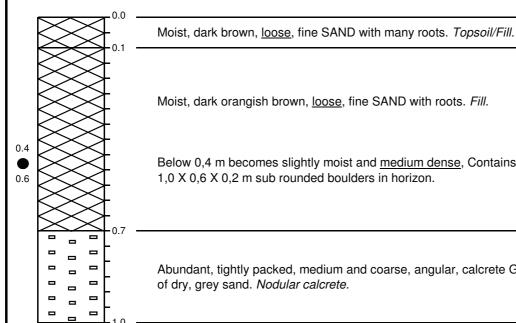
**TH18**

Moist, dark orangish brown, loose, fine SAND with roots. Fill.

Below 0,4 m becomes slightly moist and medium dense, Contains large 1,0 X 0,6 X 0,2 m sub rounded boulders in horizon.

Abundant, tightly packed, medium and coarse, angular, calcrete GRAVELS in a matrix of dry, grey sand. Nodular calcrete.

- 1. Bottom of hole at 1,0 m. Refusal on sandstone boulders.
- 2. No ground water seepage encountered.
- 3. Disturbed sample taken at 0,4 to 0,6 m.
- 4. Co-ordinates determined from Garmin hand-held GPS to WGS 84 system.

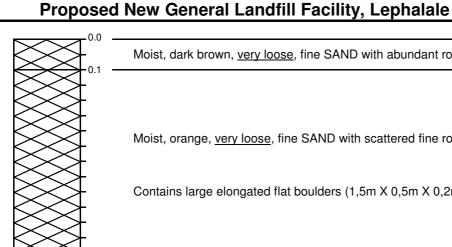
**TH19**

Moist, dark brown, very loose, fine SAND with abundant roots. Topsoil/Fill.

Moist, orange, very loose, fine SAND with scattered fine roots. Fill.

Contains large elongated flat boulders (1,5m X 0,5m X 0,2m) in aeolian sand matrix.

- 1. Bottom of hole at 0,7 m. Refusal on pale yellow, medium weathered, coarse grained, widely jointed, soft to medium hard rock, sandstone. Contains large elongated flat boulders (1,5m X 0,5m X 0,2m) in aeolian sand matrix.
- 2. No ground water seepage encountered.
- 3. Co-ordinates determined from Garmin hand-held GPS to WGS 84 system.

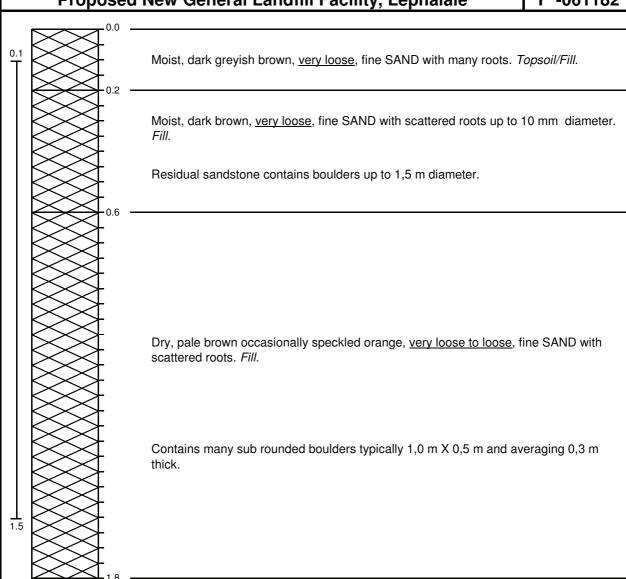
# PROFILE SHEET TH20 Environment Impact Assessment - Eskom Proposed New General Landfill Facility, Lephalale Y -061182

- 1. Bottom of hole at 1,8 m. Refusal on sandstone boulders.
- 2. No ground water seepage encountered.
- 3. Bulk sample taken at 0,1 to 1,5 m.
- 4. Co-ordinates determined from Garmin hand-held GPS to WGS 84 system.
