PLANT ENGINEERING

LIFE OF PLANT PLAN

CONTAINMENT BUILDINGS

KBA 0022 N NEPO LOPP 164

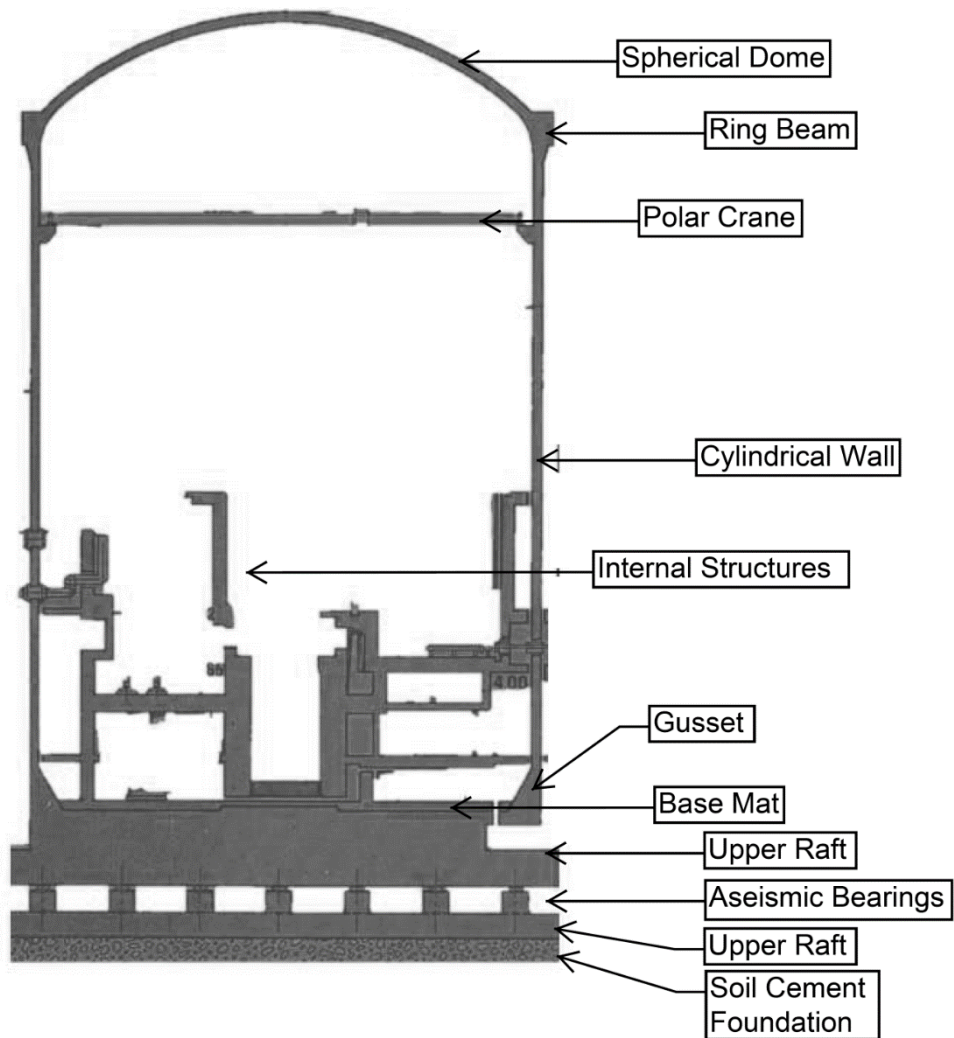
Figure 1: Cross-section illustration of a Koeberg Containment Building

A cross-section illustration of Containment is shown in Figure 1, and a summary of the illustrated components' dimensions are provided in Table 1.

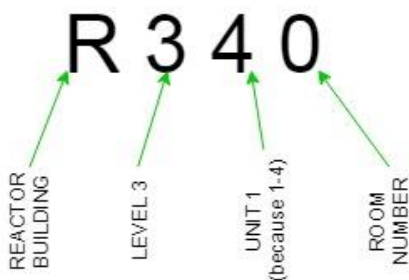
REACTOR VESSEL ROOM

R refers to the Reactor Building, *x* = 1-4 and *y* = 5-8 corresponding, i.e. 1 corresponds to 5 and 2 to 6 etc. and Z is a number assigned to the room, as illustrated below:
