Basic Assessment Process for rehabilitation Activities at the Eskom Kilbarchan Colliery, Newcastle, KwaZulu-Natal

Rehabilitation Action Plan

ESK3520

June 2016

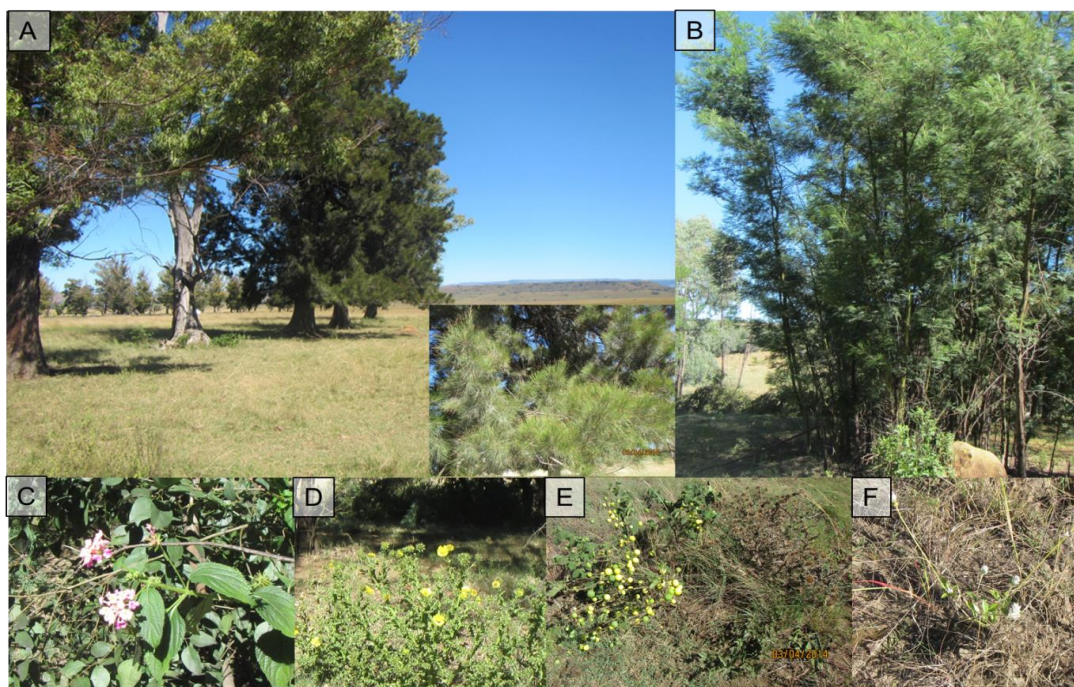
Table 7-3 lists the alien species identified on site and examples of the alien species recorded from the site can be seen in Figure 7-2. These species should be removed from the rest of the project area where possible and must be managed to avoid the (re)establishment in unwanted areas. Control methodology will have to occur over at least three growing seasons to ensure the seed bank is depleted. Continuous monitoring will be required to control plant establishment from seeds being blown in from adjacent areas. It would be preferable to use mechanical control and biocontrol where possible as opposed to chemical control (refer to Table 7-3 for potential control methods).

Figure 7-2: Examples of Alien Plant Species Identified on Site (A: *Eucalyptus* sp. (left) and *Pinus patula* (right); B: *Acacia decurrens*; C: *Lantana camara*; D: *Berkheya rigida* (native pioneer); E: *Solanum sisymbriifolium* and F: *Gomphrena celestioides*)
