ENVIRONMENTAL IMPACT ASSESSMENT FOR THE PROPOSED NUCLEAR POWER STATION ('NUCLEAR-1') AND ASSOCIATED INFRASTRUCTURE

Geological Hazard Environmental Impact Report

December 2009

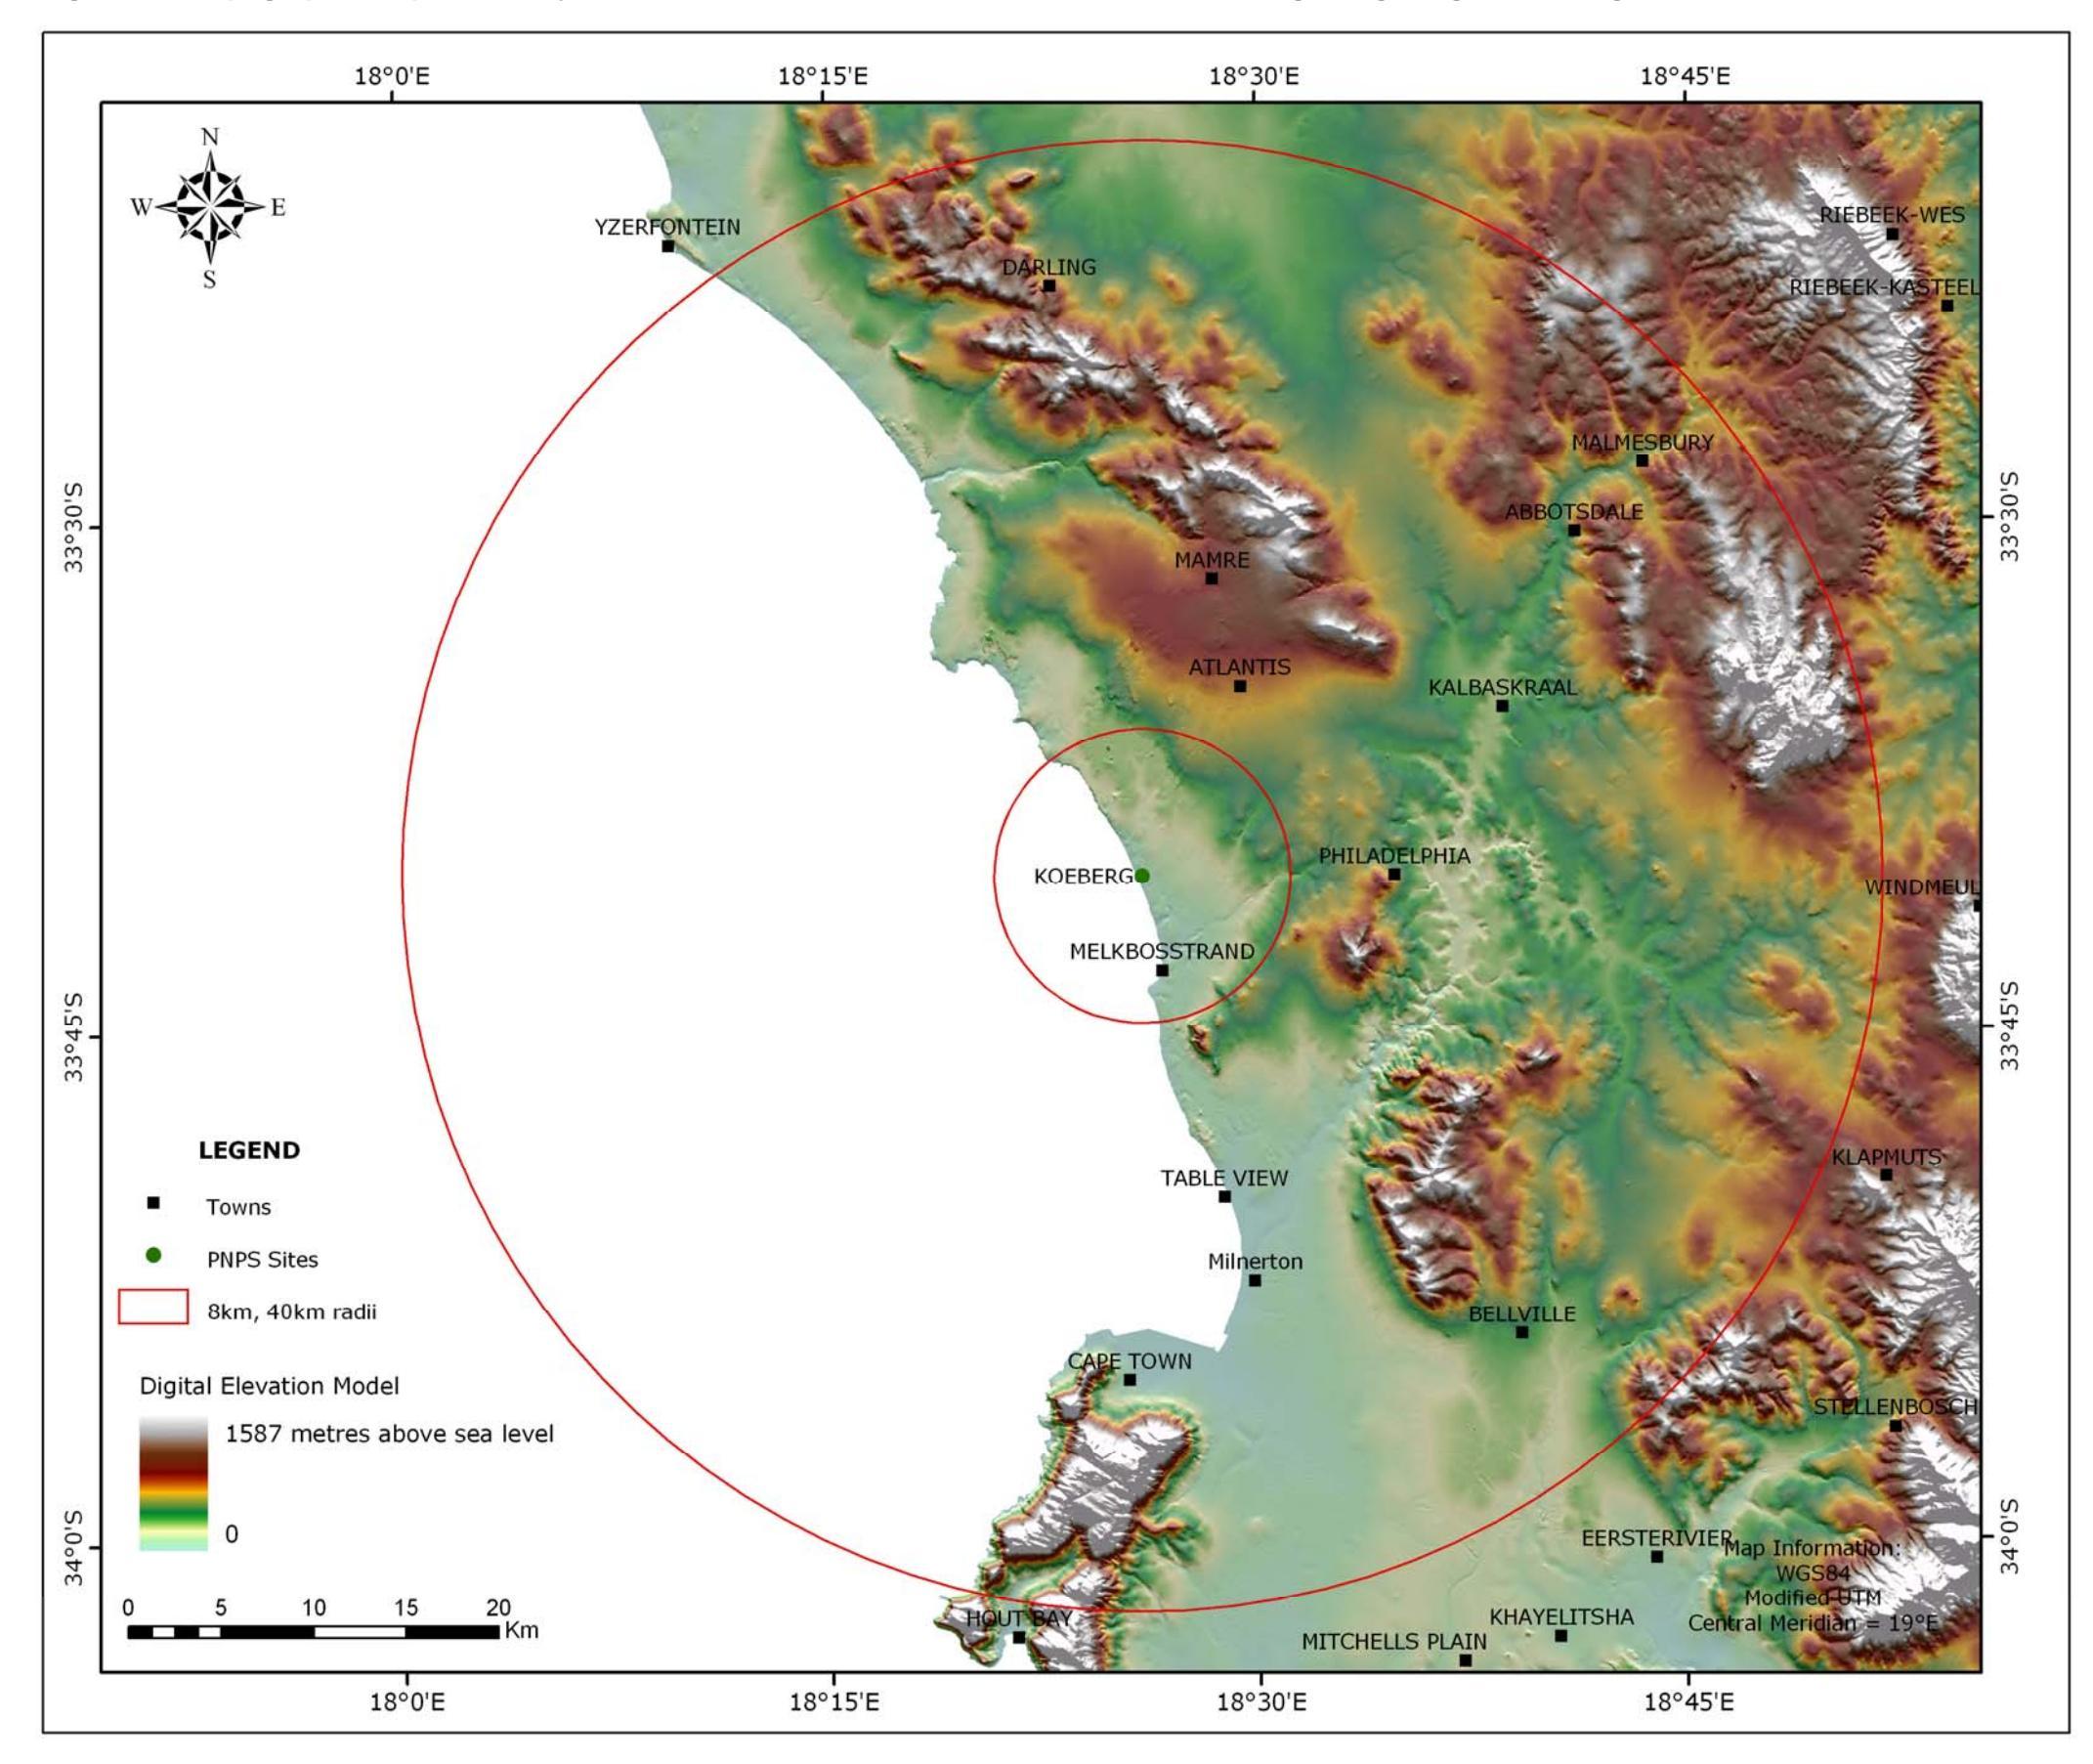
Figure 1.2: Topographic map of the Duynefontein Site area with the 8 km and 40 km radii that guide geological investigation

The coastline at Duynefontein (**Figure 1.2**) is dominated by sandy beaches with intermittent ragged outcrops and gullies in quartzitic greywacke of the Tygerberg Formation of the Malmesbury Group. About 20 m of sand belonging to the Cenozoicage (**Appendix 1**) Sandveld Group covers the bedrock at the site terrace. Light grey calcified dune sand and calcarenite crop out amongst the generally white to light grey calcareous sand of the Witzand Formation.

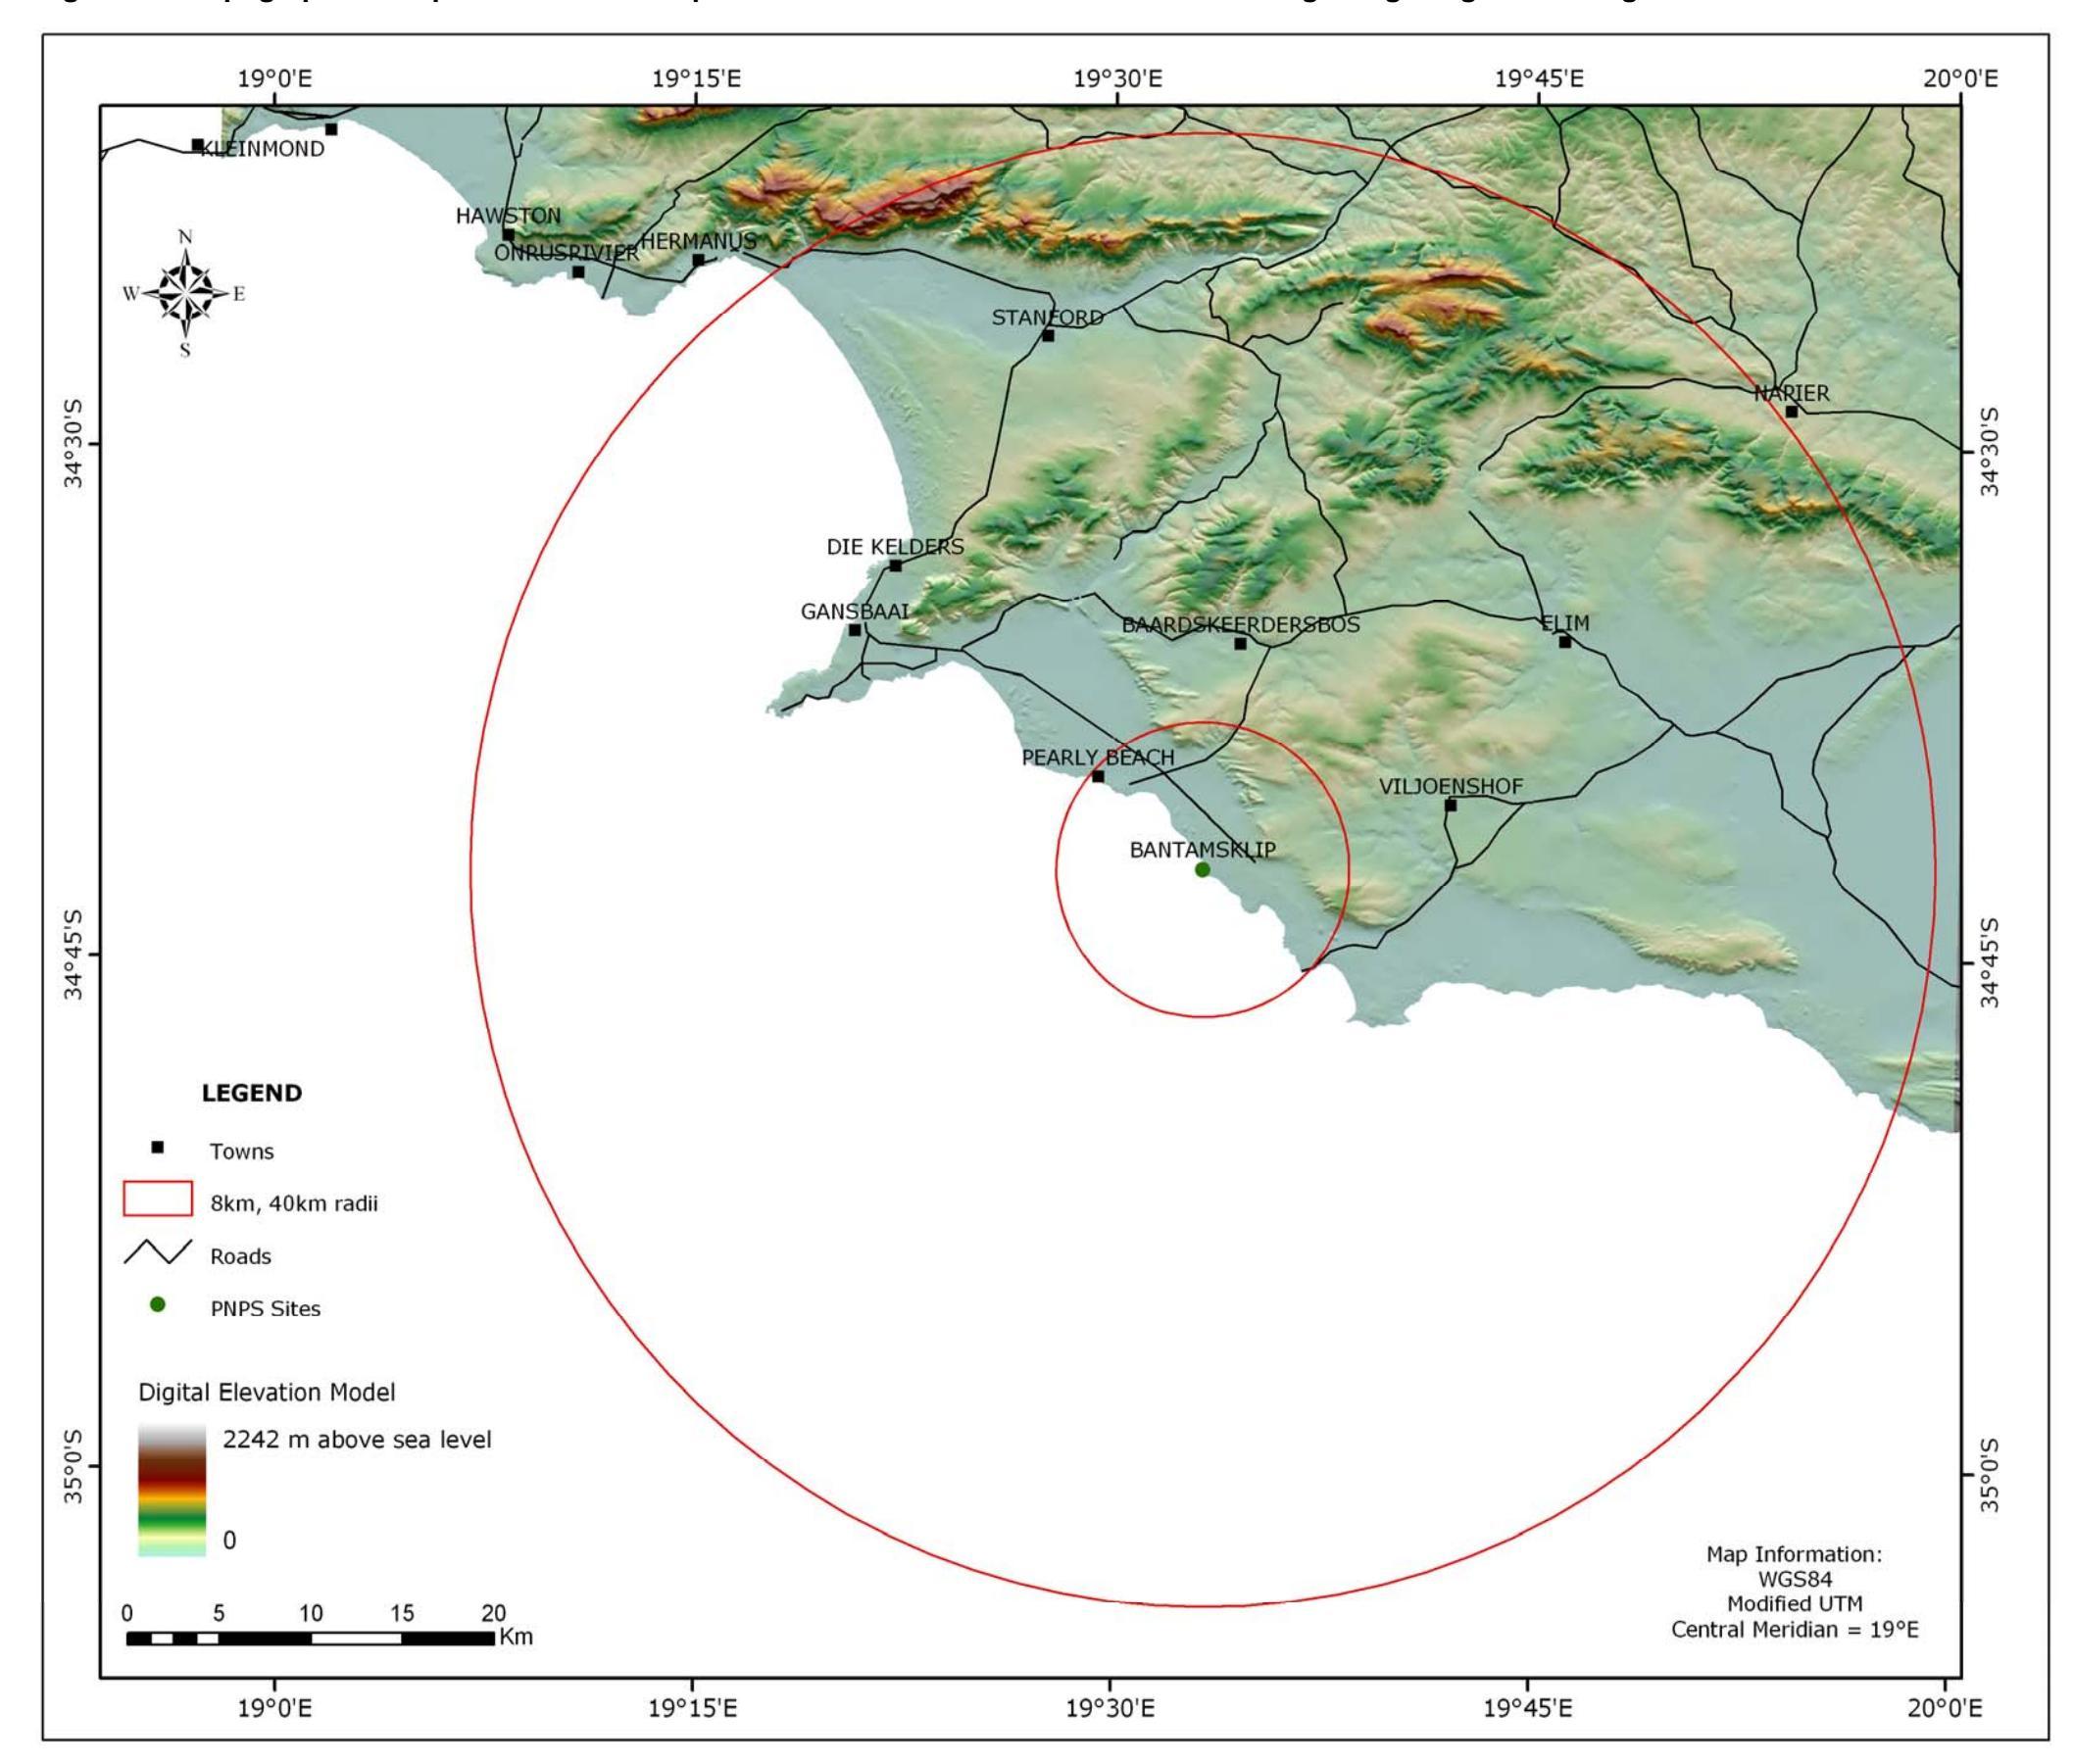
Figure 1.3: Topographical map of the Bantamsklip Site area with the 8 km and 40 km radii that guide geological investigation

A much more rugged coastline is found at Bantamsklip (**Figure 1.3**), dominated by ragged outcrops and gullies developed on fractured and faulted, well-bedded quartz arenites of the Peninsula Formation. A flat coastal terrace covered with white sand and grassy vegetation occurs between the rocky coastline and first dunes at Bantamsklip. Semi-consolidated, vegetated dunes persist to the road between Gansbaai and Buffelsjags, north of which lies an extensive flat sandy plain with fynbos and local wetlands. The plain ends against a relatively straight 50 m Late Pliocene-age shoreline eroded into hills composed of calcarenite, and laterally against promontories of resistant rocks of the Table Mountain Group.

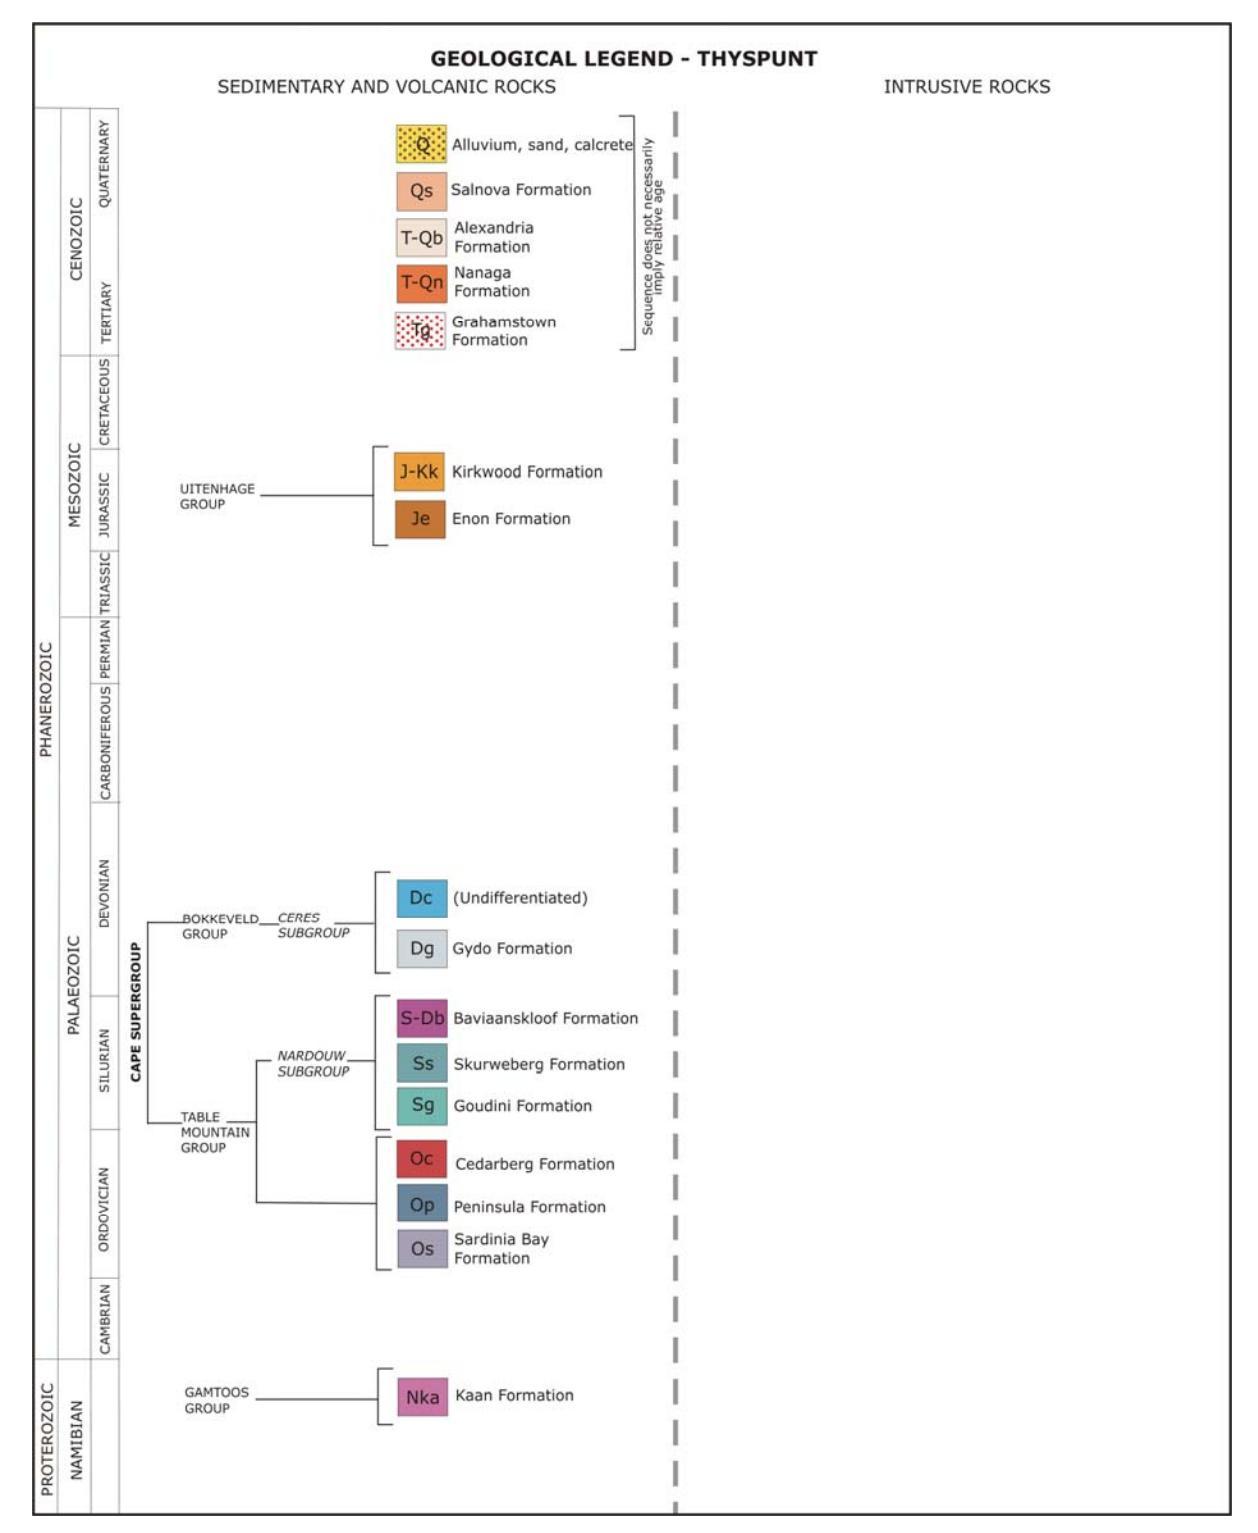
Figure 2.2: Legend for the Thyspunt geological map in Figure 2.1

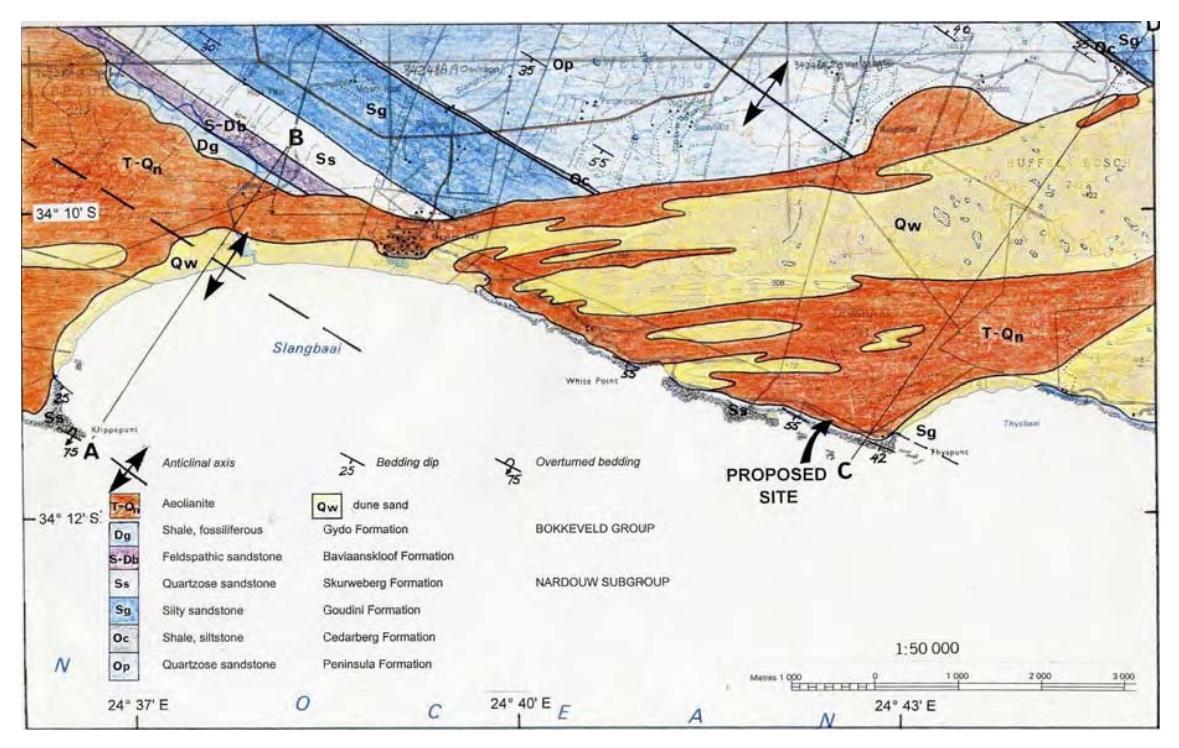
Figure 2.3: Sketch map depicting the onshore geology of the Site location area between Thyspunt and Klippepunt compiled from the 1:50 000 scale geological filed sheets and updated from reconnaissance fieldwork (from De Beer, 2000)

A schematic map (**Figure 2.3**) and cross-section (**Figure 2.4**) prepared by De Beer (2000), illustrates the folding of the Table Mountain Group at Thyspunt, which is located on the southern limb of a large anticlinal structure, with asymmetric north-verging synclinal and anticlinal folds that extend south-eastward.

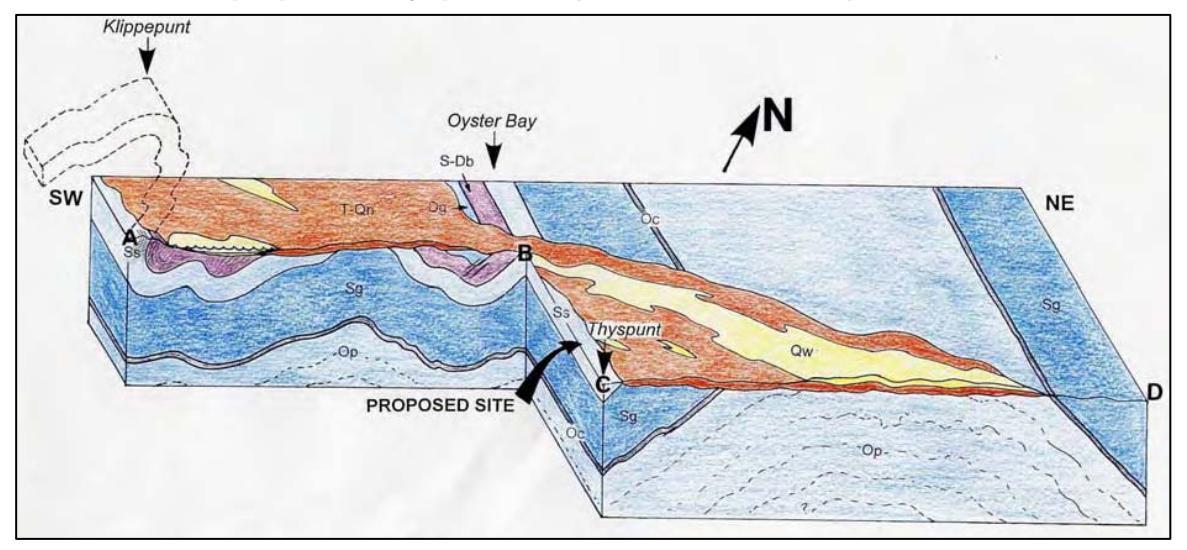
Figure 2.4: Schematic block diagram with cross-section A-B and C-D from Figure 2.3, showing the local geological structures between Thyspunt and Klippepunt in relation to the proposed Thyspunt site (from De Beer, 2000)

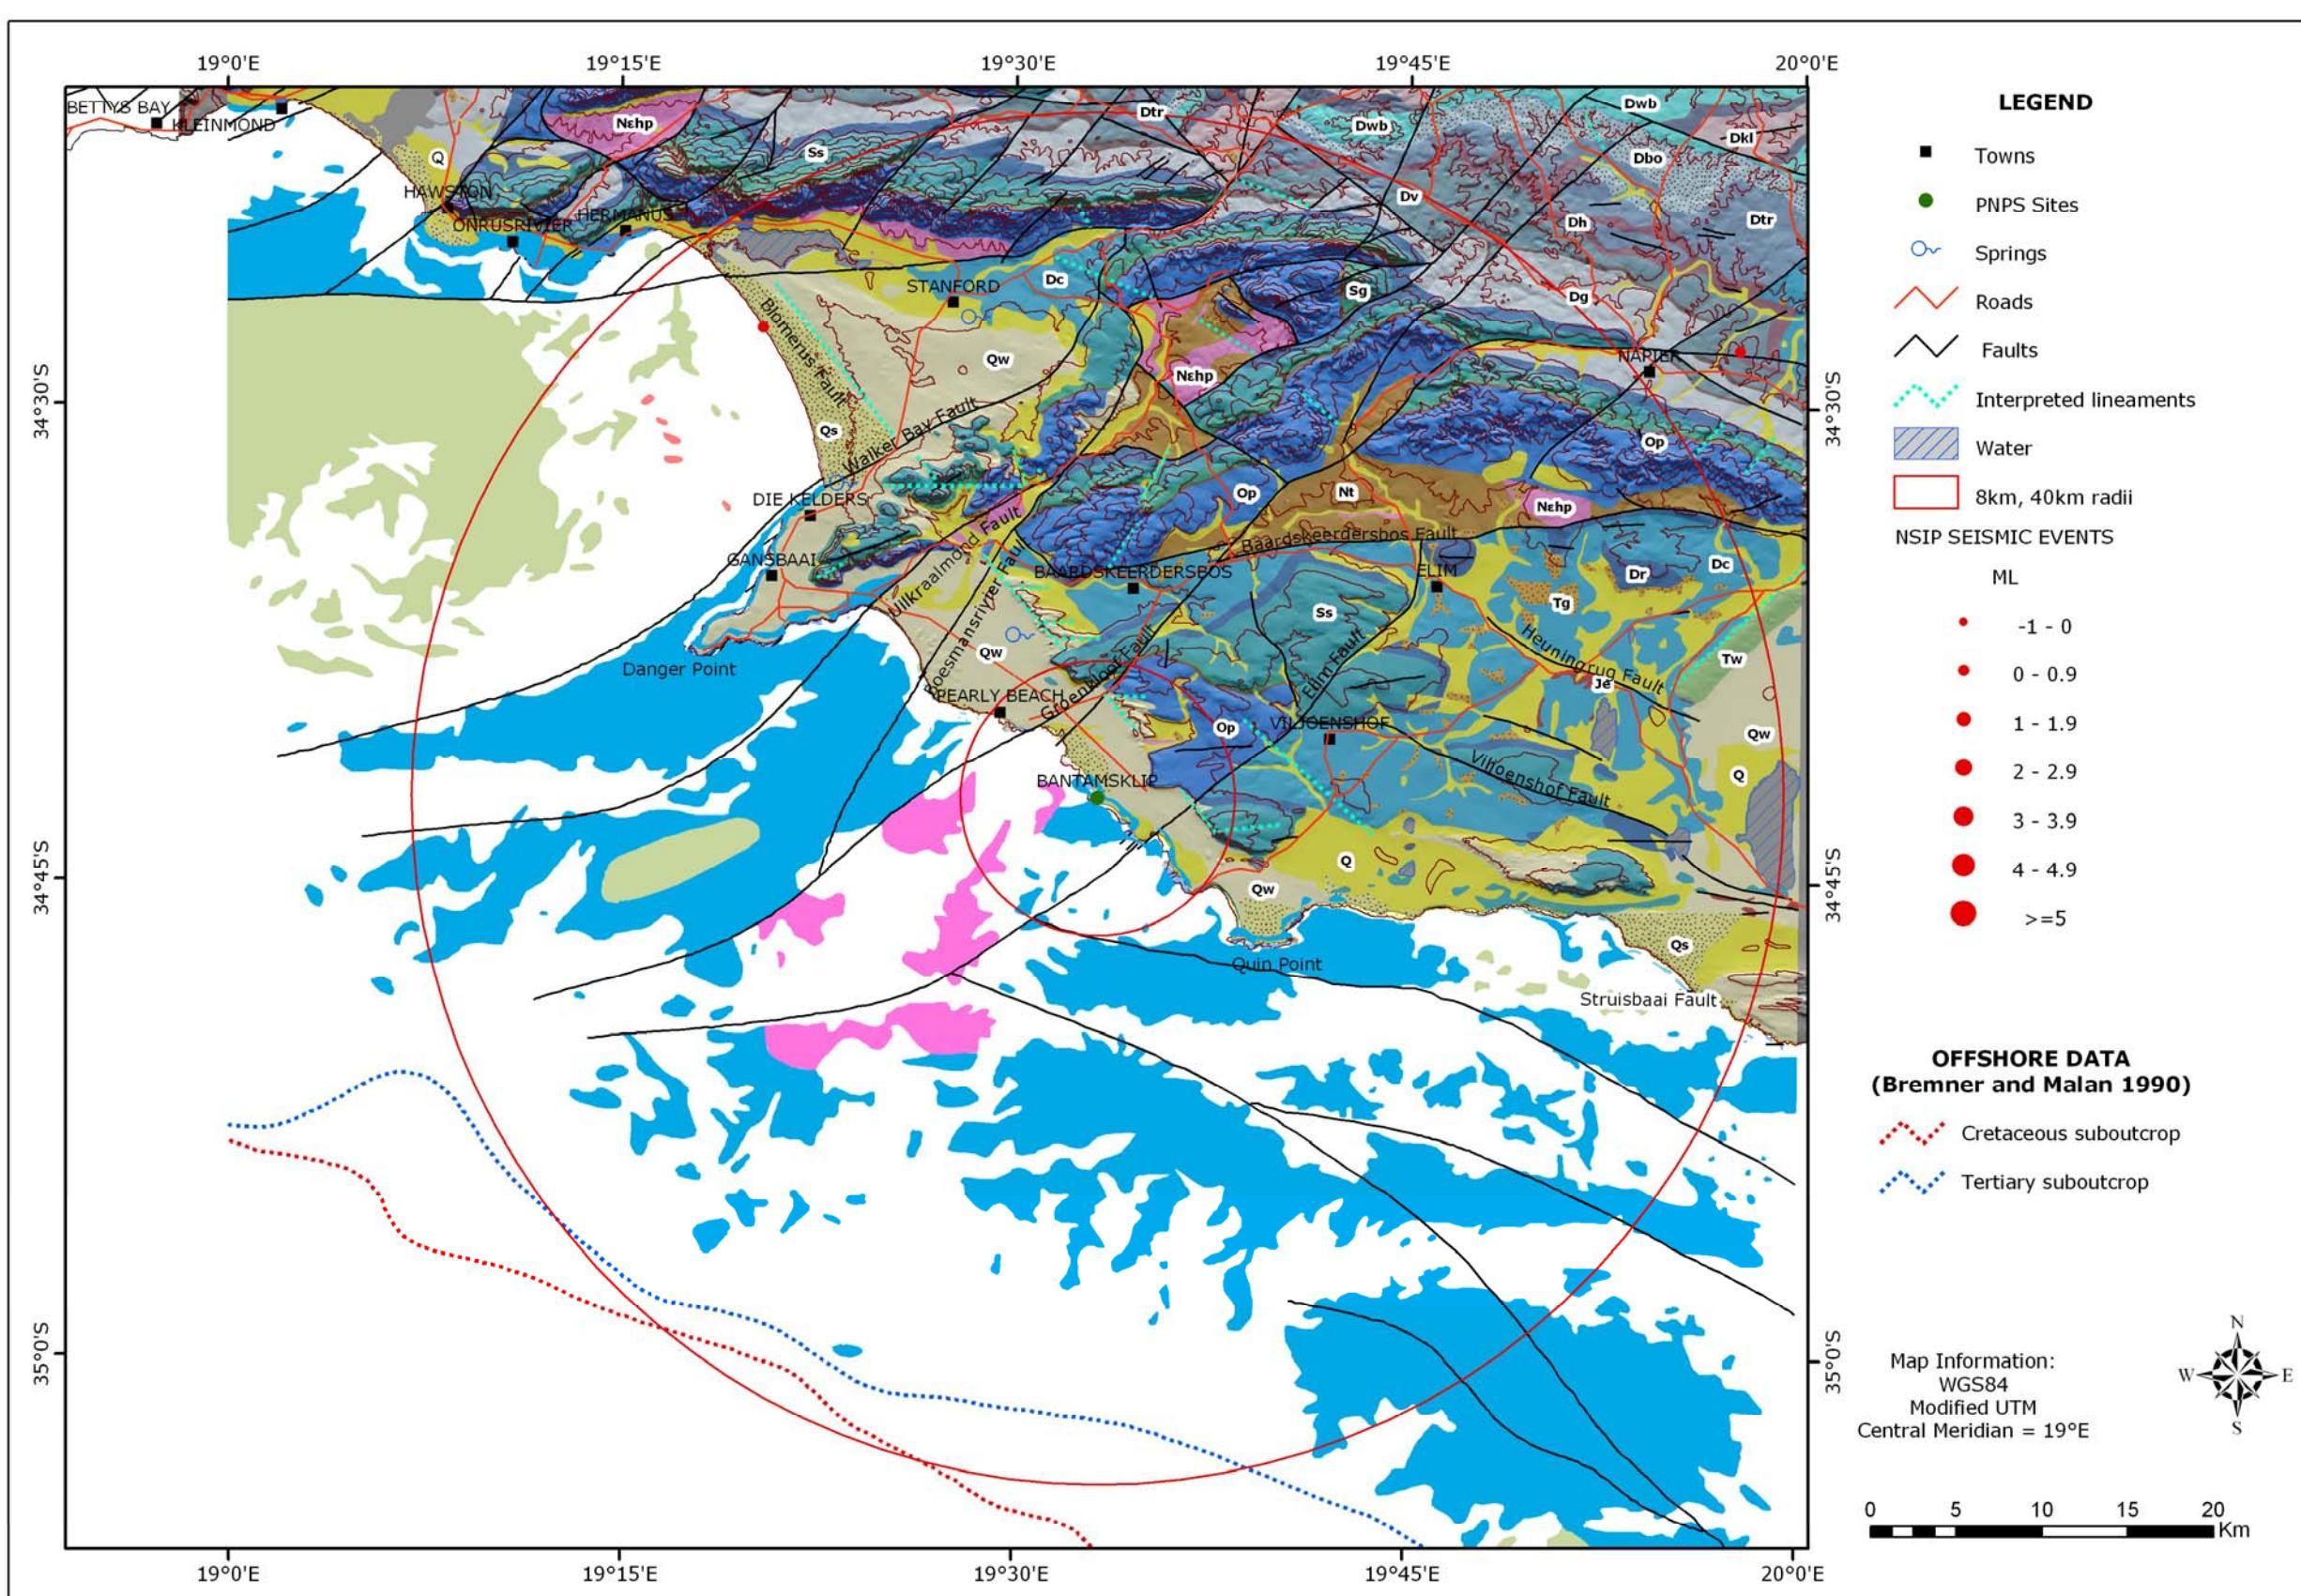
Figure 2.5: Geological map of the Batamsklip Nuclear Site area with the 8 km and 40 km radii that guide geological investigation

The Bantamsklip site is situated in a fractured part of the Cape Fold Belt, called the syntaxis where NE–SW trending faults dominate. The geology and tectonics of the Bantamsklip Site Regional area (320 km) and Site Vicinity area (40 km) has been reviewed briefly by De Beer (2006). The geology of the Site Vicinity Area geology is depicted in **Figure 2.5** with legend depicted in **Figure 2.6**.
