## KOMATI POWER STATION SHUTDOWN & DISMANTLING

#### **DRAFT ENVIRONMENTAL & SOCIAL IMPACT ASSESSMENT REPORT Part II - APPENDICES**

Project Name:	Komati Power Station Shutdown and Dismantling
Report Title:	Draft Environmental and Social Impact Assessment Report – Part II Appendices
Report Status	Draft

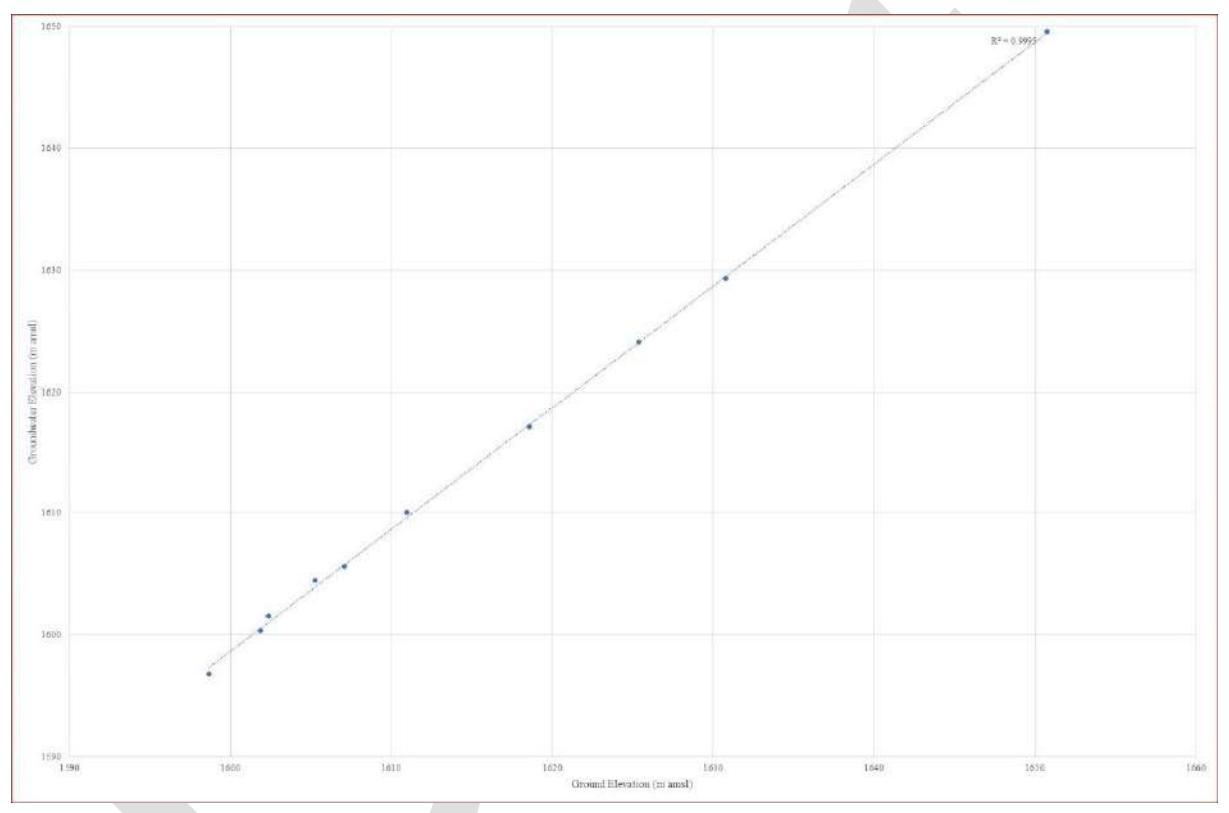
Figure A – Correlation: Topography versus Groundwater Elevation

Comparing topographic and groundwater elevations an  $\mathbb{R}^2$  value of 0.99 is calculable (**Figure A**) resulting in a very strong correlation coefficient and consistent with previous works. The interpolated groundwater flow is illustrated on **Appendix A: Figure 6** and confirms an overall flow direction to the north.

Very broadly, an average hydraulic gradient is calculated with reference to groundwater elevations (**Table 5**) at BH08 in the south and BH01 in the north. This represents a difference of ~52.82 m over a lateral distance of approximately 2,866 m, equating to a hydraulic gradient of ~0.018. It should be stressed that hydrogeological conditions are unlikely to be homogenous especially recognising that the shallow aquifer is discontinuous and, therefore, local variability should be expected that may differ markedly from this calculated average.

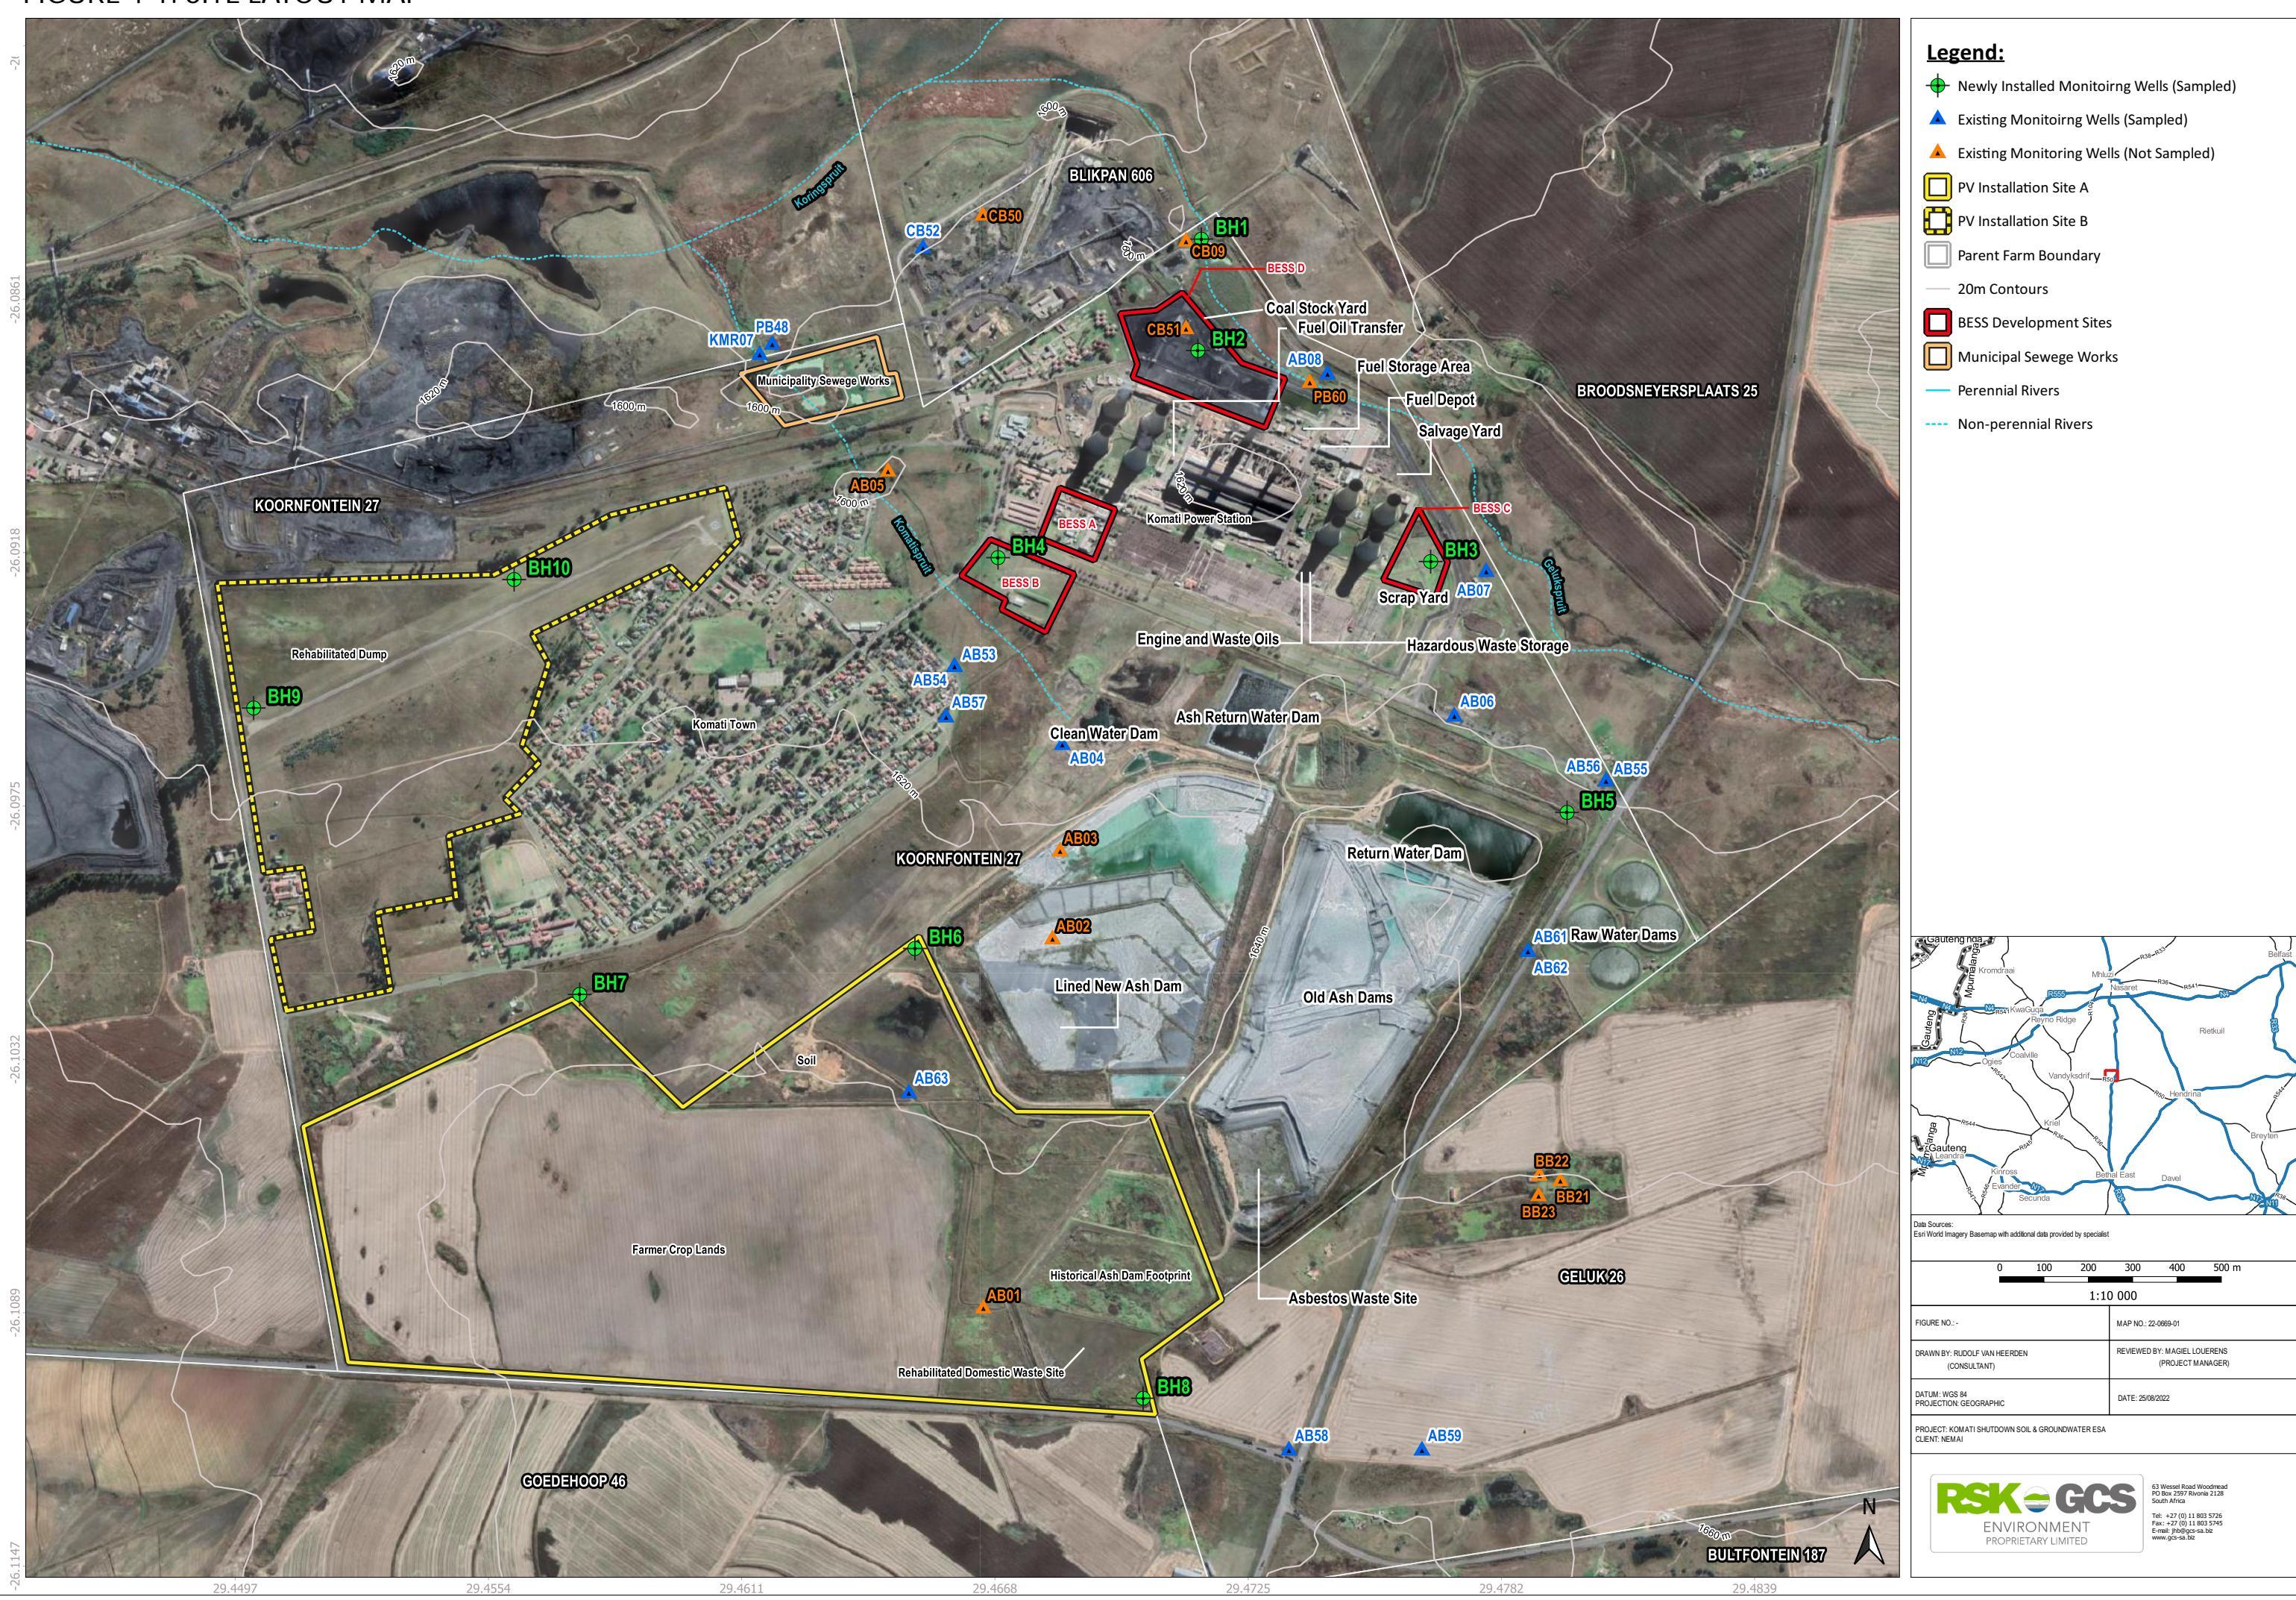
## FIGURE 4-1: SITE LAYOUT MAP

- c. Garage area
  - d. Hazardous waste storage area
  - e. Fuel storage area
  - f. Cooling towers
