<b>Eskom</b> Transmission	Guideline		Document Classificatio [TYPE CLAS			
	ION BIRD COL	LISION	Reference:	[TR	MNUMBER]	
PREVENTIO	N GUIDELINE		Revision:	0		
			Effective date:	Jun	e 2005	
			Total pages:	1	Of	4
			Revision date:	Jun	e 2008	
COMPILED BY	FUNC	CTIONAL F	RESP.	AUTH	ORIZED BY	
H.F. VOSLOO SERVITUDE SPECI C V ROOYEN EWT	E. SH	IUNMAGU MANAGEF		G. BR Fechi	UCE NOLOGY MA	 NAGER
DATE:	DATE	≣:		DATE:

# 1. Introduction

The purpose of this document is to describe the problem of bird collisions with transmission lines and to indicate which mitigation methods are available to address the problem.

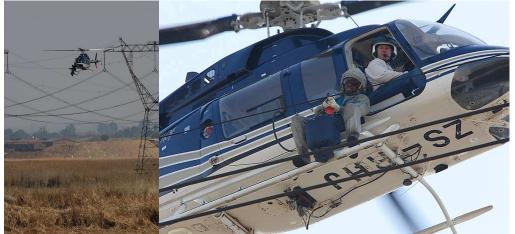
A measure that has been proved to be reasonably successful in reducing collisions is to fit the earth wire with anti-collision devices.

Figure 2: The installation of flappers on the shield wire from a helicopter.

Success rates of up to 60% reduction in mortality and even more have been documented (Ferrer and Janns, 1999). There are several devices available in southern Africa for the marking of power lines. These devices will be described below and the advantages and disadvantages discussed. The fitting of the marking devices are typically done from a helicopter, which adds considerably to the cost of any project.

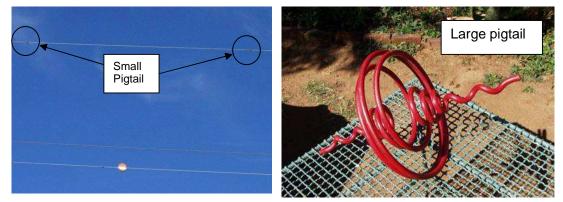
Static devices are mechanically more durable than dynamic devices because they lack the element of wear and tear that moving parts inevitably have. However, in South Africa, static devices, particularly the so called Bird Flight Diverter (also known as the pigtail) has had limited success (Anderson 2001). The most obvious reason seems to be that they are simply less visible, especially the small ones (see figure 5). A better option would be to use the bigger pigtail (see figure 5, right), although it is still not the preferred option.

# Figure 3: Example of static devices.

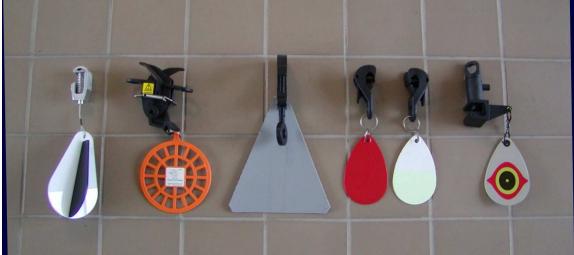
Dynamic devices (usually called bird flappers), have moving parts as opposed to static devices where there are none.. Dynamic devices are very effective in reducing collisions as the birds seem to see them very well (van Rooyen unp. data) probably because of the movement that attracts attention. The disadvantage of dynamic devices is that they are subject to extensive wear and tear, inevitably limiting the lifespan of the device. Wear could result on the device itself as well as on the cable to which it is attached.

Figure 4: Examples of the dynamic bird flapper devices

This has obvious cost implications if a line needs to be re-marked at intervals of a few years. No solution to that problem has been found to date and it must be accepted as a constraint. Figure 4 shows examples of bird flappers currently available on the market.

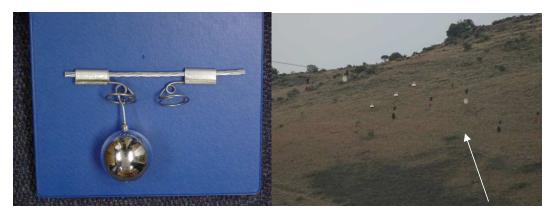
A new product that shows great potential is the Inotec BFD88, a reflective stainless steel sphere of 70mm diameter. Experiments have shown the visibility of this device to be superior to coloured (red, yellow, white, black) objects especially during the low light conditions at dawn and dusk when birds may be flying from roosting areas to feeding areas and back. Due to the spherical shape, the device reflects any available light in all directions and is therefore visible from all directions including above or below the diverter. The diverter does not require direct sunlight and is effective during overcast conditions and the low light conditions the device is particularly visible against dark backgrounds such as the ground, trees or high ground. It is also particularly visible against bright cloud when viewed from below.

Figure 5: A Reflective Bird Diverter (left) installed on a line with conventional bird flappers (right).

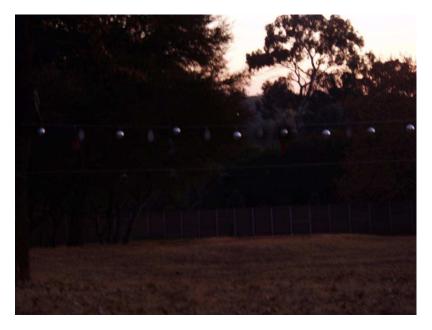
Figure 6: An example of reflective diverters on a test line at dusk with white conventional bird flappers in between

An option could be to string the Inotec NFD88 diverters close enough to form a dotted line on each earth wire on those spans crossing the river (see figure 6). Due to the relatively small size of the spheres, it would need to be spaced very close together to make it effective, maximum 5 metres apart on both earth wires.
