**Eskom Holdings (Ltd.)**

BASELINE WATER QUALITY POINTS

**Surface Geology and Sample Points**

Map 1

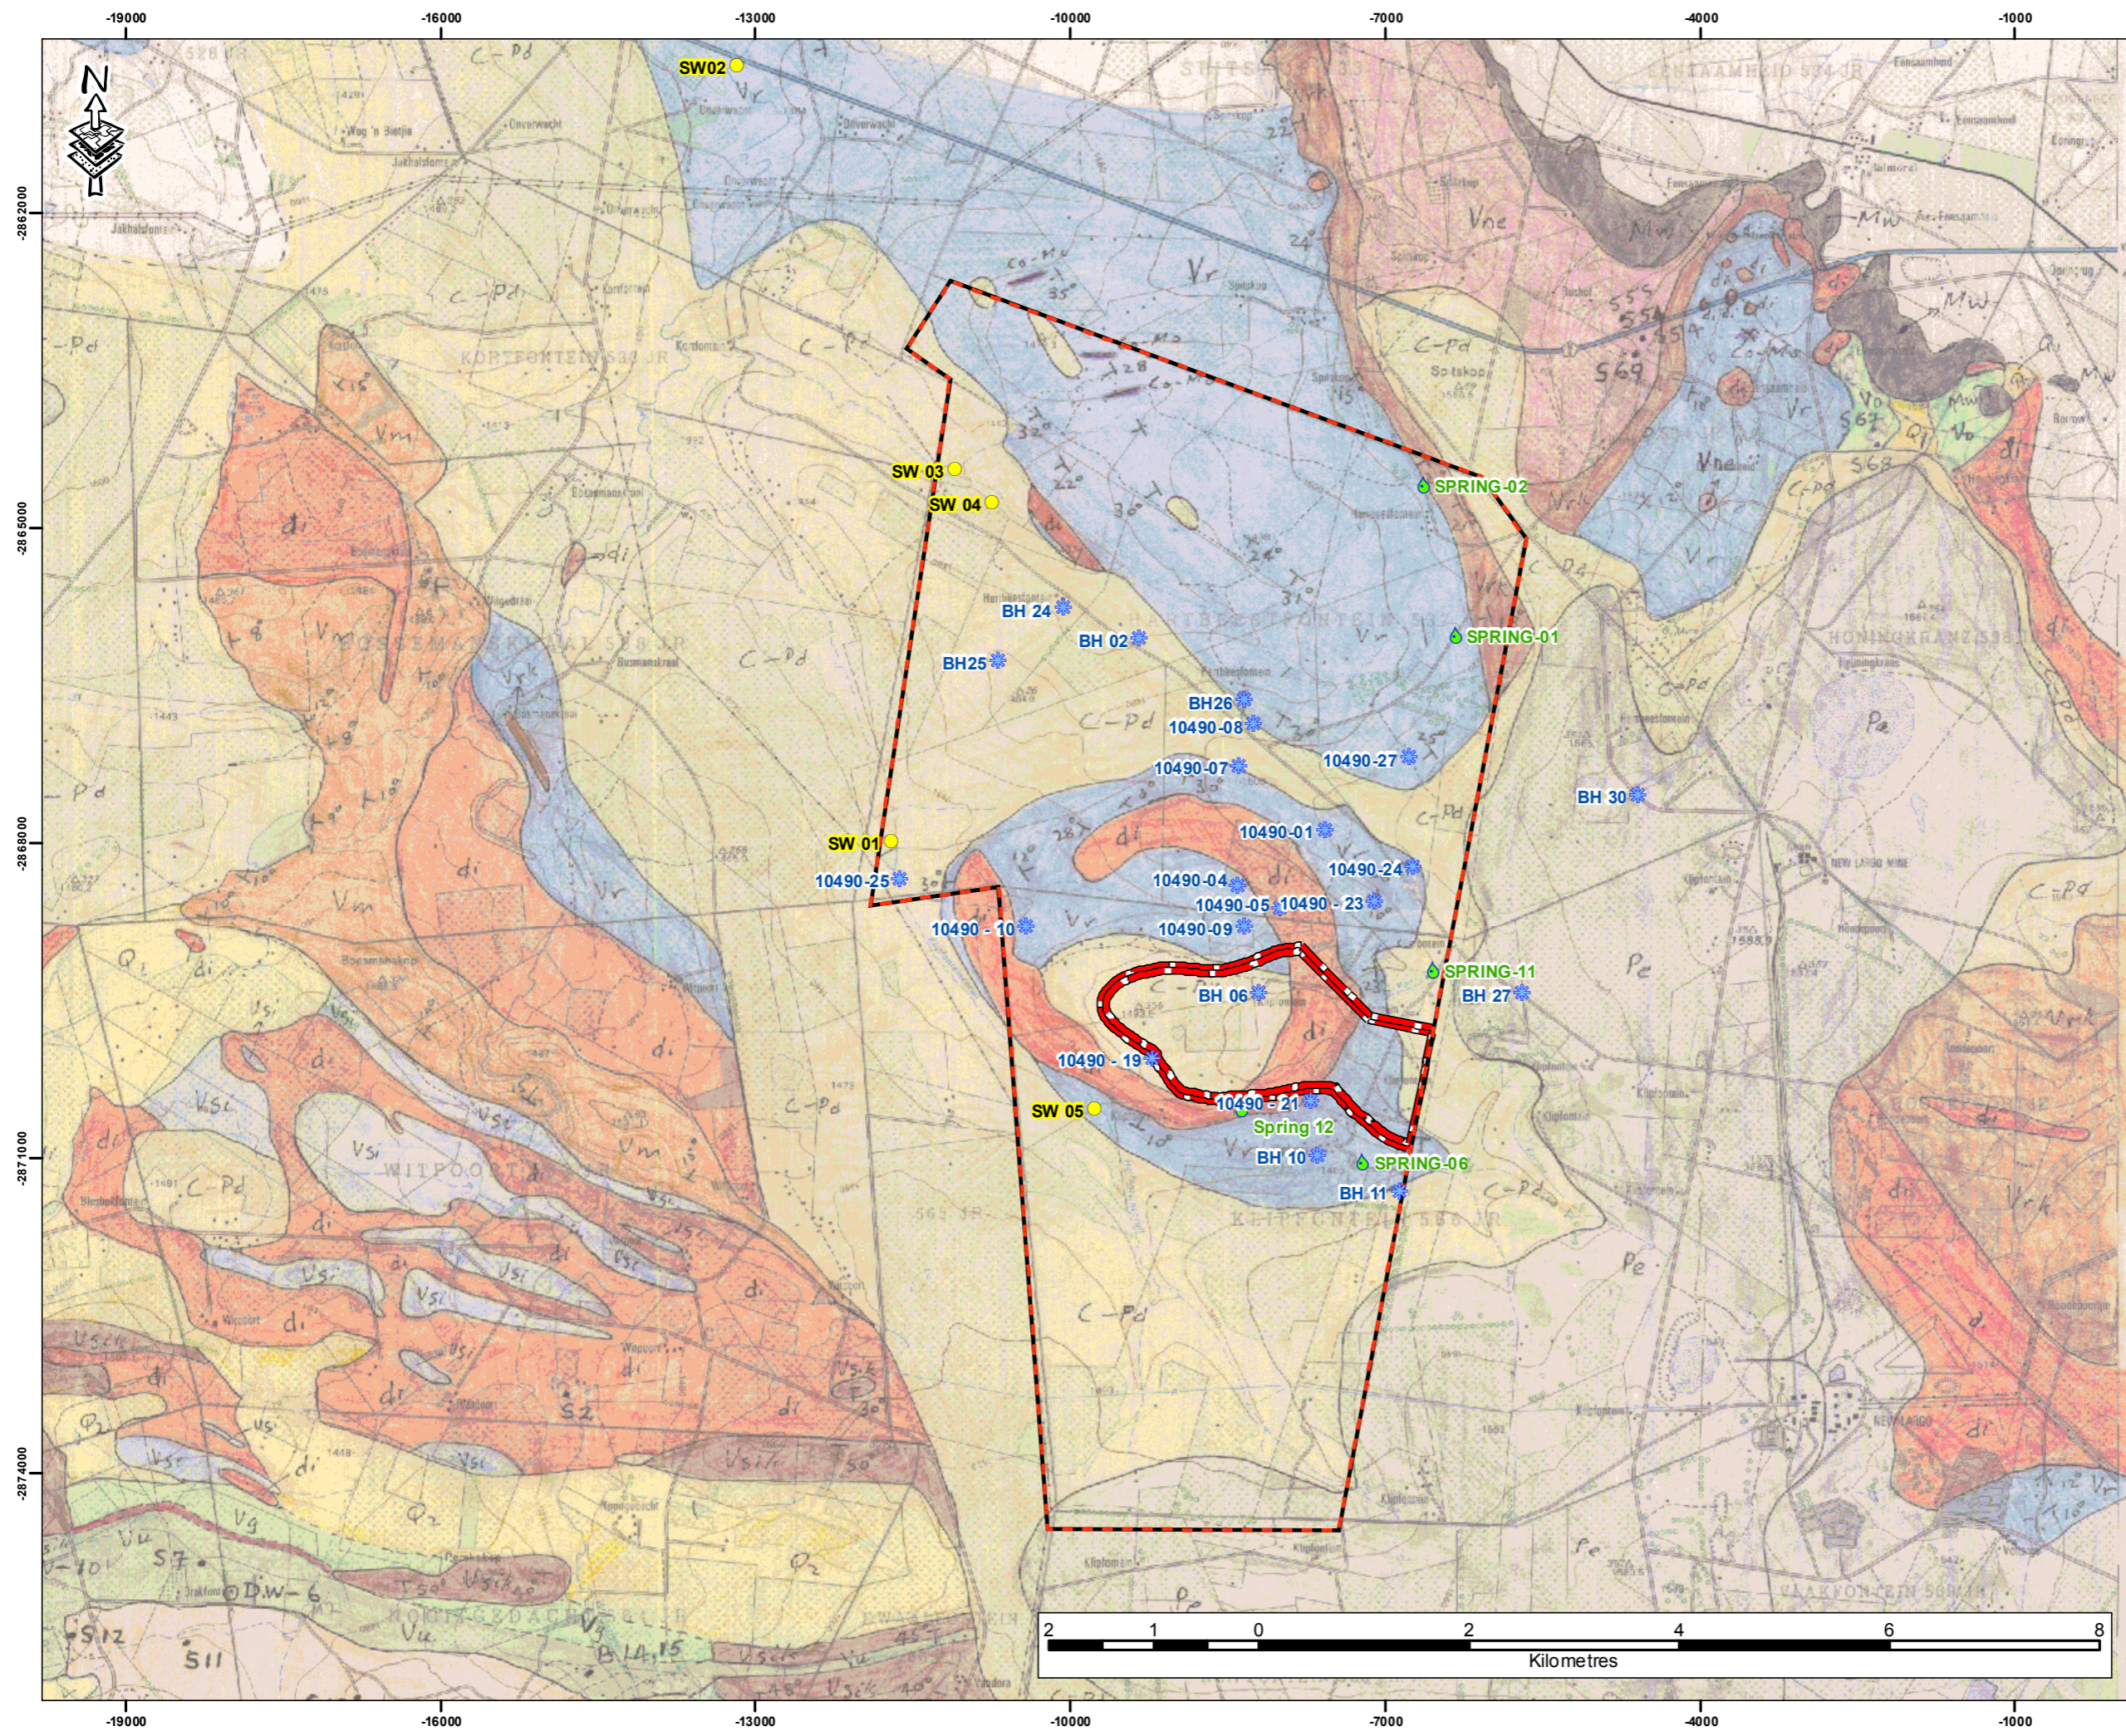
1:50 000  
 2526 Geology Map
