ENVIRONMENTAL IMPACT ASSESSMENT FOR A PROPOSED NUCLEAR POWER STATION ('NUCLEAR-1') AND ASSOCIATED INFRASTRUCTURE

Geotechnical Characterisation Assessment Study

March 2011

Prepared by: SRK Consulting (SA) (Pty) Ltd

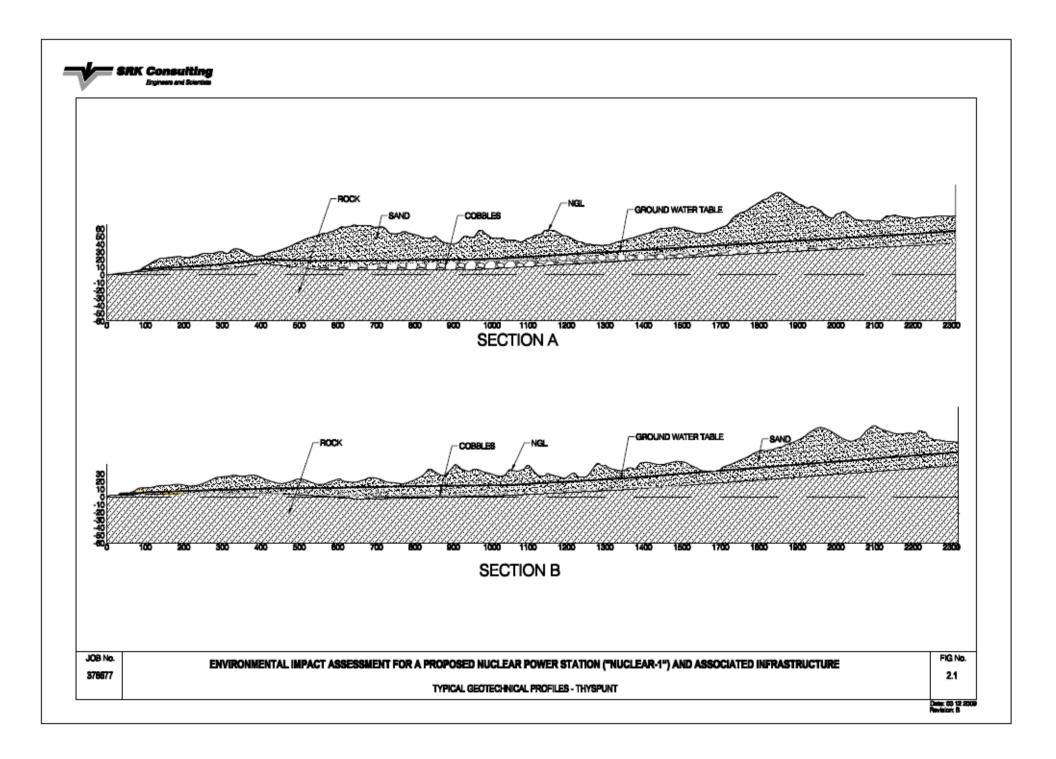
- Clay: 4%
- Silt: 3%
- Sand: 93%
- Gravel: 1%

The sand fraction is dominated by fine sand passing the 0.3 mm sieve.

The fines portion of the sand (clay and silt) exhibits low to no plasticity. The variable consistency of the site soils is a notable feature. The soils at Thyspunt are typical of coastal dune environments and with low density soils having no plasticity, these soils are highly susceptible to wind erosion. This stands to reason as the dune systems, although stabilised with vegetation currently, were in all likelihood historically roaming systems, their mobility reliant on wind-blown sands.

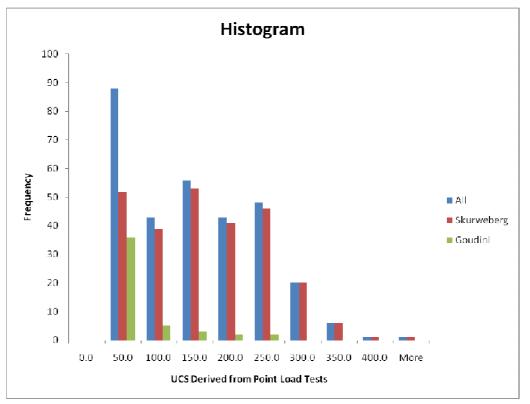
Figure 2.2: UCS (MPa) Derived from Point Load Tests – Thyspunt

Point load field tests were carried out on borehole core extracted from the Skurweberg and Goudini geological formations. Point load tests are done to give an indication of the likely rock strength in that the uniaxial compressive strength (UCS) of the rock can be derived from the point load test results. **Figure 2.2** shows a histogram of the UCS derived from point load testing.

The histograms indicate a wide range in UCS (derived from point load tests). Descriptive statistics for the data sets relevant to **Error! Reference source not found.** are shown in **Table 2.2**.

Skurweberg	Goudini	Both
Mean	160	79	122
Median	170	43	110
Standard Deviation	80	80	90
Range	412	350	427
Minimum	15	0	0
Maximum	427	350	427

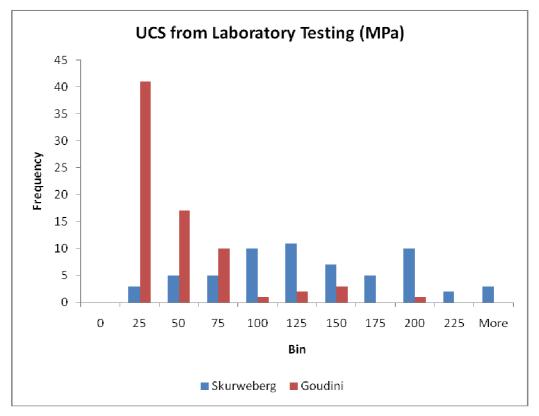
Figure 2.3: UCS (MPa) from Laboratory Analysis – Thyspunt

A comparison was made when the UCS was measured in a more controlled environment (i.e. in a laboratory). UCS values are lower than those derived from indicative point load tests as is often the case (point load tests often give elevated results). **Figure 2.3** indicates the histograms of UCS from laboratory testing and **Table 2.3** lists the relevant descriptive statistics.

Table 2.3:	UCS (MPa) from Laboratory Analysis - Thyspunt
------------	---

Skurweberg	Goudini	Both
Mean	120	35	74
Median	114	24	56
Standard Deviation	60	38	65
Range	250	194	252
Minimum	3.8	1.7	1.7
Maximum	254	196	254

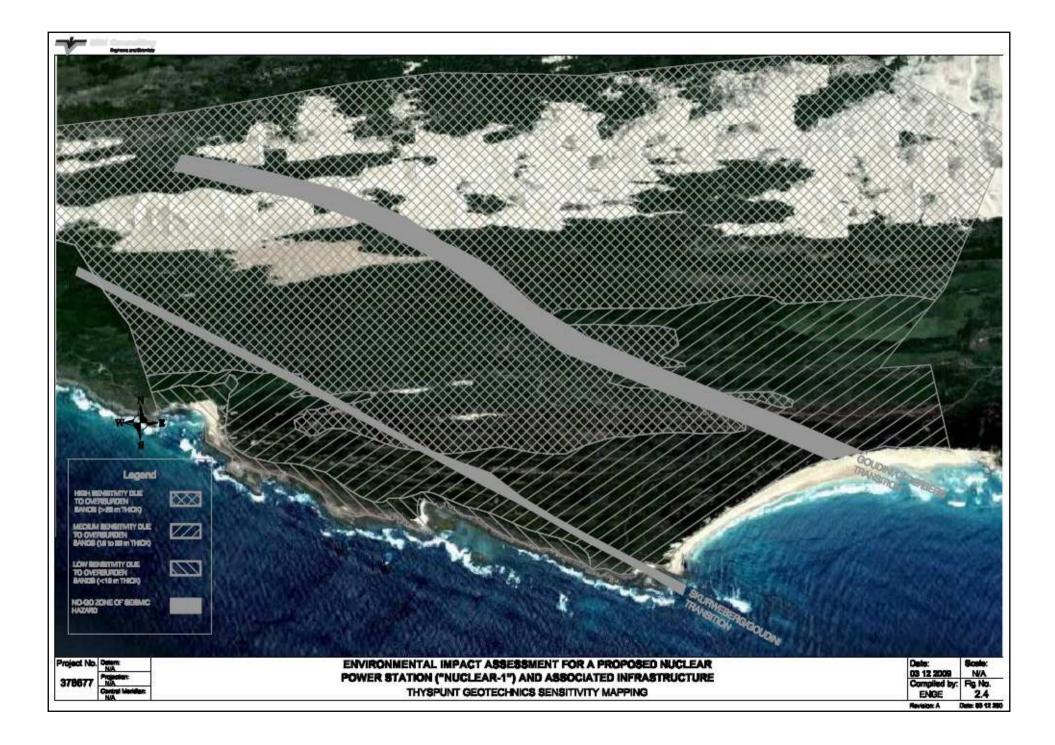
- LOW sensitivity is described as those areas where overburden sand is less than 10 m in vertical extent;
- MEDIUM sensitivity is described as those areas where overburden sand is between 10 and 20 m in vertical extent; and
- HIGH sensitivity is described by those areas where overburden sand is greater than 20 m in vertical extent.

Figure 2.4 shows these areas diagrammatically.

- Thyspunt: to place that part of the site to be founded on bedrock near the sea and minimise the excavation volumes and slope stability risks by siting in areas of less overburden thickness. Once again, this must be done within an effectively dewatered site;
- Bantamsklip: to place the site near the sea and minimise the excavation volumes and slope stability risks by siting in areas of less overburden. This must be done within an effectively dewatered site.

- At the Thyspunt and Bantamsklip sites, the final footprint should be placed as close to the sea as possible i.e. in that area where overburden sand thickness is least;
- The development foundations should not straddle the Goudini and Skurweberg Formations at Thyspunt as this will introduce complicated geotechnical design challenges;
- At the Duynefontein site, design alternatives aimed at minimising site disturbance in excavations must be explored.

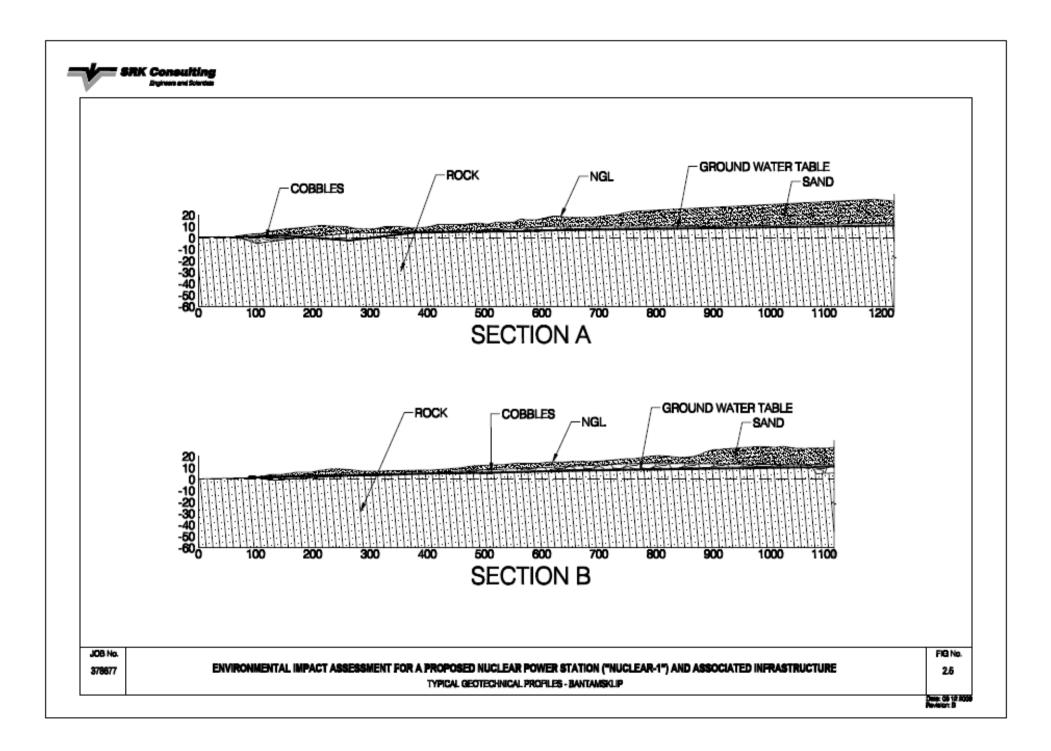
The fines portion of the grading (clay and silt) exhibits low to no plasticity. The consistency of the site soils is homogenous at the Bantamsklip site. The soils are typical of coastal dune environments and are highly susceptible to wind erosion in uncemented horizons.

The soils have no cohesion (except where calcrete has formed), and excavations within these soils will therefore require either lateral support or they will have to be battered back to safe angles. There are extensive calcrete zones within the site soils and lateral support on this site will be simplified by this as the calcrete lends cohesion to the sand.

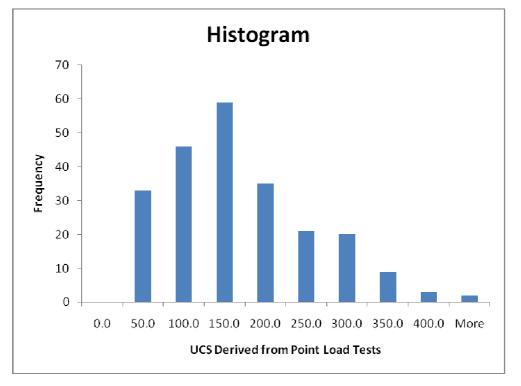
Figure 2.6: UCS (MPa) Derived from Point Load Tests – Bantamsklip

Point load field tests were carried out on core extracted from boreholes drilled at the site. **Figure 2.6** shows the distribution of UCS derived from point load testing for the Peninsula Formation quartzitic sandstones at the Bantamsklip Site.

The histogram indicates a wide range in UCS (derived from point load tests). Descriptive statistics for the data set relevant to **Figure 2.6** are shown in **Table 2.5**.

Mean	146.46	
Median	129.69	
Standard Deviation	89.05	
Range	423.7	
Minimum	3.44	
Maximum	427.14

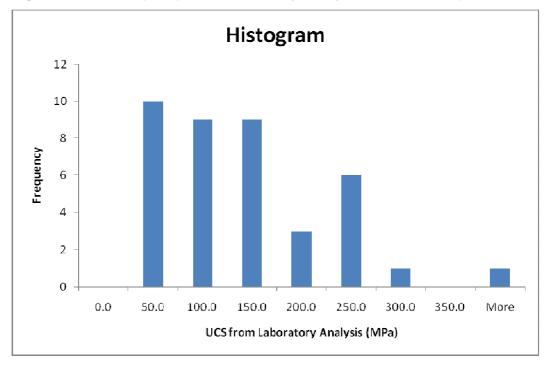
Figure 2.7: UCS (MPa) from Laboratory Analysis – Bantamsklip

The distribution of UCS measured under laboratory conditions is shown in Figure 2.7.

Descriptive statistics for the data sets relevant to Figure 2.7 are shown in Table 2.6.

The average UCS value obtained in the laboratory is higher than that derived from point load tests, but the standard deviation in results is also higher. These variations in measured rock strength are almost certainly related to the highly jointed/fractured nature of the rocks. It is therefore difficult to make a comparison of these results, except to say that the quartzitic sandstones at this site have high UCS.

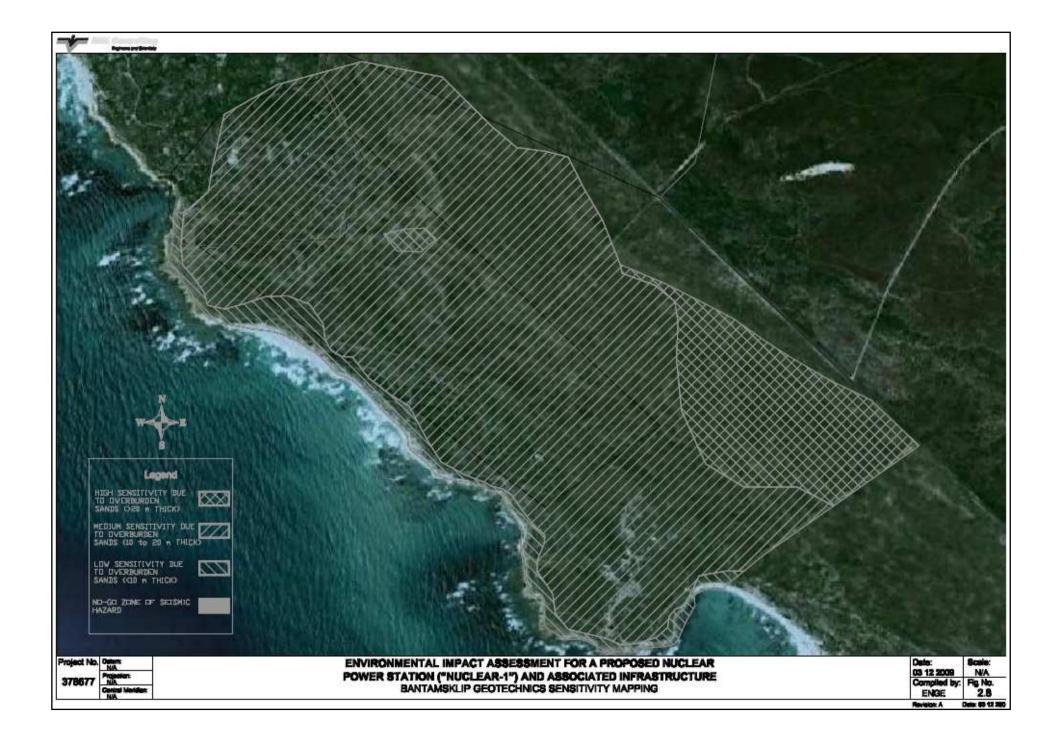
Based on the above, the Bantamsklip site has been assessed relative to the site sensitivity from a geotechnical characterisation viewpoint on the same criteria as Thyspunt.

Figure 2.8 shows these areas diagrammatically.

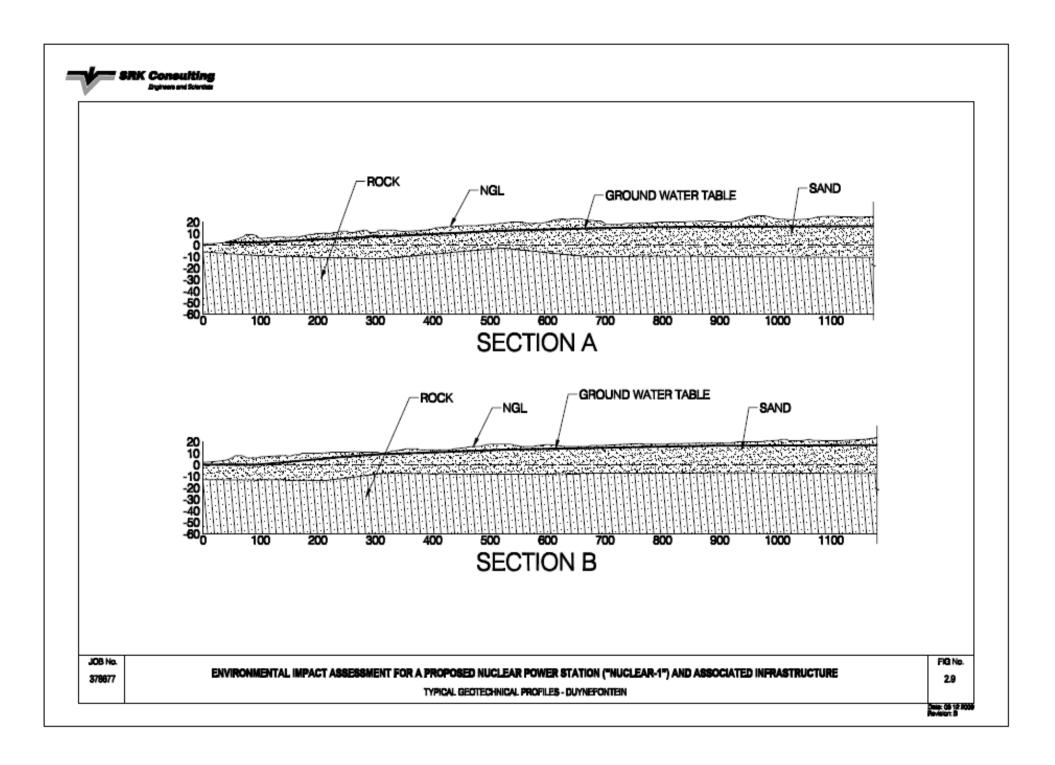
The geotechnical profile of the Duynefontein site has evolved from desk top and intrusive field investigations. Typical geotechnical profiles (parallel to the coast) for the Duynefontein site are shown in **Figure 2.9**: Typical Geotechnical Profiles – Dynefontein

, once again highlighting the soil, rock and groundwater table profiles.

The site soil profile (as shown in **Figure 2.9:** Typical Geotechnical Profiles – Dynefontein

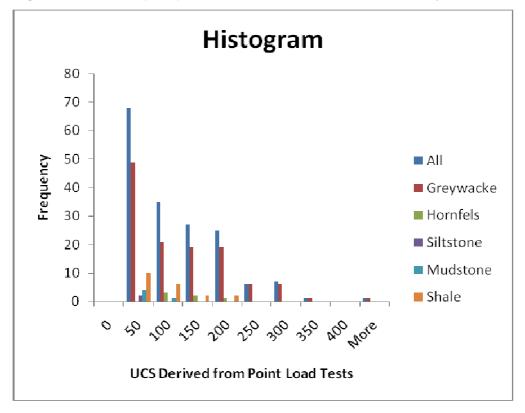
Figure 2.10: UCS (MPa) Derived from Point Load Tests – Duynefontein

Point load field tests were carried out on core produced from boreholes drilled at the Duynefontein site. **Figure 2.10** shows a histogram of the UCS derived from point load testing for the Malmesbury Group rocks underlying the site.

The histogram indicates a wide range in UCS (derived from point load tests). The primary reason for this is the varying geology tested. Descriptive statistics for the data set relevant to **Figure 2.10** are shown in **Table 2.8**.

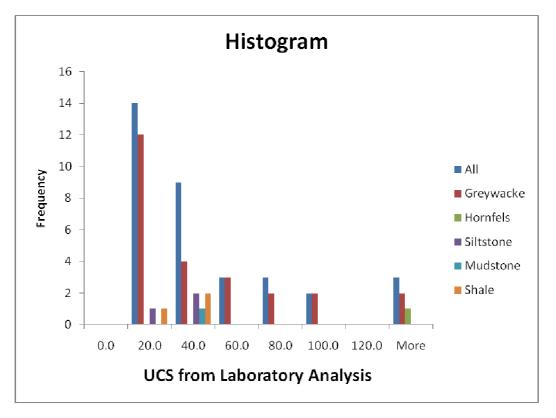
Figure 2.11: UCS (MPa) from Laboratory Analysis – Duynefontein

The distribution of UCS measured under laboratory conditions is shown in **Figure** 2.11.

Descriptive statistics for the data sets relevant to Figure 2.11 are shown in Table 2.9.

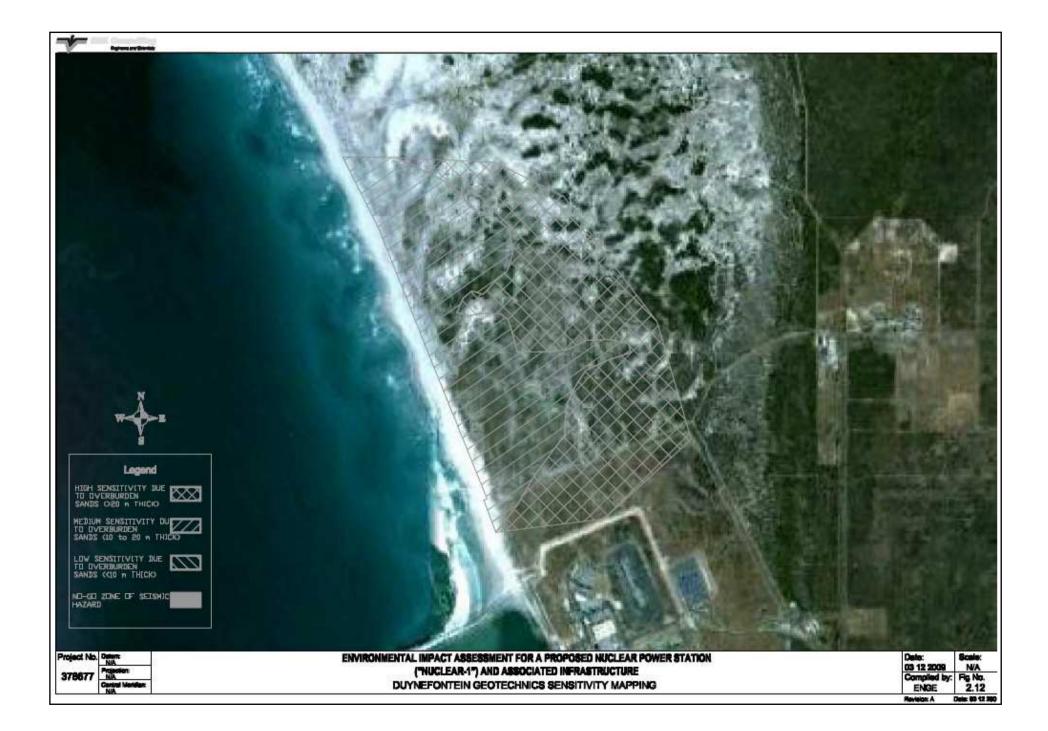
Based on the above, the Duynefontein site has been assessed relative to the site sensitivity from a geotechnical characterisation viewpoint on the same criteria as Thyspunt.

Figure 2.12 shows these areas diagrammatically.
