## DRAFT BASIC ASSESSMENT REPORT (DBAR)

PROPOSED ESKOM HOLDINGS (SOC) LIMITED BATTERY ENERGY STORAGE
SYSTEM (BESS) ELANDSKOP SUBSTATION, LOCATED WITHIN THE MSUNDUZI
LOCAL MUNICIPALITY, uMGUNGUNDLOVU DISTRICT MUNICIPALITY, KWAZULUNATAL

[November 2019]

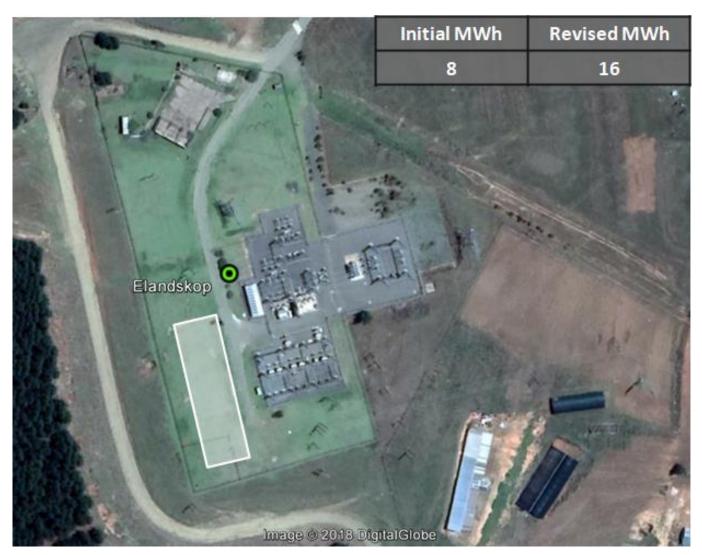
Figure 3: Elandskop Substation and Proposed Area for BESS (white), (Eskom, 2019)

The Elandskop Substation has been identified and noted to have sufficient space to accommodate the proposed Battery Energy Storage System (BESS). No acquisition of land and rezoning is required. The following criteria was implemented to determine substations that qualify for the BESS project.:

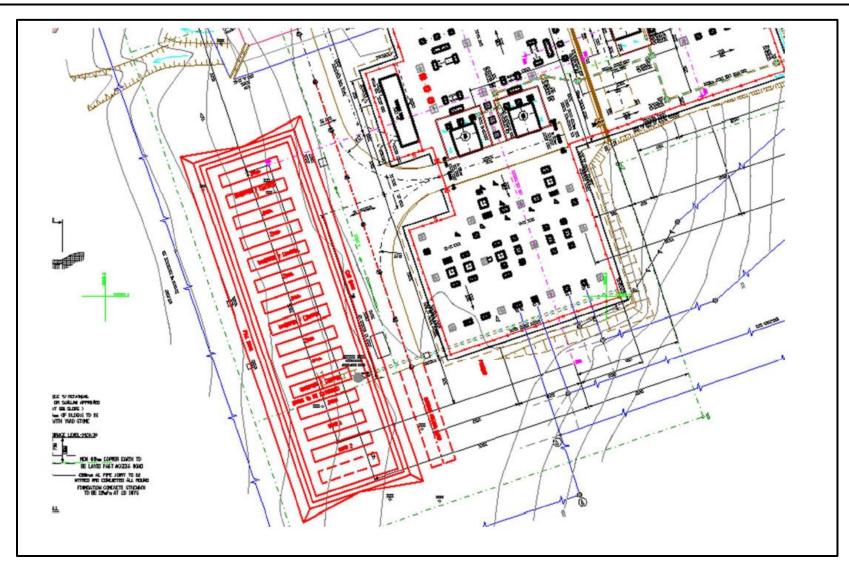
Figure 4: Conceptual Design of the Elandskop Substation and Proposed Area for BESS (Red), (Eskom, 2019)

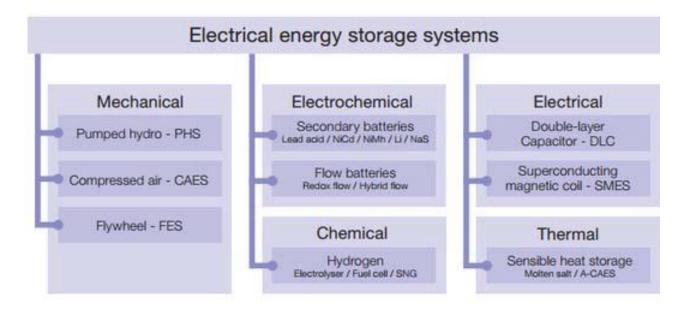
Figure 5: Electrical Energy Storage Systems (Eskom Technology, 2018)

BESS technology is categorised as Electrochemical and/or chemical solutions as per Figure 5 above. Research on battery technology is based on Lithium-ion and Flow Battery technologies. BESS technology is continuously developing and very fast leading to greater capacity and lower costs. The proposed battery energy storage system has not been classified as electricity generation nor distribution. The batteries are not able to charge itself. Electricity generation from renewable sources is limited by the intermittency and variability of wind and solar resources, i.e. when wind blows and sun shines. Energy storage allows for the storing of electricity for later use even when the renewable resource is unavailable. The process involves the conversion of electrical energy into another form of energy such as chemical energy, store it temporarily and then converted back to electrical energy, therefore giving the utility considerable flexibility and control.

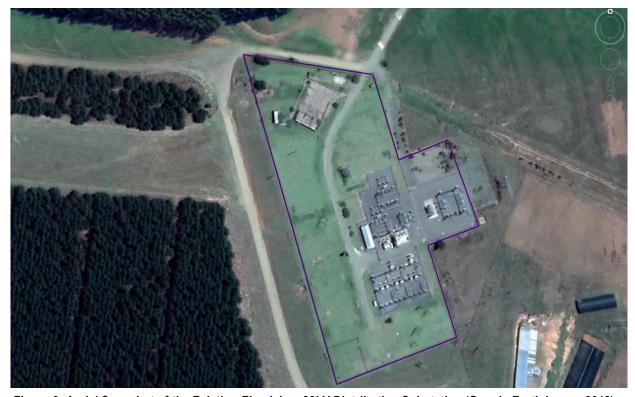
Figure 6: Aerial Snapshot of the Existing Elandskop 88kV Distribution Substation (Google Earth Image, 2018)

At 19 124m² in size, the site is large enough to accommodate the BESS infrastructure. The property is fenced; however, the site is categorized as "disturbed". Agricultural activities have not been undertaken on the site, however, during the site inspection remains on foundation was found on site. This is an indication that there previously was a building erected and demolished on site. The Elandskop 88kV Distribution Substation was established in 1993, hence the site is regarded as significantly and irreversibly transformed. The BESS project for this site does not require expansion of the site footprint from current.

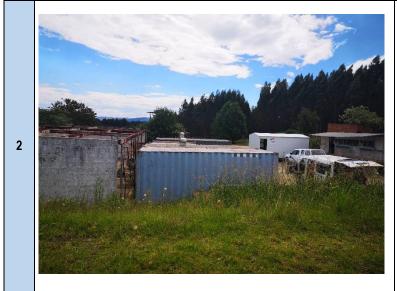
Snapshot 2: depicts containers / offices located at the entrance of the access point at the Elandskop Substation.

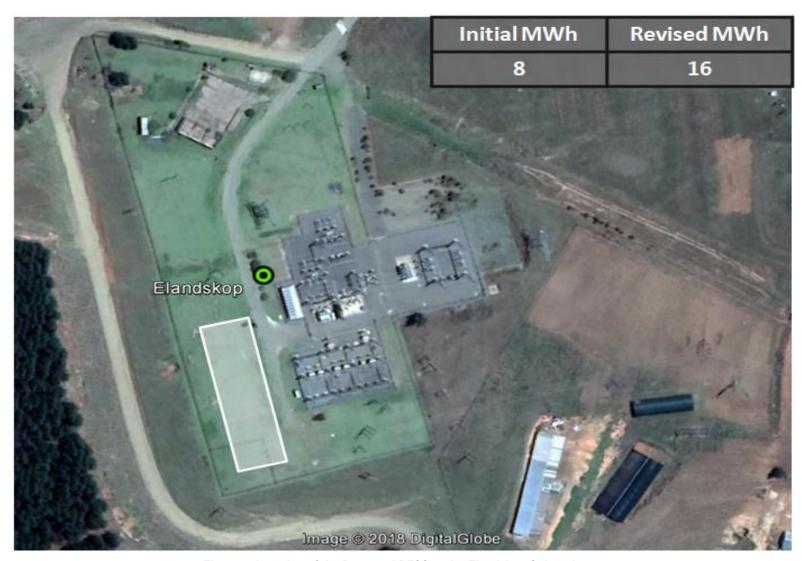
Figure 7: Location of the Proposed BESS at the Elandskop Substation

Figure 7 below is an Environmental Sketch of where BESS is proposed. The battery storage will remain within the property boundary.

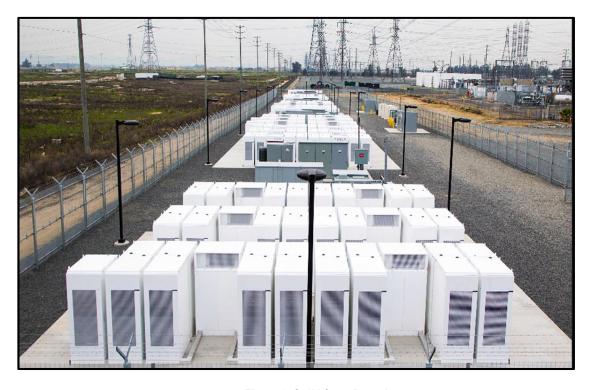
Figure 8: Solid State Batteries

8.4.1. <u>Solid State Batteries:</u> Solid State Batteries comprise of Lithium-ion, approximately 4.08 Cubic Meters per 1MWh (Exact amount of hazardous substance is unknown at this stage and will differ from supplier to supplier).

Figure 8 below is a typical setting / layout of Solid-State Batteries.

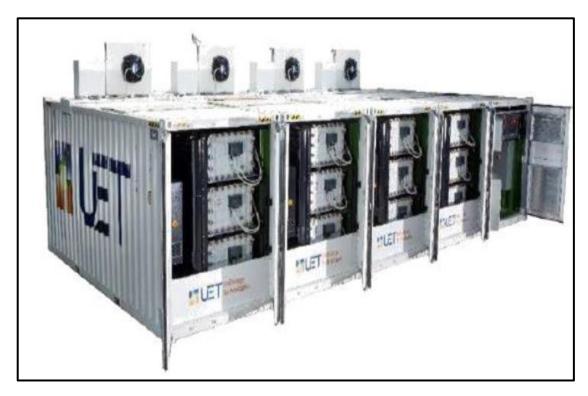
Figure 9: Flow Batteries - Vanadium Redox Battery

Figure 9 below is a typical Vanadium Redox Battery.

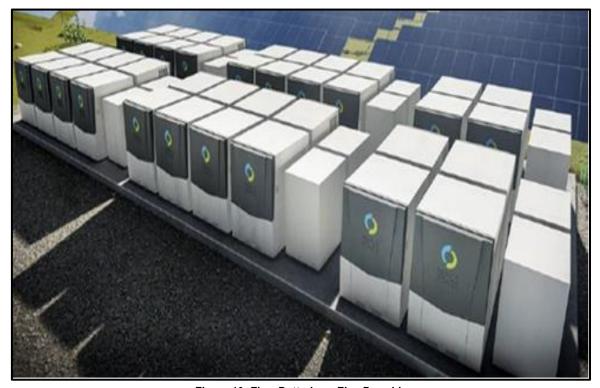
Figure 10: Flow Batteries - Zinc Bromide

- b. Zinc Bromine Battery:
  - Zinc Bromine flow battery uses a solution of Zinc bromide stored in two tanks the electrolyte is pumped from one tank to the other tank during the charging and discharging process.

Figure 10 below is a typical Zinc Bromide Battery.

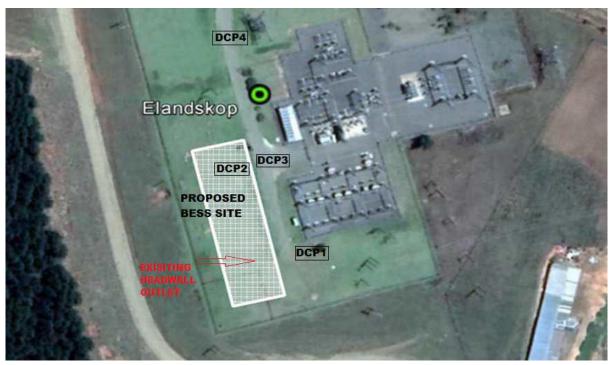
Figure 13: DCP Test Positions (Geotechnical Report, 2019)

A geotechnical investigation was conducted on 20 May 2011 and was re-evaluated on 14 August 2019 to include the BESS scope and requirements. It was noted that the soil encountered was soft, red, and sandy soils. No water table was encountered. During the fieldwork, four Dynamic Cone Penetrometer (DCP) Tests were undertaken. The tests were conducted with a 1m rod on the access road and terrace extension. The test position is indicated in Figure 13 below.

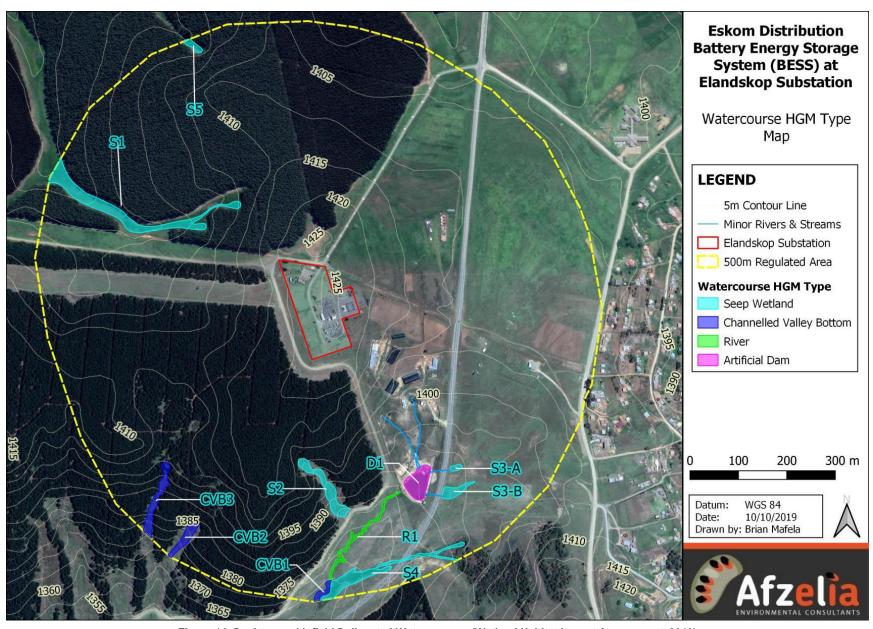
Figure 14: Desktop and Infield Delineated Watercourses (Wetland Habitat Impact Assessment, 2019)

HGM ID	HGM Type	Size	Risk
S1	Seep Wetland	0.735 Ha	
S2	Seep Wetland	0.262 Ha	
CVB1	Channelled Valley Bottom Wetland	0.065 Ha	
R1	River (Mountain Stream)	0.134 Ha	
S3	Seep Wetland (Includes sub-units S3-A and S3-B)		Not assessed further
S4	Seep Wetland		Not assessed further
S5	Seep Wetland		Not assessed further
CVB2	Channelled Valley Bottom Wetland		Not assessed further
CVB3	Channelled Valley Bottom Wetland		Not assessed further
D1	Artificial Dam		Not assessed further

Figure 14 below indicates the desktop and infield delineated watercourses.
