Environmental Impact Assessment for the Proposed Expansion of Ash Disposal Facilities at the Hendrina Power Station, Mpumalanga Province

July 2015

# FINAL ENVIRONMENTAL IMPACT ASSESSMENT REPORT

# **VOLUME 1**

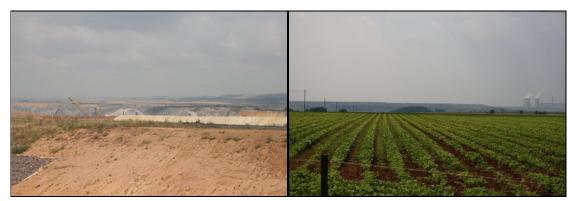
Figure 2: The agricultural and mining activities that form the greater part of the study

The greater part of the study area is made up of agricultural and mining activities (Figure 2). The proposed site for the proposed new wet ash disposal facility at Hendrina Power station is located directly adjacent to the existing wet ash disposal facilities and is currently utilised for agriculture (Figure 3).
