1. Introduction

2. The threat of soil erosion in the servitude.

The purpose of this guideline is to highlight the need for the control of erosion in Transmission servitudes and to introduce alternative methods for the prevention of erosion.

This guideline shall be applicable to Eskom Transmission Division.

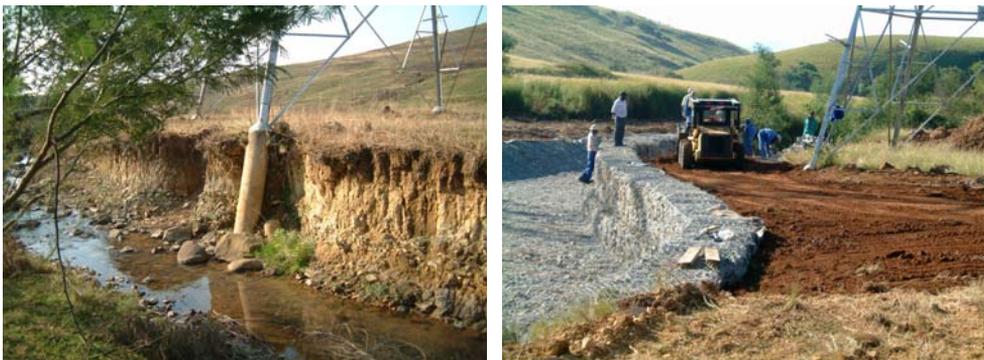
Figure 1: The photo on the left shows the foundation of a tower exposed by erosion. The photo on the right shows the extensive and costly remediation by using gabions and reno mattresses. Also note the use of good topsoil that will permit the re-establishment of vegetation around the tower (photos Jorge Correia).

- In the first case, erosion in the vicinity of the tower could threaten its structural integrity. Failure to remedy the situation may lead to the collapse of the tower and line.

- **Heavy systems:** These solutions include concrete or brick structures and gabions and reno mattresses, etc. (refer to figure 1). Concrete or cement structures can be constructed on solid rock foundation or they could be floating structures. Several publications on the planning and design of these structures are available from the Agricultural Research Council as well as from commercial companies. The choice between gabions and concrete structures depends inter alia on the availability of rocks. Care should be taken not to disturb the environment where rocks are collected as this could result in the creation of new erosion problems.

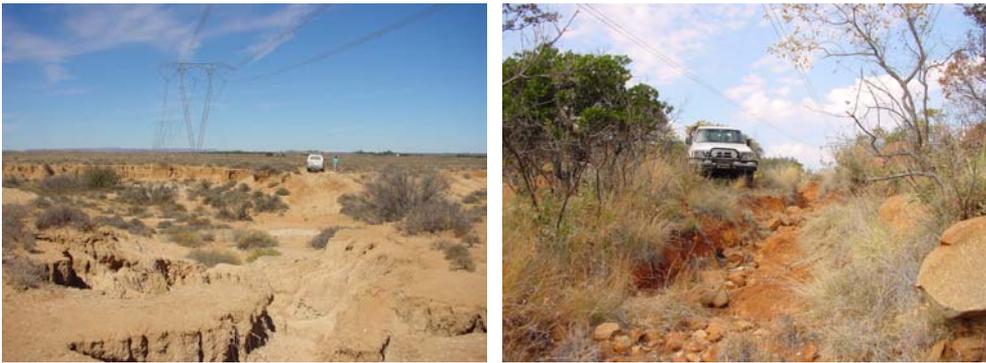
Figure 2. Examples of erosion in the servitude, which hampers access during maintenance and emergencies.

- Secondly, erosion in the area between towers may not threaten the towers directly or initially, but will prevent access for maintenance or emergency repair purposes.

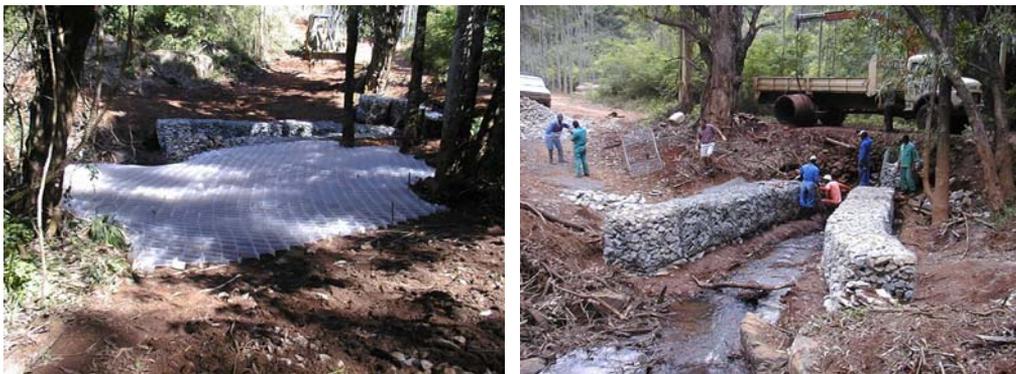
Figure 3. Extensive measures taken to prevent erosion, during the construction of access roads for a new power line. Continuous cellular mat (left) and gabions (right) are some of the measures used during the building of access roads during the construction phase of a power line. (Photos: Jose Clara).

Areas that have highly erodable soils as well as areas in the vicinity of watercourses require special measures as shown above in figure 3 above.

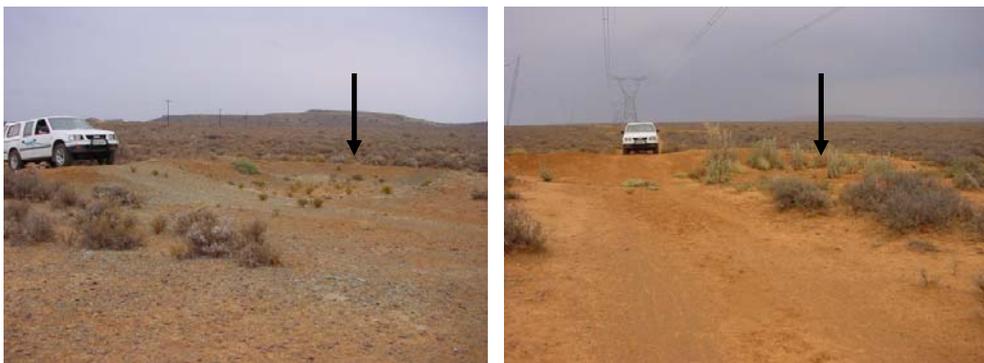
Figure 4. Examples of well constructed berms under the Hydra-Droërivier 1&3 lines. This design uses an overflow dam to spread water collected by the berm (see arrows). After ten years virtually no maintenance is required on these structures.

Regular spacing of berms will prevent the formation of erosion of the access roads. These should be spaced as follows:

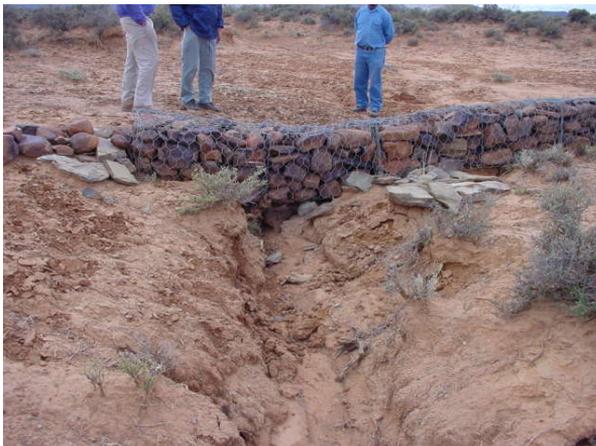
Figure 5. An example of an inappropriately designed gabion. No geotextile or apron was used in this case and erosion eventually occurred under the structure. No provision was made to prevent erosion at the overflow.

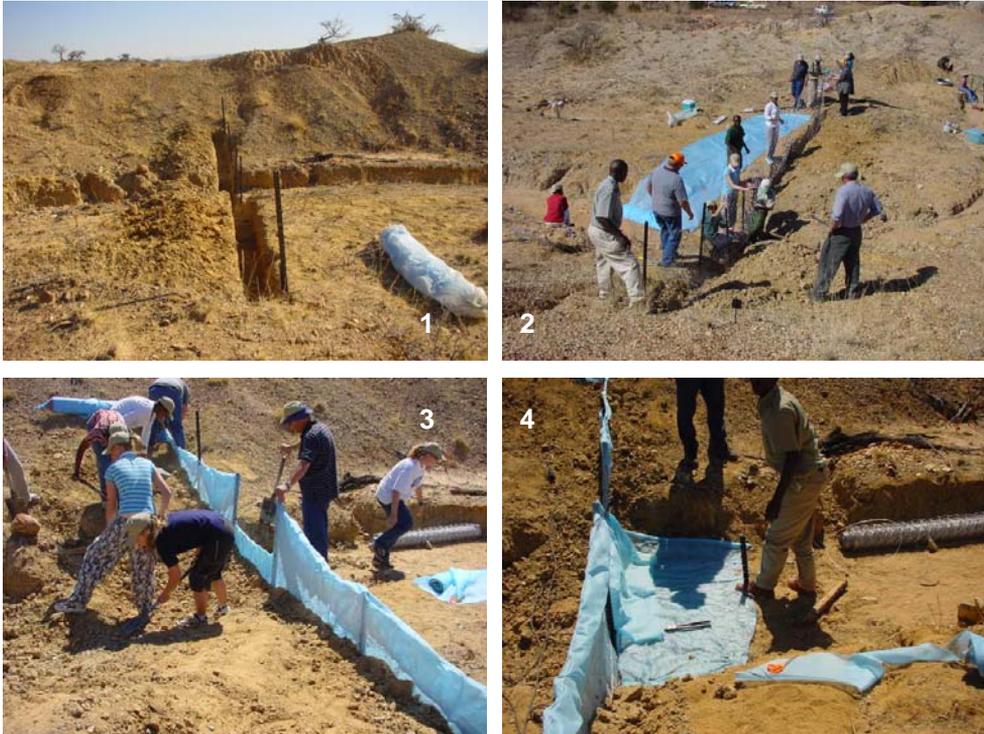
Figure 6 shows the steps in the construction of a silt-screen. Girls from two schools in Pretoria on the Mabula Game farm carried out this exercise. In photo 1 the trench is dug across the erosion channel and Y standards are placed to form the main part of the structure. In photo 2 the Y standards are connected with stay wires and covered with wire mesh. The structure is then covered with a biodegradable geo-textile in photo 3. In photo 4 the structure is completed by adding an apron, made of geo-textile and wire mesh.

The silt-screen is used to trap small particles and seeds, whilst permitting the water to pass through. In this way the fertile trapped soil will permit the re-growth of vegetation and aid the stabilization of the soil. These structures are placed at intervals such that the re-growth of the one structure will reach the overflow of the previous one.

These structures are cheap to construct and the material that is used is a very strong knitted polyethylene, which is biodegradable and will not pollute the environment. The structures are spaced at intervals, which are determined by the slope, vegetation and soils present. (van Heerden 2000, p3-4). A typical design appears in Annexure A

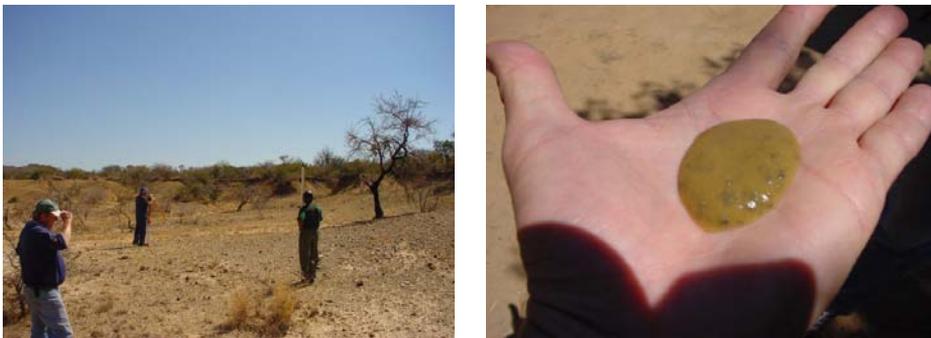
Figure 7. The photo on the left shows an area without topsoil or plant material. The position of the contour is being determined. The photo on the right shows the silicate mineral after water has been added.

To overcome this problem, use is made of a silicate water-retaining mineral. This mineral absorbs water during rain and then retains it. The water does not evaporate but remains accessible to the plants.

The silicate water retardant will absorb water during rains, but will then retain it for use by the plants during dry spells. Because the geo-textile material is biodegradable, it will decompose with time after the plants have established themselves.

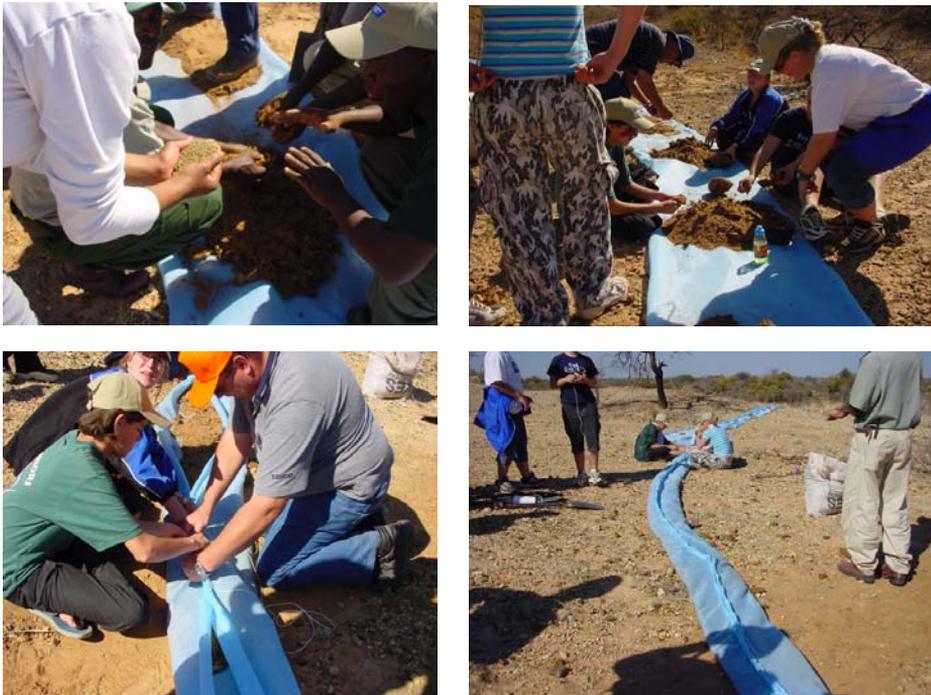
Figure 8. The photo's show the mixing of the soil, the manure seed and silicate mineral before placing it in the geotextile bags.

Recently, the following procedure was suggested for soil reclamation. A mixture of soil, manure, seeds and a silicate water retardant mineral is mixed and placed in long bags made of a geotextile. These bags are then pinned to the ground, following the contour.
