ENVIRONMENTAL IMPACT ASSESSMENT FOR A PROPOSED NUCLEAR POWER STATION ('NUCLEAR-1') AND ASSOCIATED INFRASTRUCTURE

Geotechnical Characterisation Assessment Study

March 2011

Prepared by: **SRK Consulting (SA) (Pty) Ltd**

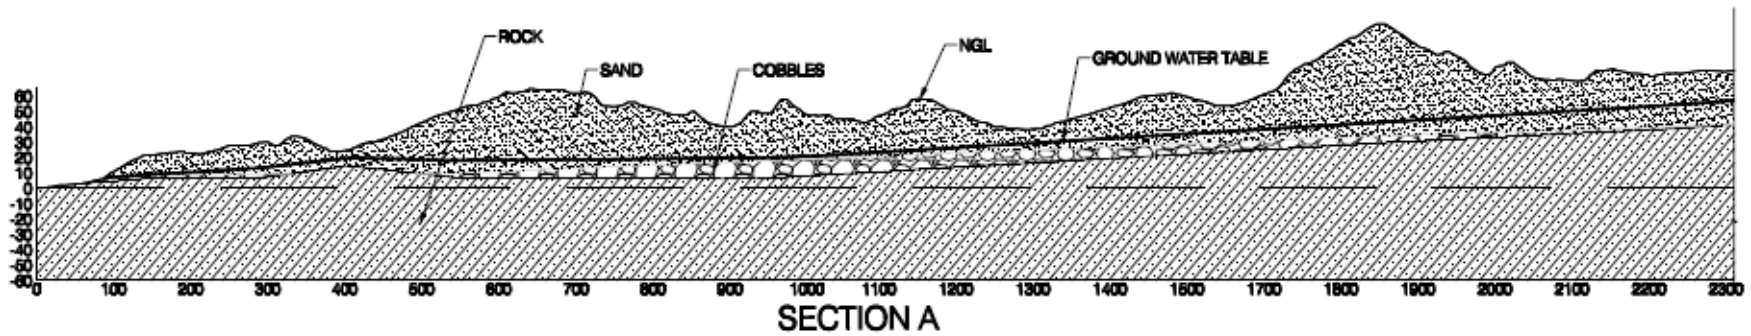
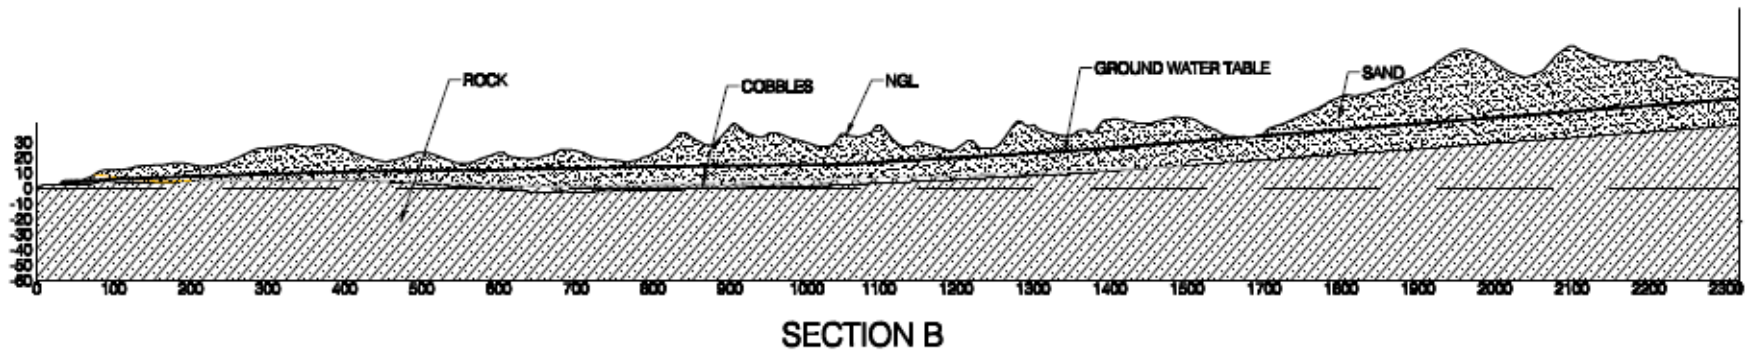
JOB No.
376877

- Clay: 4%
- Silt: 3%
- Sand: 93%
- Gravel: 1%

The sand fraction is dominated by fine sand passing the 0.3 mm sieve.

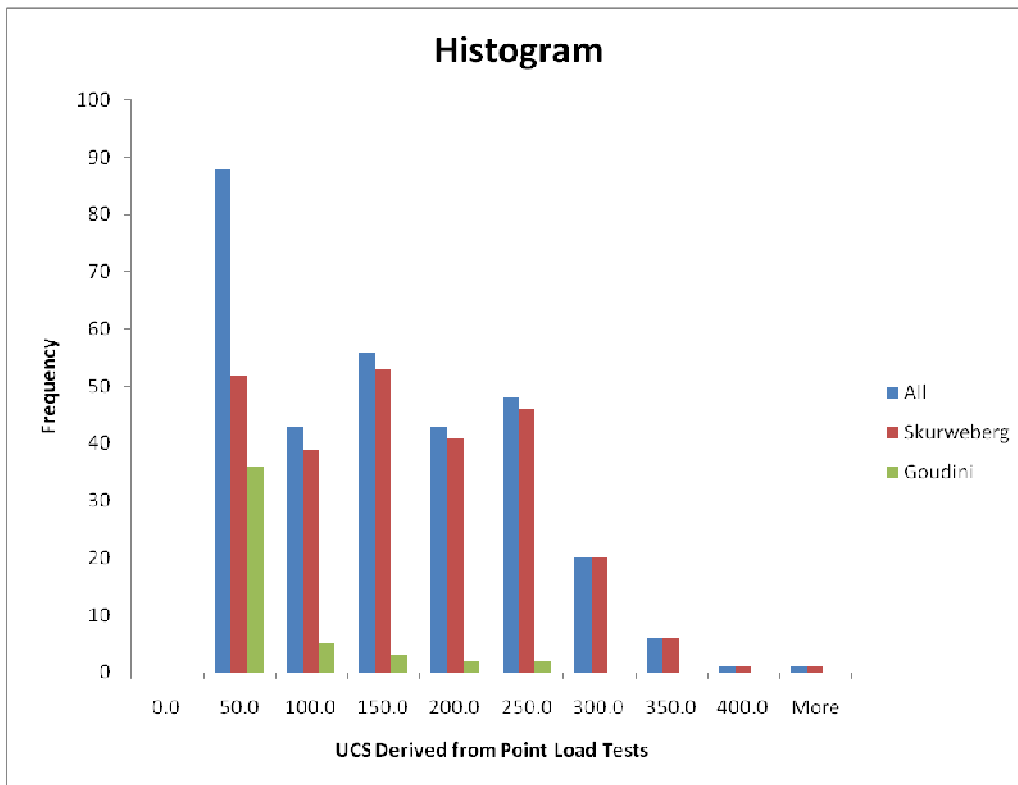
Figure 2.2: UCS (MPa) Derived from Point Load Tests – Thyspunt

Point load field tests were carried out on borehole core extracted from the Skurweberg and Goudini geological formations. Point load tests are done to give an indication of the likely rock strength in that the uniaxial compressive strength (UCS) of the rock can be derived from the point load test results. **Figure 2.2** shows a histogram of the UCS derived from point load testing.

The histograms indicate a wide range in UCS (derived from point load tests). Descriptive statistics for the data sets relevant to **Error! Reference source not found.** are shown in **Table 2.2.**

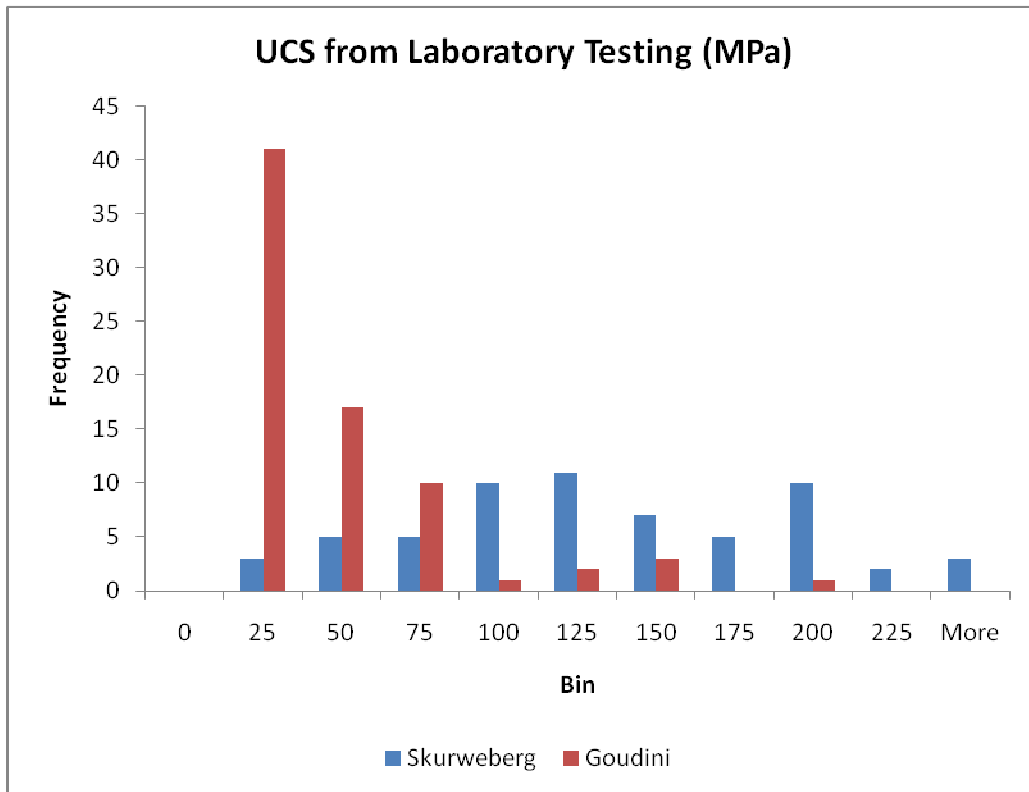
Figure 2.3: UCS (MPa) from Laboratory Analysis – Thyspunt

A comparison was made when the UCS was measured in a more controlled environment (i.e. in a laboratory). UCS values are lower than those derived from indicative point load tests as is often the case (point load tests often give elevated results). **Figure 2.3** indicates the histograms of UCS from laboratory testing and **Table 2.3** lists the relevant descriptive statistics.

Skurweberg	Goudini	Both
Mean	120	35	74
Median	114	24	56
Standard Deviation	60	38	65
Range	250	194	252
Minimum	3.8	1.7	1.7
Maximum	254	196	254

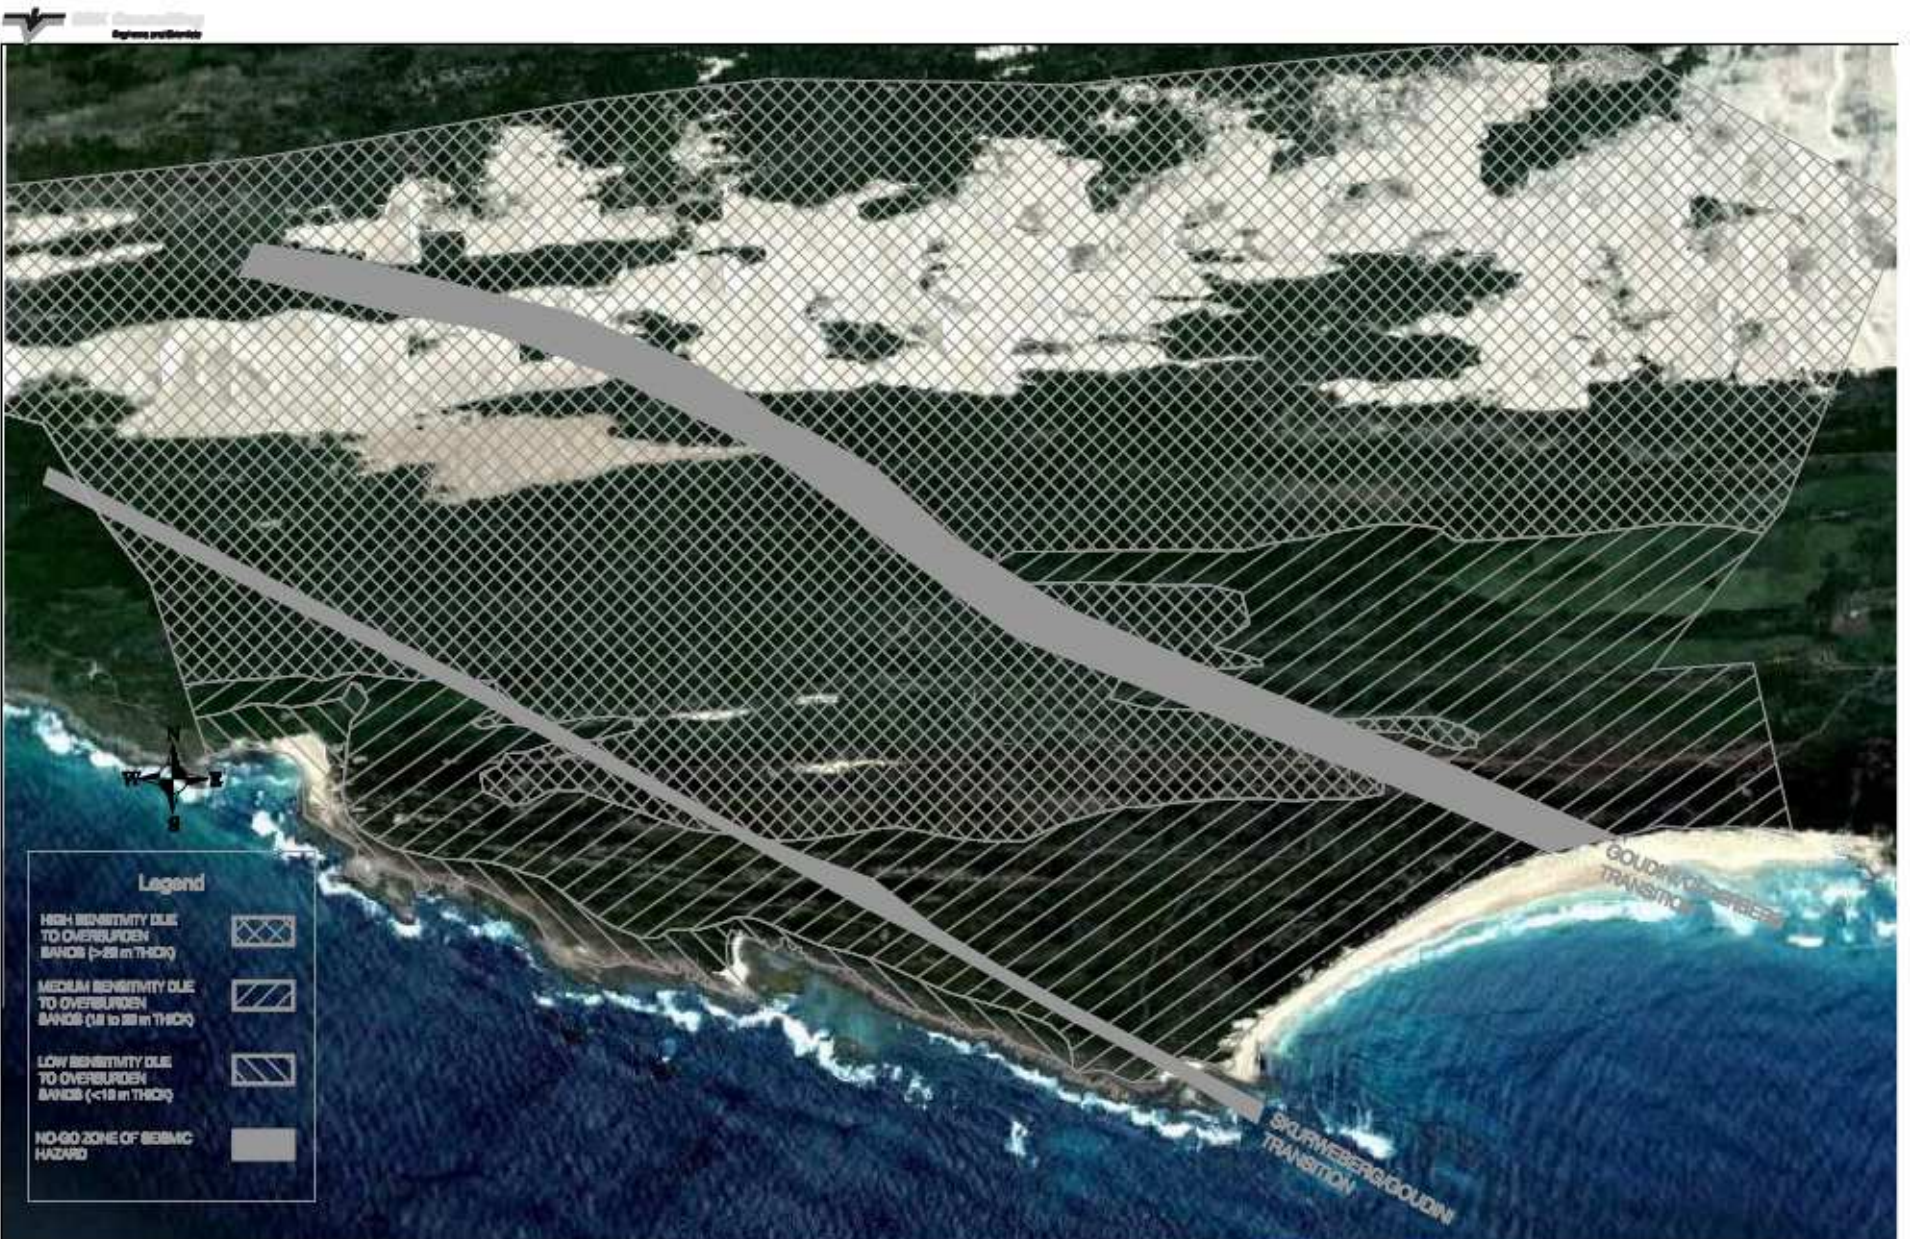
ENVIRONMENTAL IMPACT ASSESSMENT FOR A PROPOSED NUCLEAR POWER STATION ("NUCLEAR-1") AND ASSOCIATED INFRASTRUCTURE
THYSPUNT GEOTECHNICS SENSITIVITY MAPPING

Based on the above, the Thyspunt site has been assessed relative to the site sensitivity from a geotechnical characterisation viewpoint. An obvious driver is the depth of overburden sand that will be removed in order to reach bedrock for founding of the NPS. The overburden has been characterised as non-cohesive material (i.e. sand as opposed to cohesive material like clay). This means that significant excavations will need to be cut back to acceptable angles to ensure safety during construction. For the purposes of defining site sensitivity, the following criteria have been used:

- LOW sensitivity is described as those areas where overburden sand is less than 10 m in vertical extent;
- MEDIUM sensitivity is described as those areas where overburden sand is between 10 and 20 m in vertical extent; and
- HIGH sensitivity is described by those areas where overburden sand is greater than 20 m in vertical extent.

Figure 2.4 shows these areas diagrammatically.

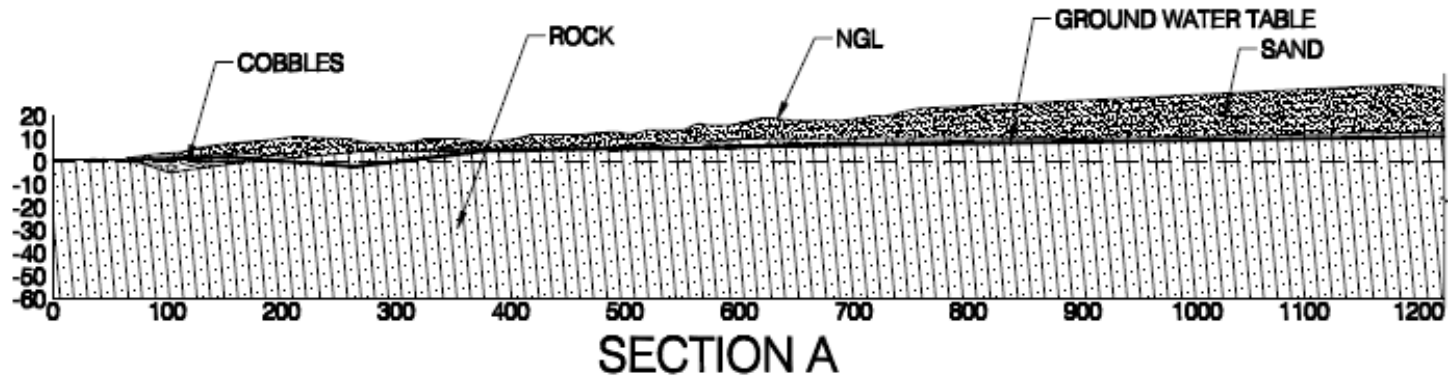
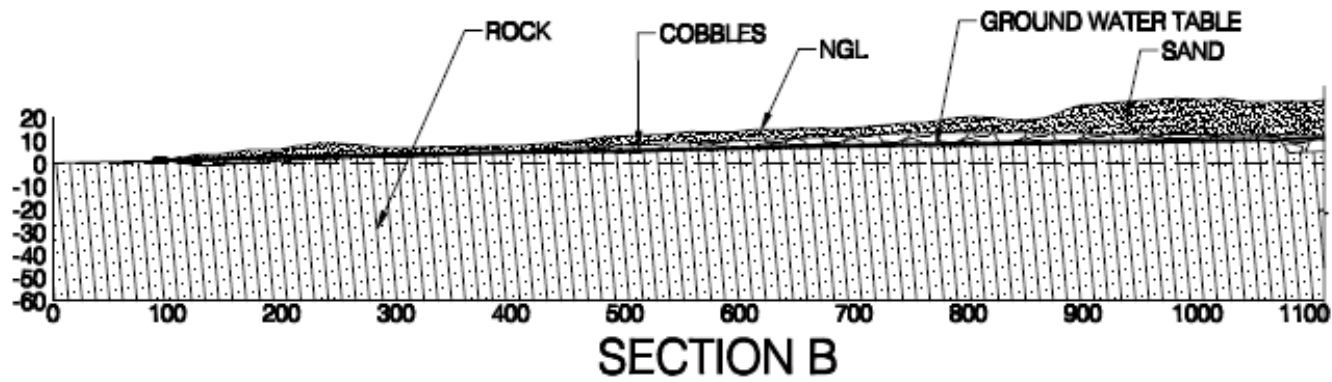
ENVIRONMENTAL IMPACT ASSESSMENT FOR A PROPOSED NUCLEAR POWER STATION ("NUCLEAR-1") AND ASSOCIATED INFRASTRUCTURE
TYPICAL GEOTECHNICAL PROFILES - BANTAMSKLIP

The fines portion of the grading (clay and silt) exhibits low to no plasticity. The consistency of the site soils is homogenous at the Bantamsklip site. The soils are typical of coastal dune environments and are highly susceptible to wind erosion in uncemented horizons.

The soils have no cohesion (except where calcrete has formed), and excavations within these soils will therefore require either lateral support or they will have to be battered back to safe angles. There are extensive calcrete zones within the site soils and lateral support on this site will be simplified by this as the calcrete lends cohesion to the sand.

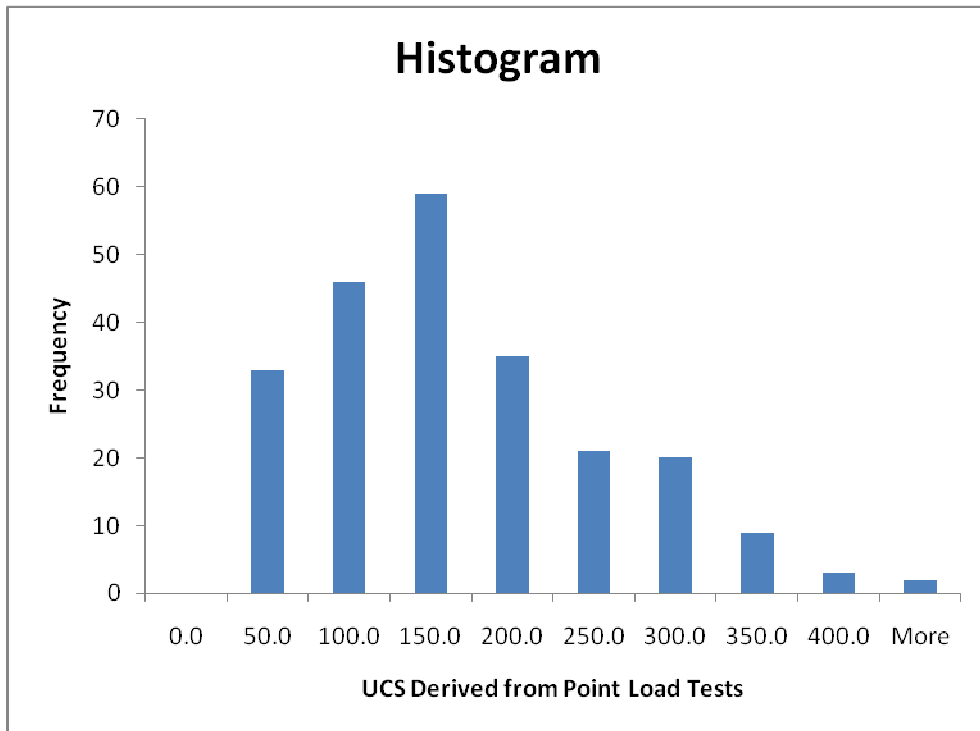
Figure 2.6: UCS (MPa) Derived from Point Load Tests – Bantamsklip

Point load field tests were carried out on core extracted from boreholes drilled at the site. **Figure 2.6** shows the distribution of UCS derived from point load testing for the Peninsula Formation quartzitic sandstones at the Bantamsklip Site.

The histogram indicates a wide range in UCS (derived from point load tests). Descriptive statistics for the data set relevant to **Figure 2.6** are shown in **Table 2.5**.

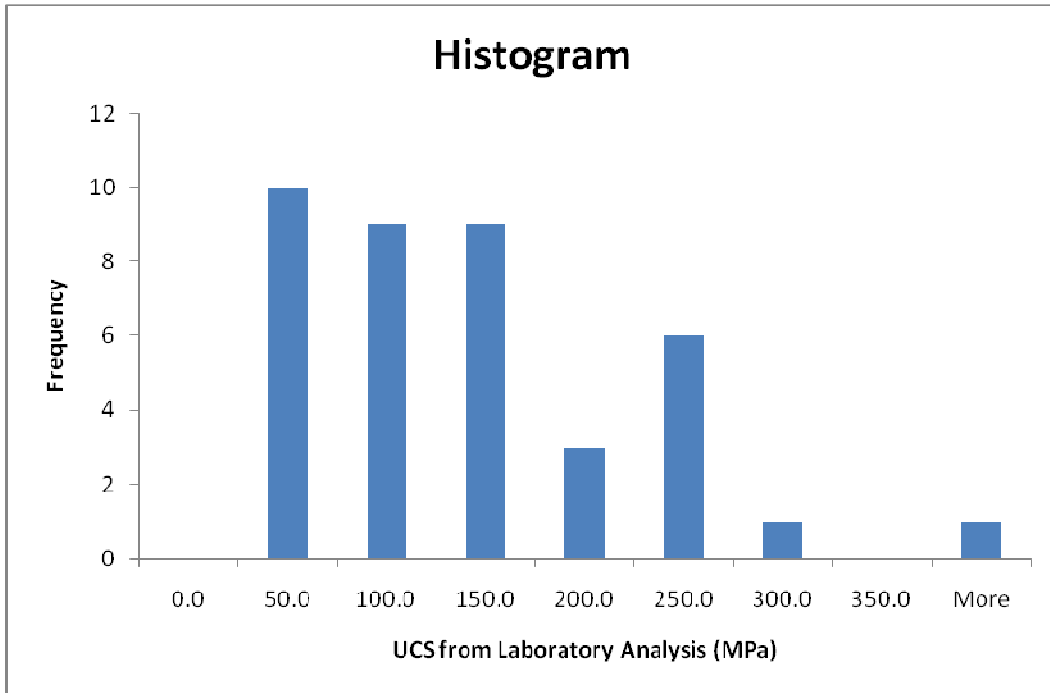
Figure 2.7: UCS (MPa) from Laboratory Analysis – Bantamsklip

The distribution of UCS measured under laboratory conditions is shown in **Figure 2.7**.

Descriptive statistics for the data sets relevant to **Figure 2.7** are shown in **Table 2.6**.

The average UCS value obtained in the laboratory is higher than that derived from point load tests, but the standard deviation in results is also higher. These variations in measured rock strength are almost certainly related to the highly jointed/fractured nature of the rocks. It is therefore difficult to make a comparison of these results, except to say that the quartzitic sandstones at this site have high UCS.

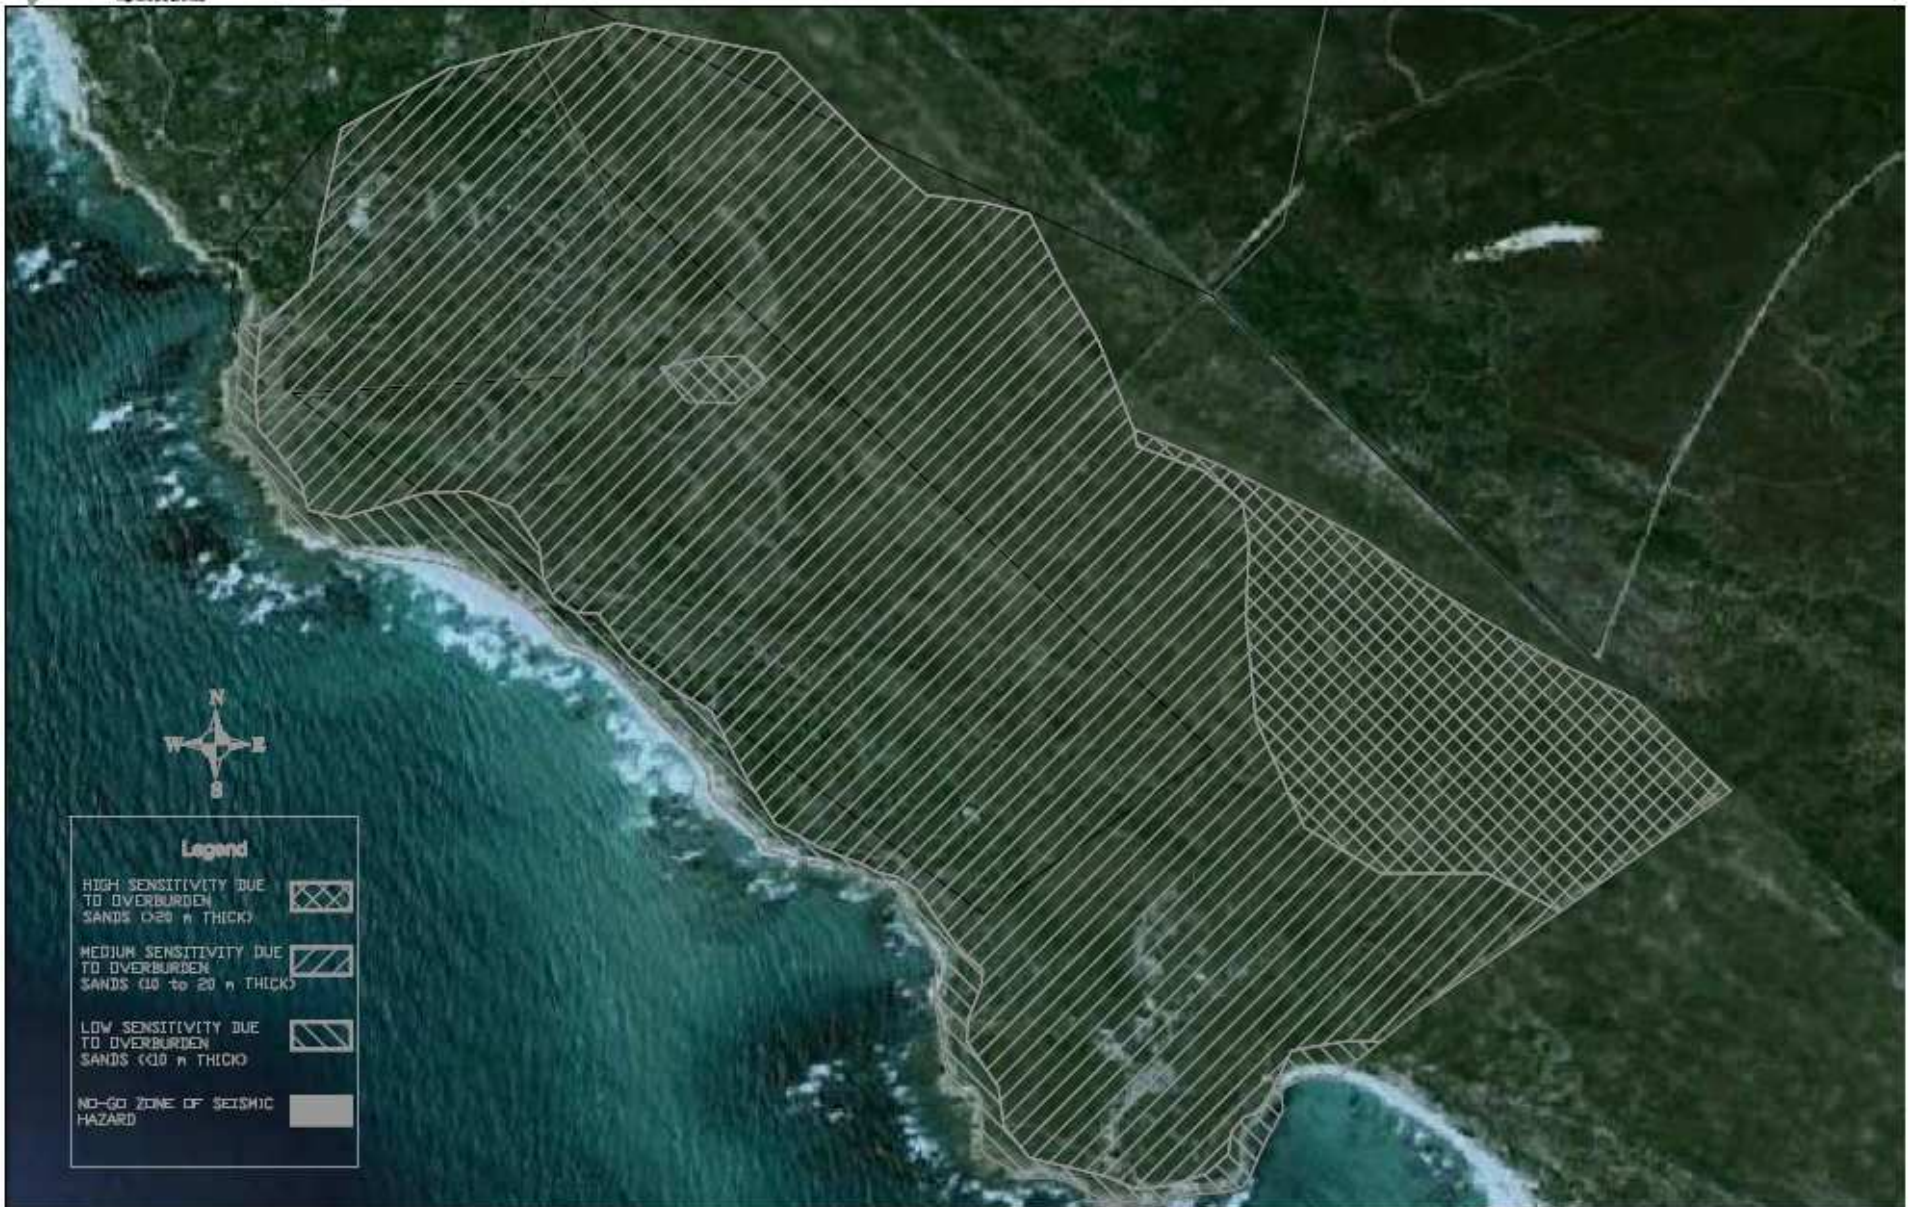
Based on the above, the Bantamsklip site has been assessed relative to the site sensitivity from a geotechnical characterisation viewpoint on the same criteria as Thyspunt.

Figure 2.8 shows these areas diagrammatically.

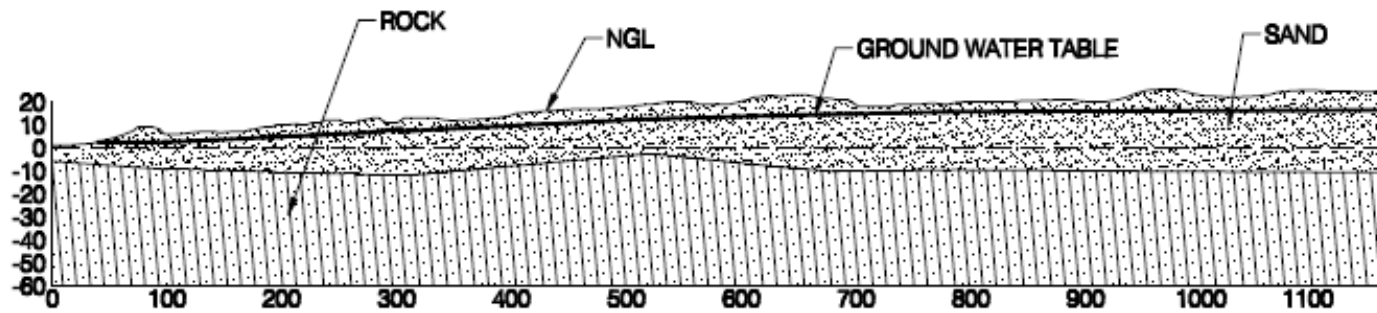
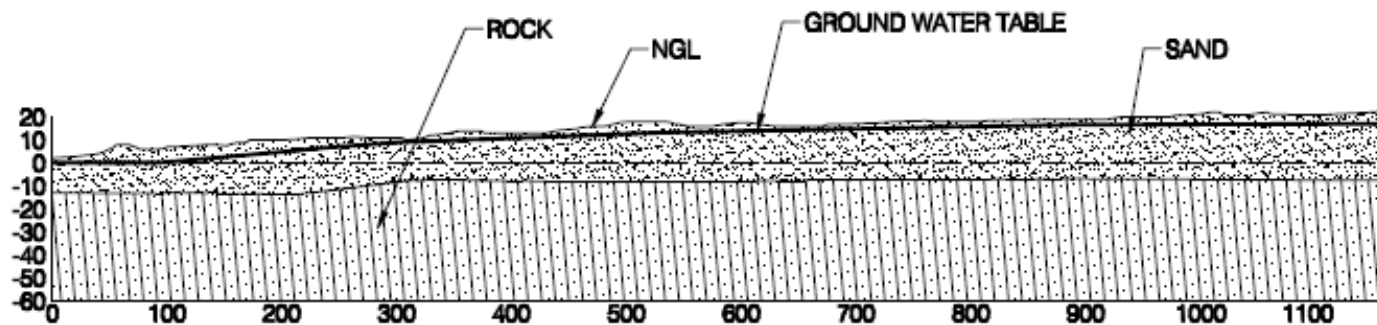
The geotechnical profile of the Duynfontein site has evolved from desk top and intrusive field investigations. Typical geotechnical profiles (parallel to the coast) for the Duynfontein site are shown in **Figure 2.9:** Typical Geotechnical Profiles – Dynefontein, once again highlighting the soil, rock and groundwater table profiles.

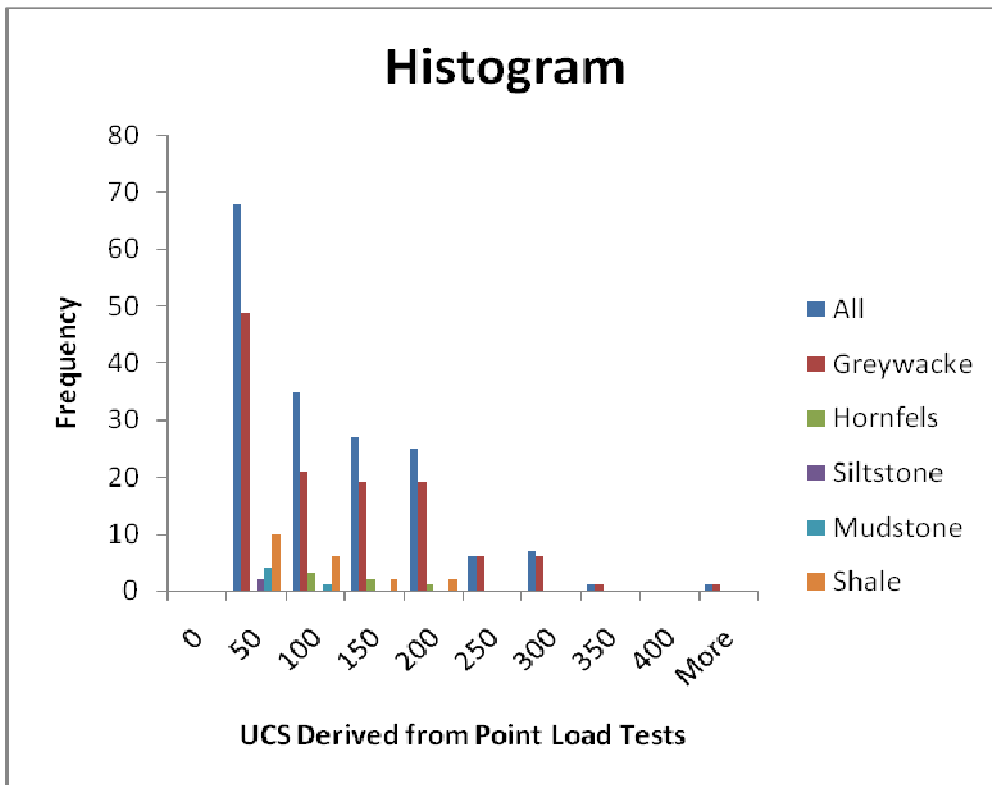
Figure 2.10: UCS (MPa) Derived from Point Load Tests – Duynefontein

Point load field tests were carried out on core produced from boreholes drilled at the Dynefontein site. **Figure 2.10** shows a histogram of the UCS derived from point load testing for the Malmesbury Group rocks underlying the site.

The histogram indicates a wide range in UCS (derived from point load tests). The primary reason for this is the varying geology tested. Descriptive statistics for the data set relevant to **Figure 2.10** are shown in **Table 2.8**.

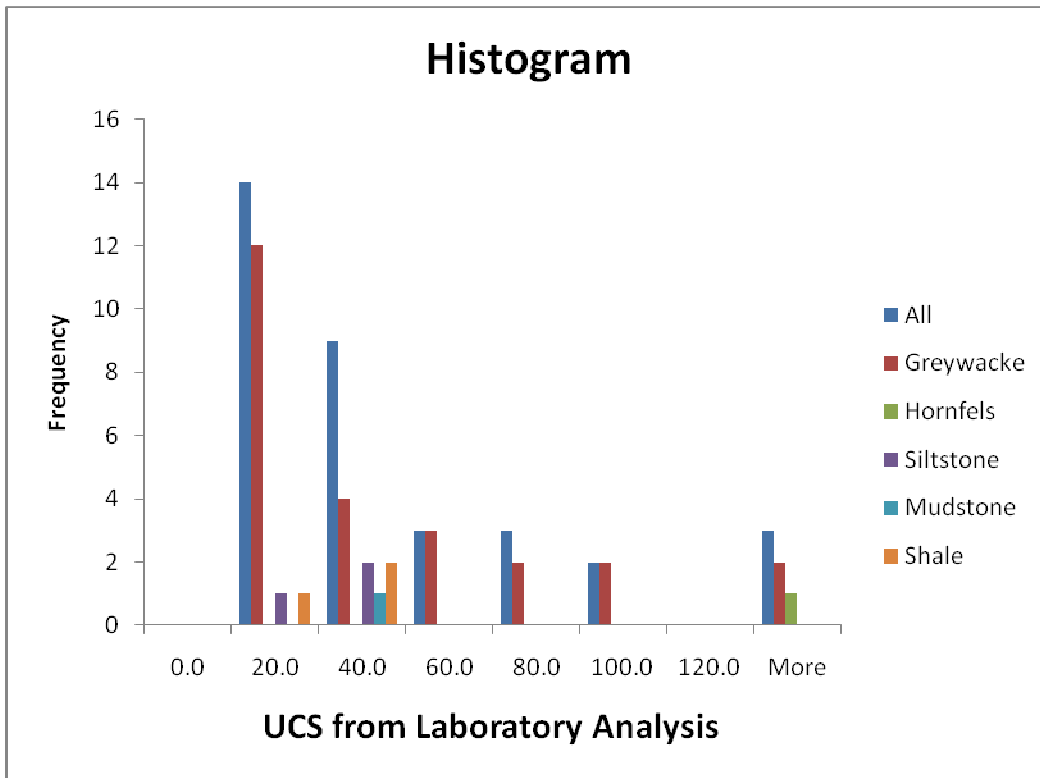
Figure 2.11: UCS (MPa) from Laboratory Analysis – Duynefontein

The distribution of UCS measured under laboratory conditions is shown in **Figure 2.11**.

Descriptive statistics for the data sets relevant to **Figure 2.11** are shown in **Table 2.9**.

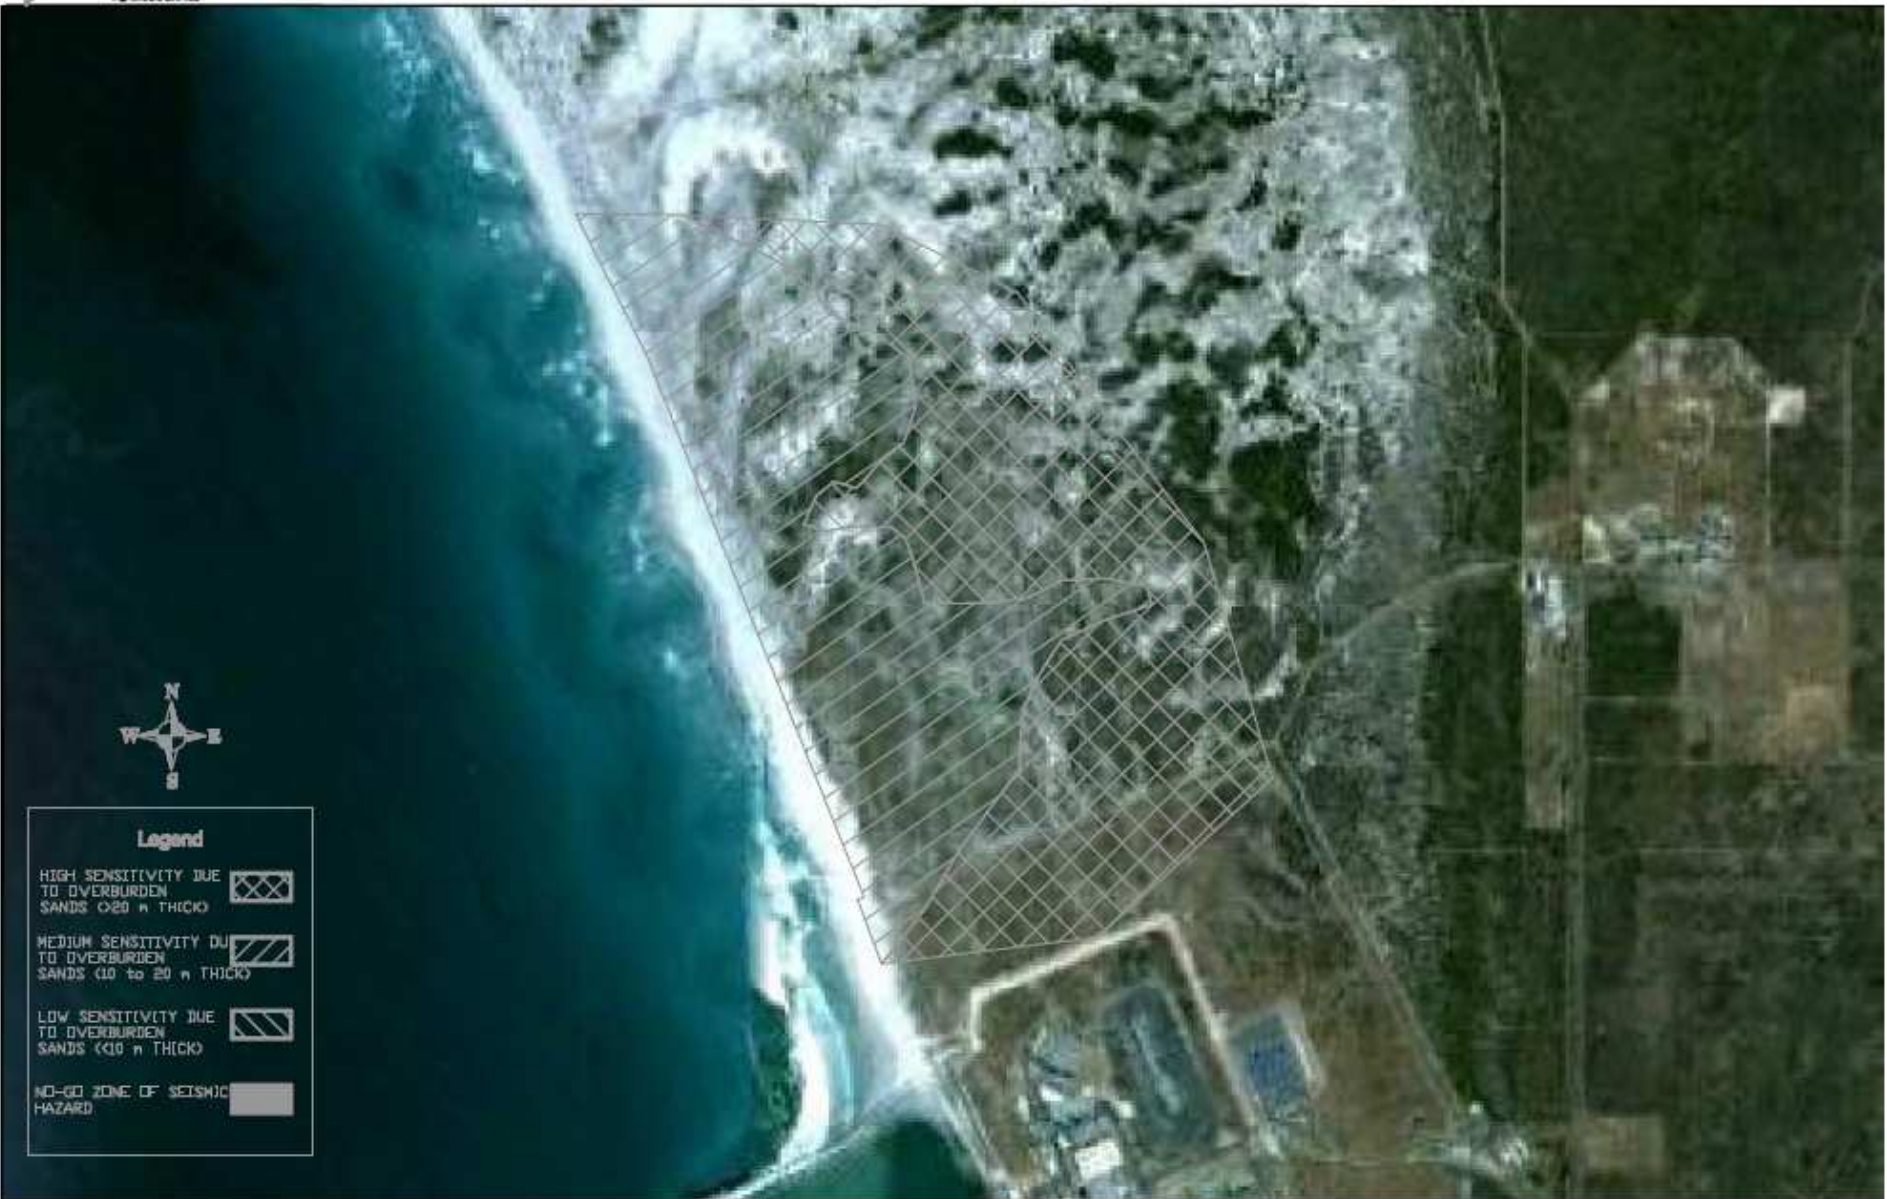
Based on the above, the Duynfontein site has been assessed relative to the site sensitivity from a geotechnical characterisation viewpoint on the same criteria as Thyspunt.

Figure 2.12 shows these areas diagrammatically.
