# Kendal Ash Dump Extension

## *Surface Water Impact Assessment*

19124260/328927/3

October 2019

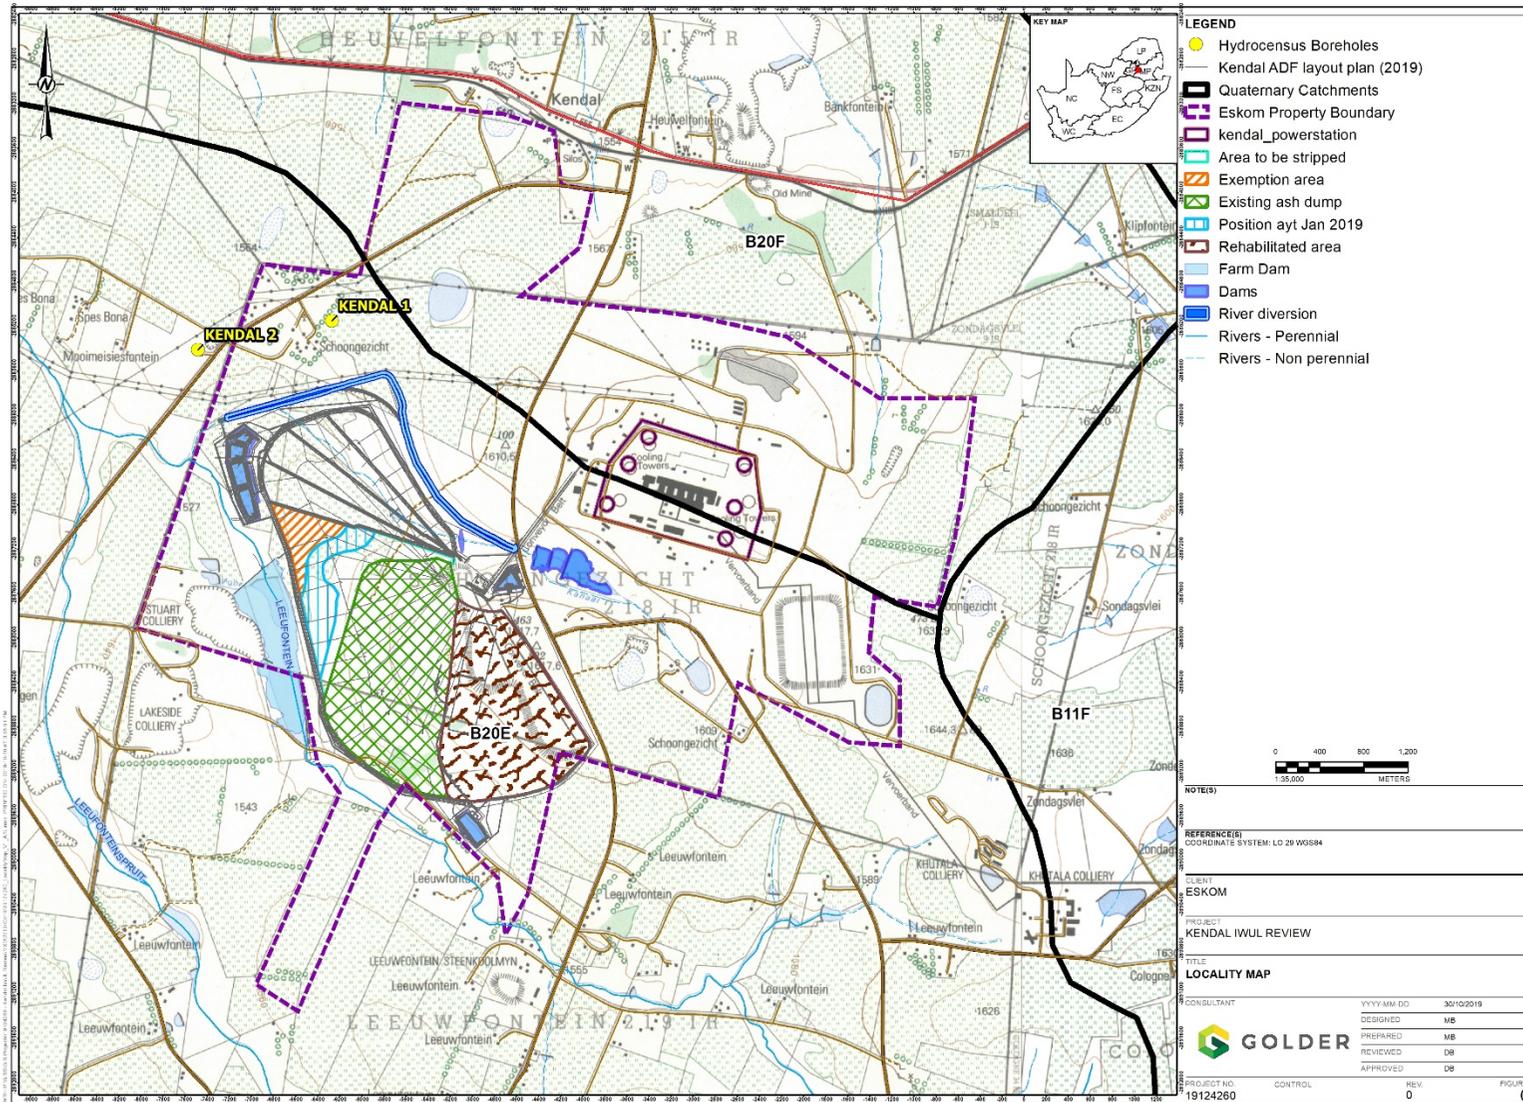
Figure 1: Kental Power Station and ADF location

The project is located on the farm Schoongezicht 218 IR, Emalaheni Local Municipality within the Mpumalanga Province, south west of the Eskom Kendal Power Station, at coordinates: 26° 5'56.02"S and 28°56'13.86"E (Figure 1).

Kendal Power station and the associated ADF are located in quaternary B20E which forms part of the Wilge sub-catchment. The two drainage areas relevant to the ADF are the Schoongezichtspruit that drains between Kendal Power Station and the ADF in a north westerly direction to confluence with the Leeuwfonteinspruit below the ADF, flowing in a north westerly direction on the southern side of the ADF. The Leeuwfonteinspruit flows into the Wilge River.

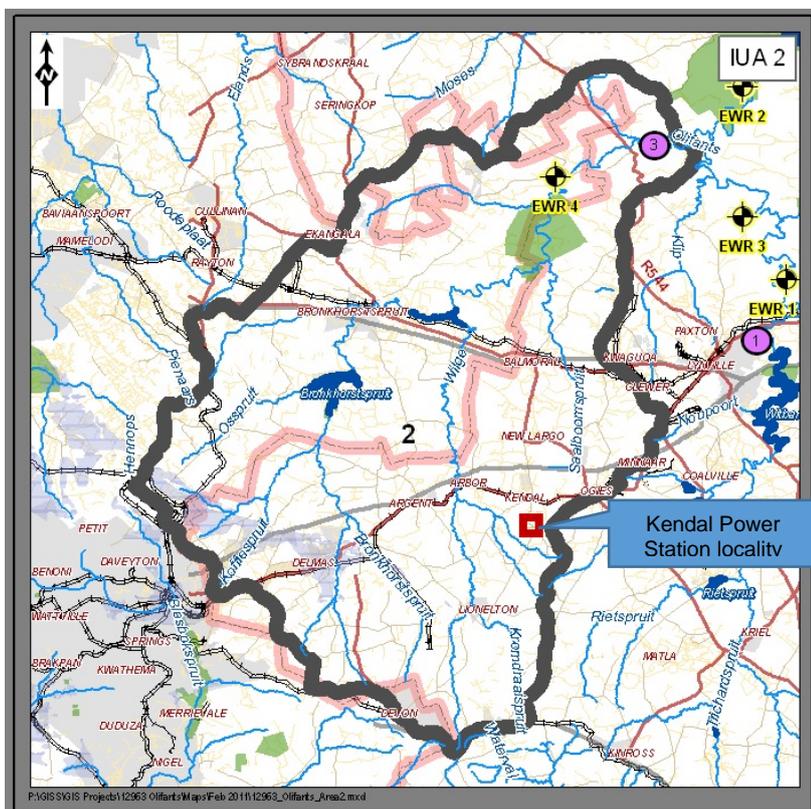
Figure 2: EWR 4 in relation to the Kendal Power Station and ADF (DWS, 2016b)

The Ecological Water Requirements (EWR) for the site located on the Wilge River (EWR4) just downstream of the confluence of the Wilge River and the Saalklapspruit (Figure 2) (DWS, 2016b) are set out in Table 1 and Table 2.

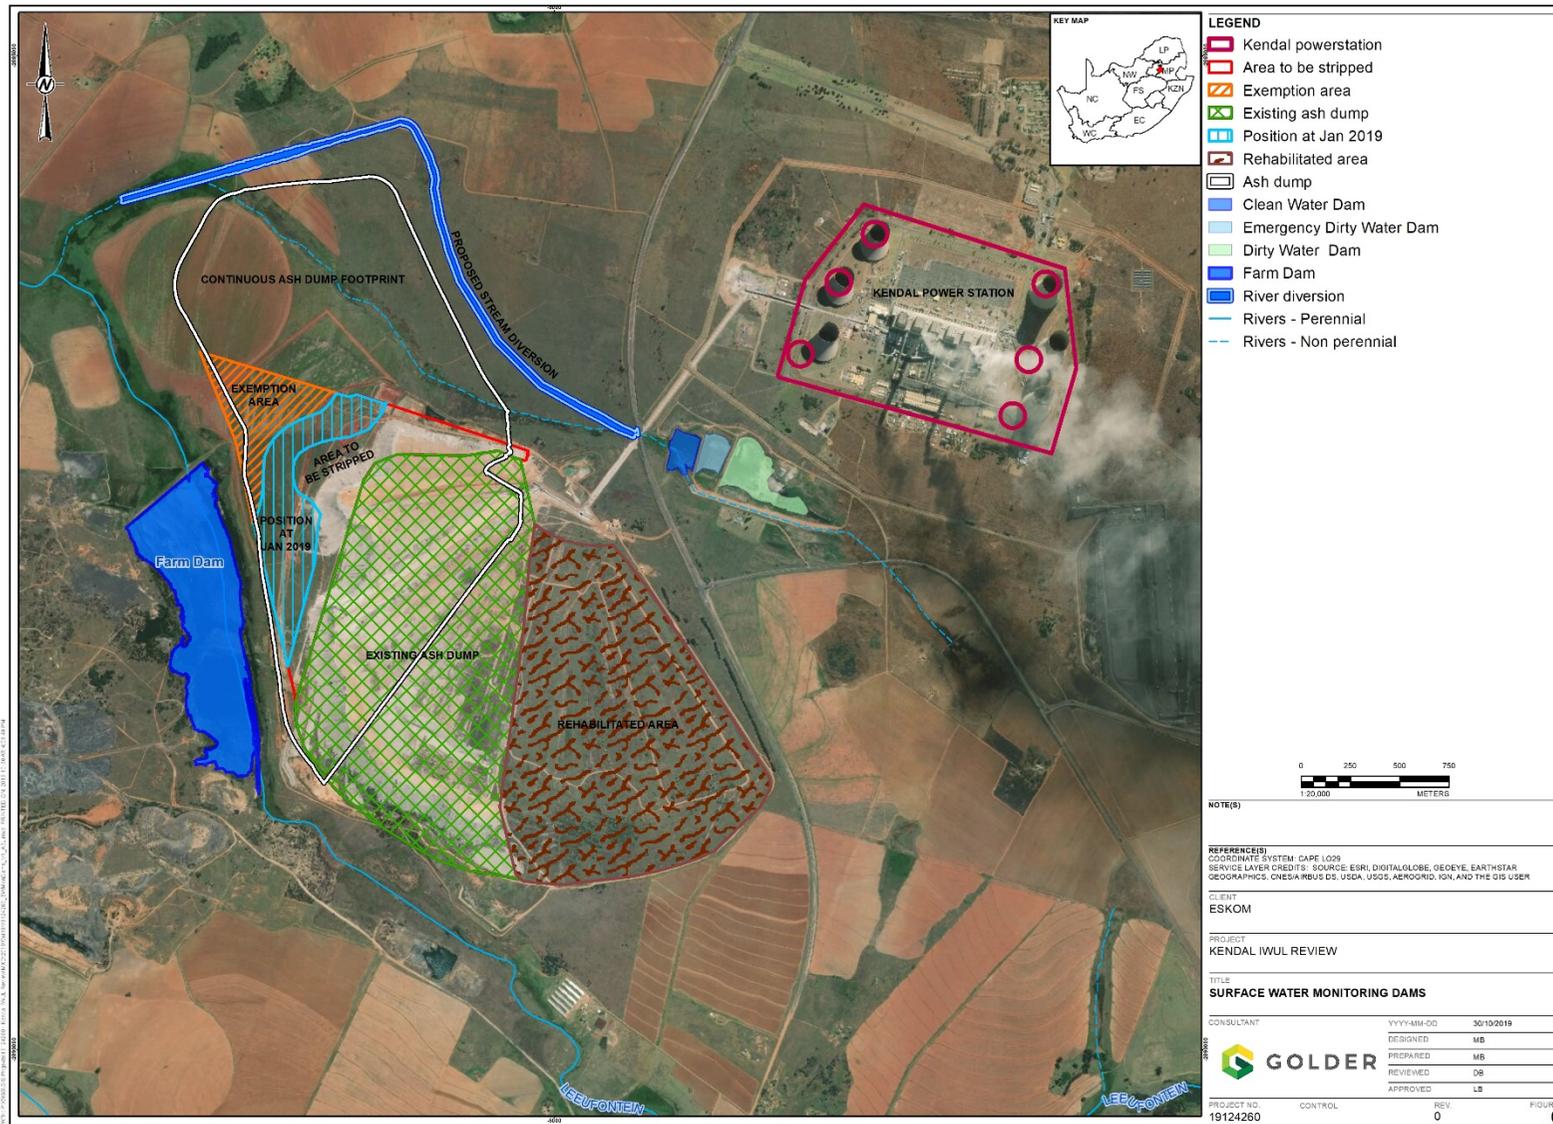
Figure 3: Existing ADF and extended area including the river diversion to be constructed (licensed under IWUL number: 04/B20E/ABEGI/3888)

Eskom proposes to undertake a Part 2 Amendment process for the exemption authorisation that was granted on 5 May 2016. The exemption is valid for a period of 4 years, from 5 May 2016 to 5 May 2020. Project delays have however meant that Eskom will surpass the time-frame granted within the exemption period. Furthermore, the exempted area still has a remaining footprint of 52 hectares to be filled up with ash prior to ashing on the new lined area.

Eskom, therefore, intends to extend the exemption authorisation period to continue ashing on the exempted area until the exempted footprint is covered with ash, in order to proceed to the lined area.

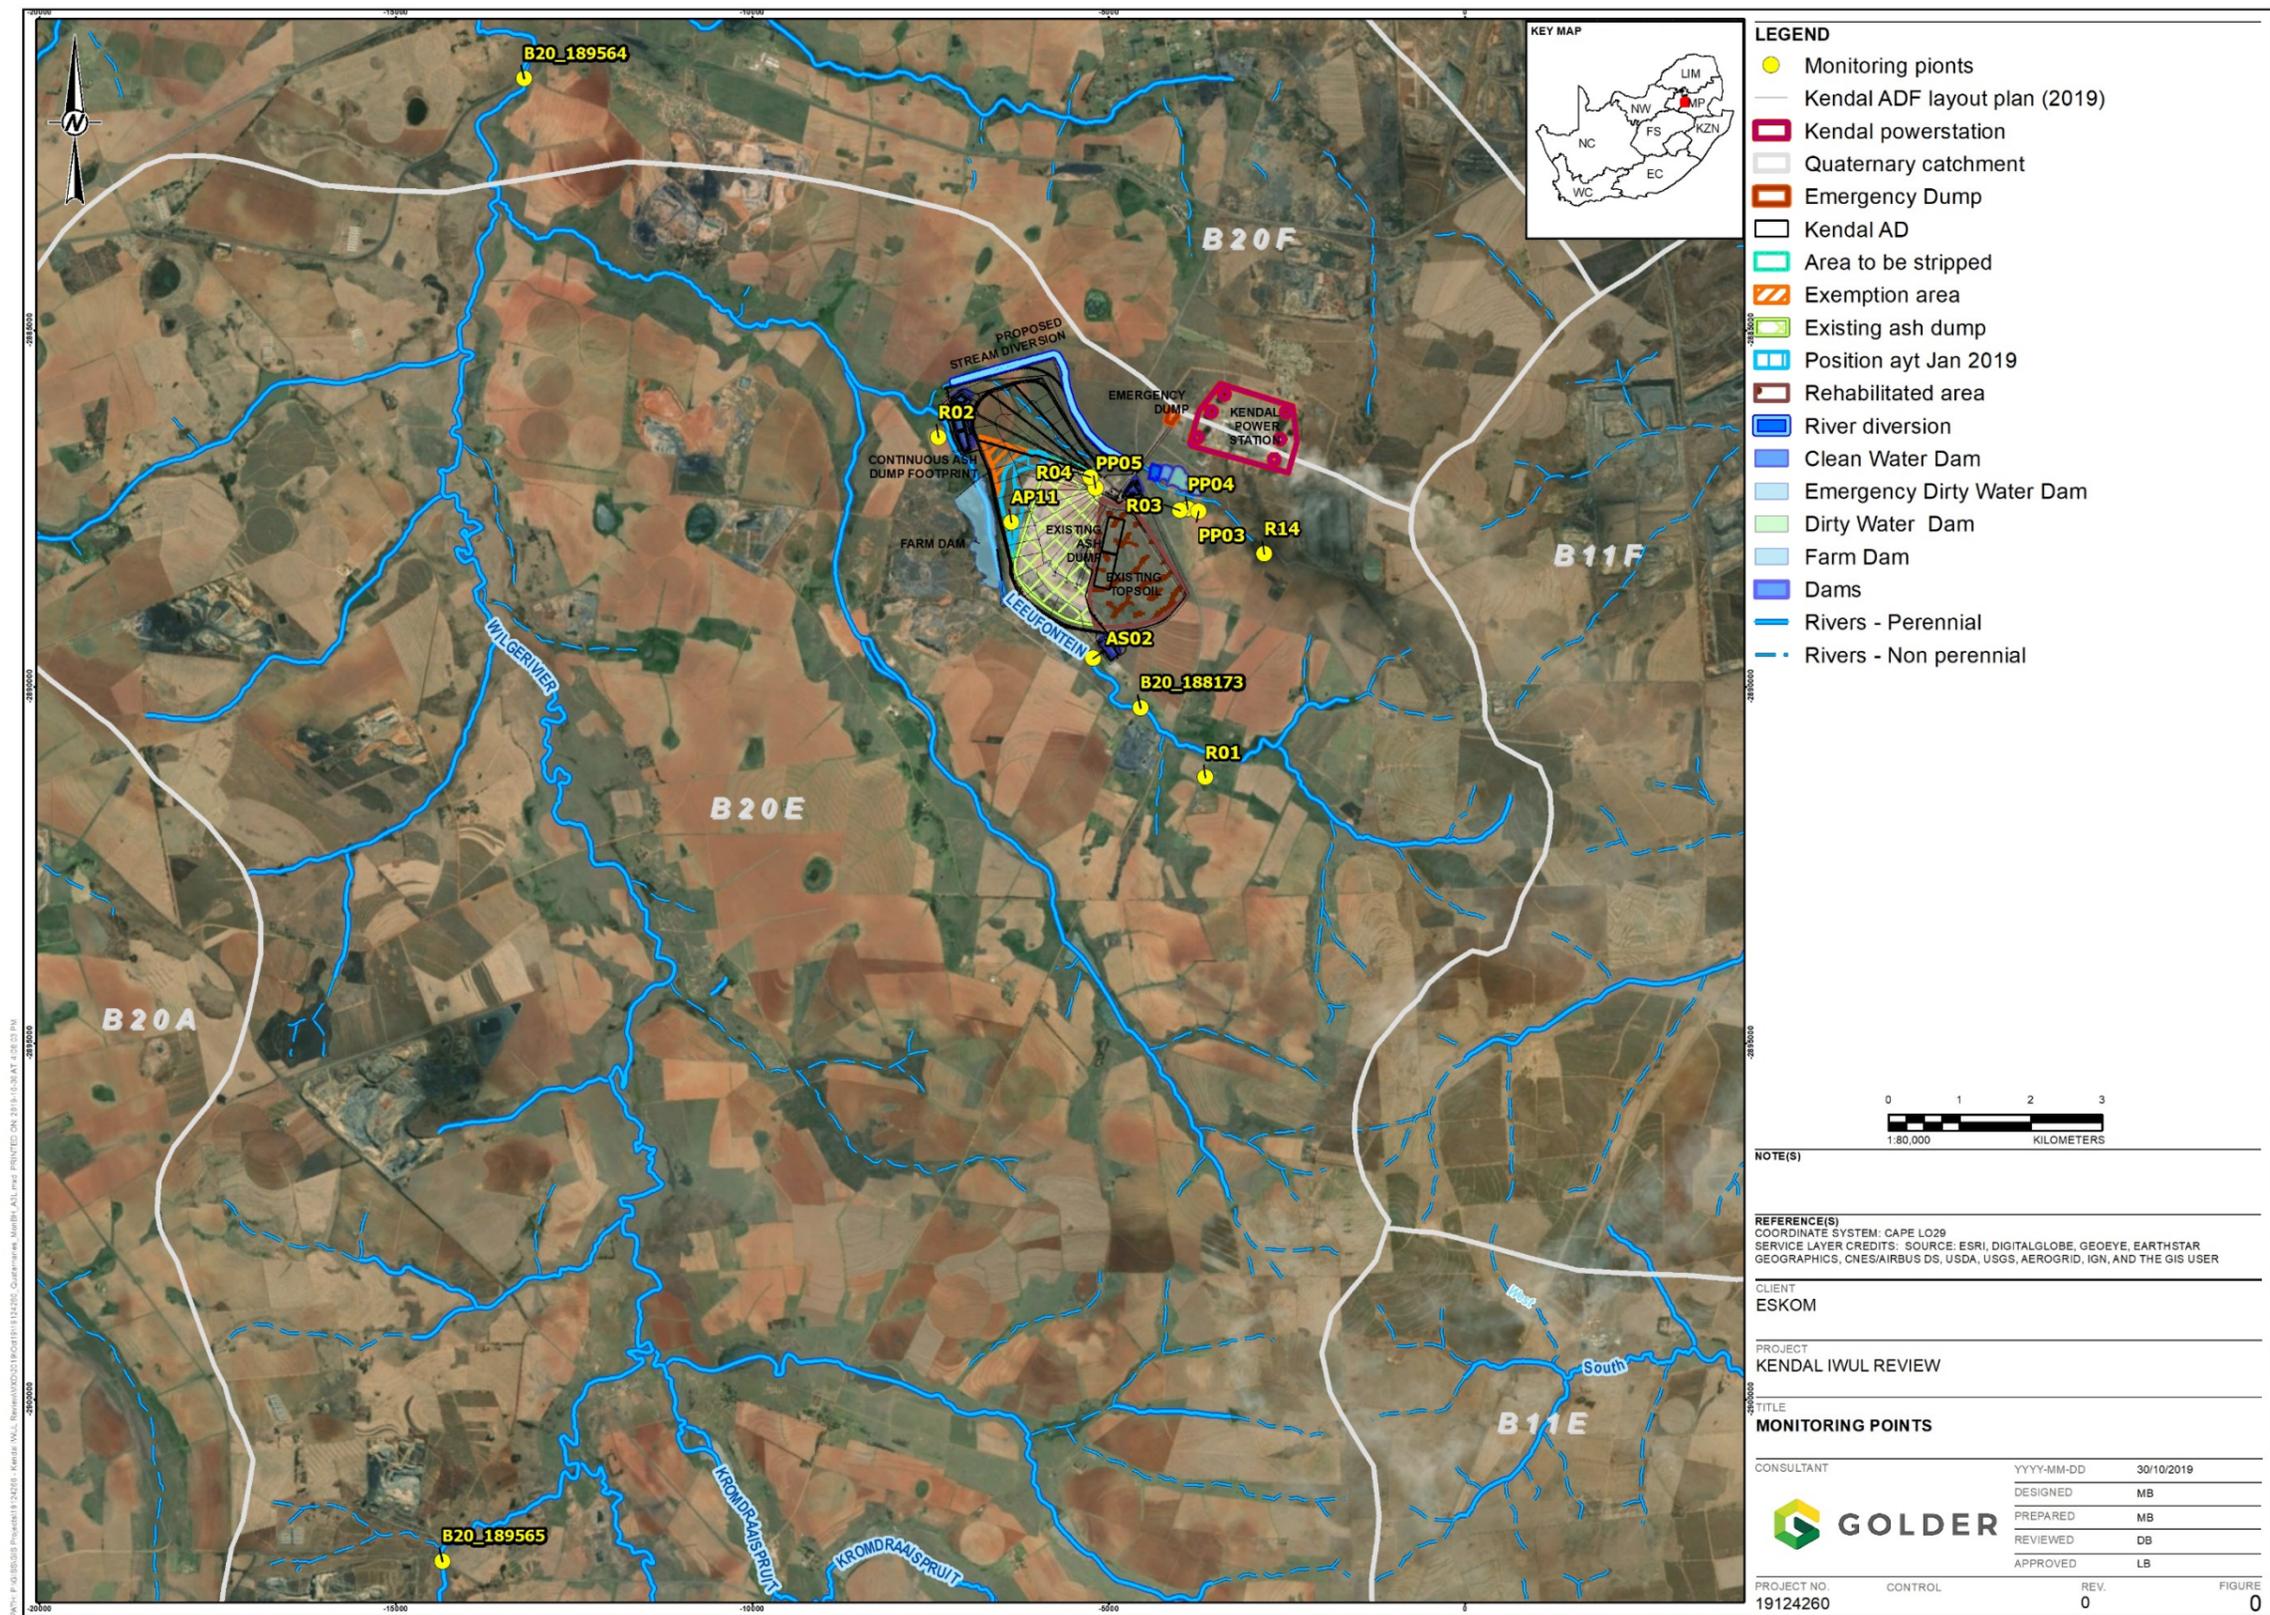
Figure 4: Surface water monitoring points (Kandal points as well as DWS points)

The surface water sampling points sampled during November 2018 and July 2019 are illustrated in Figure 4. The points were chosen to assess the water quality of the Leeuwfonteinspruit and Schoongezichtspruit in close proximity to the existing ash dump and before the tributaries enter the Wilge River. There is a farm dam to the west of the existing ADF and it is located close to a mining void (Figure 3). It has been observed that water from the mining voids decants into the farm dam thus increasing the size of the dam and possibly also impacting on the quality of the water in the dam. The rehabilitation of this dam is also included in IWUL number: 04/B20E/ABEGI/3888.

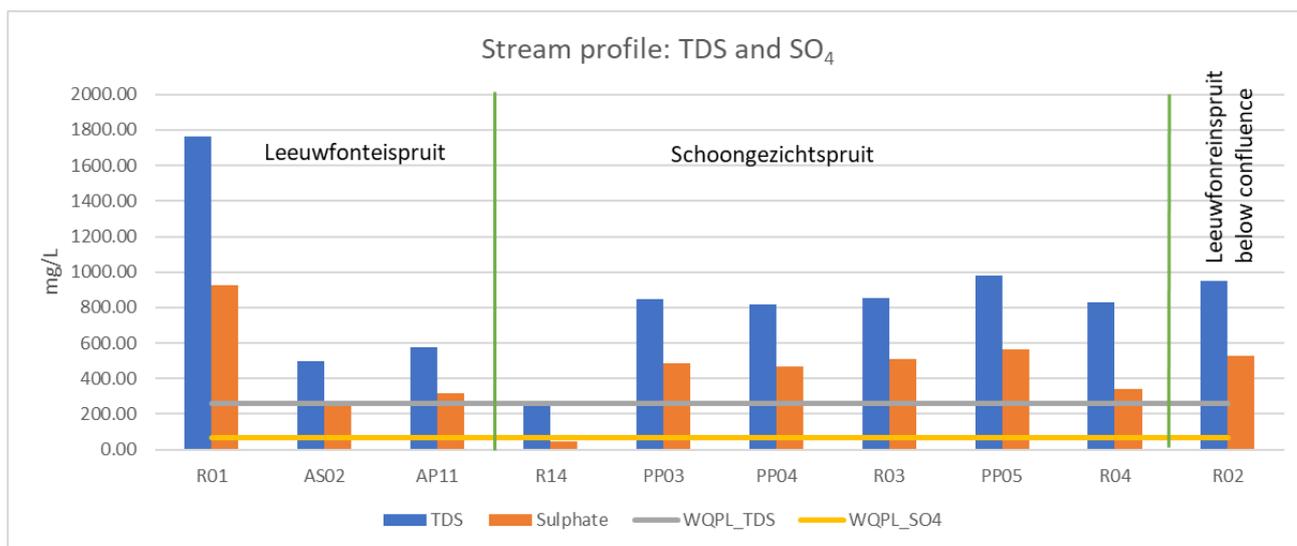
- The highest area of contamination is at site R01 on the Leeuwfonteinspruit, upstream of the ash operations which shows upstream impacts from coal mining;
- pH at all sites is within the WQPL (upper and lower);
- Sulphates and total dissolved solids exceeded the WQPL (Figure 5) at all sites except for R14, the most upstream of the sites in the Schoongezichtspruit.

**Figure 5: Water quality profile in the Leeuwfonteinspruit and Schoongezichtspruit**

- All metals except for aluminium were very low at all sites, aluminium was elevated at all sites except for the most upstream points on both streams and the most downstream point after the confluence of the two streams. Boron and fluoride which were shown to be leachable from the ash, are within the WQPL, except for boron at AP11, the dam west of ash stack in Leeuwfonteinspruit.

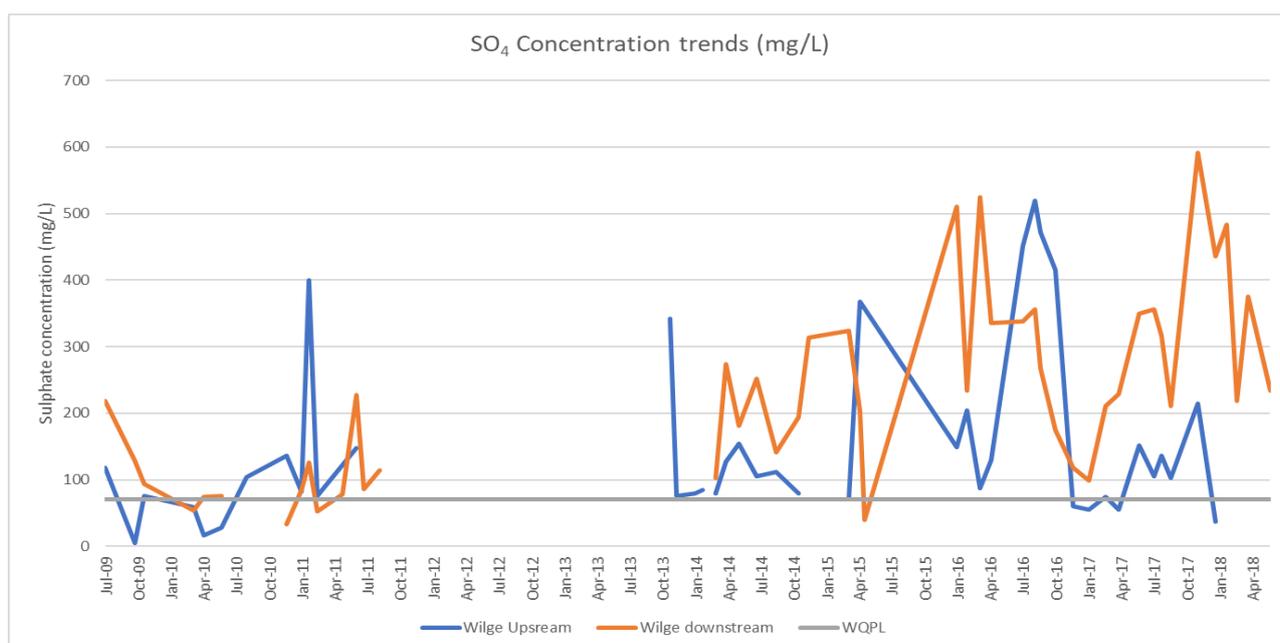
**Figure 6: Sulphate trends in the Wilge River for the period July 2009 to June 2018 (DWS monitoring)**

- B20\_189565 approximately 20 kilometres upstream of the confluence of Leeuwfonteinspruit with the Wilge River indicates that mining impacts have occurred upstream of the site with very high EC readings ranging from 25 to 142 mS/m and associated calculated TDS values of 200 – 1 136 mg/L, as well as sulphate levels ranging from 36 – 400 mg/L (Figure 6). The contamination appears to be from several abandoned mines in the upper reaches of the Wilge River catchment.
