1. Introduction

Koeberg Nuclear Power Station (KNPS) is currently in the process of applying for a licence extension. Its nuclear installation licence is valid for 40 years, and approval by the National Nuclear Regulator (NNR) is required to continue its safe operation beyond the 40-year licensing period. This storybook aims to clarify the facts relating to KNPS and how the safety of the plant is assured. More information is available publicly, for example, the [Public Information Document](#). The following topical issues relating to Koeberg are covered in this storybook:

4. The Koeberg containment buildings

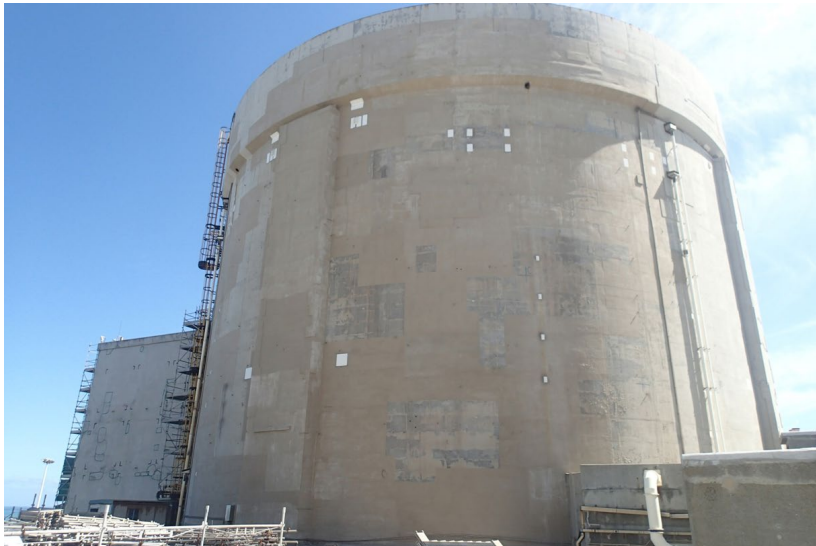
Figure 5: The Koeberg containment building

The containment building houses the reactor pressure vessel and associated reactor cooling systems, steam generators, and other important components needed to produce steam to generate electricity. Its main function is to contain the release of radioactive material in the unlikely event of a nuclear accident. To achieve this, the design comprises very thick, highly reinforced and post-tensioned concrete walls (providing the strength) and an internal steel liner (providing the leak tightness).

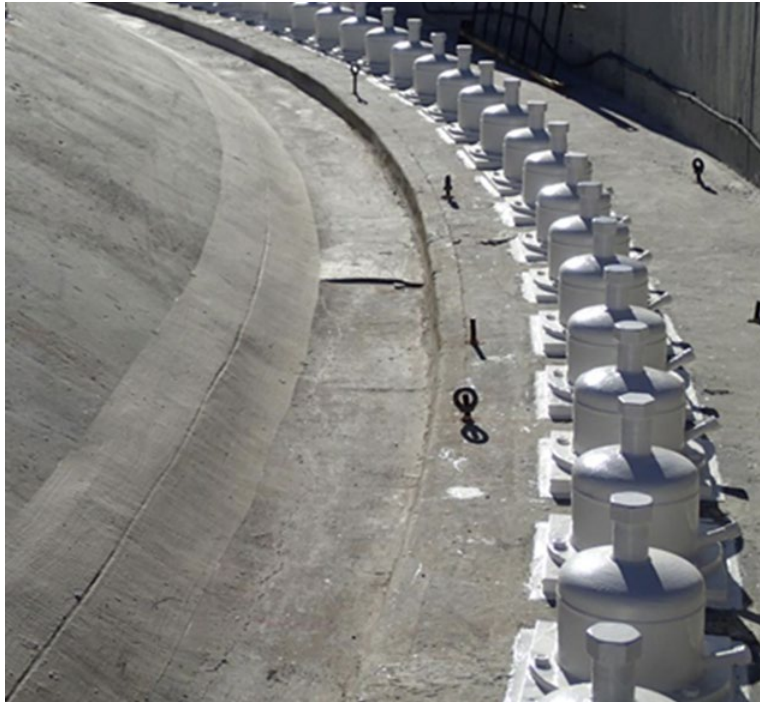
Figure 8: Containment dome crack sealed and coated

The crack in the dome of the containment building does not affect the structural integrity of the containment building. Although it is a 110m long crack along the circumference of the dome, it is monitored and has been sealed and painted. It is similar to cracks noted in containment buildings in other countries. It is not unusual for concrete to crack and design codes allow for cracks in concrete. This crack is specifically monitored during the containment building pressure tests and evaluated by international experts. The crack has not grown even when the building was subjected to the pressure tests and it is not a concern for the structural integrity of the containment building.

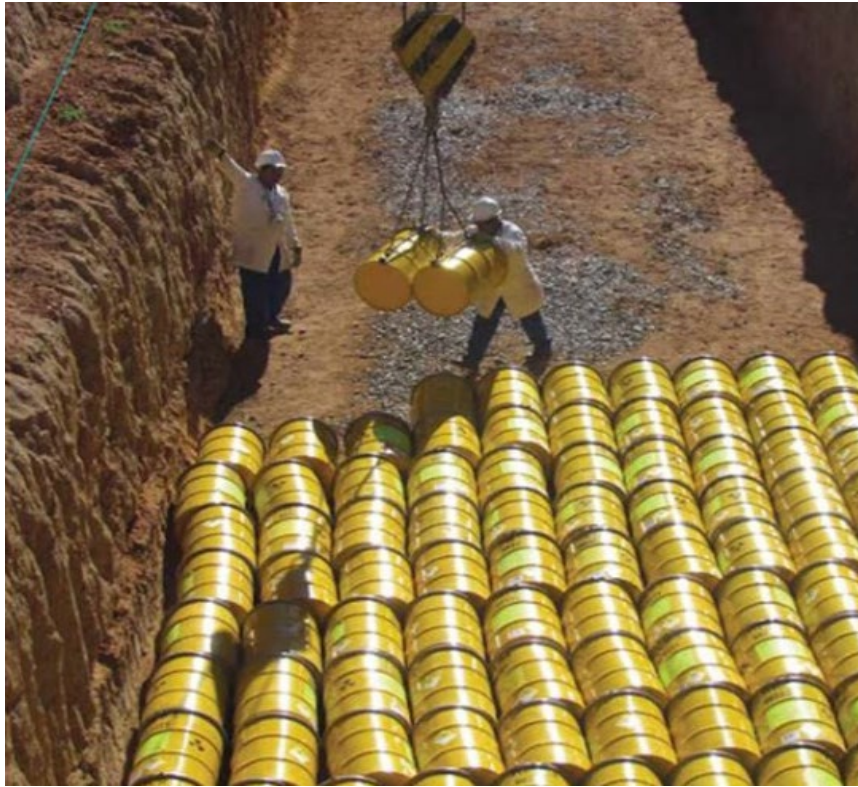
Figure 11: Radioactive waste in steel drums stored at Vaalputs National Waste Disposal Facility

Low and intermediate-level waste constitutes approximately 97% of the waste produced. The low-level waste (LILW-SL) contains relatively low levels of radioactivity and the likelihood of the drums leaking and affecting the environment is low. The LILW-SL concrete and steel drums are designed to contain waste materials safely and prevent leakage. The waste is compressed into sealed, clearly marked, steel drums and stored onsite until they are transported to the designated national waste disposal site at Vaalputs in the Northern Cape. Higher radioactivity level resins and concentrates from the treatment of liquid and gaseous effluent are solidified by mixing them with cement and pouring them into concrete drums before being transported to Vaalputs. Waste packages comply with stringent regulatory acceptance criteria to ensure that the waste can be transported and disposed of safely.

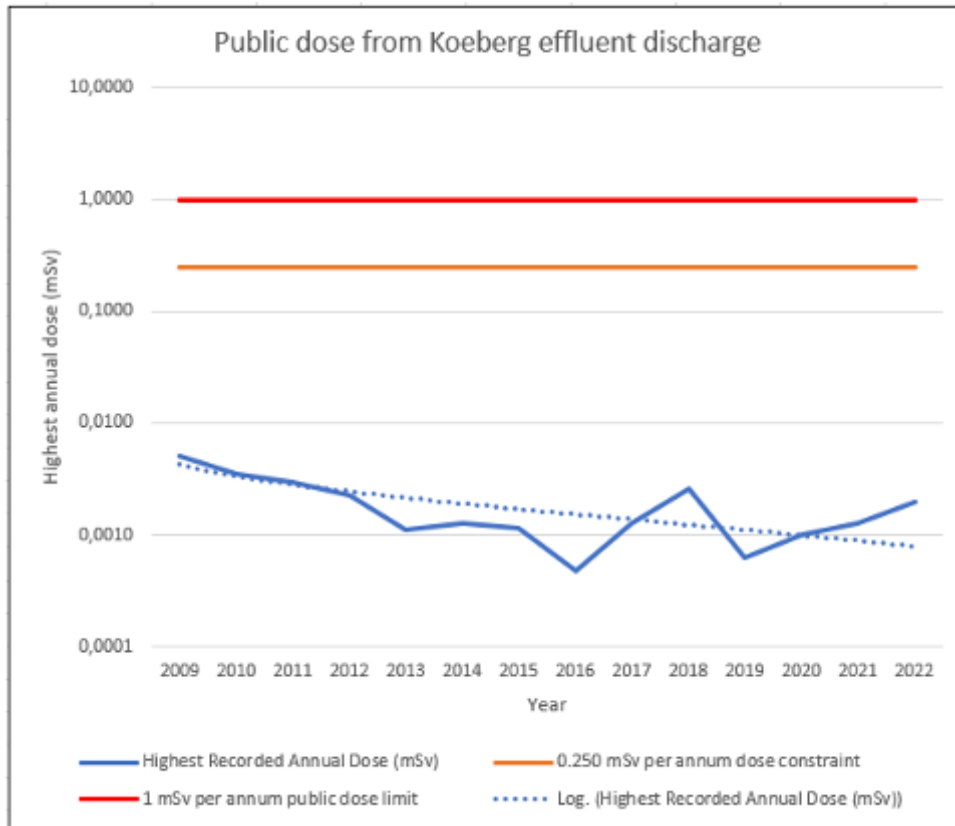
Figure 17: The trend of public dose due to Koeberg's effluent discharges (including tritium)

The average annual dose for a person living near Koeberg is generally more than 100 times lower than the dose received from natural background radiation. Therefore, the likelihood of any health effects due to Koeberg operations is very low. Tritium has no chemically toxic effects on the human body other than its radioactivity. However, as can be seen by the trend below, the radioactivity from effluent discharged (including tritium) is well within legislative requirements and on a decreasing trend.
