# Introduction

Koeberg Nuclear Power Station (KNPS) is currently in the process of applying for a licence extension for Koeberg Unit 2. Its nuclear installation licence is valid for 40 years, and approval by the National Nuclear Regulator (NNR) is required to continue its safe operation beyond the 40-year licensing period. This storybook aims to clarify the facts relating to KNPS and how the safety of the plant is assured. More information is available publicly, for example, the [Public Information Document](#). The following topical issues relating to Koeberg are covered in this storybook:

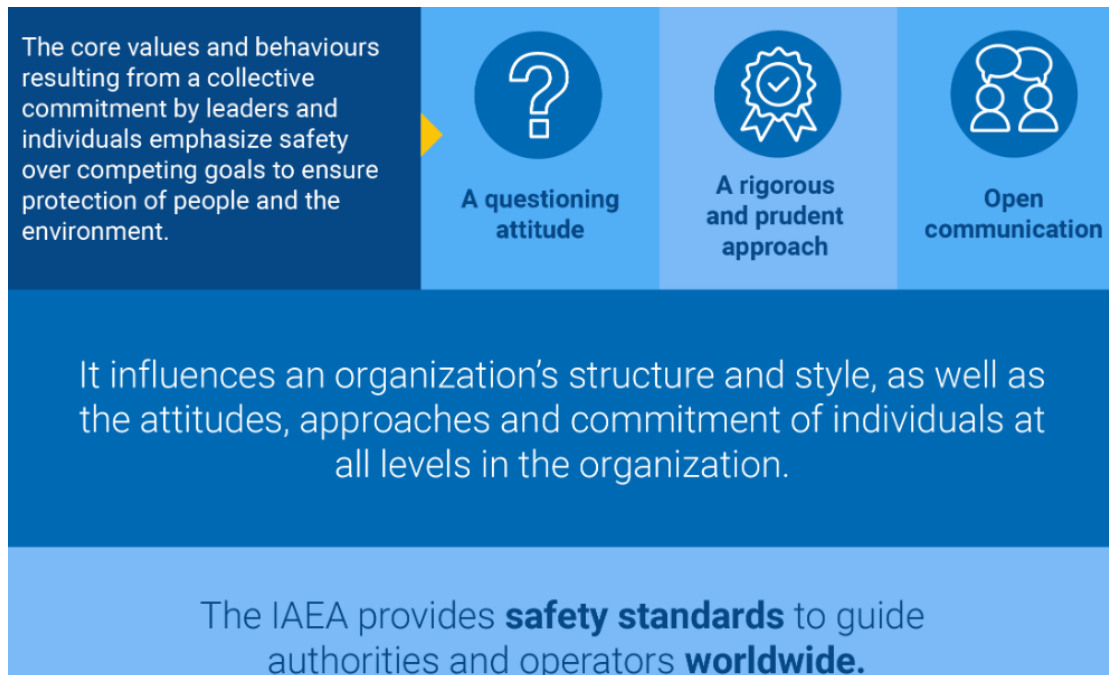
Figure 2: IAEA approach to nuclear safety culture

A strong culture for safety is illustrated in Figure 2 below (courtesy of IAEA):

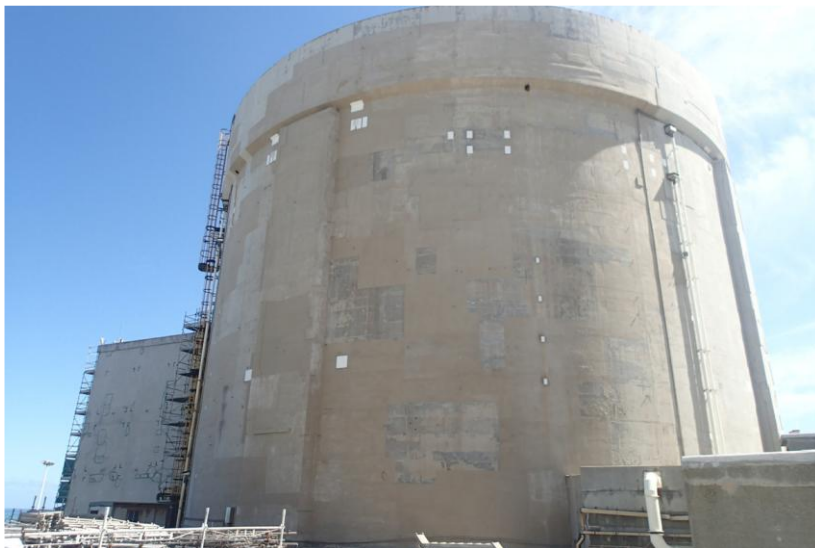
Figure 5: The Koeberg containment building

The containment building houses the reactor pressure vessel and associated reactor cooling systems, steam generators, and other important components needed to produce steam to generate electricity. Its main function is to contain the release of radioactive material in the unlikely event of a nuclear accident. To achieve this, the design comprises very thick, highly reinforced and post-tensioned concrete walls (providing the strength) and an internal steel liner (providing the leak tightness).

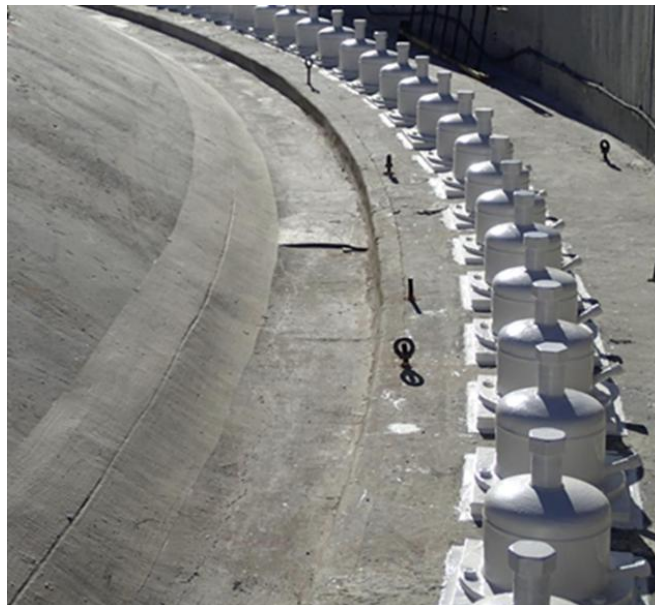
Figure 8: Containment dome crack sealed and coated

The crack in the dome of the containment building does not affect the structural integrity of the containment building. Although it is a 110m long crack along the circumference of the dome, it is monitored and has been sealed and painted. It is similar to cracks noted in containment buildings in other countries. It is not unusual for concrete to crack and design codes allow for cracks in concrete. This crack is specifically monitored during the containment building pressure tests and evaluated by international experts. The crack has not grown even when the building was subjected to the pressure tests and it is not a concern for the structural integrity of the containment building.

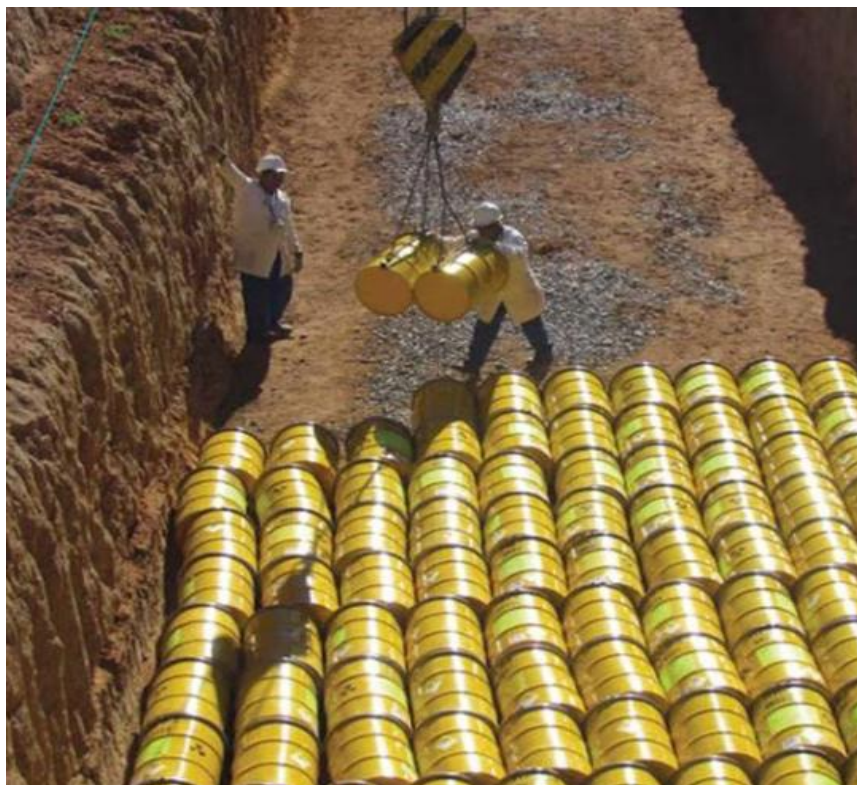
Figure 10: Radioactive waste in steel drums stored at Vaalputs National Waste Disposal Facility

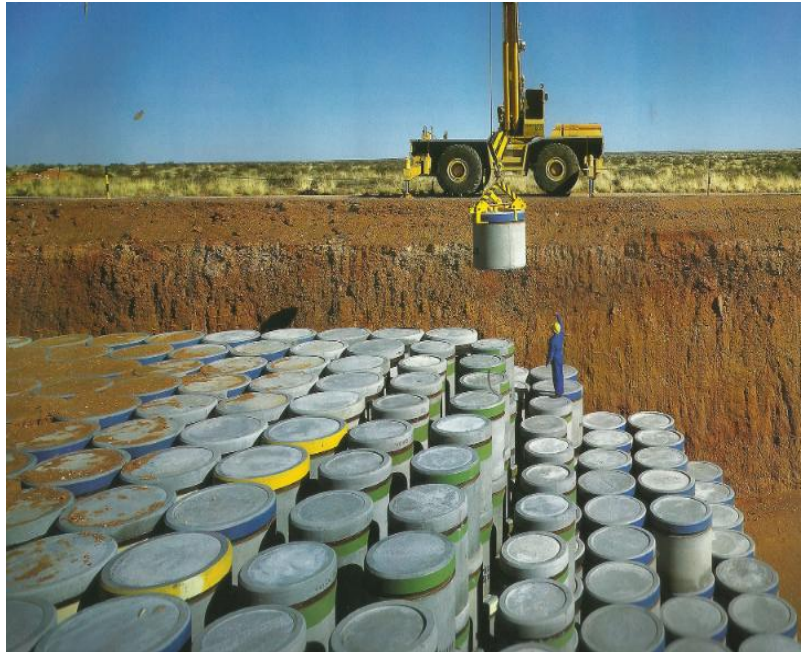
Figure 11: Radioactive waste in concrete waste drums stored at Vaalputs National Waste Disposal Facility

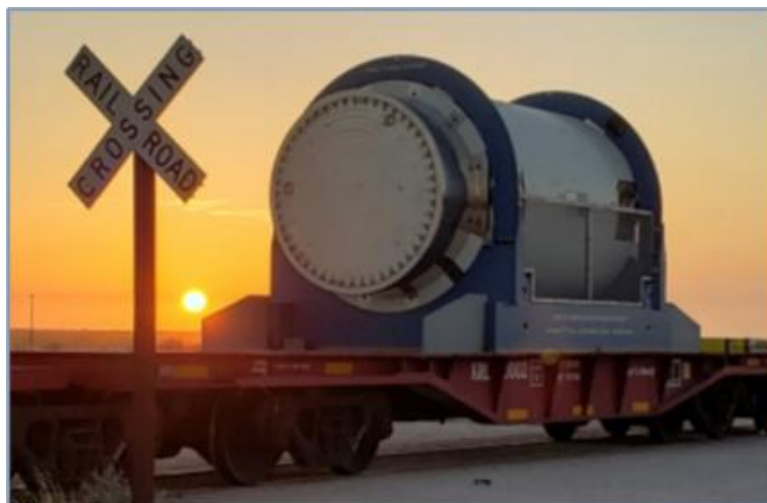
Figure 14: Dry cask for nuclear fuel storage

Spent fuel is stored in spent fuel pools (see Figure 13) and in dry storage casks at Koeberg (see Figure 14). Provision for additional fuel storage casks is planned and will be available when needed. Spent fuel pools and dry storage casks are safe and reliable means to store spent fuel. The approach is widely used and aligned with international practices.

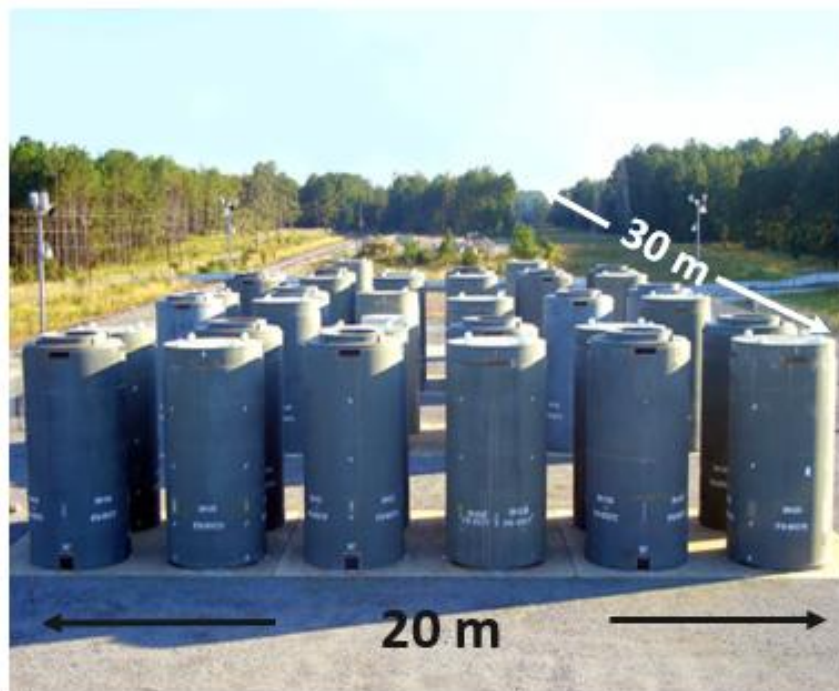
Figure 16: An example of a dry cask storage area for spent nuclear fuel
