BOTANICAL SURVEY AT ESKOM SKAAPVLEI SUBSTATION INCLUDED IN THE WEST COAST GROUP OF BATTERY ENERGY STORAGE SYSTEM (BESS) PROJECT, WESTERN CAPE PROVINCE

VEGETATION ASSESSMENT

AUGUST 2019

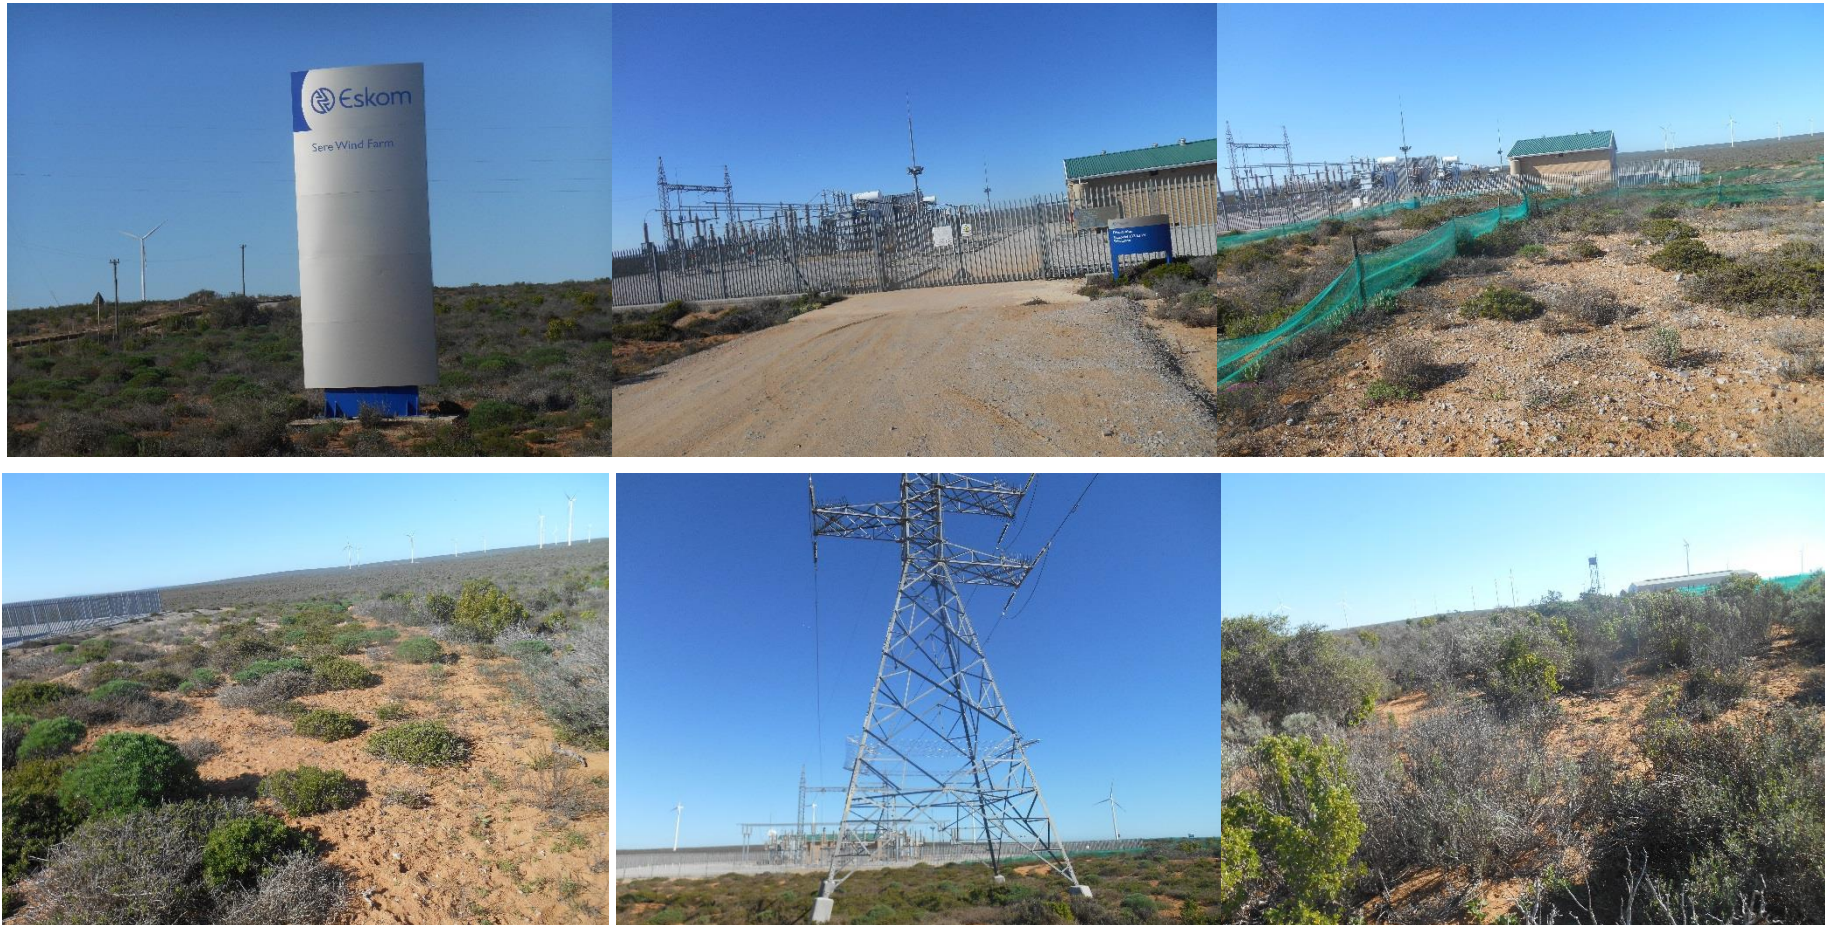
Figure 4. Collage of photographs taken within the proposed development site

The site is located within Erf 1862 Farm Olifants River Settlement (C07800070000186200000), Sere Wind Farm area, in Matzikama Local Municipality, West Coast District Municipality, Western Cape Province (**Figures 1, 2 and 3**). The collage of photographs taken within the proposed development site is indicated in **Figure 4** below.

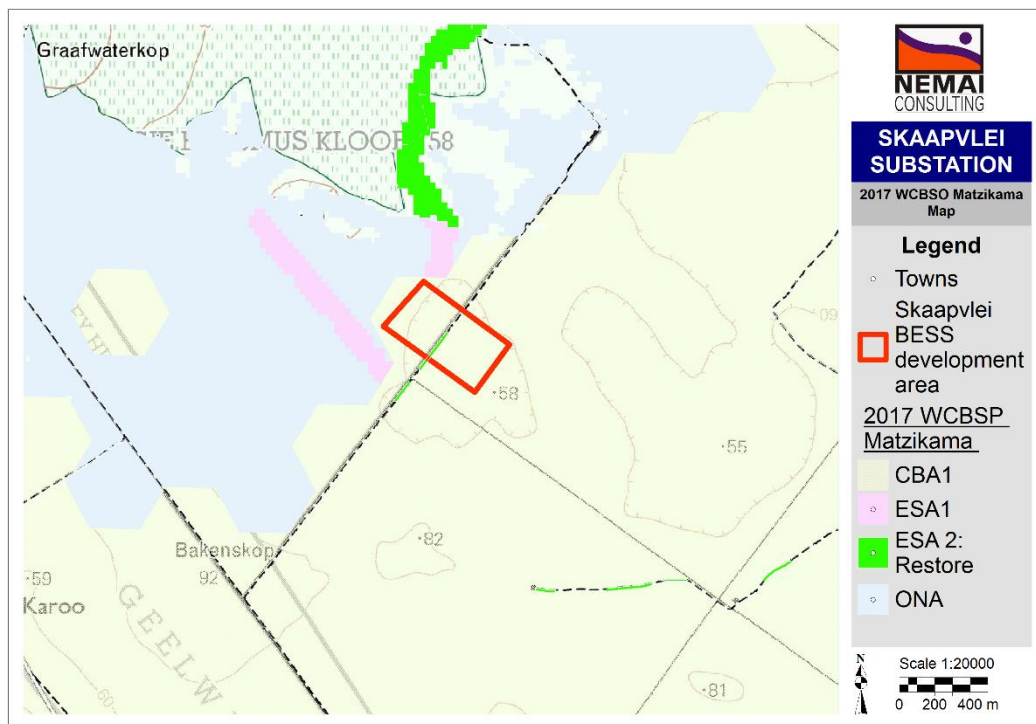
Figure 8. CBA and ESA with relation to the proposed development area

The proposed development site falls within CBA 1 (Terrestrial) and ESA 2 (Restore) categories (**Figure 8**). According to the Skowno *et al.* (2009), the proposed development area is situated in a natural habitat in terms of its land cover. The CBA on site is still functional with the presence of plant Species of conservation concern and therefore the mitigation measures in this report must be implemented in order to conserve the biodiversity and ecosystems functioning on site.

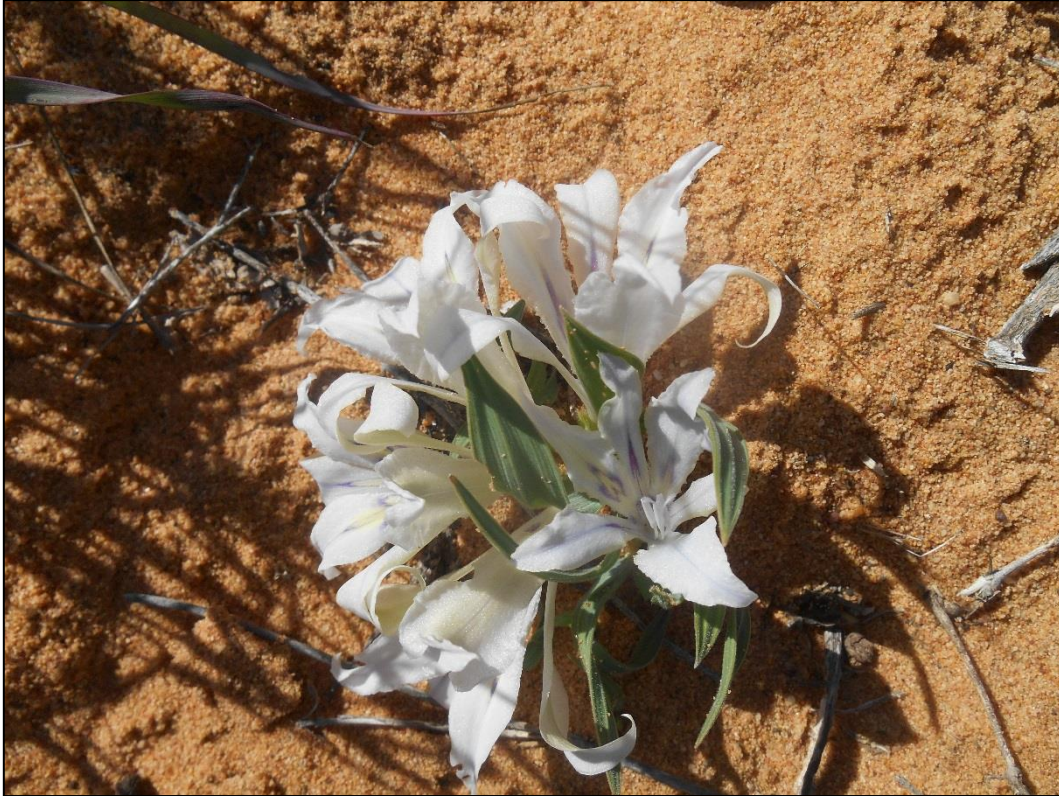
Figure 12. *Babiana virescens* recorded on site

Babiana virescens (**Figure 12**) occurs in granite hills and valley bottoms. It is found in Fynbos and Succulent Karoo biomes. The distribution of this plant species ranges from Hondeklipbaai to Nuwerus and Lutzville (van der Colff & von Staden, 2015).

During the field survey, only one plant species of conservation concern was observed within the study area, namely *Babiana virescens* (listed as Near Threatened).

Babiana virescens recorded on site

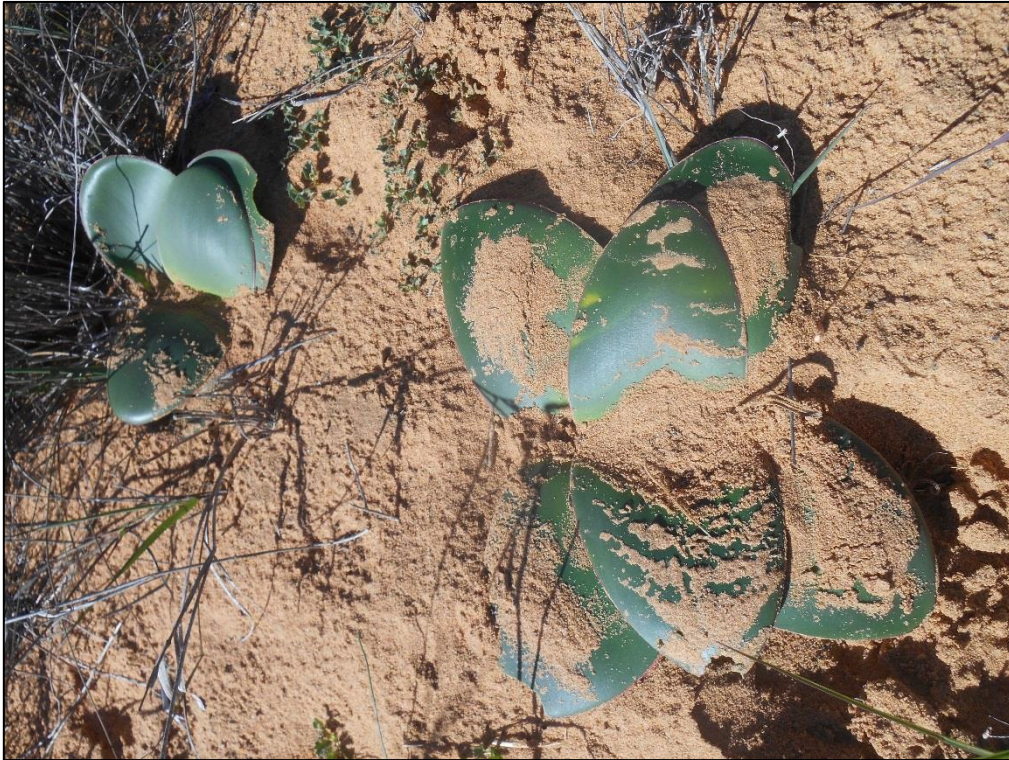
Figure 13. *Brunsvigia orientalis* recorded on site

Although *Brunsvigia orientalis* (**Figure 13**) and *Boophone haemanthoides* (**Figure 14**) are listed in the 'Red List' as of 'Least Concern' a 'Search and Rescue' strategy should nevertheless be implemented to save these plants from where they would be impacted by BESS project. These plant species are listed in Schedule 4 as Protected Flora in Western Cape Nature Conservation Laws Amendment Act of 2000.
