Camden Power Station

ROUTINE MONITORING PHASE 57
APRIL 2014

Project no.: 220-22-mon.697
Current Phase: Ph57 Final Report
Report no.: RVN 697.2/1471

Final Report - Routine Monitoring Phase 57

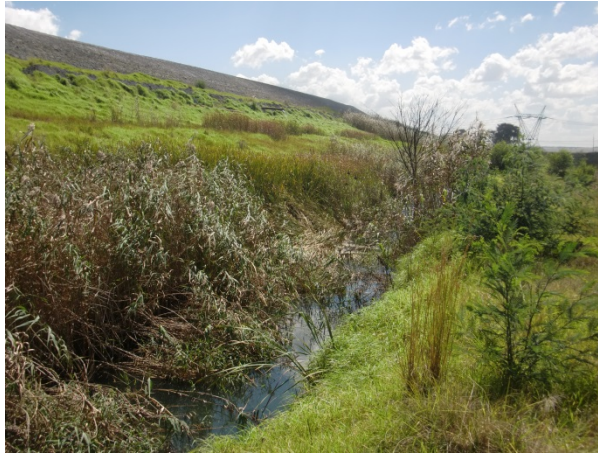
Photo 2. – Water level of C17.

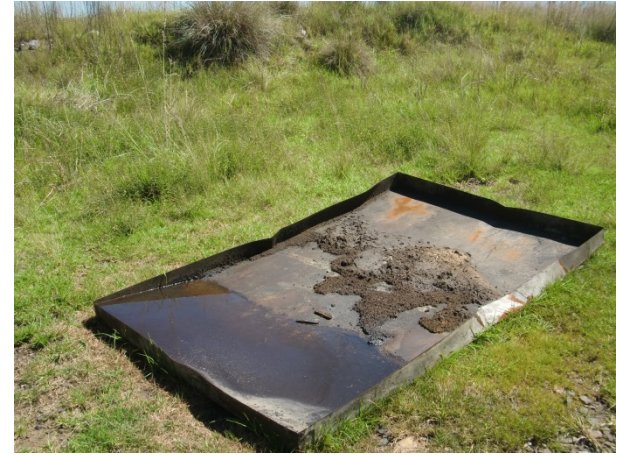
Photo 3. – Pan with oil north west of Ash dam at C17.

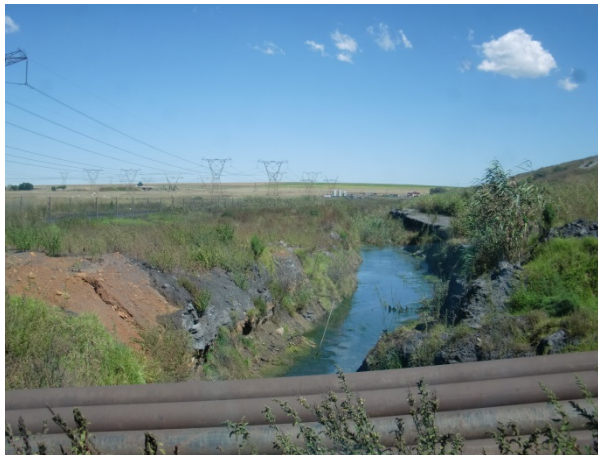
Photo 5. – Water level in Canal C18 next to contractors area.

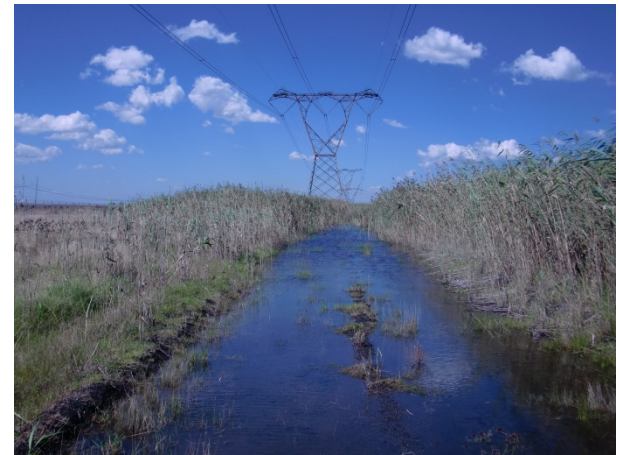
Photo 6. – Water level at C01.
