Specialist Basic Assessment report:

Proposed Letaba/Makutswi project

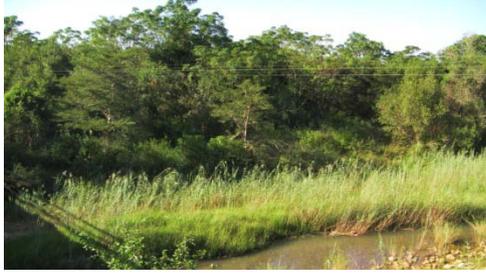
Figure 43: Crossing of the Ngwabitsi River.

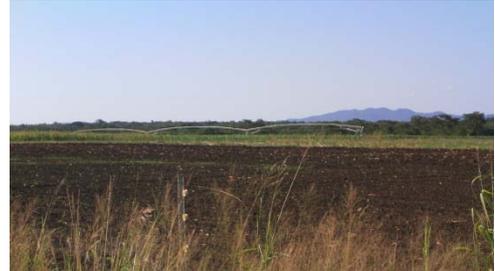
Figure 44: Cultivation an important activity along the sector.

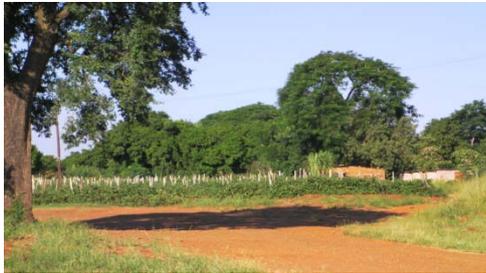
Figure 45: Intensive farming on the banks of the Ga-Selati River.

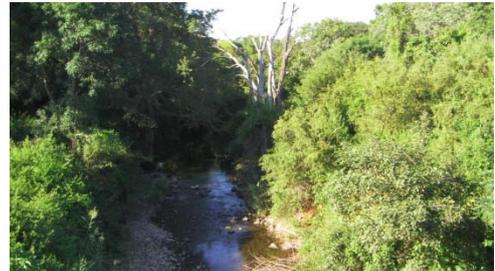
Figure 46: River crossing of the Ga-Selati River.

To the southeast of the Ga-Selati River, cultivation and grazing are the main impacts on the natural vegetation. The riparian vegetation along the streams and rivers are in a good condition and once the final route is identified, a walk down study of the whole route is needed to map (GPS) all protected trees. This information is needed to apply for permits for the cutting, trimming and removal of any of the protected tree species. These permits must be acquired before the clearing of the servitude can commence.

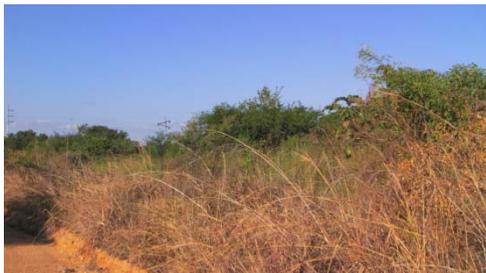
Figure 49: Some encroachment along corridor due to poor land use practices.

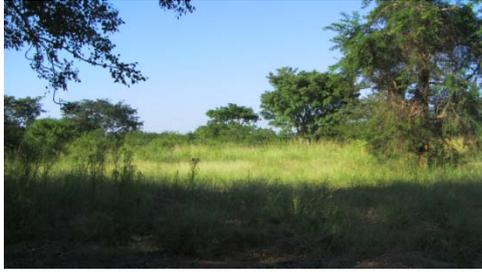
Figure 50: Grazing and cultivation modified the natural vegetation.

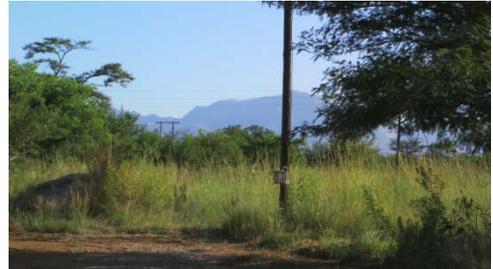
Figure 51: Vegetation around the Makutswi substation modified.

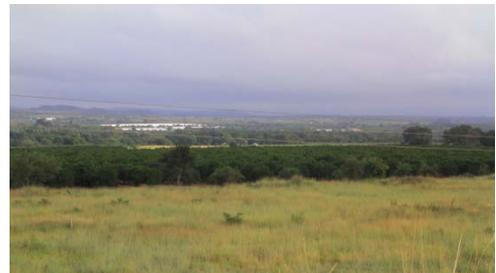
Figure 58: Corridor to the west impacted by cultivation along the river.

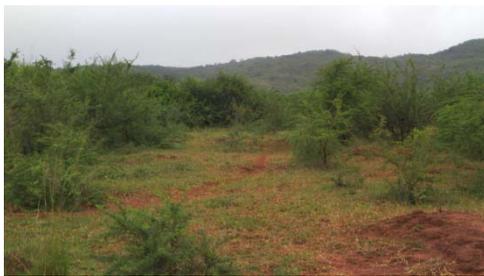
Figure 59: Impacts related to informal housing, wood collection and cultivation modified natural vegetation to the south of the R36.

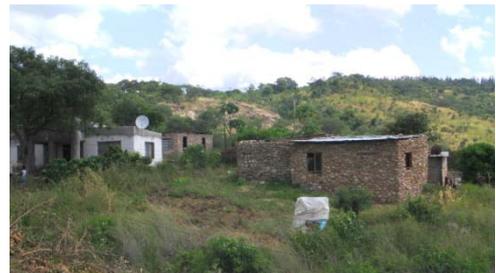
The landscape south of the R36 is dominated by low hills and although there are villages in the area, access to the proposed corridor is not available. Roads and river crossings must be constructed before the building of the power line can commence.

Figure 60: Undulating landscape south of the R36 – poor access for construction.

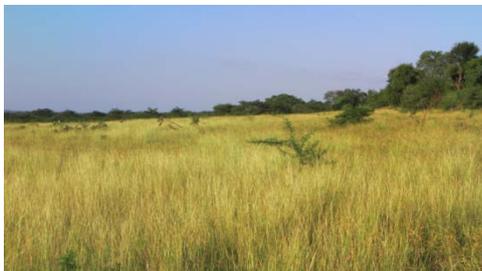
Figure 62: Vegetation north of the Letsitele River in a fair condition.

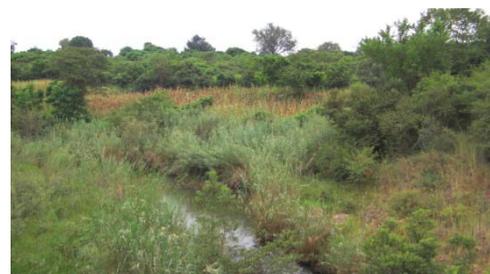
Figure 63: View of the Letsitele River – possible crossing.

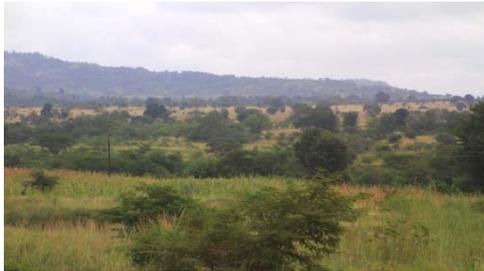
Figure 65: Natural vegetation modified south of Khujwana.

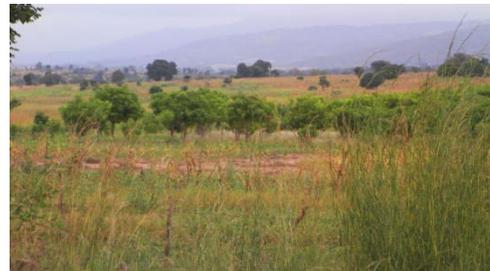
Figure 66: Cultivation an impact in the area.

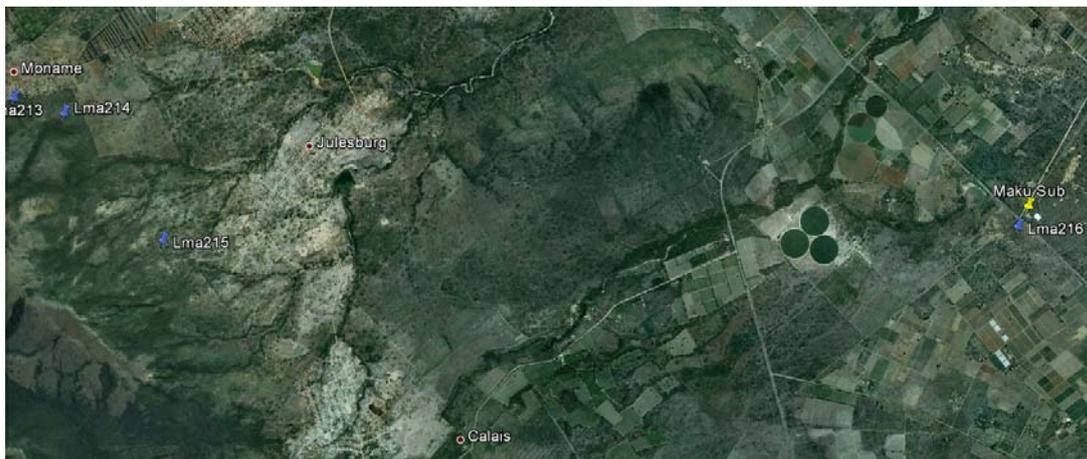
Figure 75: Last sector of the proposed power line from the Letaba substation (Alternative 1) to the existing Makutswi substation. Stream and river crossings are circled in blue and note the large impoundment west of the substation next to the R36.

The large impoundment to the west of the substation will be difficult to cross as it covers a large distance. All stream and river crossings (Ga-Selati – Figure 75 and 76) are considered as sensitive areas and act as migration corridors for biota. The pylons must be at least 50m from all stream crossings and outside the 1:100 year flood line for the Ga-Selati, Ngwabitsi, Thabina and Letsitele rivers along this route.

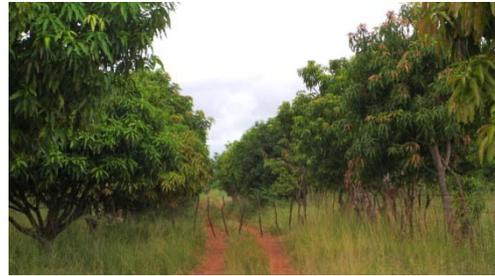
Figure 78: Many orchards in the foothills to the east of the high mountains.

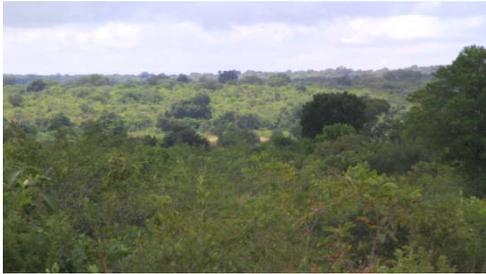
Figure 79: Natural vegetation in a fair to good condition in the foothills and low slopes of the mountains.

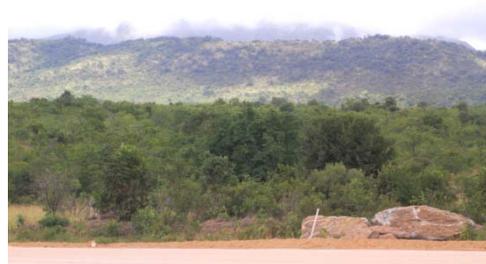
Figure 81: Natural vegetation (proposed corridor) to the west of the residential in a good condition.

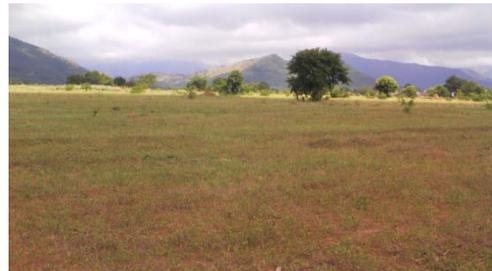
Figure 85: Large areas cleared of natural vegetation – some large trees left.

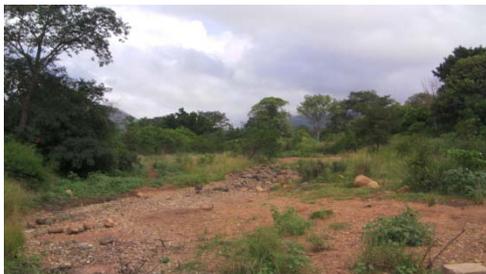
Figure 86: Example of stream and river crossings along the corridor – sensitive to erosion.
